**QUINQUENNIAL INSPECTION REPORT  
OF  
NEW BRANCEPETH, ST. CATHERINE**

**DIOCESE OF DURHAM  
ARCHDEACONRY OF AUCKLAND  
DEANERY OF DURHAM**

**QUINQUENNIAL INSPECTION AND REPORT  
OCTOBER 2020**

**David Beaumont BA (Hons) Grad Dip, RIBA, AABC**

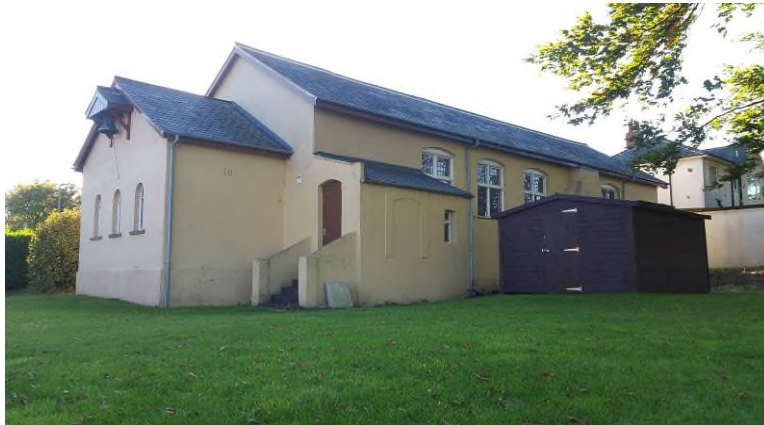
**E** **Nave** – Roof re-slated in 2019, new second hand on the E side and the best of the reclaimed on the W. The roof was raised with counter battens to bring it up to modern standard and as a consequence the slating over the porch was lifted accordingly, the work is ok.

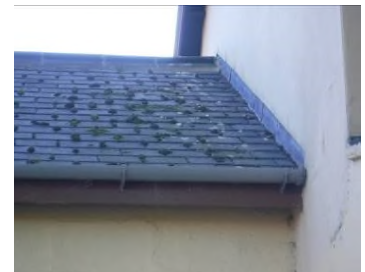
**W.C.** – Has a lean-to slate roof, this is a little bit scruffy with arisings off the main roof works and just needs to be tidied up, has mineral felt flashings elsewhere the flashings are in lead.

**Boiler room** – Has an old mineral felt that may well last another five years, it does have some moss on it, and there is no obvious leaking inside.

**Organ loft** – Has a mineral felt roof of a later period than the boiler room, this was inspected in 2019 and found to be satisfactory, possibly five to ten years left on this one.

The fascias have been redecorated recently though the undersides of them, where the exposed rafter feet are coming through the wall head aren't, and the paint is flaking away from that, it would be wise to get onto those and also to establish if there is any rot in them. The S side of the cantilevered entrance canopy's decoration is breaking down.

**Recommendation:** monitor the boiler room roof, consider decorating soffits

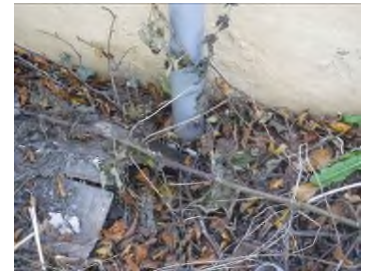
**B** Due to the reroofing works the church has been completely renewed in plastic rainwater goods on fascia brackets with downpipes to gullies and soakaway. The gullies need clearing of leaves and debris and insure that they are free running.

**Recommendation:** clear gullies

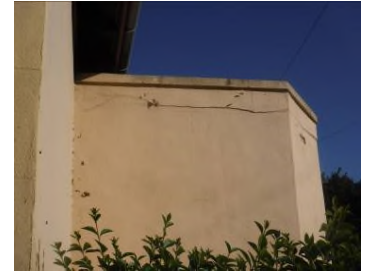
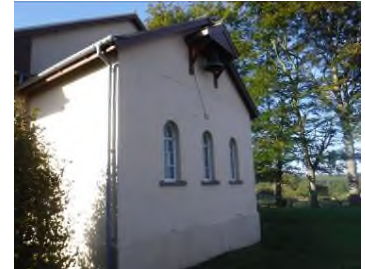
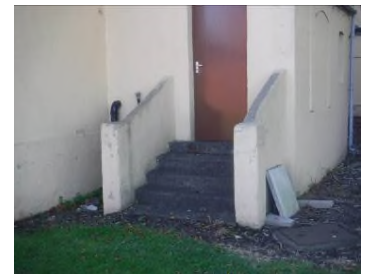
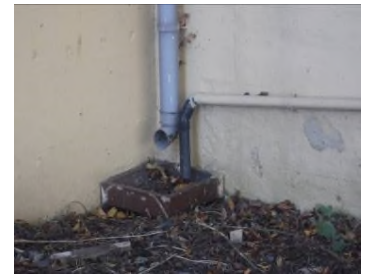
The walls are all rendered onto brickwork and they have in the past lost part of their render at low level, this has been patched over since the last inspection and as a consequence all on the entrance side looks ok.

There was a particular problem at head height around the organ chamber but that has been addressed by decoration, it looks as if the parapet wall is loose slightly but it isn't, it is just the way it is.

**Vestry** – The N side of the vestry shows its ancient plaster repairs over time but it is generally ok, bit of a crack in the render at low level on the plinth but there is no real difficulty, this area is in a different coloured paint. The W side is a little bit more scruffy with hairline but it will live for a while.

**Boiler room** – Is generally ok, has the same trouble at low level as the nave.

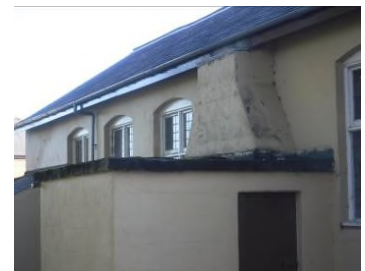
This has been reduced in height and terminated just above the throating with a lead cap on it, a bit rudimentary but I think it will do. The decoration on there is a bit poor.

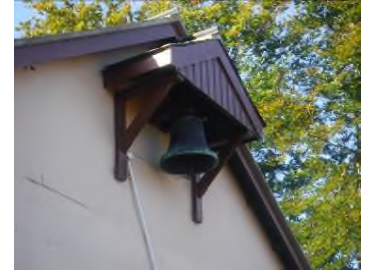
- **Bell:** The bell has been relocated on the N gable at high level above a simple lean-to slated roof. It is rung by a fairly simple operation.

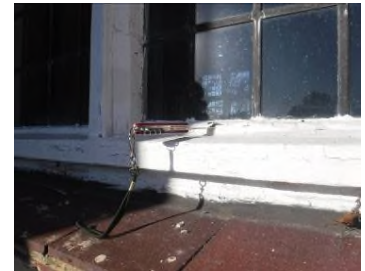
The windows themselves are timber with rectangular plain glazing, Edwardian in appearance, all very attractive, clear glass, some of the cills are rotten and some of the horizontal glazing beads above the cills have also rotted, they are all serviceable and keeping the rain out and they are in not too bad a condition since the last QI, but the church does have it in mind to attend to repairs in the next quinquennium.

**Recommendation:** E set aside funds for future window repairs

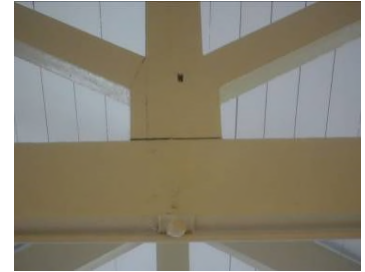
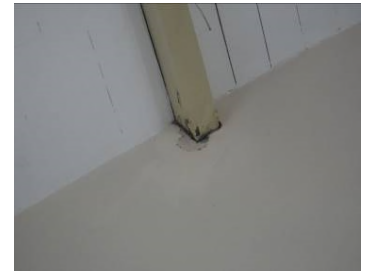
- B** Five trusses form the main nave space, supporting purlins onto ceiling boarding. Every second truss has a projecting supporting member going down into the wall head and the truss condition looks fine. There is some slight possible deflection to the penultimate s beam as the gap has opened up on the truss post-but looks historic. Is there rot at the purlins at the n end? Or is this decoration marks?

**Recommendation:** inspect purlins

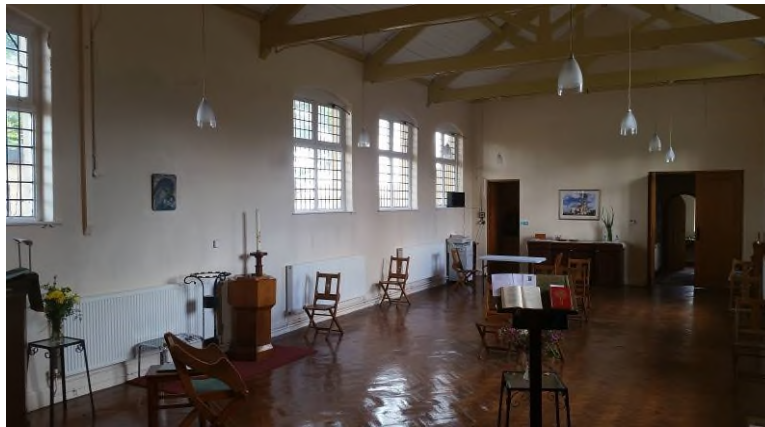
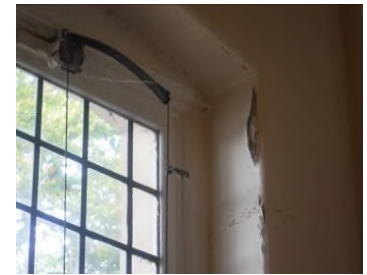
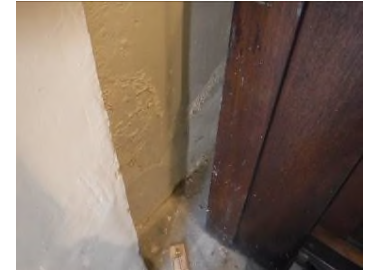
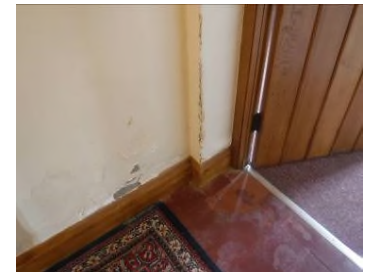
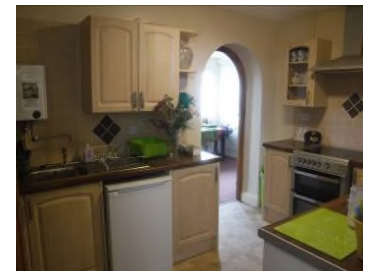
**Nave** – The N end of the nave was quite a poor arrangement and that has now been attended to and recovered very well, however there is a little bit of timber that is showing rot at the eaves line. The warden advises that it has been treated and is dormant. It could be removed to improve the decoration of the gable. There is no access into the space behind it- over the kitchen and vestry. There looks to be the ghost of a blocked in opening at the apex.

Some plaster breaking down at window reveals

**Porch** – All ok apart form a little damp close to the vestry corner and there is a bit of rust to the door reveal, plaster stop. Nothing to do other than keep on top of the decoration.

**Recommendation:** Consider if it is worthwhile having the kitchen/Vestry roof voids available for access. Remove the rotten timber at the nave gable, upkeep decoration at reveals.

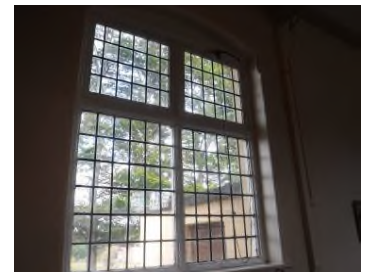
- **Nave** – Some slight dirt marks to the glazing, comes from age but generally it is all sound, the interior finish of the windows looks ok and there are no noticeable draughts. They have top hung vents, some with cords, others are missing, and they don't look as if they operate or are planned to. One of the windows glass is buckling at the W side of S end above the pulpit and there is one cracked quarry on the E side. Repair during joinery repairs

**Vestry** – Metal single glazed windows with obscure glazing apart from one in clear, possibly as a result of a break-in in the past. These also have top vents but they are none operating. Slight marking of rust coming through but no attention required.

**W.C.** – Plain timber window with obscure glazing, the top opening light doesn't, it is probably painted shut.

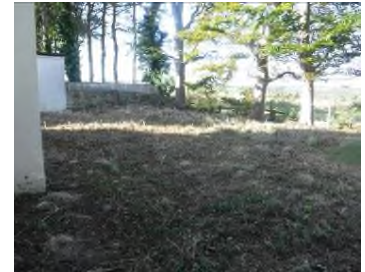
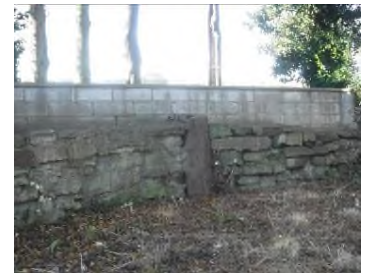
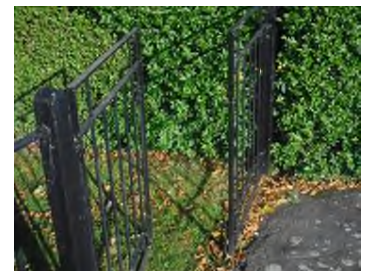
**E side** – This side has field fencing, rather broken down in timber with sheep fencing and barbwire looks a bit scruffy, is this the responsibility of the church? Next to this a line of eight Beech trees planted quite closely together but they do provide a good wind break.

**S side** – This boundary is to a house property it is a mixture of low concrete stonewalls and part of a building. There is a tree stump built into the wall or rather, the wall has been built around the tree stump, it looks like it is managed.

At the rear of the church there is a rough area that has been swept up, the remainder of the area is in grass. On the E boundary the garden double gate doesn't quite latch very well.

**Recommendation:** establish boundary ownership

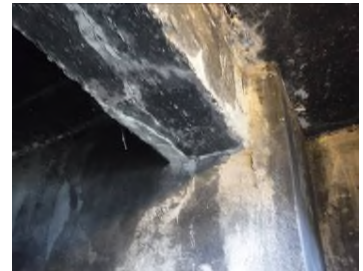
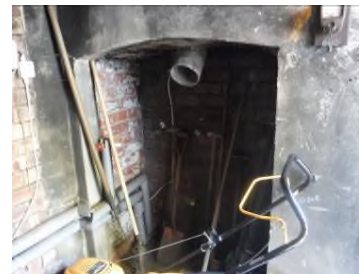
- **Ceiling** – Concrete ceiling with one beam running across it, a little bit damp looking at the E end going onto the chimney breast, looks like its old corrosion and it's safe.

The door is a bit ancient and has still got a bit of decoration failure but it has now been pieced in at the bottom with a new covering and that is adequate.
