Christ Church, New Seaham

Diocese of Durham  
Archdeaconry of Sunderland  
Deanery of Easington

Quinquennial Inspection Report  
June 2025

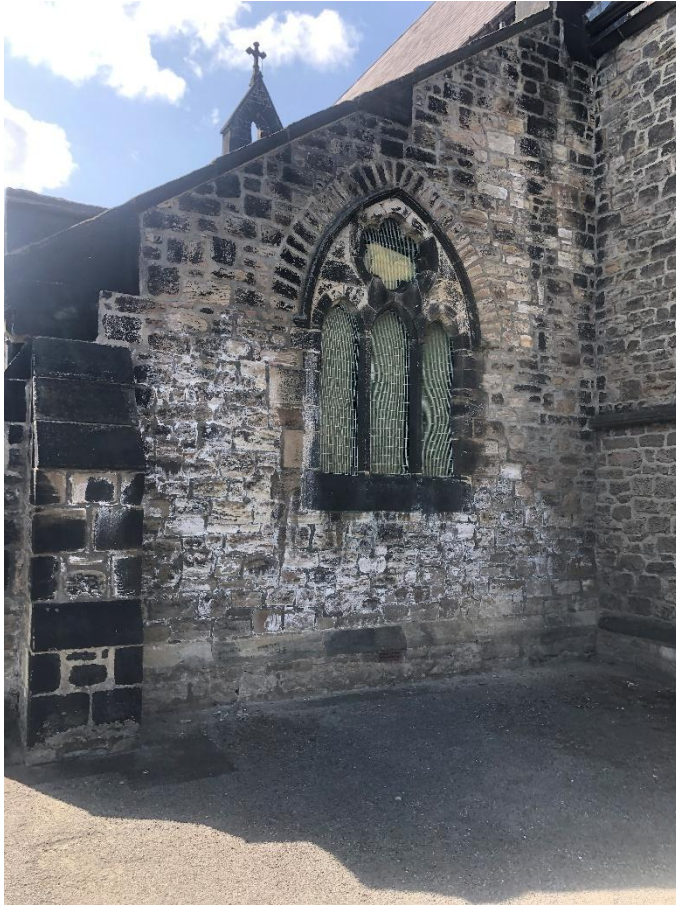
Fig. 1 (IMG\_8893)

| Remove external salts from east window frontage to south aisle (see Appendix B, Fig. 1) | £200.00 |

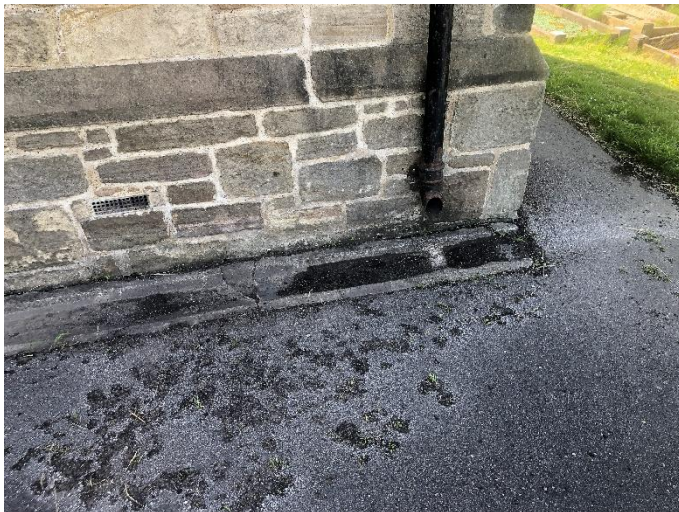
Fig. 2 (IMG\_7159)

| Provide improved ground level rainwater removal (see Appendix B, Fig. 2-3) | £1,000.00 |

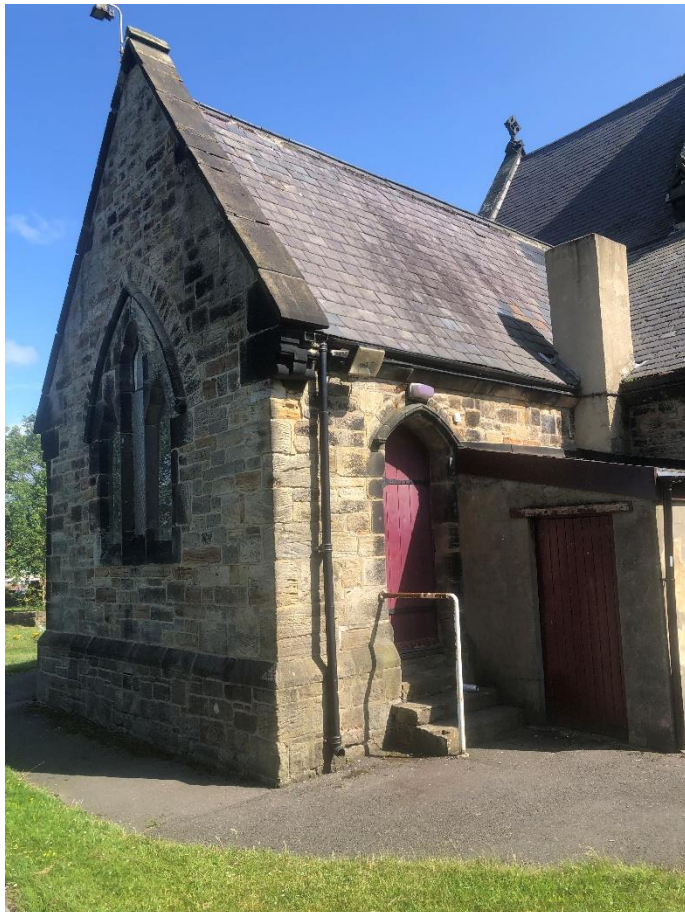
Fig. 4 (IMG\_8875)

| Comprehensive external lighting replacement with LED units (see Appendix B, Fig 4) | £2,000.00 |

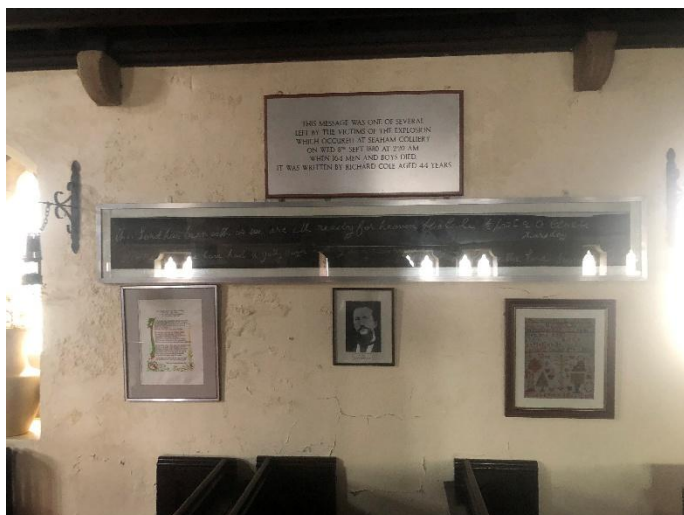
Fig. 5 (IMG\_8811)

| Various church interior walls to be re-decorated, having removed affected plaster; replaster with breathable coating (see Appendix B, Fig. 5) | £5,000.00 |

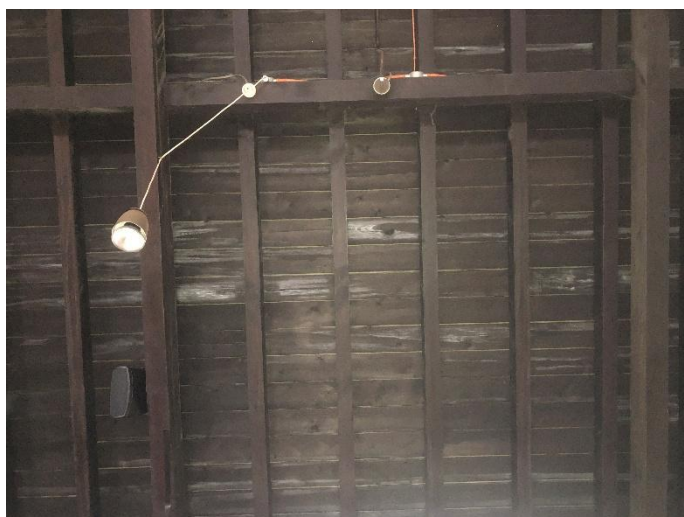
Fig. 6 (IMG\_8790)

| <b>INTERNAL INSPECTION</b> | |
|---|---|
| 8.4 | Northern aisle timber boarded ceiling shows signs of salts/ moisture penetration (see Appendix B, Fig. 6). |

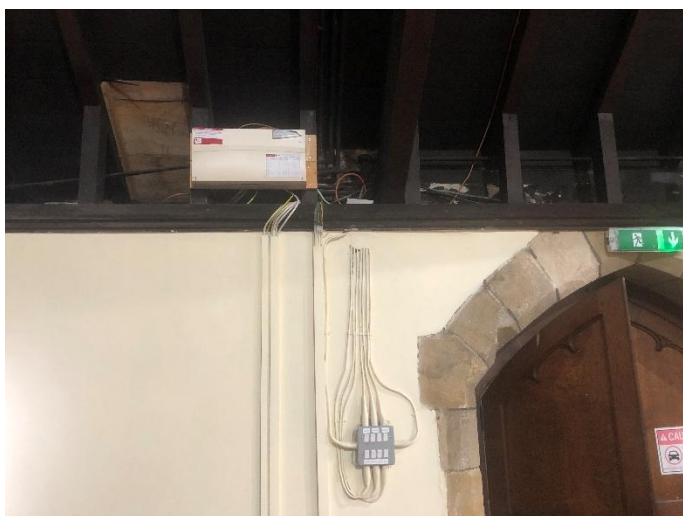
Fig. 11 (IMG\_8841)

| 15.1 | <p>The electrical installation appears to be of different ages. The lighting circuits appear to be in MICC cable, with other circuits in surface mounted plastic conduit (see Appendix B, Fig. 11).</p> <p>The mix of tungsten/halogen lighting in the nave, chancel and aisles is less efficient than contemporary equivalents. More recent LED floodlights at chancel arch heads are not all working and high level installation means replacement needs specialist access equipment.</p> <p>There are plain fluorescent, surface mounted fittings elsewhere, and wall mounted circular fluorescents to the accessible WC.</p> |

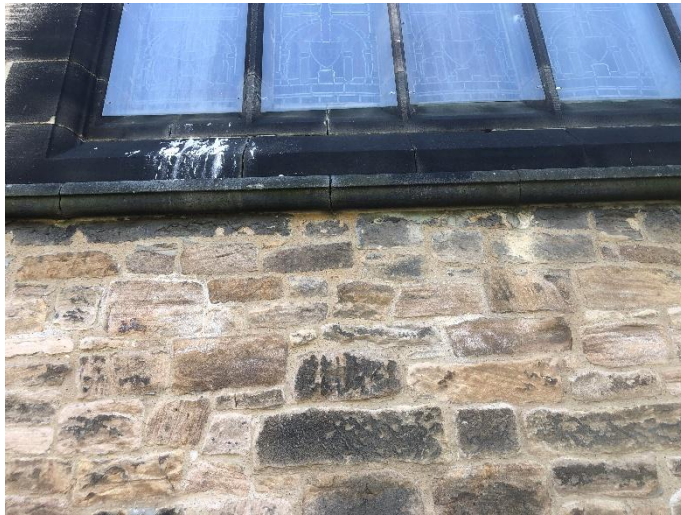
Fig. 12 (IMG\_8891)

| EXTERNAL INSPECTION | |
|---|---|
| 5.4 | Generally, all window sills and joints to be checked and repointed as required. There are a small number of open joints to the east window (sill/drip course) – see Appendix B, Fig. 12. |

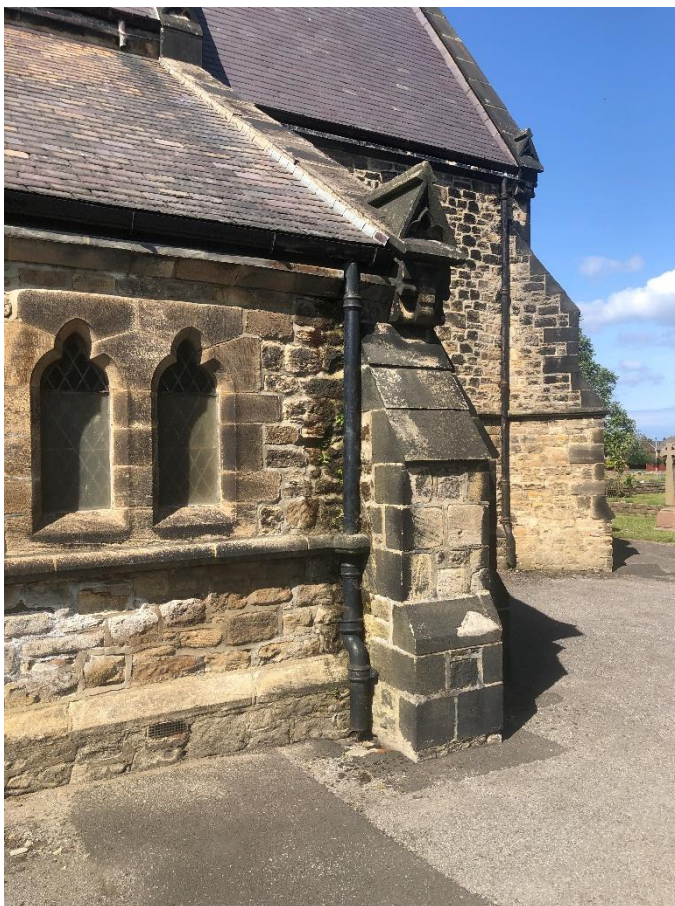
Fig. 13 (IMG\_8902)

| EXTERNAL INSPECTION | |
|---|---|
| 4.2 | A number of downpipes are terminated above dished channels or directly over tarmac. Cracks or lack of adequate fall may result in water collecting at wall bases. This may result in rising dampness to walls without damp proof courses (see Appendix B, Fig. 13-14). |
| 5.2 | <p>The dark, weathered, dressed stonework is generally sound and well pointed (see Appendix B, Fig. 13) with some areas in need of repointing.</p> <p>Any future pointing should <i>not</i> be of the 'projecting struck' cement-based pattern evident in the south aisle. Lower areas of the west elevations have a cementitious pointing that should also be avoided.</p> |

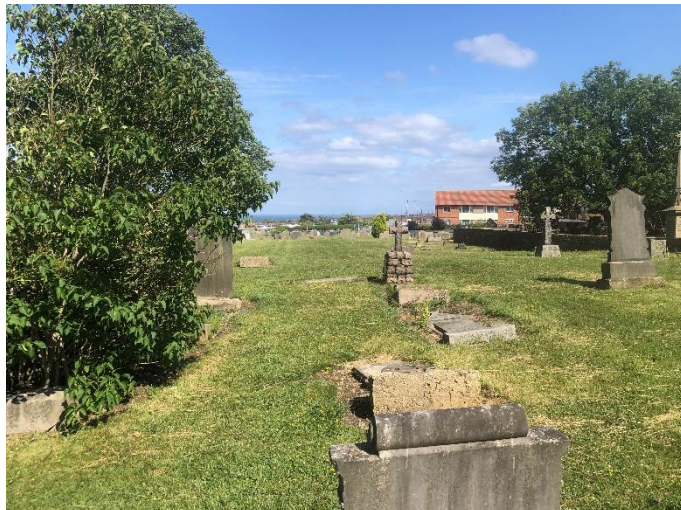
Fig. 17 (IMG\_8879)

| <b>CURTILAGE</b> | |
|---|---|
| 21.2 | Other decorative trees and shrubs in the churchyard are healthy and help punctuate the open space. However, there appears to be a pattern of progressive encroachment by self-sown planting on memorials, which will be destructive to headstones etc (see Appendix B, Fig. 17). |

| <b>CURTILAGE</b> | |
|---|---|
| 21.3 | The precise extent of ownership and consecrated ground should be established to determine responsibility. |
