**QUINQUENNIAL INSPECTION REPORT  
OF  
ST. MATTHEW, NEWBOTTLE, CO. DURHAM**

**QUINQUENNIAL INSPECTION AND REPORT**

**AUGUST 2020**

**David Beaumont BA (Hons) Grad Dip, RIBA, AABC**

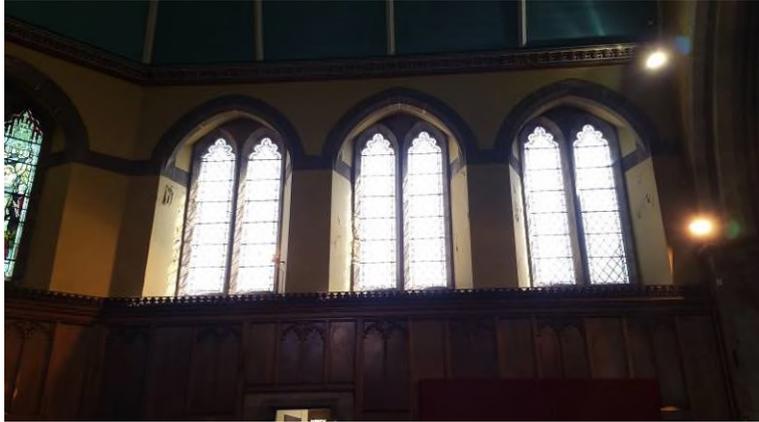
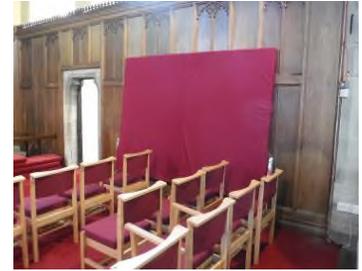
The three clerestory lights within the chancel provides significant glare to the projector screen and there have been early thoughts on how to reduce the glare by installing blinds. This has been touched on by the PCC and early discussions have been held with the DAC.

It would be worthwhile in developing these proposals to look at a drop down chancel screen and establish its cost and to seek out a quotation for blinds at the three windows for comparison. There are technical matters to resolve in both of these instances but review of both possibilities might lead to a solution.

**Recommendation:** consider developing further proposals

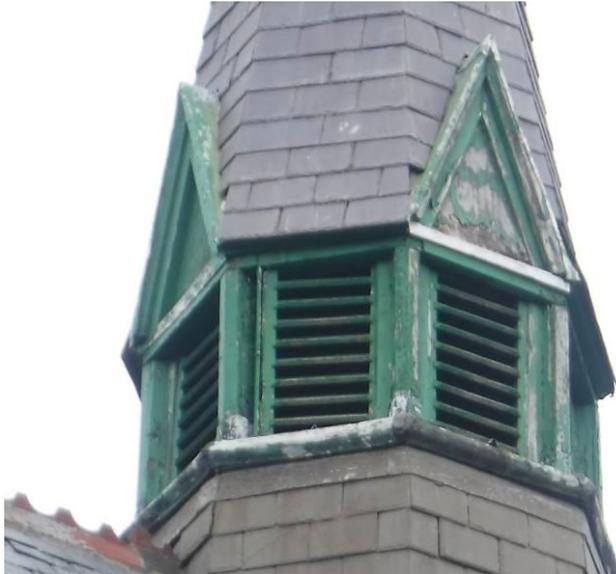
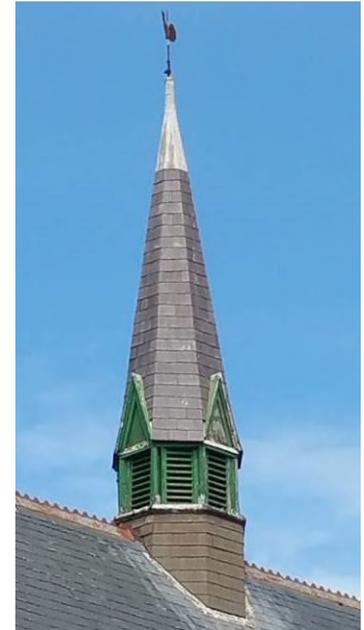
#### C Fleche:

This is a steeple above the nave crossing and this is alleged to be in fair condition.

The structure was looked at in 2005 by Howard Smith the DAC Bells Advisor. We need to see his report. A couple of years later a new bell sound system was installed. So it has seen people in it and the Vicar tells me that it is in good condition, but it doesn't look it from the decoration outside.

The slating all looks ok. The timber frame and louvres with small dormer features, are in painted timber work whose decoration has broken down now. The wonky louvre is the access panel not correctly fixed back.

**Recommendation:** Establish if there is a report on the bells and by association perhaps on the fleche. Carry out an external and internal inspection of the fleche. Repair as necessary and redecorate joinery.

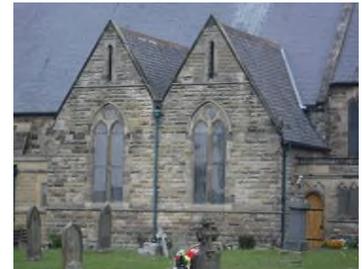
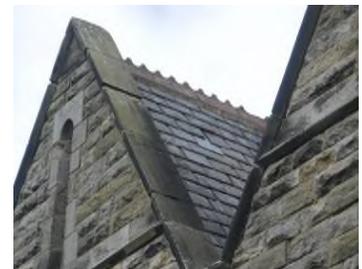
Some ridge bedding coming out of the western most ridge, the southern one has also been patched but it seems ok, not able to see into the valley where there is a lead-lined box gutter, these could do with being inspected. Both the north and south ridges bedding is poor. The valleys as what can be seen from the ground look ok, as does there flashings up against the nave, there has been some work to the western most and it looks like one is missing, it has also got a soaker flashing in lead alternative material by the look of it.

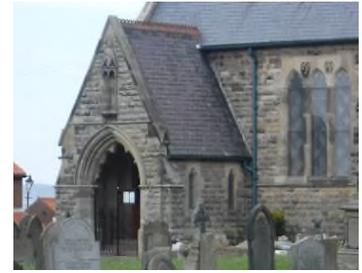
**South porch:** is generally fair, there is some ridge bedding coming out but it is not a problem at the moment. The water table back pointing in mortar doesn't look so good and there looks to be flashing missing at the foot of the eastern slope.

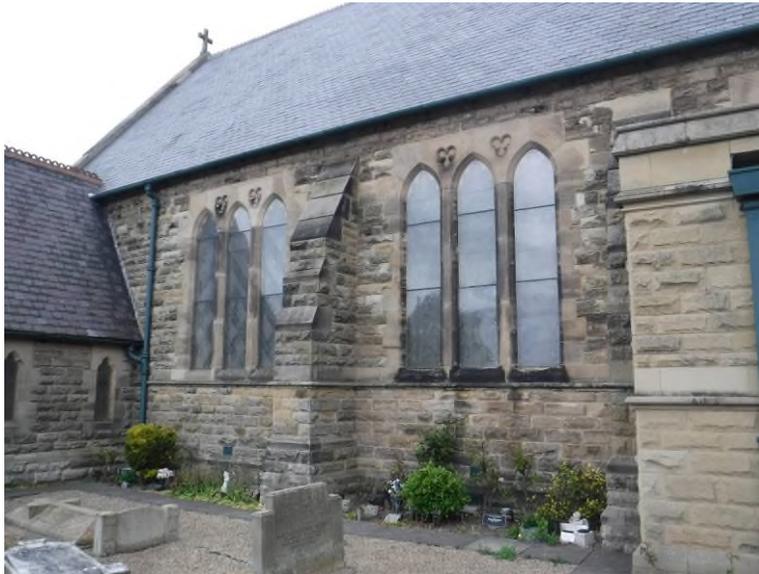
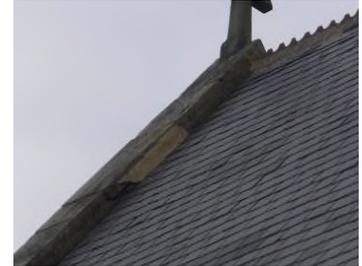
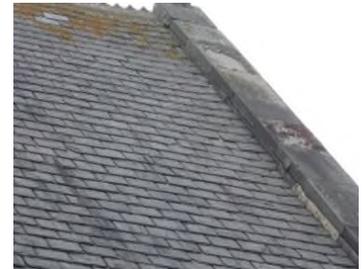
**Nave:**

**South side** - has about three missing tiles. The water table at the west mortar pointing is breaking down, it doesn't look as if there is lead behind it, and it is breaking down at the apex.

**North side** – multiple repairs in the past with ill matching slates, some slates missing. The mortar bedding to the water table breaking down badly at midway.

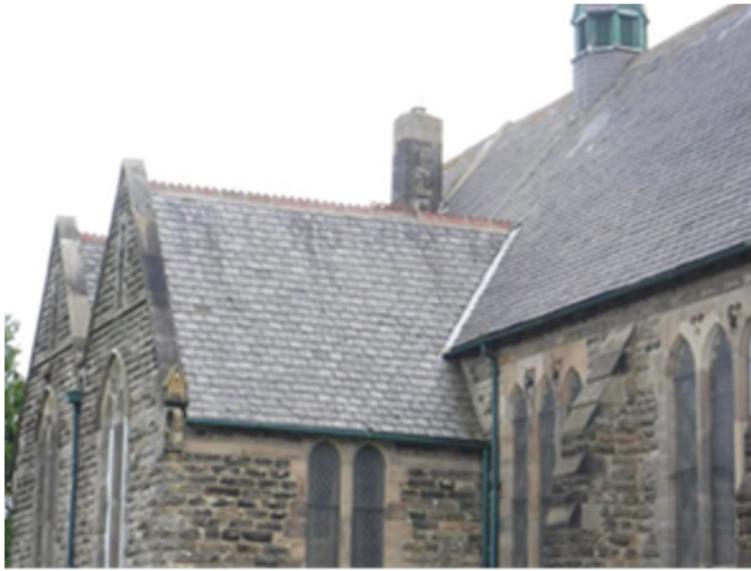
Ill matching ridge cresting on the western most side, slating reasonable, one broken one right down at the gutter and a poor replacement not matching.

There is also a lump of stuff in the foot of the lead gutter, the lead gutters themselves look ok. This has a box gutter which had an attempted theft which wasn't stolen and was repaired in recent years, I can't see into it like the south side.

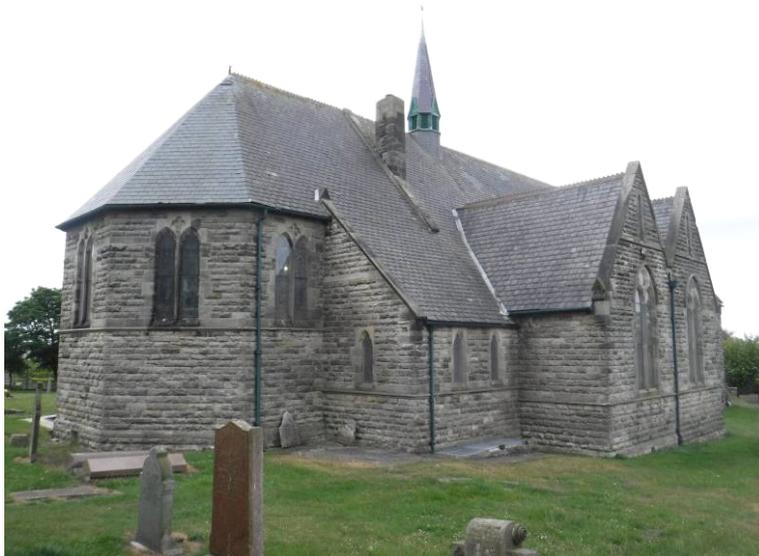
**Chancel:**

This shares a roof that sweeps over the Memorial chapel. At the junction of the nave the wall head comes through to create a coping this coping the condition of the mortar flaunching against the coping isn't great at the foot on the nave side it is coming away, this has the chimney which is redundant and can be cleared away in time, the top surface of the water table looks poor. There is damp inside at this point.

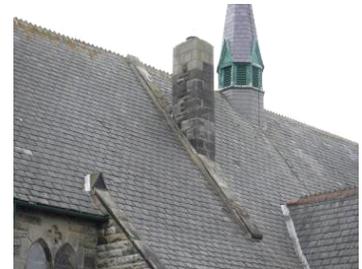
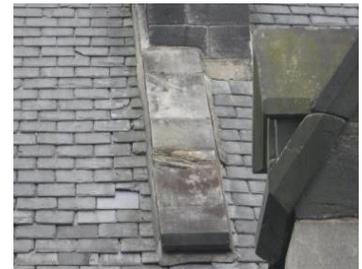
The ridge cresting over the chancel looks to be two different patterns but the bedding seems ok. There is an ill matching replacement with tingle up at the ridge, generally the sweeping

of the roofing is ok. The mortar haunching over the memorial chapel water table is ok.

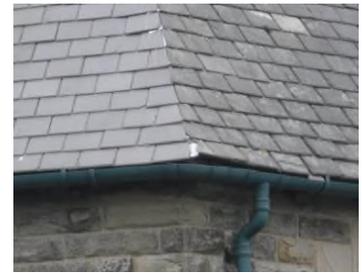
The chancel is faceted and has lead soakers at the cut mitre hips, the hips have had storm damage and there are some loose slates in the gutter and at the apex the slates look to be lifting. The cross has lost part of its iron ornament. Slate missing at the south east corner.

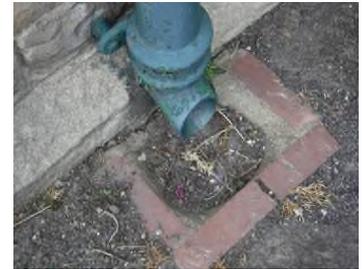
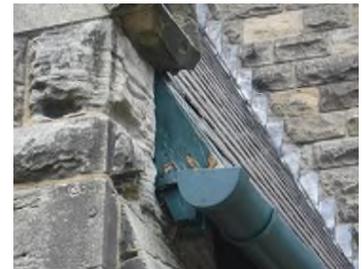
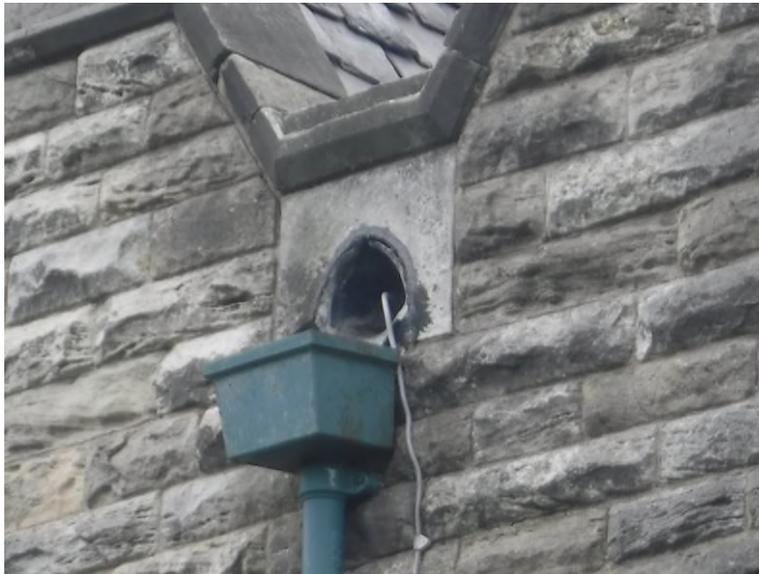
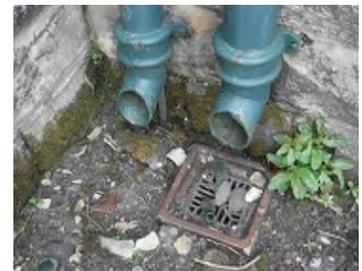
Individual defects are; going into either salt glaze or more modern gullies. Some are down to the ground, some are open shoed but all generally seem in good condition. The north transept pipe discharges to ground.

No obvious problems on the gutter joints, gutters look at little low on a couple of occasions on the south side but there is no other position they could be in.

Bottom shoe coming away from the north transept central downpipe, perhaps this one should have anti-climb paint on it. There is a bit of grass in the memorial chapel gutter.

**Recommendation:** Consider anti climb paint on transept pipes. Connect discharge of north transept pipe to drainage.

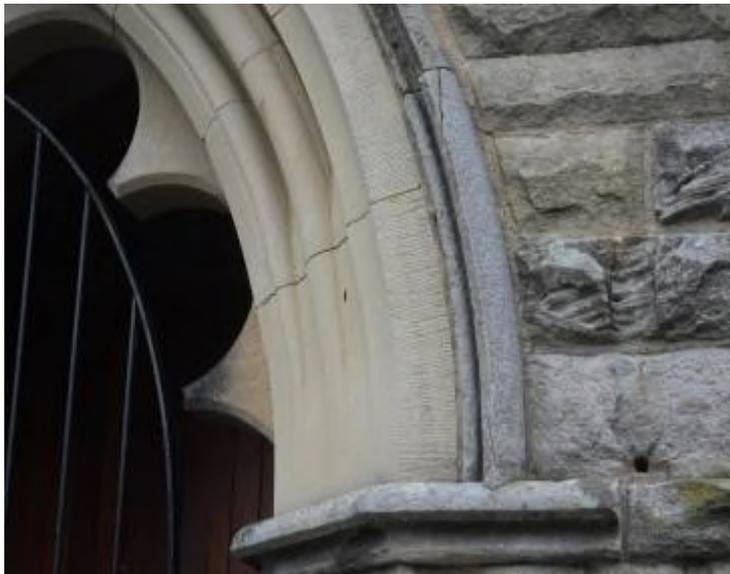
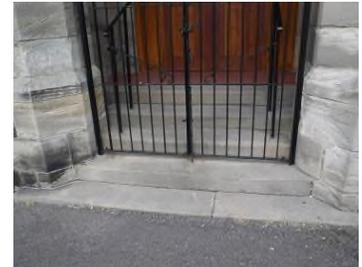
Slight crack to the hoodmold on the western side of the arch at the springing point. Slight open jointing to the hoodmold a bit of lamination to the water table but no issue. Generally the walling is sound, a bit of damp showing on the west side at low level. Windows are ok.

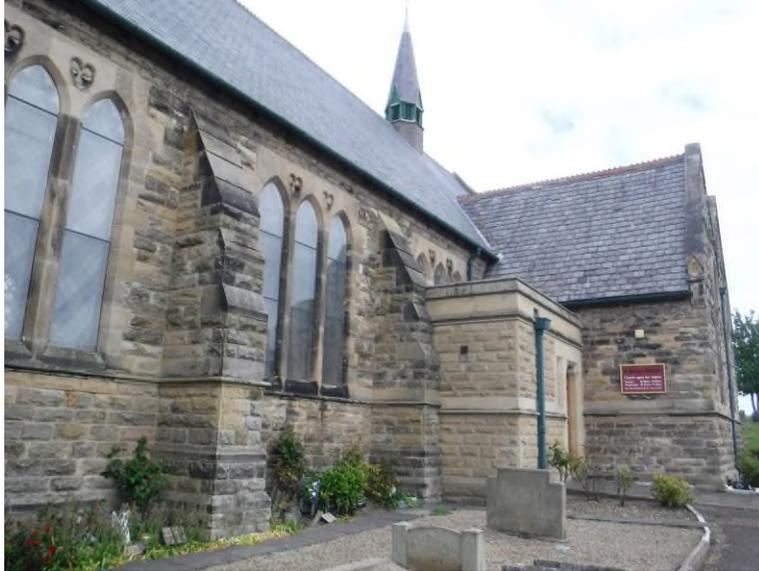
**South Nave:**

Erosion to the central window cills but no problem presently.

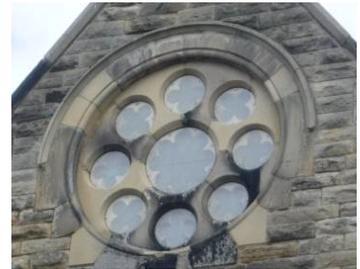
**West Nave:**

There is some replacement ashlar work to the circular window at the apex, otherwise the bottom cill part looks as if it is eroding slightly but I think it is ok for the moment, stringcourse looks ok as does the over-sailing corbel course. Three, two light windows that have had their hoodmolds replaced and two have had their bottom mullions replaced in the past and also their cills, all looking fine. Walling is generally fine as are the buttresses.

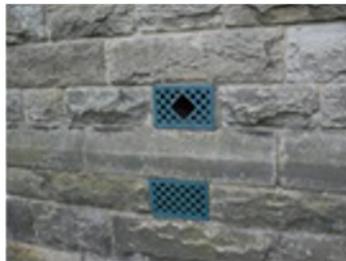
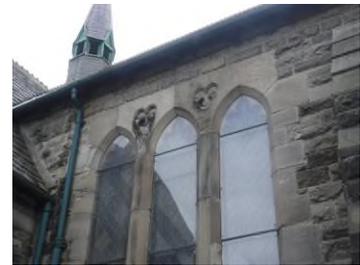
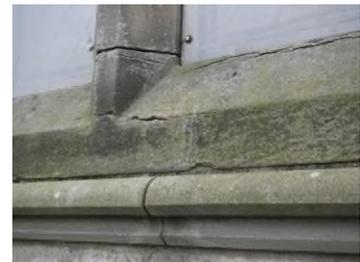
**North Nave:**

The western most has a little cracking to the part of one of the arches but has no need for work at the moment. Some slight shaling if the mullions but again they are ok.

One of the air brick cavity ventilator grilles has lost part of its grid and might be an entry for mice. There has been some big replacement work to the head of the plate tracery and some mullion parts as well.

**Recommendation:** repair grille

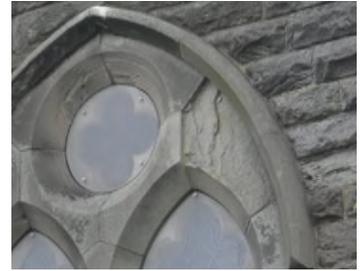
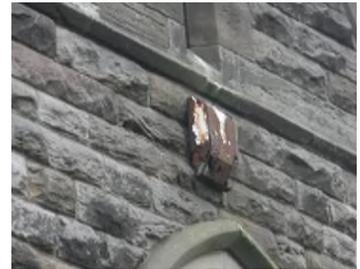
The lighting strap comes down in the middle of the wall, it is unprotected. There is a shear crack below the stringcourse, in fact, it is the only cracking evident on the building. Perhaps a bit more shaling starting to occur on the north west corner but again no action required.

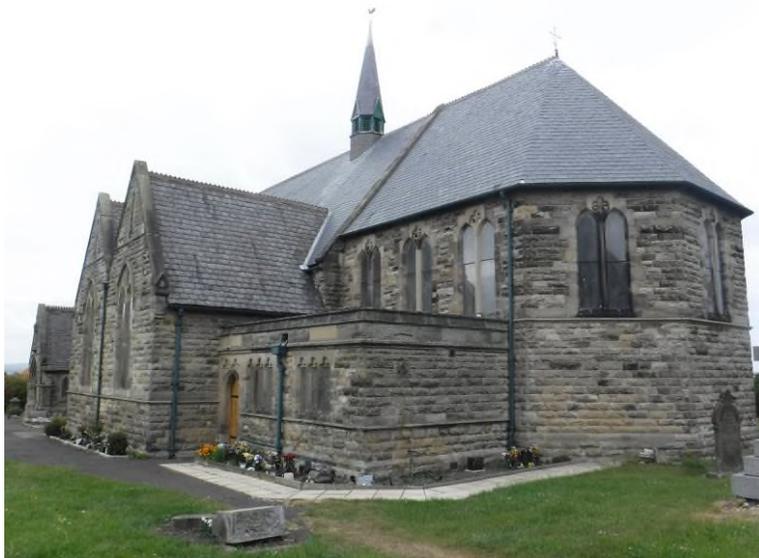
**Chancel:**

Walling is generally fine, the northern most lancets at the arch have had a bit of patching in the past, slight touch of lamination about them but they are in fair order.

It is interesting to note that it is the quatrefoil weathering that has caused the further damage to the stonework panel and that's why a tilt fillet of mortar at 6 o'clock position of the quatrefoil

provides a water shedding to avoid water collecting, which then freezes and cracks and so break off the bottom of the quatrefoil.

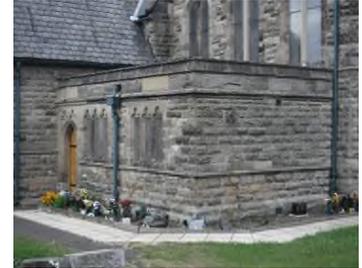
Flat roof construction. The parapet looks ok, some deep erosion on one stone on the eastern side but ok. Has been some replacement of the hoodmold close to the door but otherwise fine as are the window dressings, they all look ok, though the polycarbonate looks a bit dirty here. The walling is generally sound.

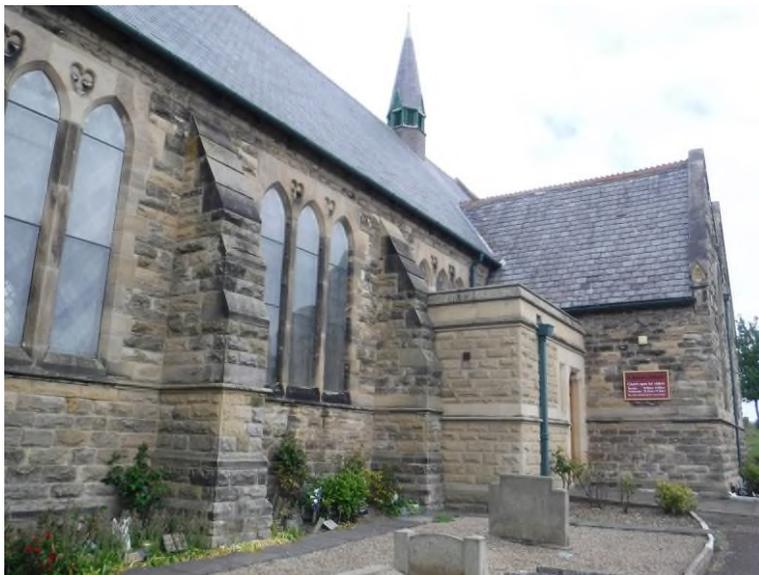
### **Disabled W.C.:**

This is a modern addition and all the masonry is in fine condition.

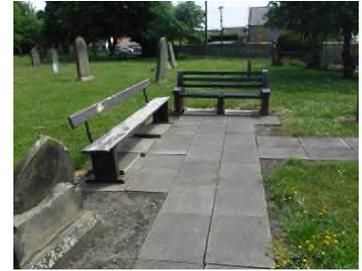
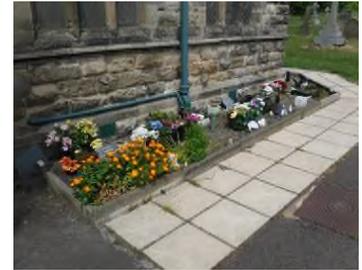
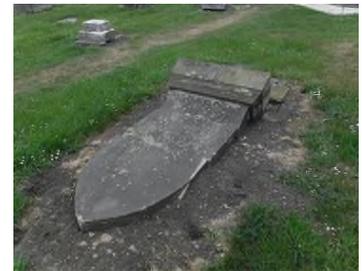
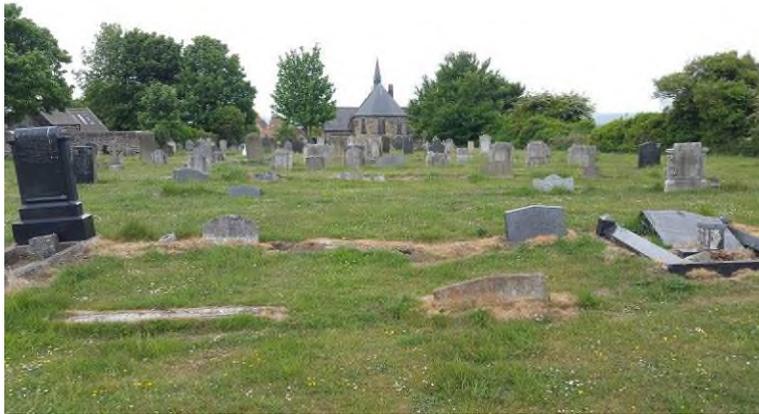
Internal grounds- the west path tarmac is poor and the low side walls are tumbling.

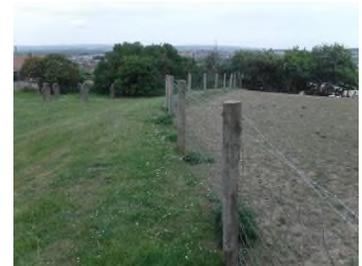
### **North side:**

Fencing and stonewall looking on to new paddock area, the condition is fair but could do with tidying up. North west corner is now barbed wire and sheep netting.

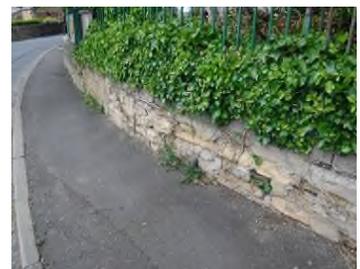
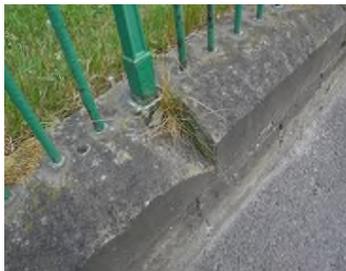
At this point the boundary goes to the private land to the house next door. The railings here are undecorated. Wall top is ivy covered and a bit of a mess. It is bowing slightly, it looks like a different style of wall to the principle wall. It looks like the gas main comes in here at low level.

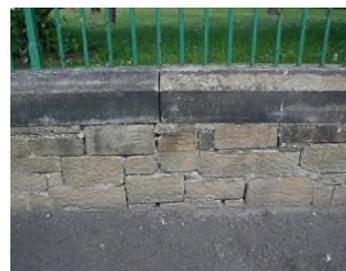
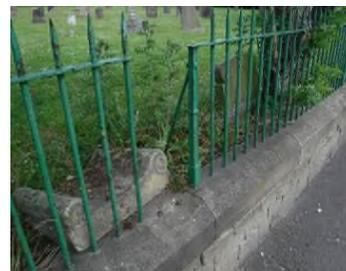
Further along the railings are decorated but rusting in places. The copings are broken due to iron rusting. Along the length of the wall there are buckles and twists to it. It is generally ok but it has had some knocks. It could really do with a repoint, the

principle issue is that the two trees on the boundary are effecting it now, they are beginning to bulge the wall out and the eastern most tree is pushing it into the lamp standard that is taking the three phased power line by the bus stop.

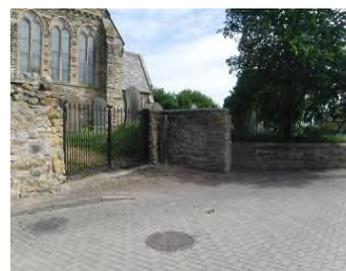
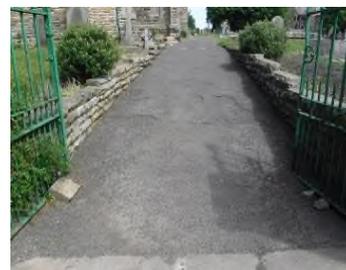
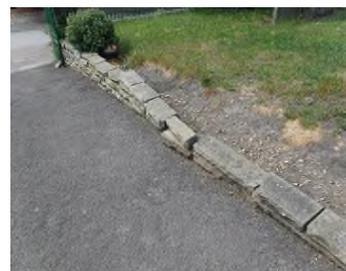
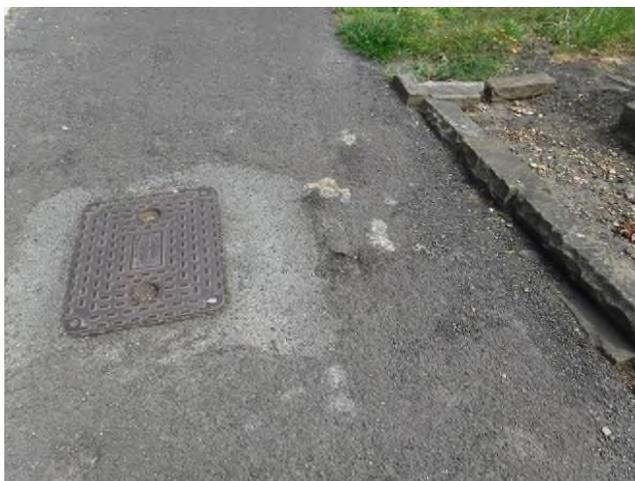
**West Boundary:**

Very large piers of stone holding up two rusted gates no longer in use and wedged by stone. There is a worn threshold of stonework here. Just beyond this is a margin of modern brick paving which has sunk as a result of the weight of parked vehicles. Beyond this is an old random stone wall, much patched up with cement and brick and reclaim bits and bobs, it has large modern metal gates. At this point the PCC were wondering whether this was another way into the churchyard by providing a more gradual ramped way in and I think the answer to that is no, particularly when you are having to excavate to get the levels and you are hitting all of the grave stones. The stone boundary wall looks onto a small cul-de-sac of houses.

Tarmac path to the entrance is undulating and breaking up. Kerb is formed to create a flower bed from old grave kerb edging and it is coming apart.

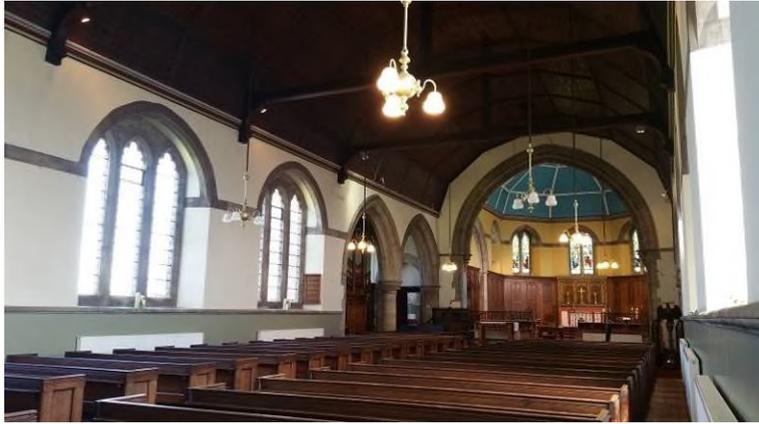
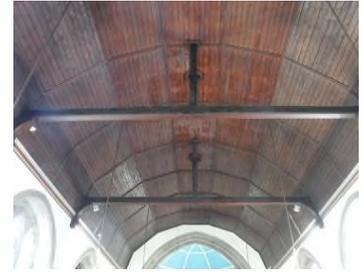
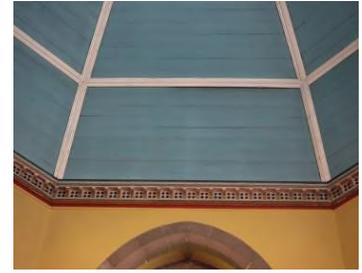
**Ceilings** – Natural ceilings throughout and they are looking a little dull now and could do with decoration but they will last another five or ten years really. The only area with markings, that could be redecorated are the north transept areas.

The chancel has a ribbed hand painted ceiling which is all reasonably sound though there are board gaps and the eastern most lower panel seems to be drifting out slightly but it's not very obvious and I don't think there is anything to do here.

**Recommendation:** redecorate north transept

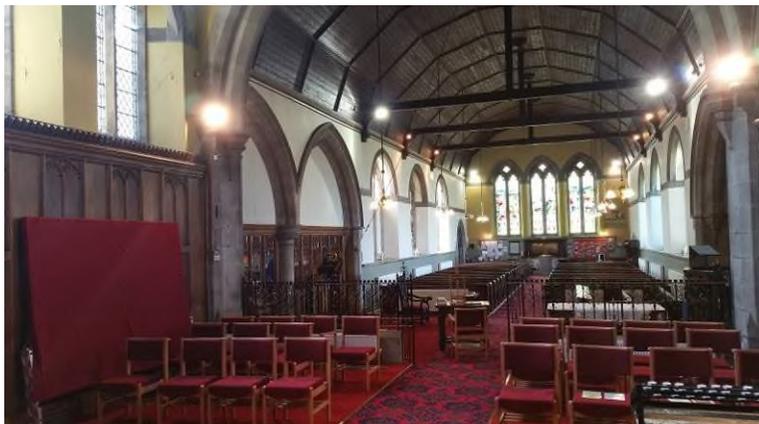
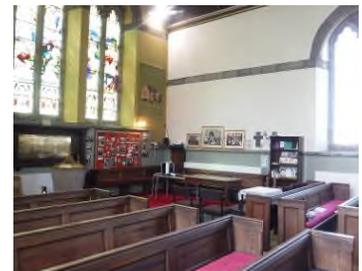
### Walls

The walls are all painted apart from the stone dressings to windows and doors, the general painting scheme is good. Within the nave, the west wall at high level looks a little poor but I think what is happening is it is catching a lot of dirt that is up in the attic of the roof, so when the wind blows it dusts down the wall and there's little that can be done other than redecorate.

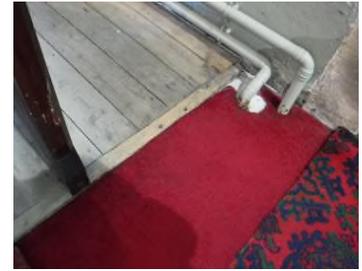
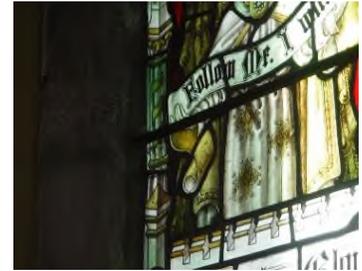
**D Windows** – All the glass is protected by polycarbonate sheeting and there is a combination of pictorial and clear glass in diamond patterns. The west window is reported as rattling and it would be worthwhile having a closer inspection of it. It has had a refurbishment in recent years- perhaps the copper wiring on the ferramenta is coming away because the ferramenta itself doesn't look to be loose in the masonry.

**Recommendation:** inspect west window

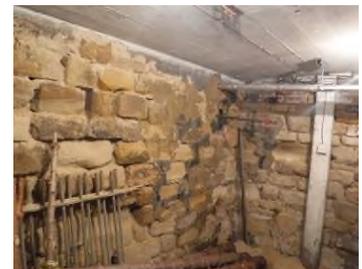
**C Boiler House:**

- Ceiling - Cambered and shuttered concrete ceiling, large lump out of it in one corner but not a problem.
- Walls – Sandstone, quite eroded on the south side. Has some brick and blockwork patching to the former coal chute with modern artificial stone.
- Floor – Brick paved floor which has been partially removed where the boiler is and has been replaced by gravel possibly for drainage purposes.

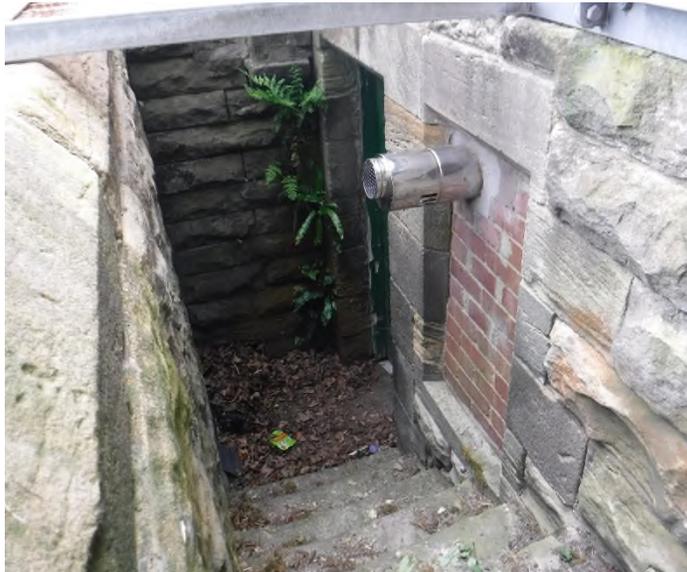
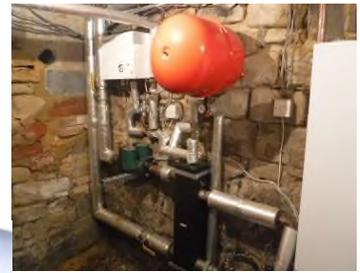
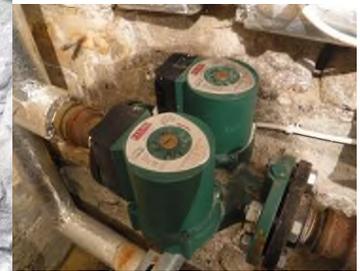
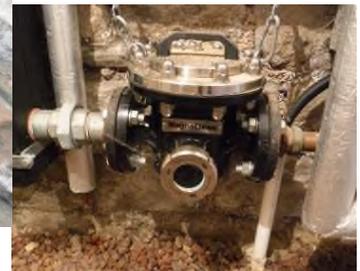
- New EcoTEC Plus boiler by Valiant complete with expansion tank Magna clean and twin pumps and a Grundfos pressurized system.
- Old timber door to the boiler room doesn't have any latching on though there is a door bolt that is somewhat failed now, decoration is broken down.

- At the bottom of the stairs is a landing, doesn't seem to have a gully in it, it's full of leaves, the steps are worn but ok though they are covered in leaves and should be swept down. The enclosure walls are fair, though there are some greenery growing up against it, this should be removed. The stairs are enclosed by a galvanised security system which is ok. Putting in the new boiler has produced a long flue that projects into the stair way rather but I don't think there is a health and safety issue because this is a cordoned off space.

**Recommendation:** update door, clean up side walls, sweep up leaves
