## QUINQUENNIAL REPORT

*For the Parish Church of  
St. Matthew's Church, Newbottle*

**Report Date:** 24<sup>rd</sup> September 2025

Inspecting Architect:  
Becky Smith BA(Hons), MArch, ARB RIBA CR

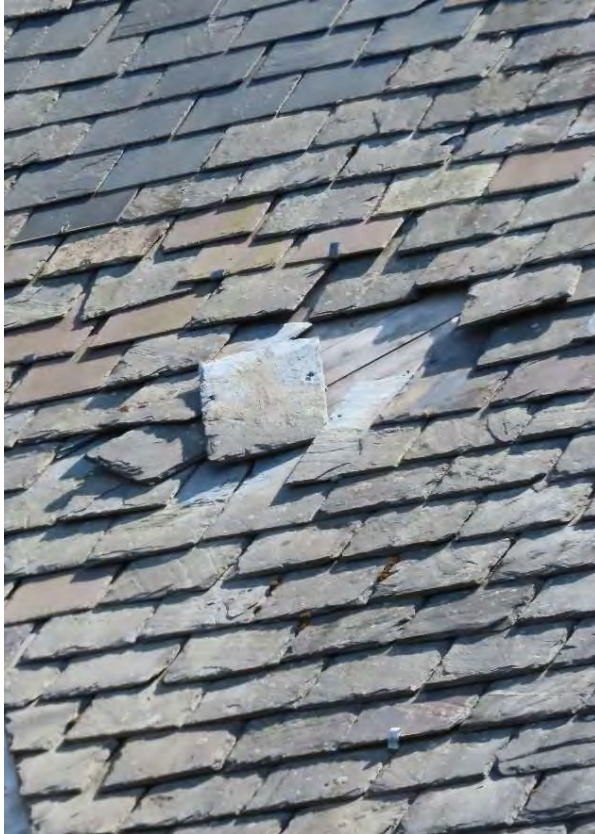
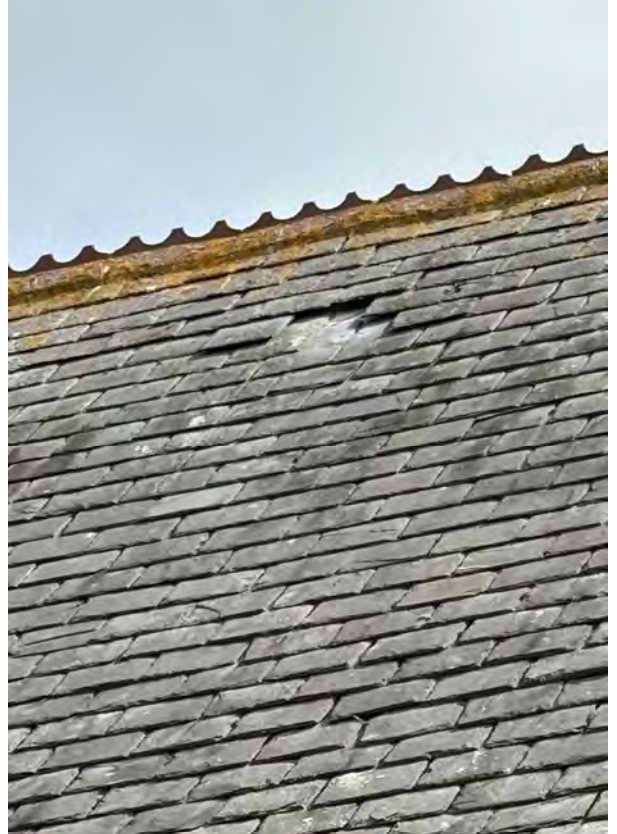
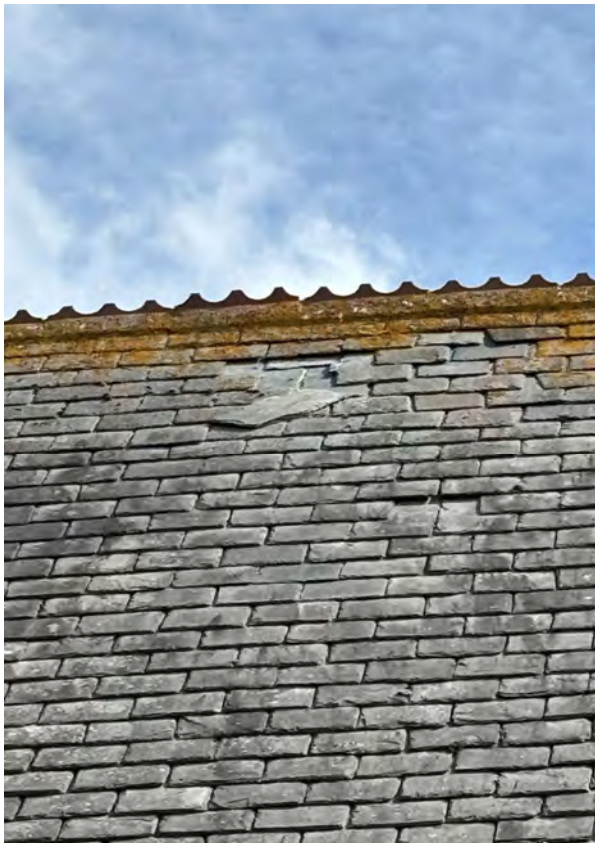
| Image & Location | Description | Condition | Repair Needs | Category |
|---|---|---|---|---|
| | | <p><b>North Roof</b></p> <p>Significant quantity of slates requiring replacement. Several areas of missing, cracked or slipped slates. Many of these slates are still lying on the ground surrounding the church as much of the damage was caused during the early winter storms of 2025. Some slipped slates are still on the roof but unsecured and as damage has been concentrated in a number of areas, weatherproofing ability of the roof covering has been compromised.</p> | <p>Roof contractor to fix missing, slipped and cracked slates using new or sound salvaged Welsh slate to match the existing in size, thickness and colour. To be fixed as existing.</p> <p>Develop a scheme for full reroofing of the Northern slopes.</p> | |

Example areas of damage to North Roof

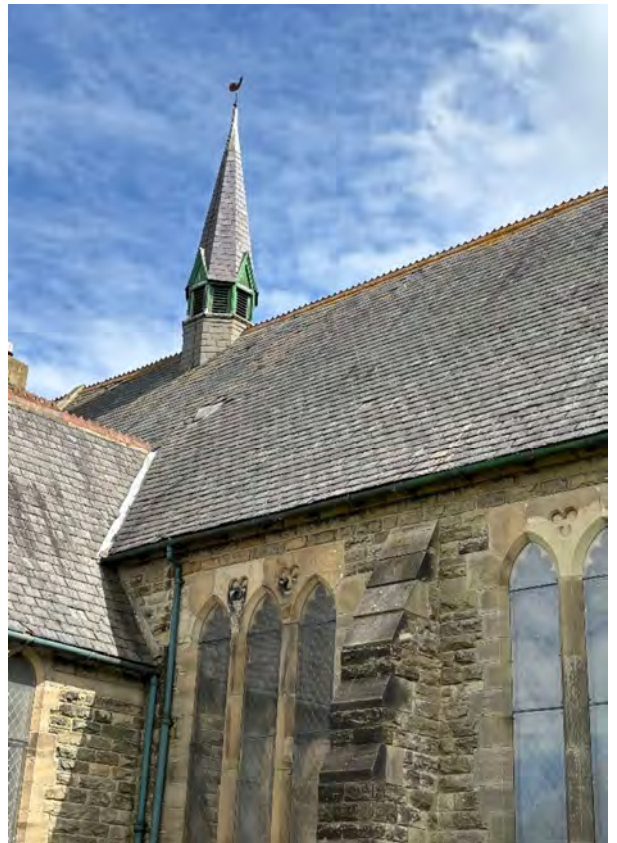
Overview of areas of North Roof

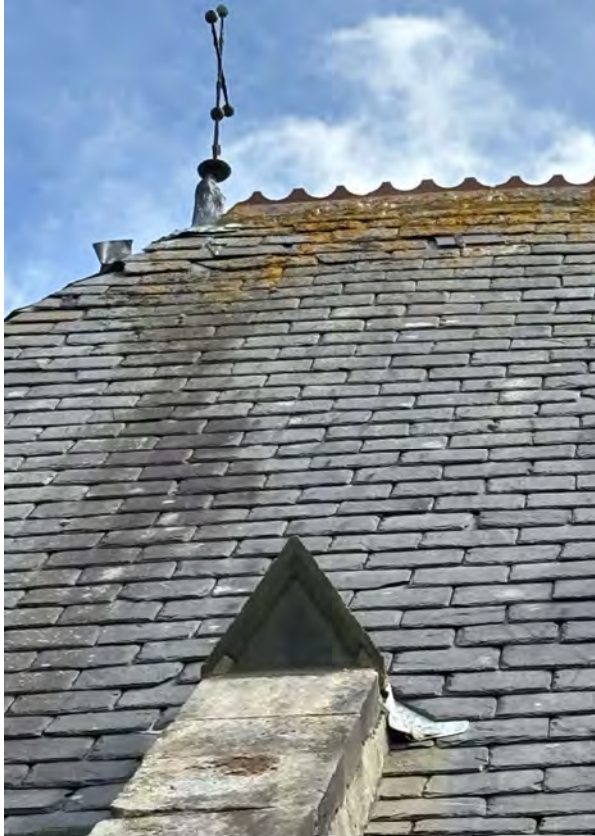
| Image & Location | Description | Condition | Repair Needs | Category |
|---|---|---|---|---|
| | | <b>Chancel</b><br>Broken and slipped slates mainly near the ridge, with some missing entirely. | Roof contractor to fix missing, slipped and cracked slates using new or sound salvaged Welsh slate to match the existing in size, thickness and colour. To be fixed as existing. | 1 |

Missing, cracked slipped slates to Chancel

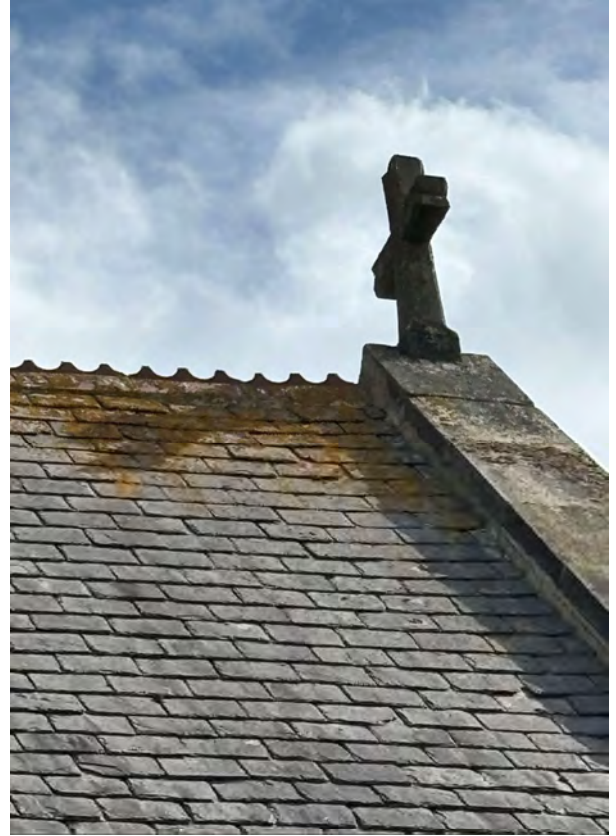
Areas of moss growth

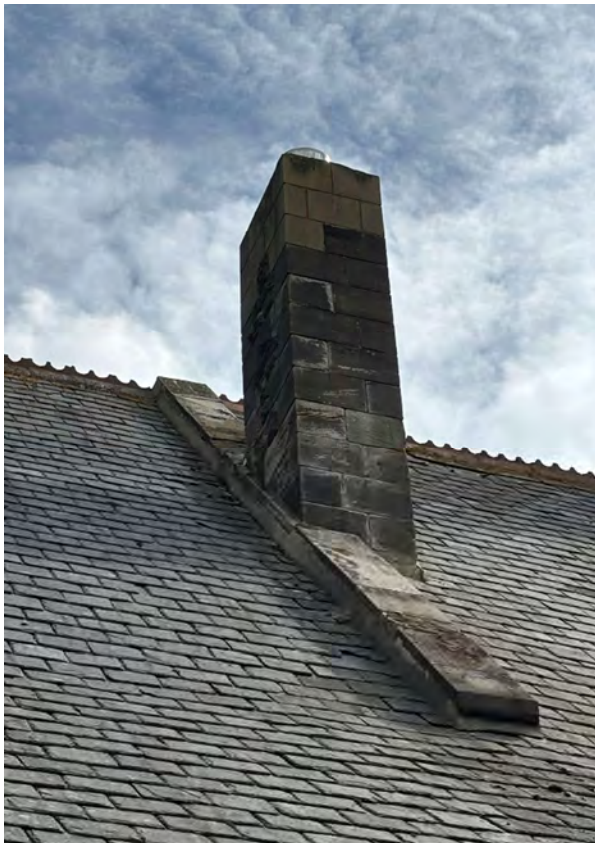
| Image & Location | Description | Condition | Repair Needs | Category |
|---|---|---|---|---|
| | | <p><b>Chimney</b><br/>There has been some replacement of stonework, but there are open and hungry joints to visible faces which require pointing. Isolated stones are weathered and should be inspected and repaired if needed when high level access is available.</p> <p><b>North Transept</b><br/>There are many broken pieces of slate in the valley gutter which will likely be preventing water from flowing towards the outlet and possibly causing ponding. These should be cleared to prevent issues arising that could contribute to the damp internally.</p> <p>Significant weathering to ridge tiles with deterioration / loss of mortar bedding below ridge tiles where mortar has cracked, loosened or fallen away entirely. Some variation in ridge tile styles.</p> | <p>Inspect chimney and repoint / carry out repairs to stonework.</p> <p>Remove all slates and debris from valley gutter. Ensure this is undertaken on a regular basis until works to roof complete.</p> <p>This area requires further investigation to understand the cause of damp to interior below and repairs undertaken.</p> | <p>3</p> <p>M</p> <p>2</p> |

Area of Chimney which may be allowing water ingress internally. Failing mortar fillet to water table.

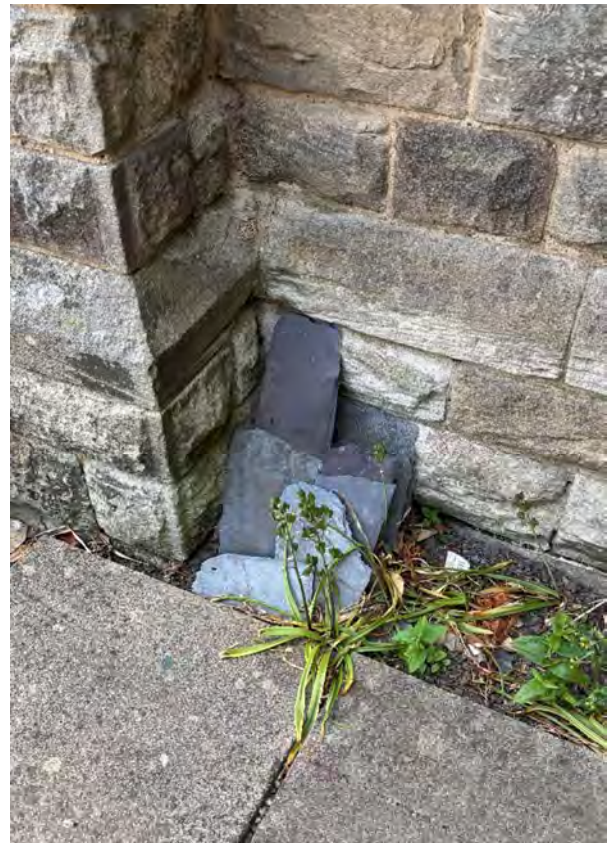
Quantity of slates missing from roof noticeable due to amount stacked next to building in various locations.

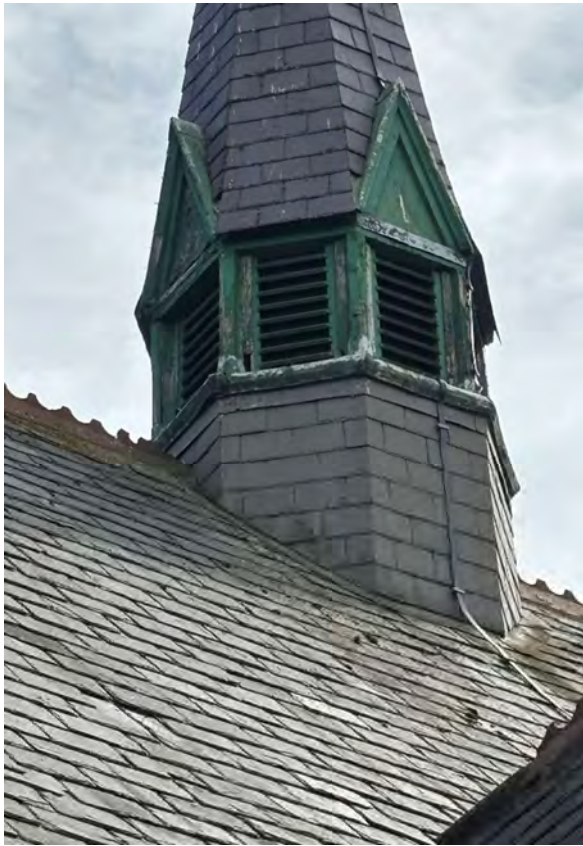
| Image & Location | Description | Condition | Repair Needs | Category |
|---|---|---|---|---|
| | | <p>There is significant paint failure to the green painted timber louvres and frames. Some areas of the timber frame/detailing are missing which may also indicate possible surface decay to some parts of the structure.</p> | <p>Paint to be removed sufficient to allow the timber to be inspected for rot. Replace decayed sections with matching timber, treated and repainted using breathable paint which is historically accurate in colour.</p> | 2 |

Fleche appears to be deteriorating with flaking paint / timber rot visible.

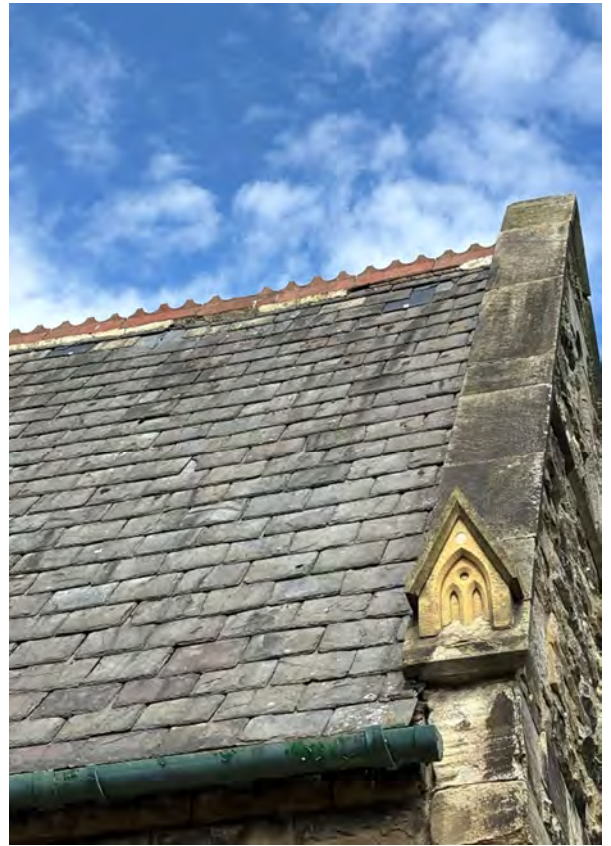
| Image & Location | Description | Condition | Repair Needs | Category |
|---|---|---|---|---|
| <br> | | <p>Loose / deteriorating ridge tiles with some loss of mortar bedding below ridge tiles where mortar has cracked, loosened or fallen away entirely.</p> | Remove failing mortar and re-bed ridge tiles in a suitable lime mortar to prevent water ingress from wind-driven rain. | 3 |

Loss of mortar bedding to ridge tiles.

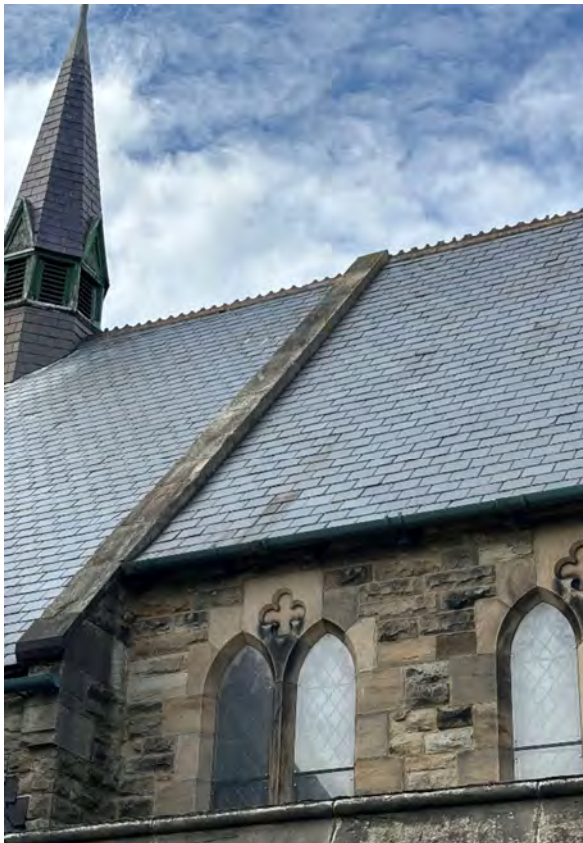
| Image & Location | Description | Condition | Repair Needs | Category |
|---|---|---|---|---|
| | | <b>South Roof</b><br>Some cracked, broken, missing slates to South Roof but not to same quantities as North side. | Replace damaged and missing slates with matching slates. | 1 |

South roof in better condition however still some slipped / missing / broken tiles

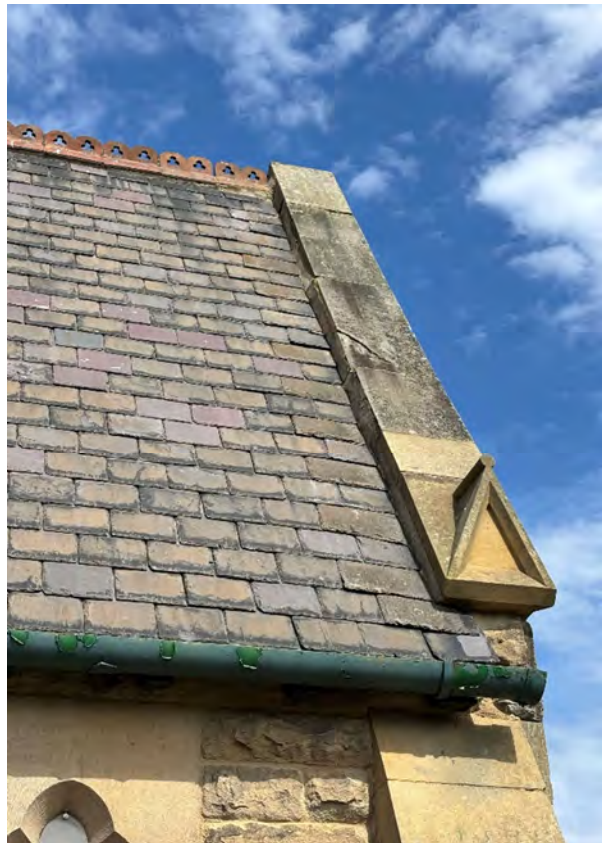
Some delamination / loss of pointing to stone.

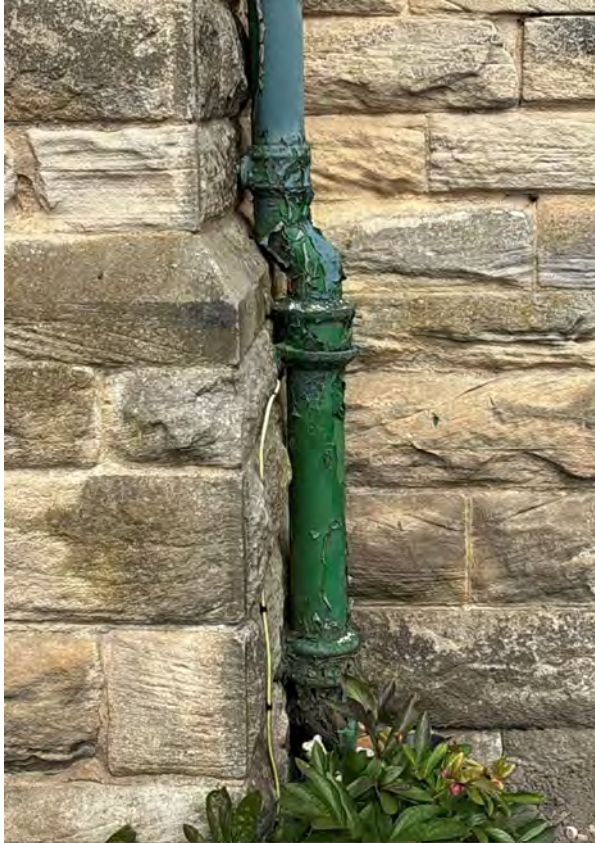
Evidence of paint failure to downpipes.

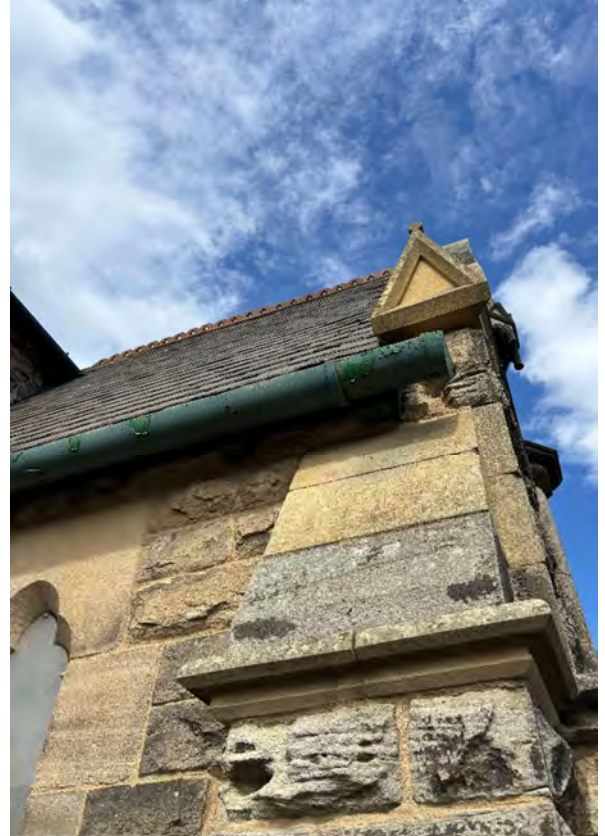
| Image & Location | Description | Condition | Repair Needs | Category |
|---|---|---|---|---|
| | | The rainwater goods are showing signs of deterioration with significant paint flaking and peeling exposing bare metal underneath. Some heavy paint deterioration at joint areas may be concealing cracks or failed sealant. | Remove existing paint and inspect condition below. Renew any defective sections and repaint. | 3 |

Evidence of paint failure to gutters.

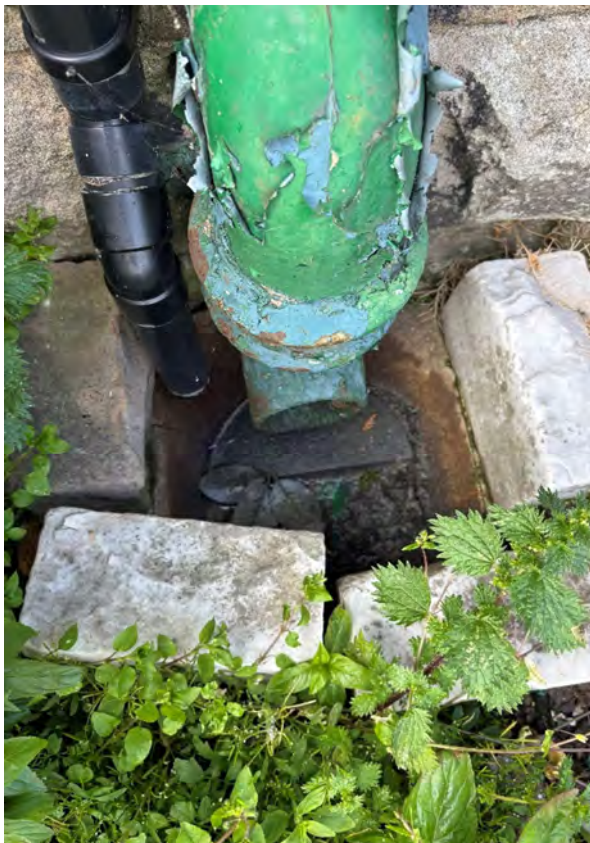
Evidence of blockage to drains.

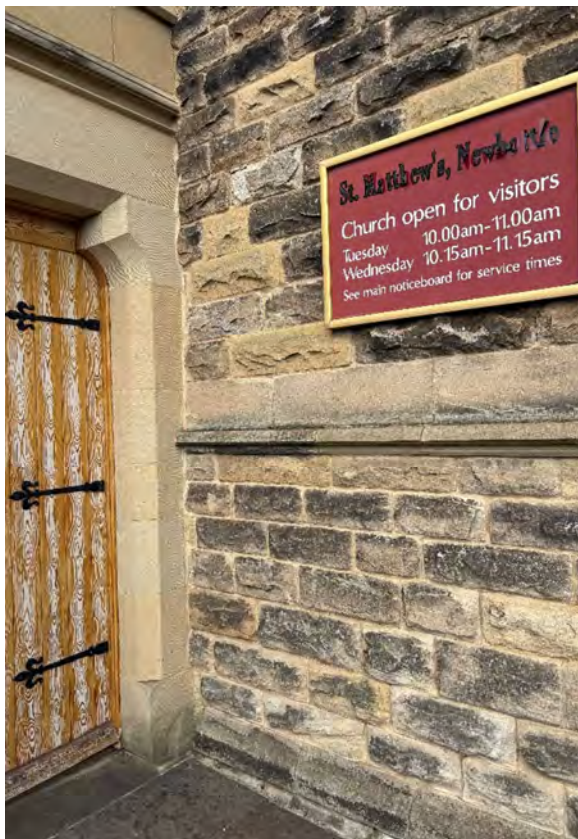
Signage within proximity of entrance showing failed lettering.

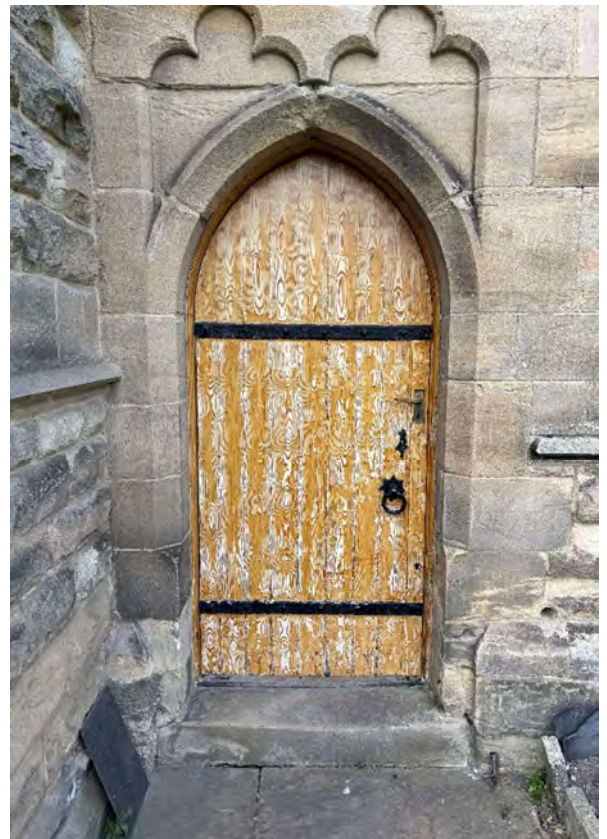
| Image & Location | Description | Condition | Repair Needs | Category |
|---|---|---|---|---|
| | | <b>Vestry Entrance</b><br>Significant surface erosion of paint/stain to door. | Sand down and redecorate / re-stain the door to provide renewed weather protection. | 3 |

Flaking of paint/finish to Vestry entrance door.

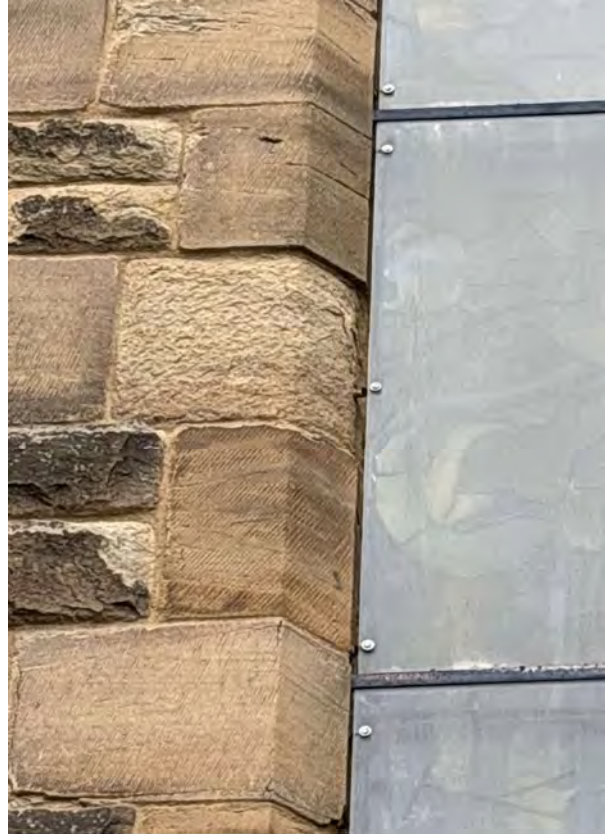
| Image & Location | Description | Condition | Repair Needs | Category |
|---|---|---|---|---|
| <u>Windows</u><br> | | <b>West Elevation:</b><br><br><b>W1</b><br>Some deterioration of stone surround in various locations. Window appears sound. | Descale weathered stones and assess whether repair or replacement stones are required.<br>Repoint where required. | 3 |

W1 – Deterioration of stone face.

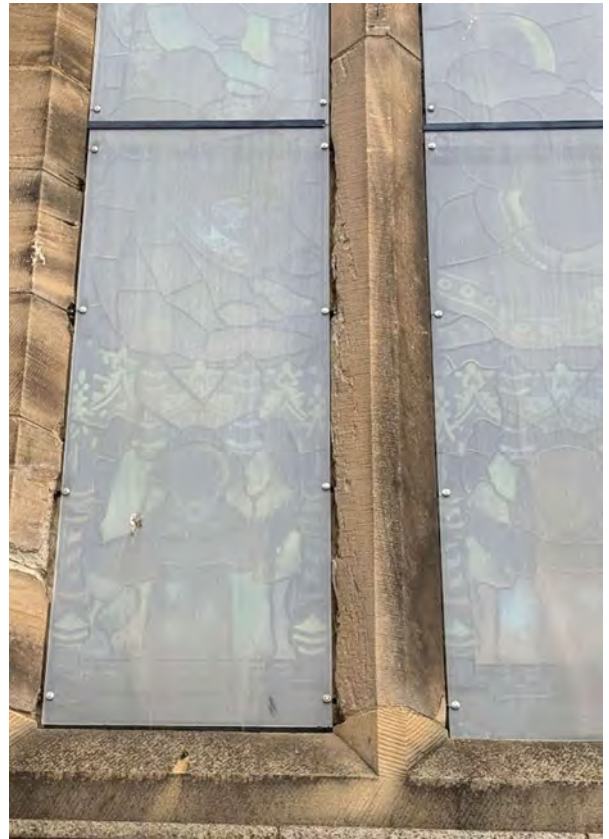
| Image & Location | Description | Condition | Repair Needs | Category |
|---|---|---|---|---|
| | | <b>W3</b><br>Some deterioration of stone surround in various locations. Window appears sound. | Descale weathered stones and assess whether repair or replacement stones are required.<br>Repoint where required. | 3 |

W3 – Deterioration of stone around left side central mullion.

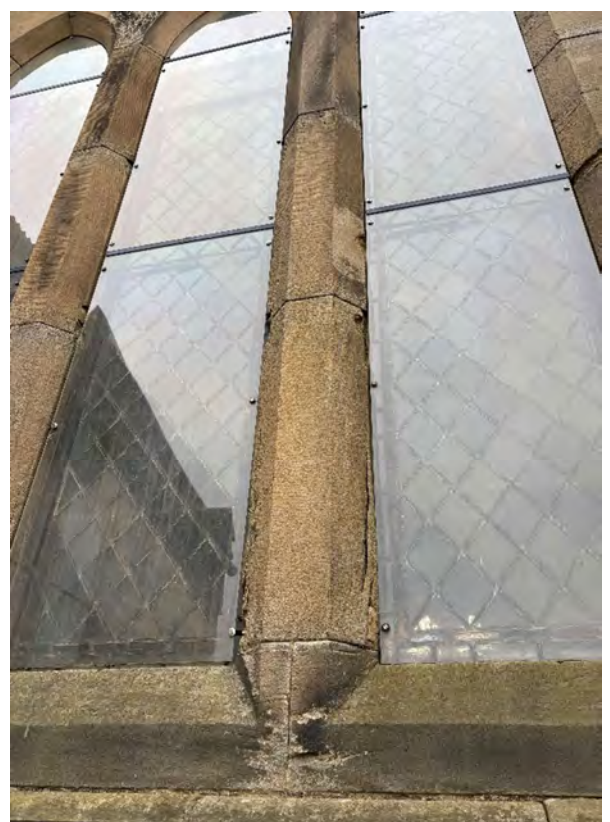
W6 – Deterioration to central mullions.

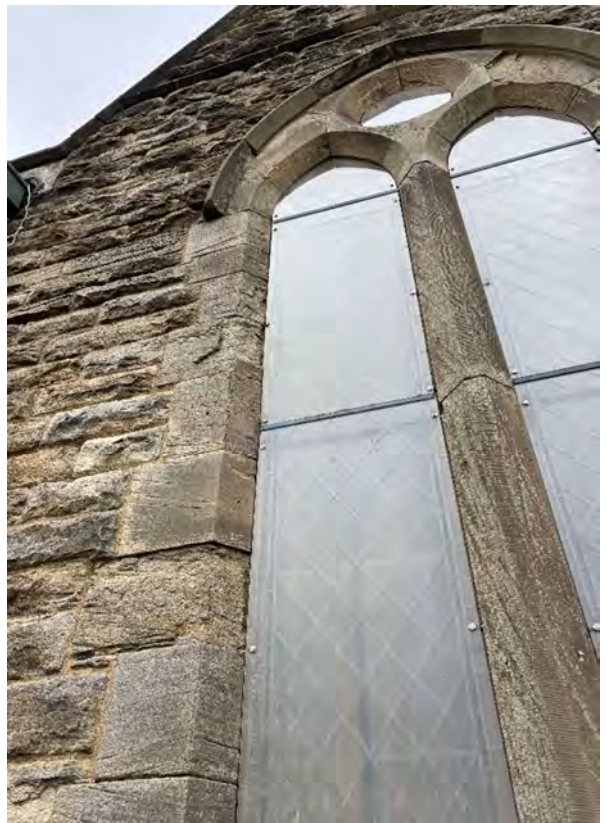
W8 – Various locations of deterioration to stone surround.

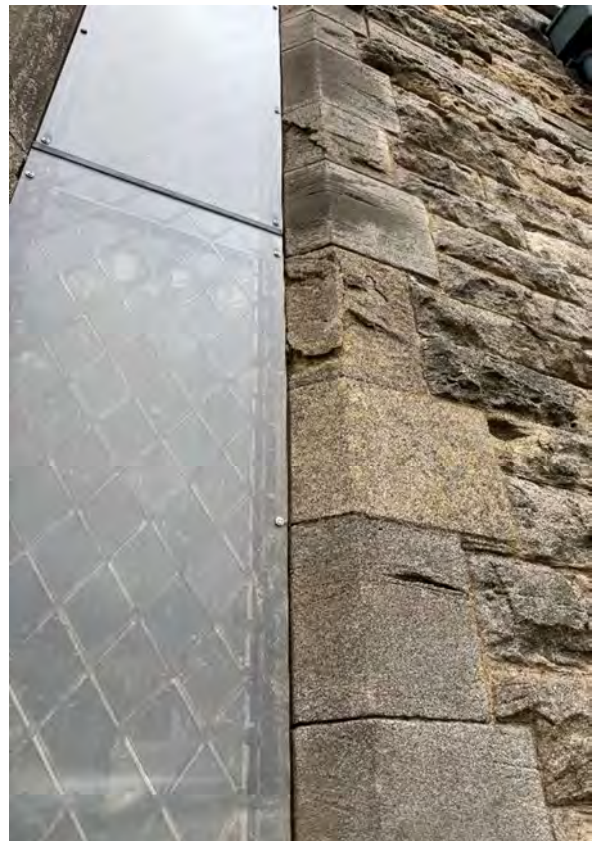
W9 – Significant deterioration of stone surround.

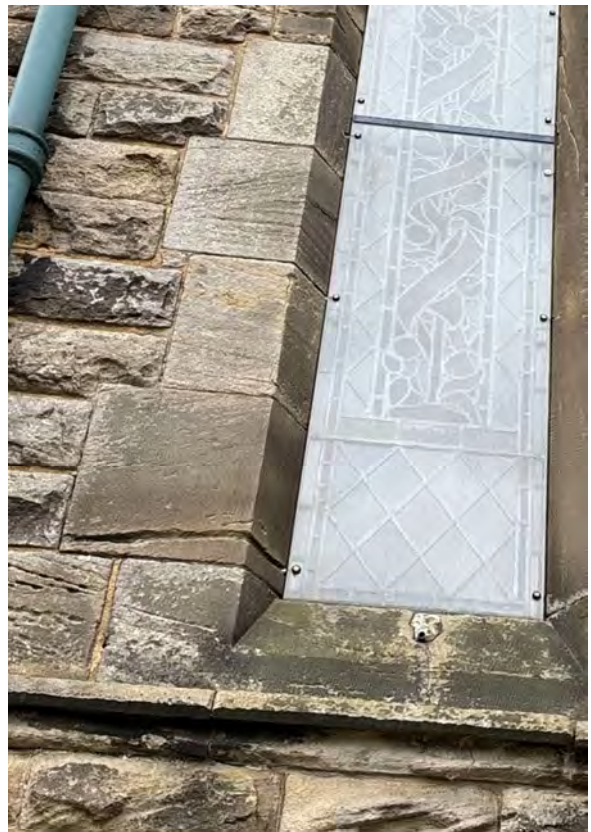
W12a – Deterioration visible at lower and upper areas of stone surround.

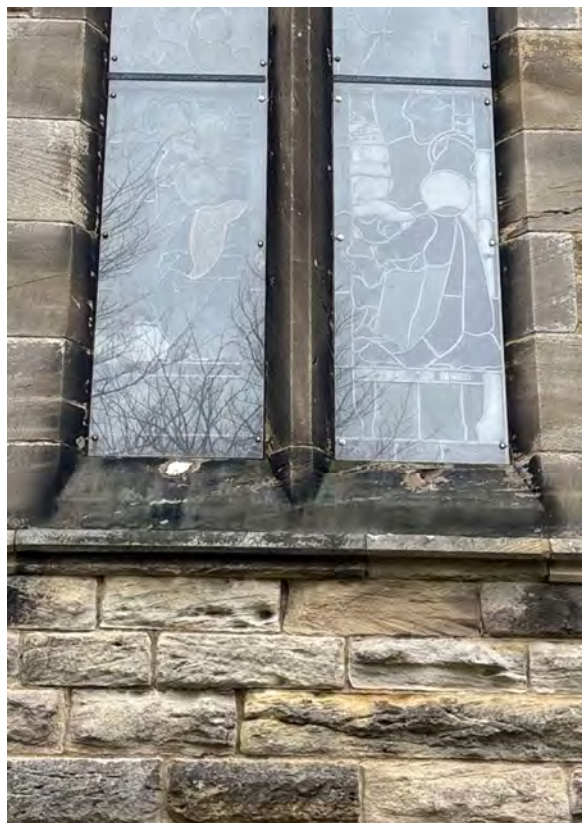
W13 – Deterioration to cill around metal fixing

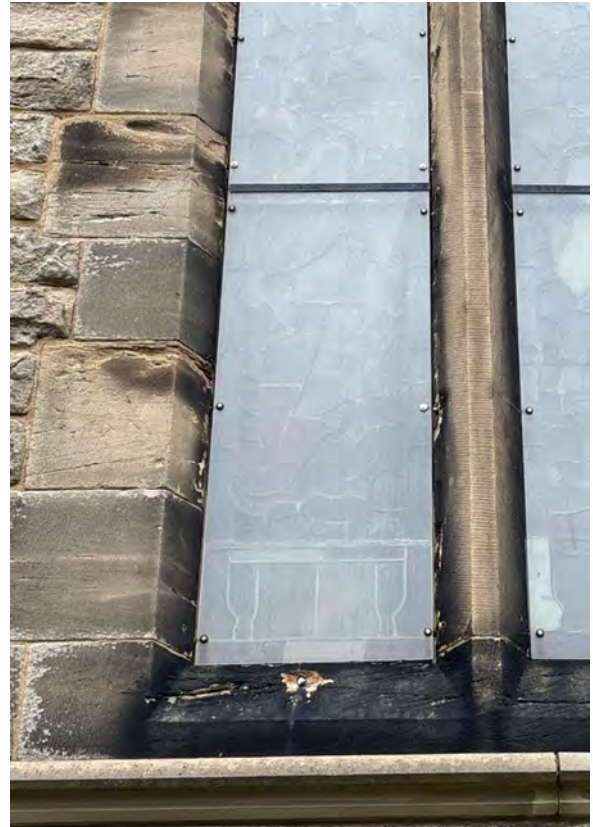
W14 – Deterioration to cill around metal fixing

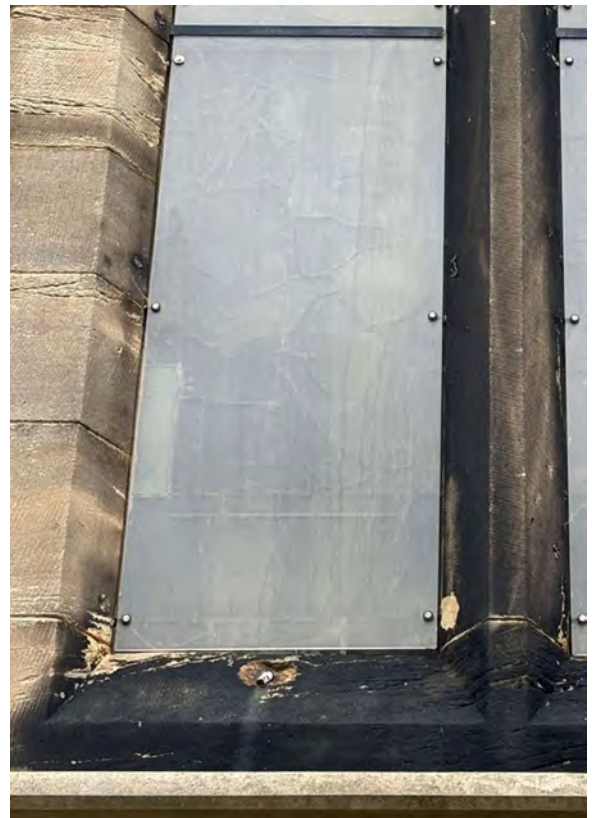
W15 – Deterioration to cill around metal fixing

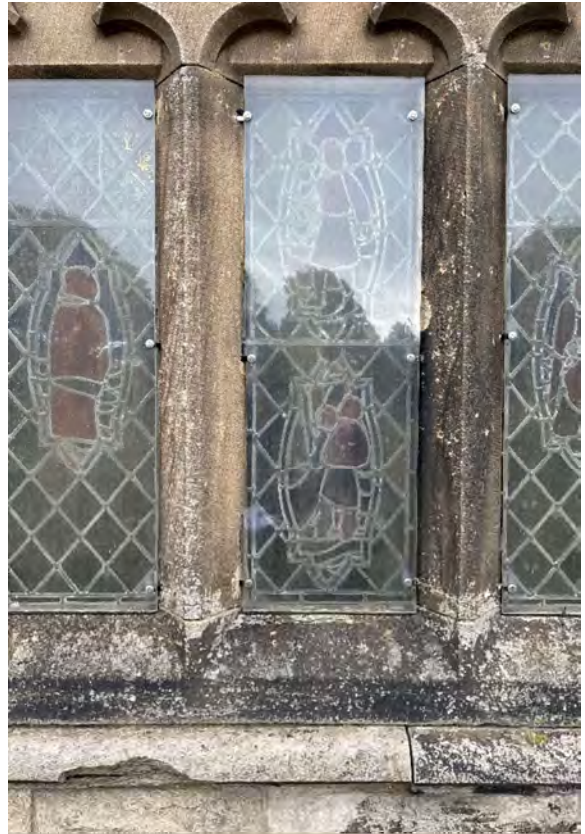
W16 – Some deterioration and cracking to stone surround.

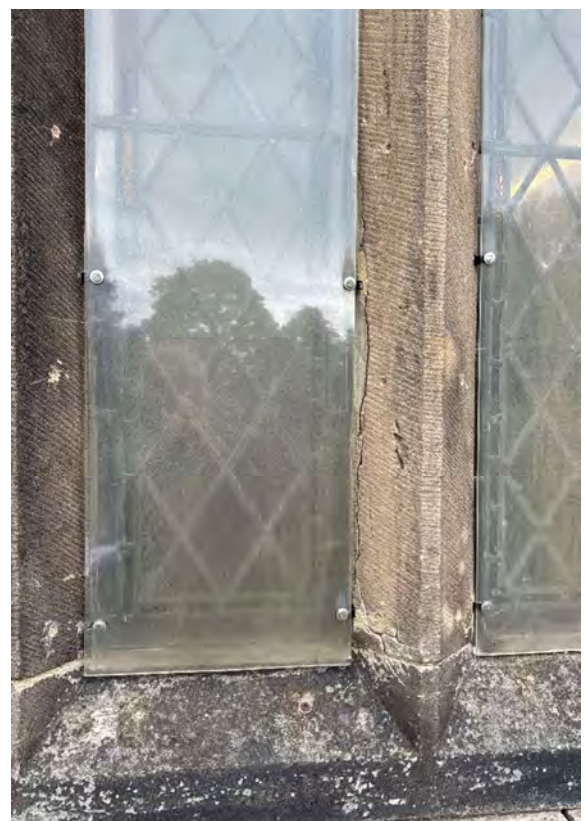
W17 – Deterioration to mullion.

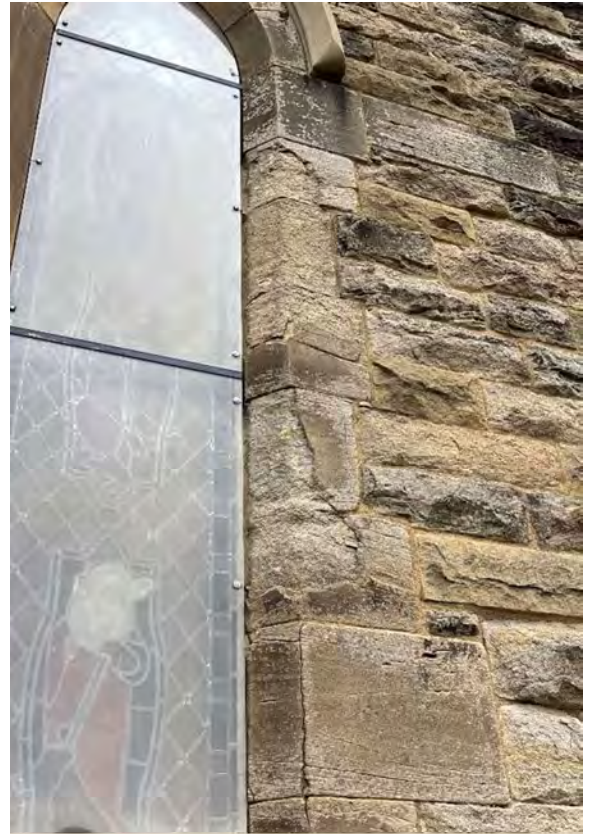
| Image & Location | Description | Condition | Repair Needs | Category |
|---|---|---|---|---|
| | | <p><b>W18</b><br/>Some delamination of stone mainly to right side of surround with some hairline cracking. Window appears sound. Slight weathering to mullion.</p> <p><b>W19</b><br/>Delamination of stone to right side mid and upper tracery. Some hairline cracks to upper left side of tracery. Some rubble/debris to right window behind perspex possibly suggesting loss of pointing to areas. Windows appear sound</p> | <p>Repoint where required.</p> <p>Descale weathered stones and assess whether repair or replacement stones are required. Repoint where required.</p> <p>Descale weathered stones and assess whether repair or replacement stones are required. Repoint where required. Remove perspex to clean debris and dust and refix.</p> | <p>3</p> <p>3</p> |

W18 – Significant deterioration of stone surround.

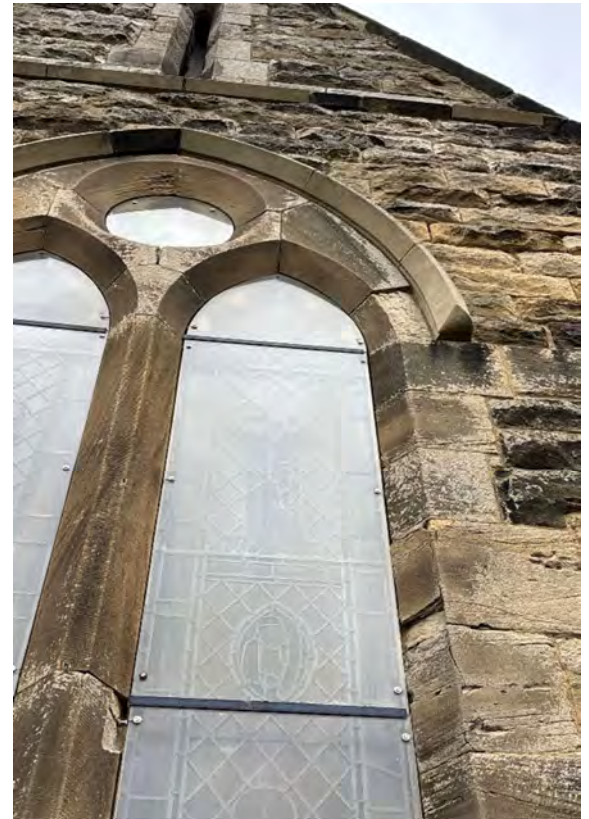
W19 – Significant deterioration of stone surround and parts of mullion.

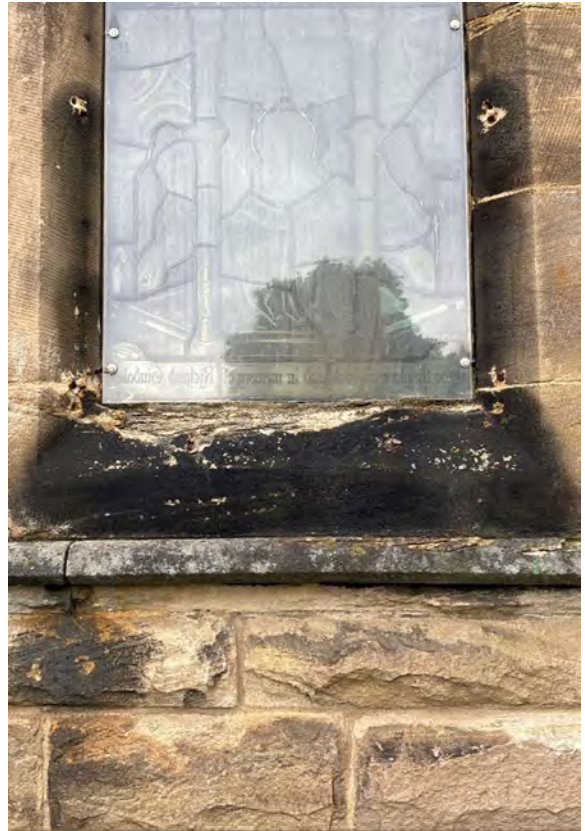
W21 – Significant deterioration of cills.

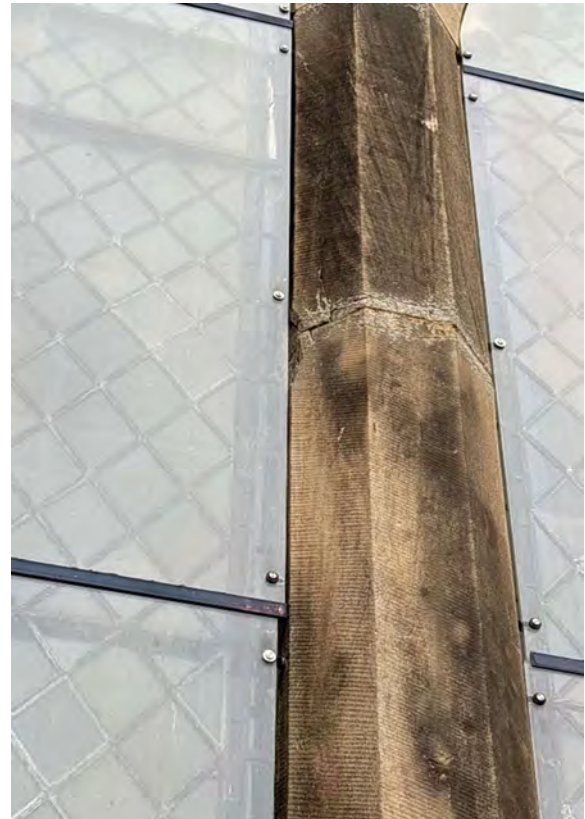
| Image & Location | Description | Condition | Repair Needs | Category |
|---|---|---|---|---|
| | | <p><b>W22</b><br/>Generally ok with some minor hairline cracks and minor loss of point to areas. Window appears ok.</p> | <p>Repoint where required.</p> | 3 |

W22 – Some deterioration to mullion.

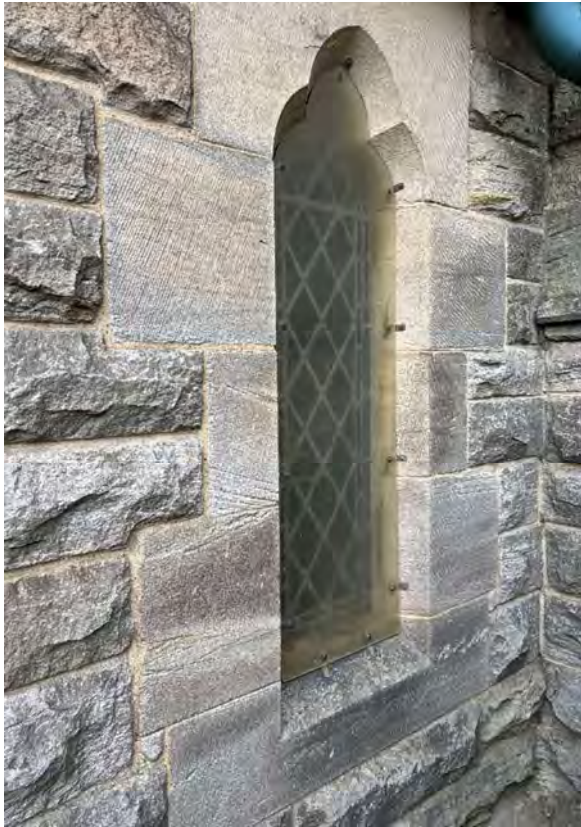
W23 – General overview of window. Some discolouration to external protection.

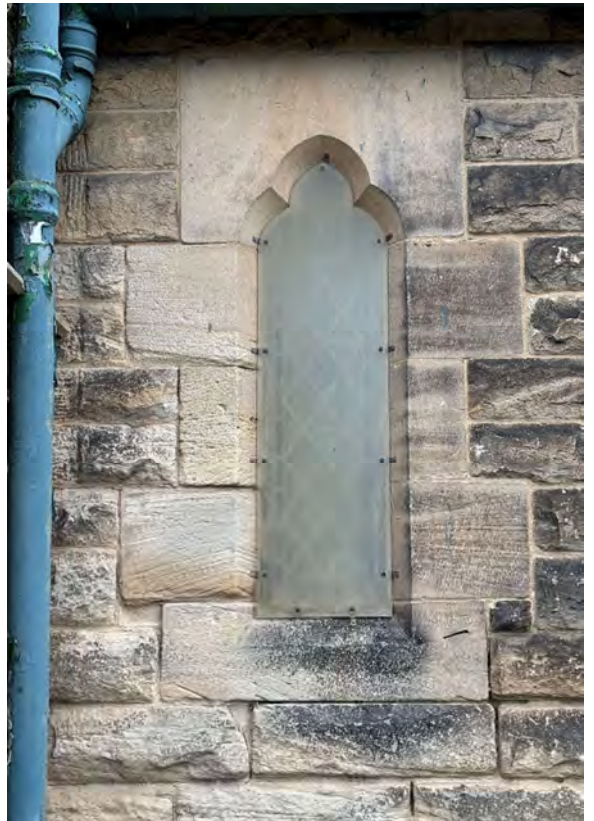
W26 – General overview of window. Some discolouration to external protection.

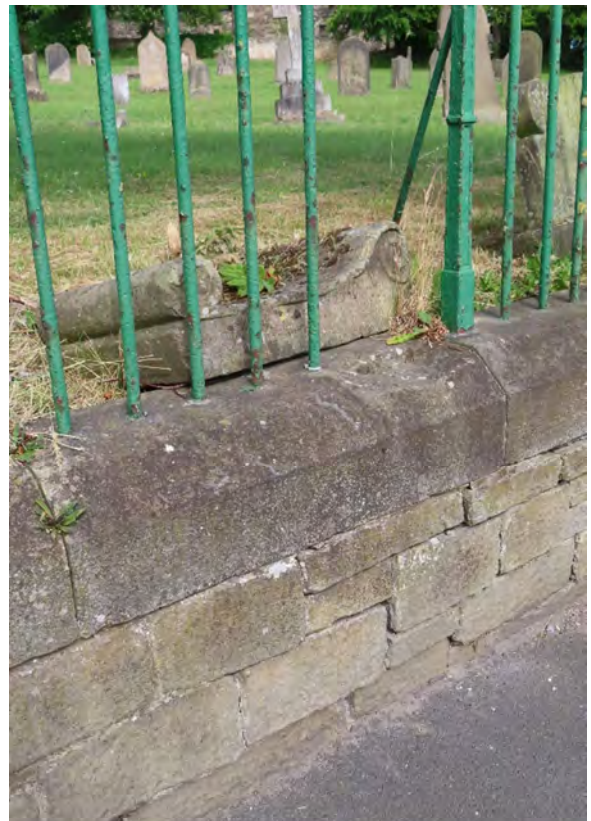
Examples of missing parts of railing and flaking of paint. Open joints to wall under. 58

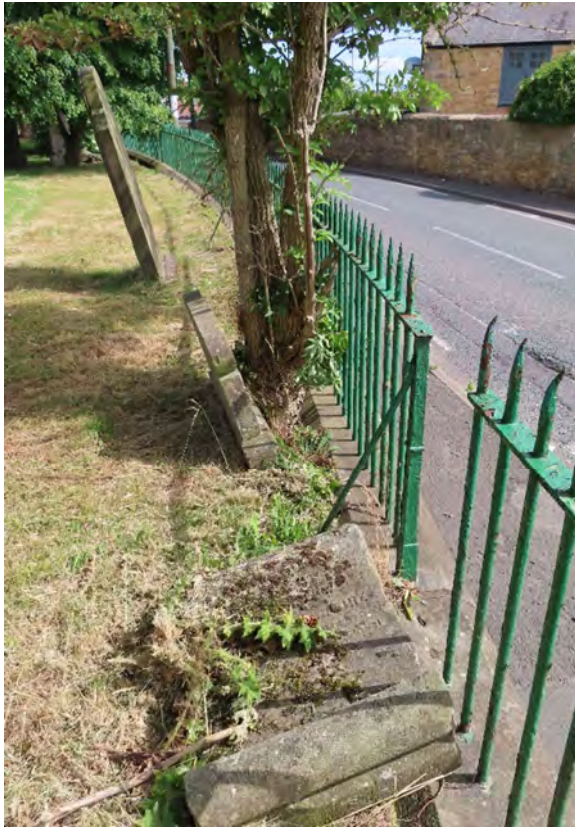
Low height of metal railings evident and sharp spikes.

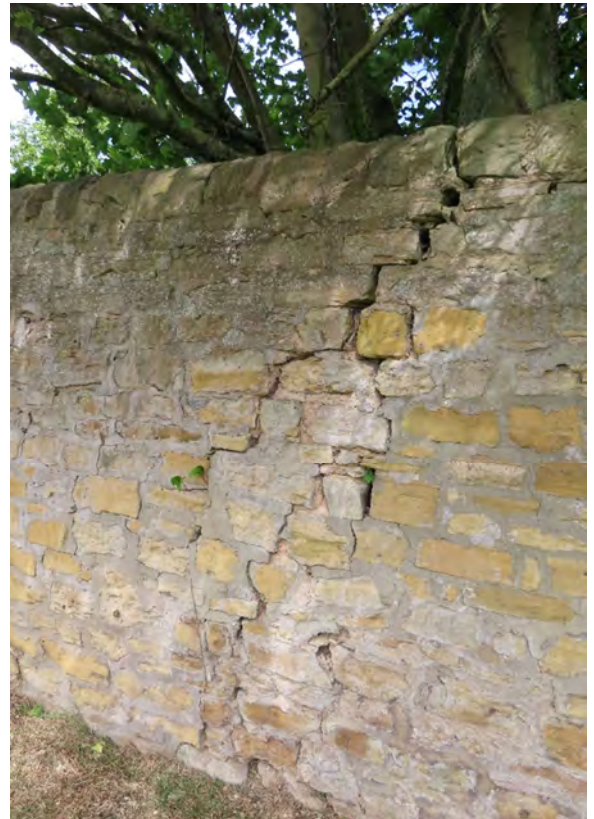
Area of wall cracking due to tree behind.

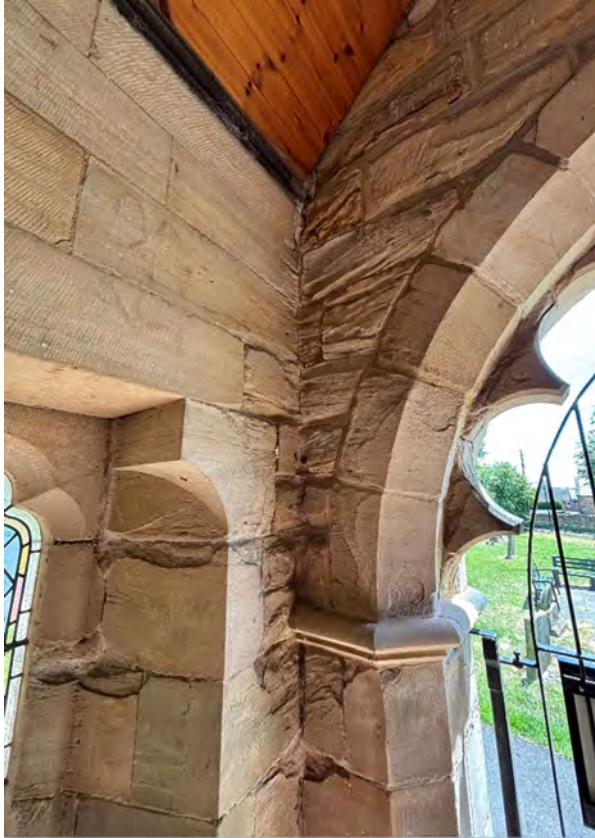
Some deterioration of stones to porch

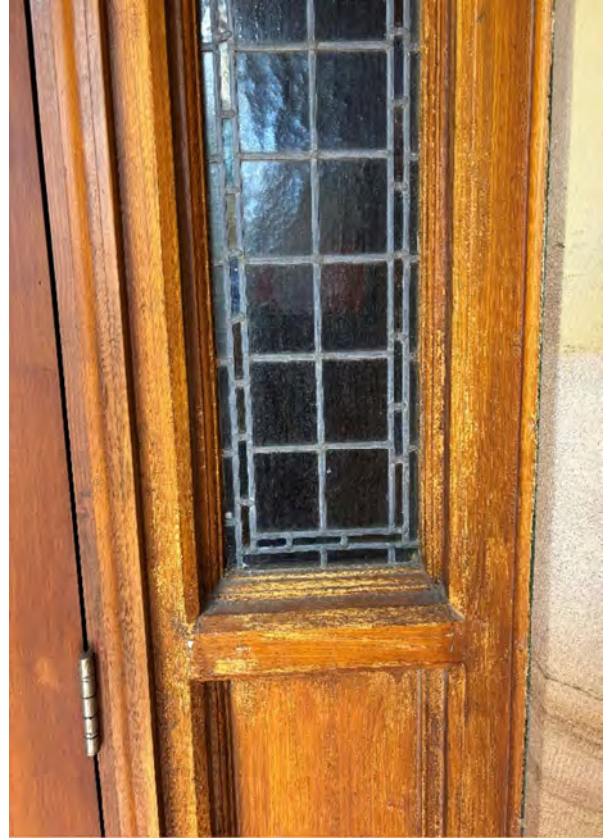
Minor flaking of paint to entrance doors.

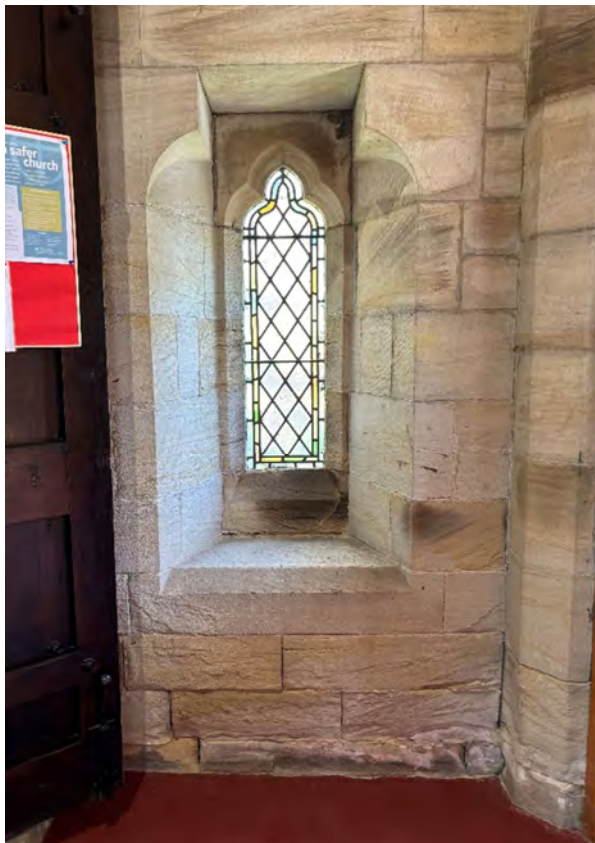
Deterioration to lower two courses.

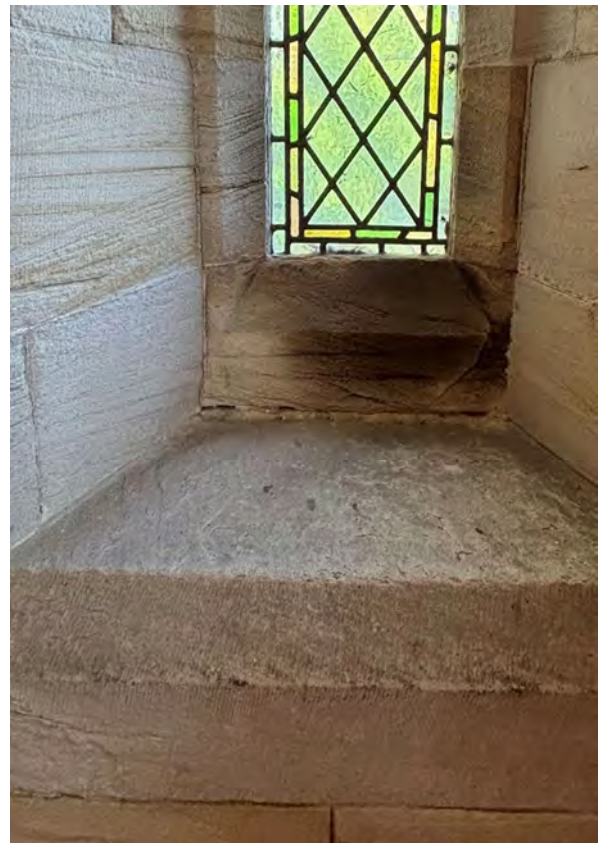
Evidence of cracking to stone cills.
