## QUINQUENNIAL REPORT

*For the Parish Church of  
St. Matthew's Church, Newbottle*

**Report Date:** 24<sup>rd</sup> September 2025

Inspecting Architect:  
Becky Smith BA(Hons), MArch, ARB RIBA CR

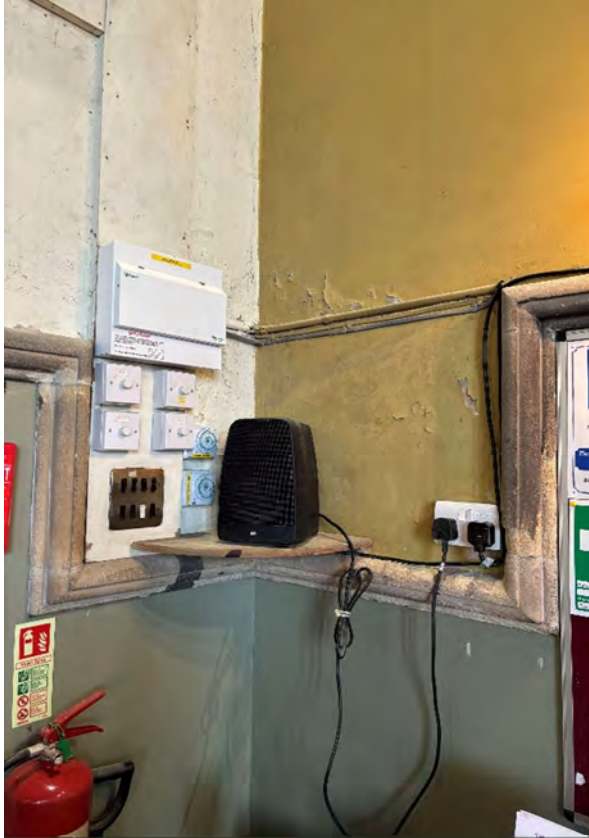
Evidence of flaking yellow paint to West Wall

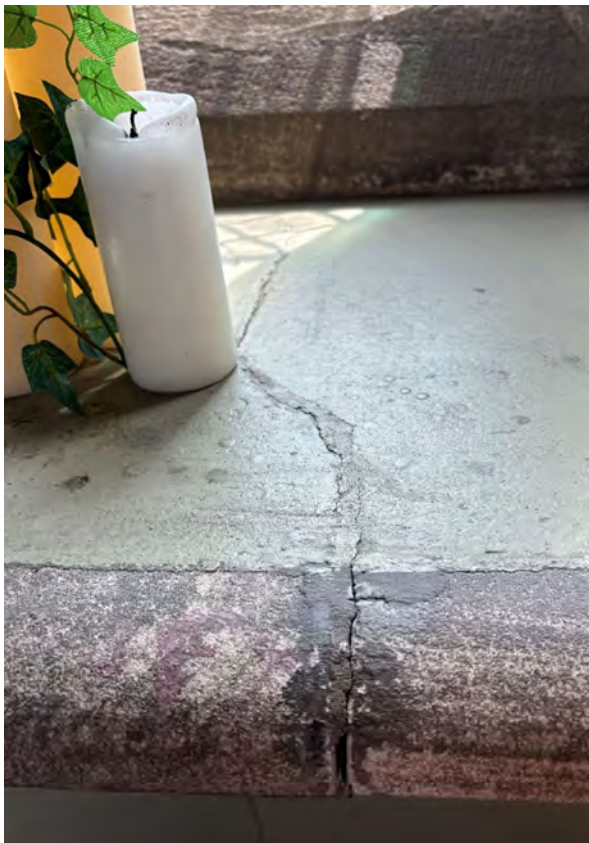
Example of historic cracking to cill in Nave

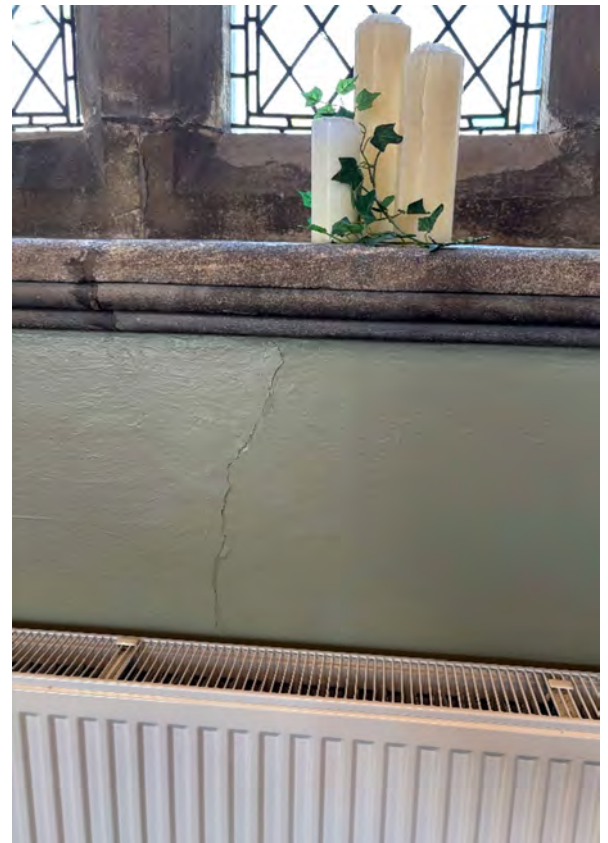
Example cracks to plaster work above radiators within the nave.

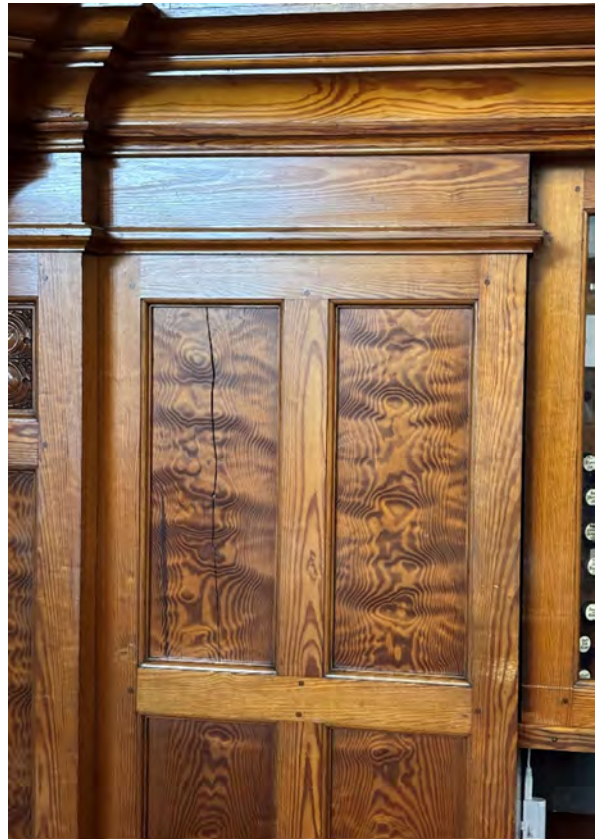
Minor crack to timber panel of Organ

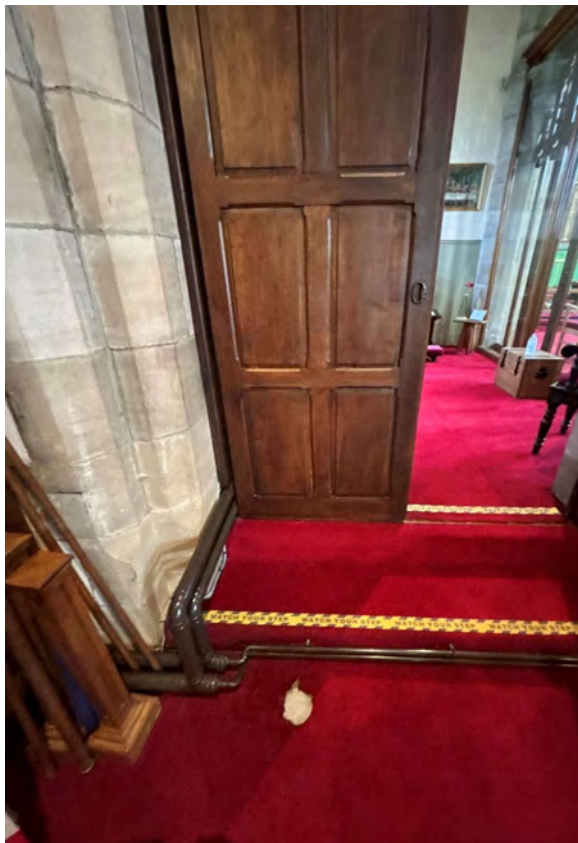
Patch of carpet missing upon approach to Memorial Chapel

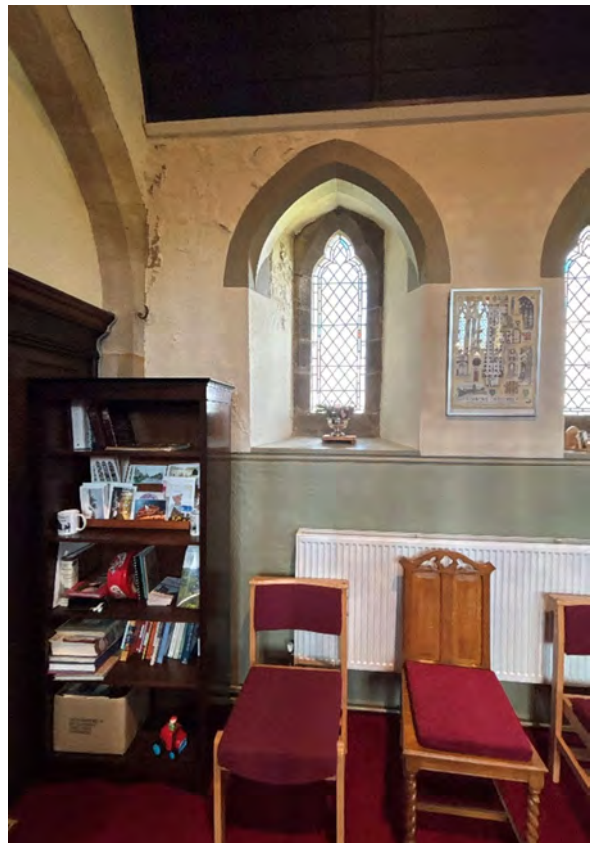
Deterioration of finishes due to issues with dampness to entrance and W10.

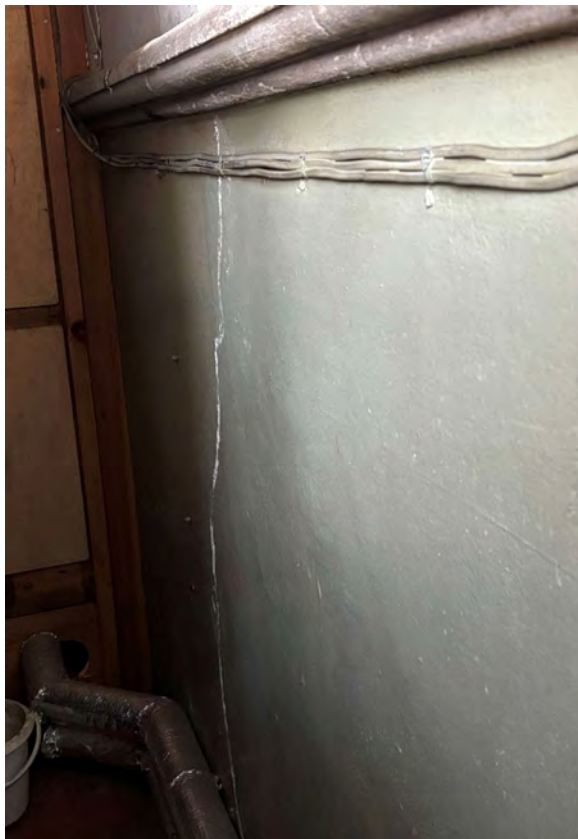
Crack below window cill of W7.

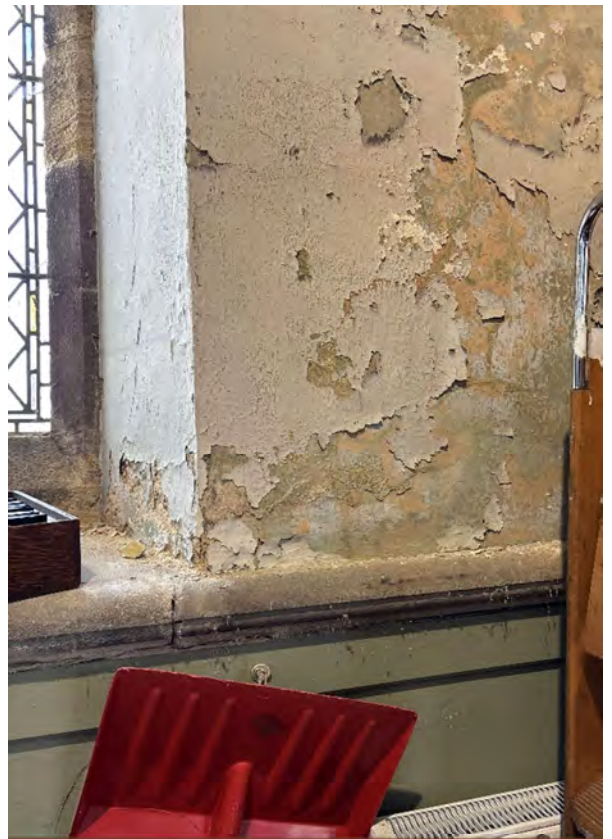
Significant moisture ingress is visible within the North Transept. The cause of this requires further investigation, beginning with repairs to the roof. It is likely that a series of works will be required to properly identify all sources of moisture ingress before any internal repair works can commence.

Significant flaking of paint and damage to plaster to walls of W8 & W9 North Transept

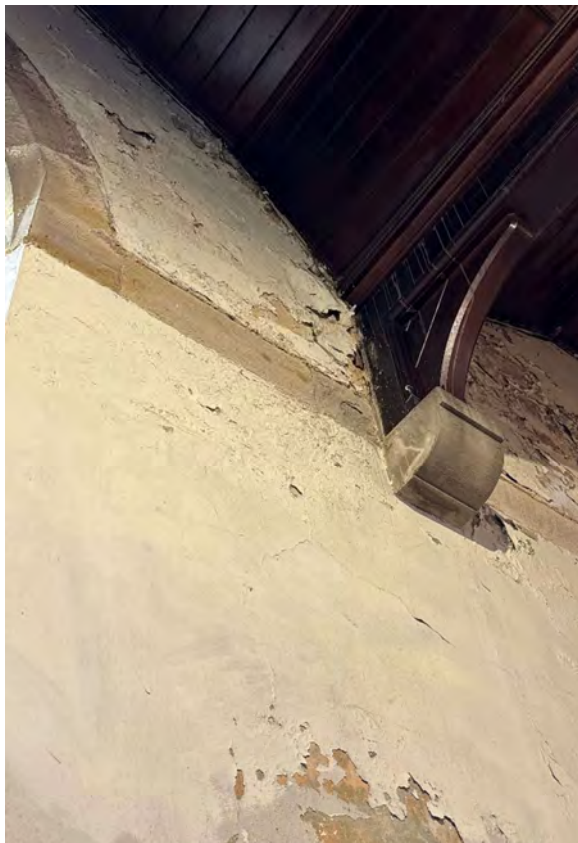
Significant flaking of paint also visible at high level to W8/W9 of North Transept.

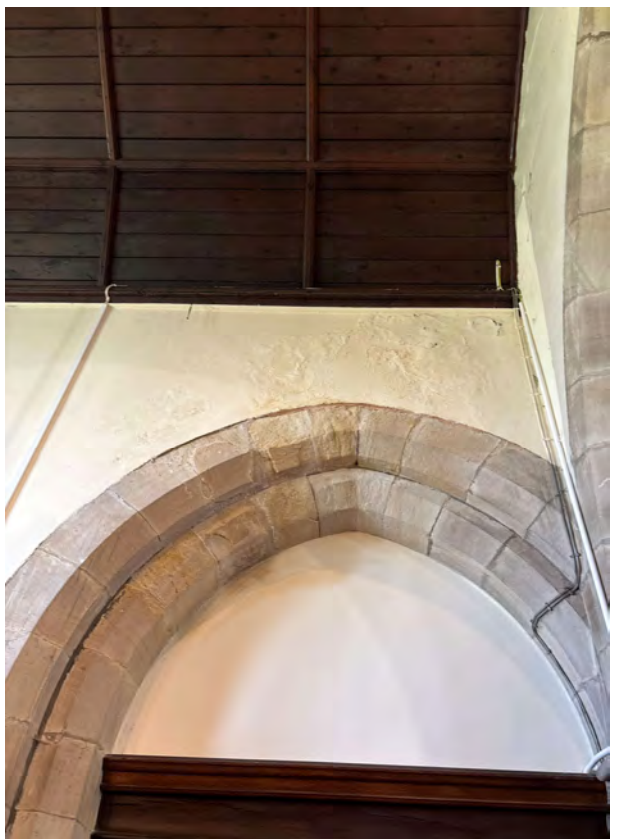
Blistering of plasterwork and deterioration of stone above Memorial Chapel entrance. 63

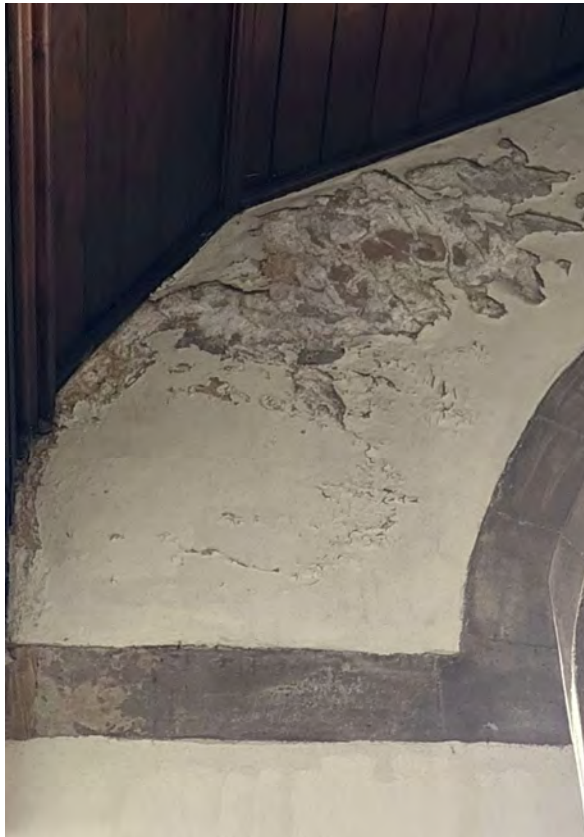
Significant flaking and blistering of paint to South wall with damage to plaster behind.

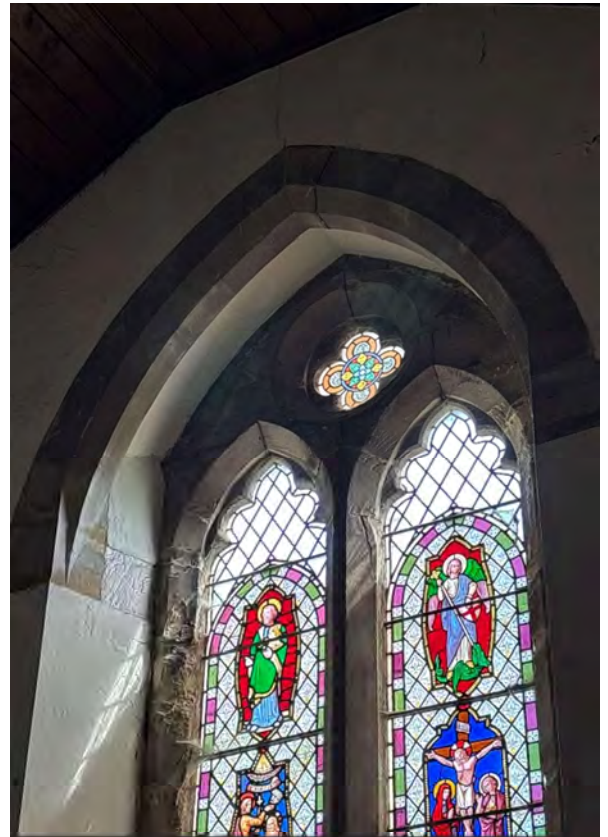
Significant delamination of stone to left side window.

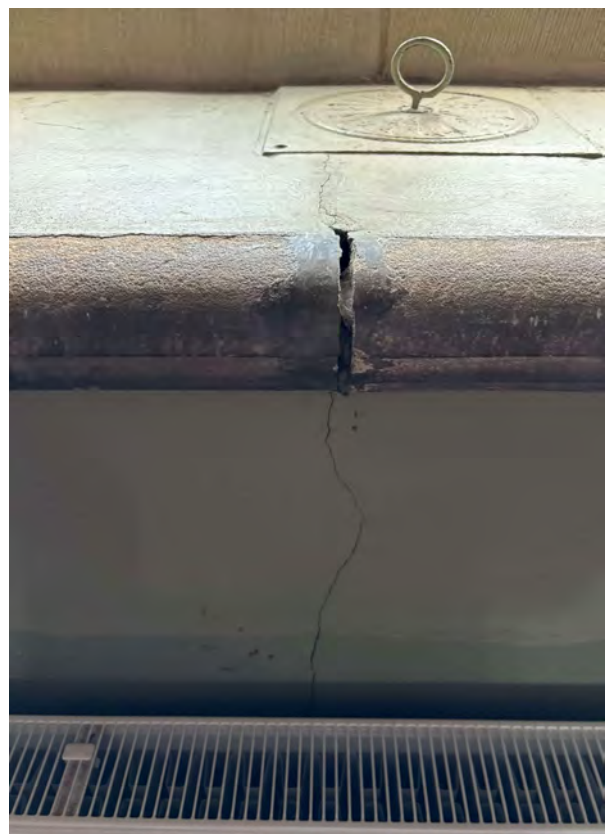
Evident crack to window cill.

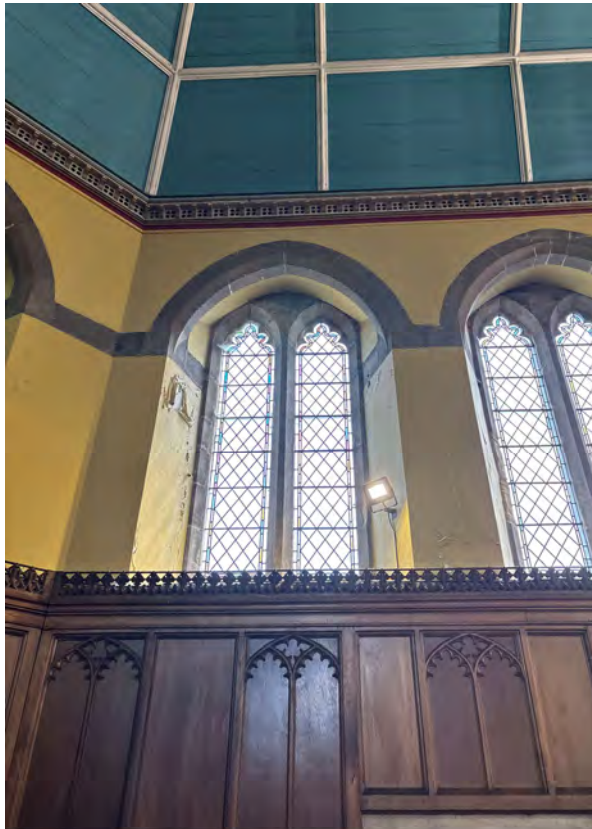
Some flaking and blistering of paint to some window surrounds.

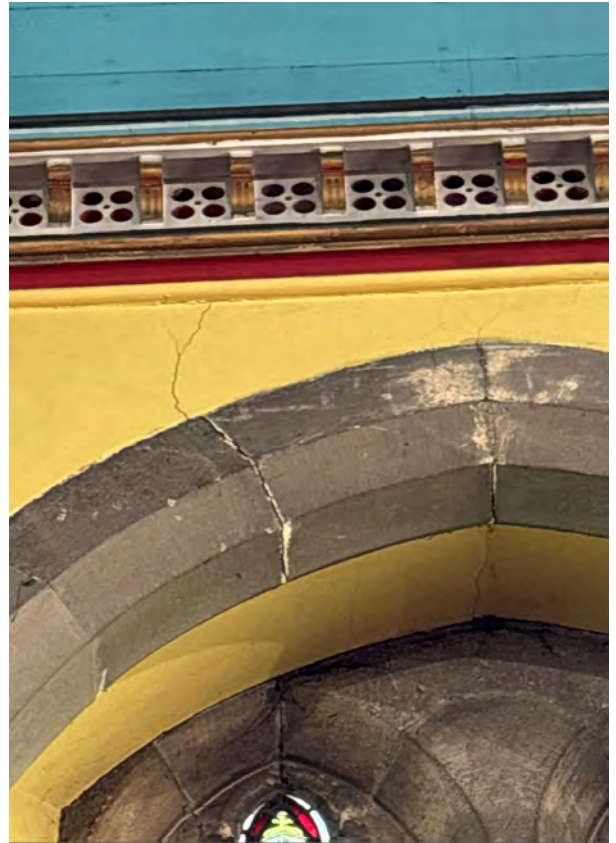
Some cracks visible above window surrounds

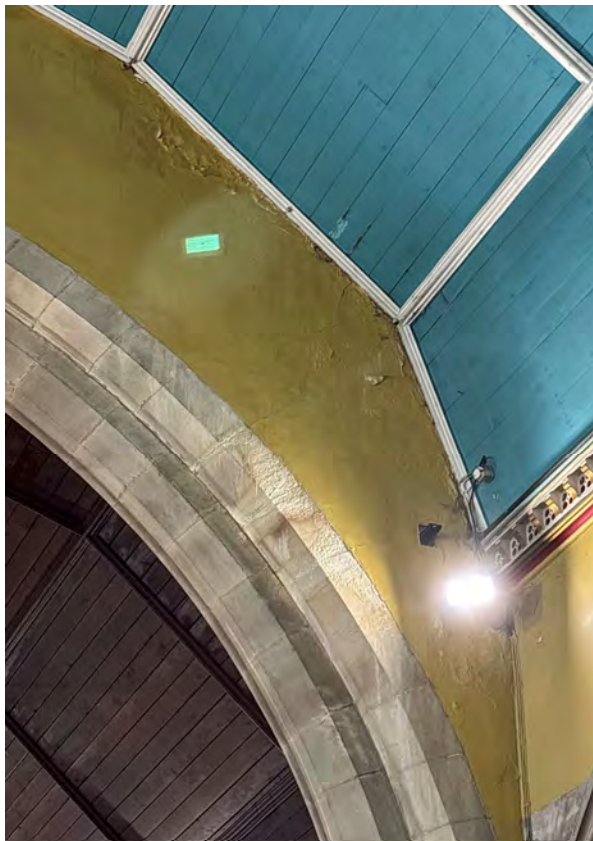
Blistering plasterwork to Chancel Return
