**QUINQUENNIAL INSPECTION REPORT
OF
NEWTON AYCLIFFE, ST. CLARE**

**DIOCESE OF DURHAM
ARCHDEACONRY OF AUCKLAND
DEANERY OF SEDGEFIELD**

**QUINQUENNIAL INSPECTION AND REPORT
February 2019
David Beaumont BA (Hons) Grad Dip, RIBA, AABC**

Address: St. Clare's, St. Cuthbert's Way, Newton Aycliffe, County Durham, DL5 5NT

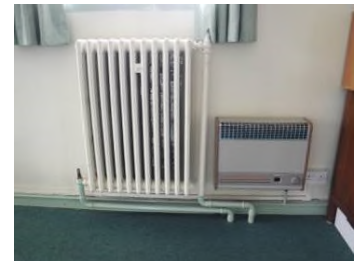
B Heating: The church has 3 methods of heating, principally hot water to radiators, secondly Baxi Brasilia Slimline 8S convectors in the choir vestry, thirdly Creda electric heaters in the lady chapel.

The gas fired boiler serving most of the church rooms was replaced in 2016 with an Ideal Falcon GTS boiler. There is also a further Main Mersey Super gas fired boiler in the kitchen next to the choir vestry last service is 2008.

The system is only put on for services and having it ticking over at about 13 degrees was suggested at the inspection. The wardens report that this has been done and that the change is beneficial.

Recommendation: Carry out annual services and check of the system. Put test certificates in the Log Book

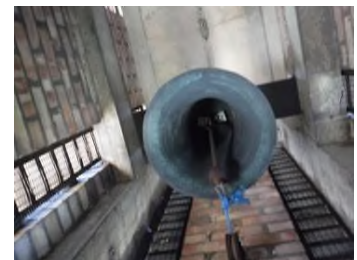
D Bells: One tolled bell, fixed within the tower. The headstock fixings look replacement but the rusting beam supporting the bell looks original and it is not possible to identify the size of it or its condition due to limited access.

Recommendation: Establish if the beam is satisfactory.

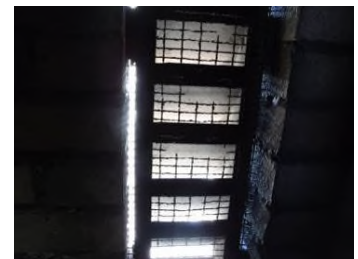
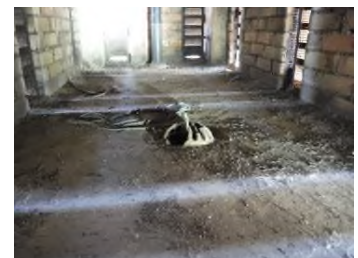
Stage 3:

Concrete roof and frame all appear sound. Brick infill panels all look ok, the mesh to the timber louvres on the south side is beginning to erode and providing a chance for pigeons in the future. Some dust around on the floor, cowl for drainage rusted and may be blocked up now. Did the tower used to have gutters- now removed? Because there is pipework here to receive gutter water.

Bell looks ok. Seems to have recent headstock fixings to the beam bell but that is rusting, it is not possible to see the size of the bell frame from my inspection.

Recommendation: renew louvre mesh, remove downpipes if redundant, sweep floors and inspect floor drainage for free flowing, check gutter joints at low level, inspect bell beam, replace ladders with aluminium fixed, remove lumber, make a lighter hatch cover and hinge it with hold open fixing,

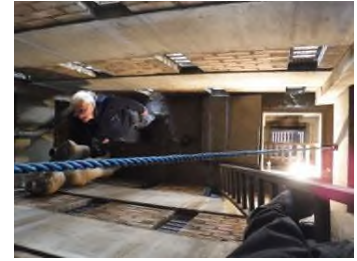
Stage 2:

Same condition as the stage above. Spindly timber ladder, as the stage below, should be replaced in aluminium, there are a couple of mannequins at this stage. The floor is quite sandy, the drainage cowl looks ok but there really can't be much in the way of water coming in here. This floor has a mineral felt lining but you can't really see it as it is covered in dust. The ceiling hatch is metal covered and is very heavy to operate, could do with being hinged and a better grab handle arrangement.

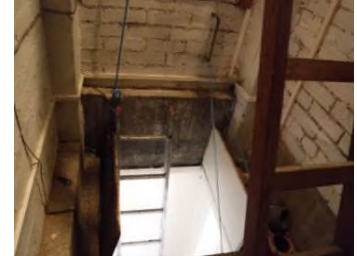
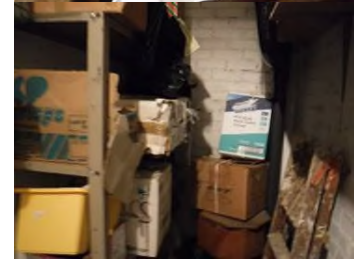
Stage 1:

Painted walls all dry and clean, some racking for storage, perhaps some signs of leakage to the rainwater gutter joints.

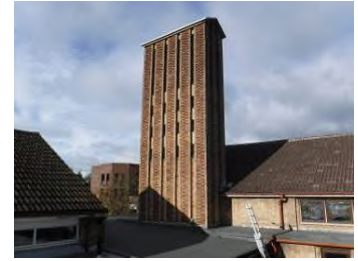
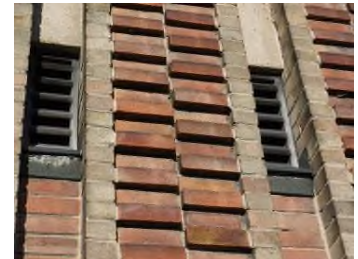
TOWER EXTERIOR

Not able to adequately see the roof covering. Suggest that it is could be ridged membrane type material with a tanalised timber trim. Likely to have had its gutters removed at the time of recovering. No apparent defects. The downpipe which drains the floors, exits on the south side.

Some minor spalling of the soffit of the roof structure but no problem. The brickwork is all sound though there are the odd small bits spalling off, but no significant defects issue, hardly any at all (unlike the boiler flue chimney).

The timber louvre are natural finish and they all look sound, they are quite thick, so they will last. The second stage mineral felt floor finish shows at the bottom of them and that looks all ok. The lighting conductor comes down on the south east corner and is loose from the base of the tower to the south aisle.

Recommendation: none

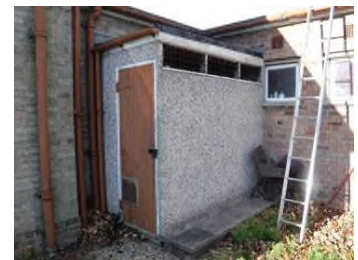
Felt roof, looks very old but is ok. It is cracking but is just sound enough.

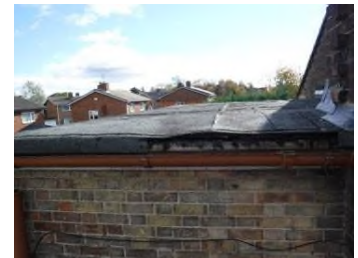
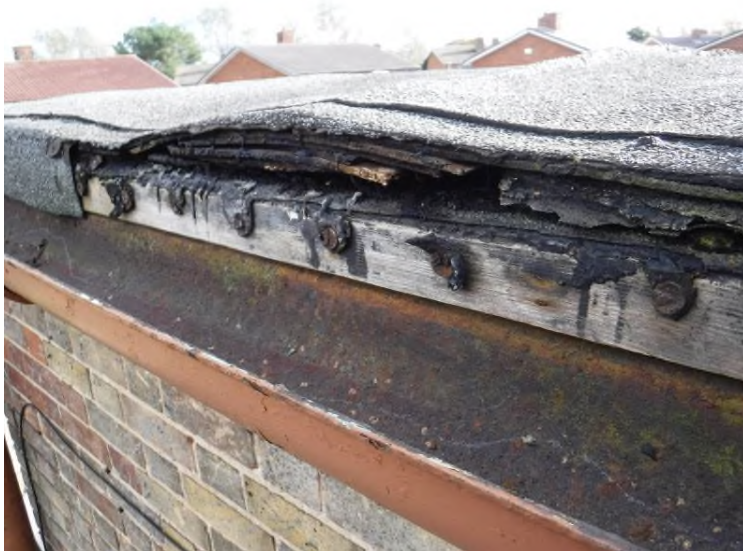
Sanctuary:

Roof is in poor condition and clearly has been over felted in the past, it is laminating at the edges, lots of hardboard showing that has expanded. The flashings to the gable are ok.

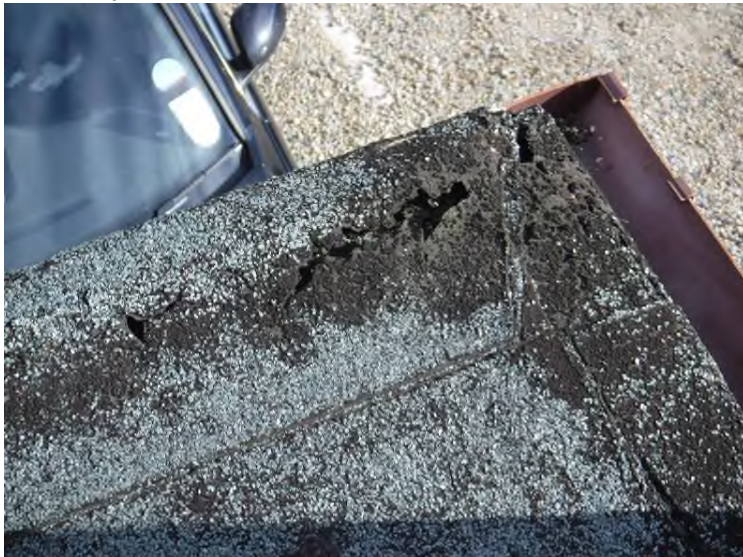
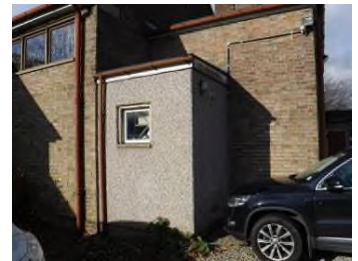
Sanctuary Store:

Giving way at the edges

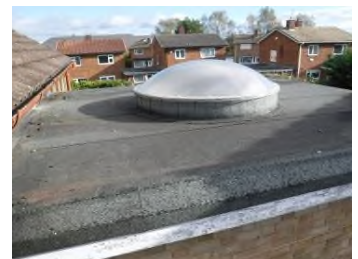
Lady Chapel:

Relayed in 2004 but requires closer examination to establish if defect free.

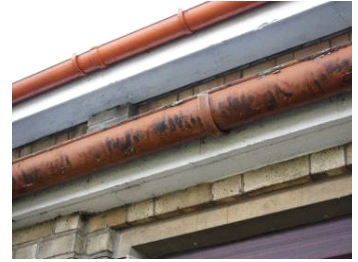
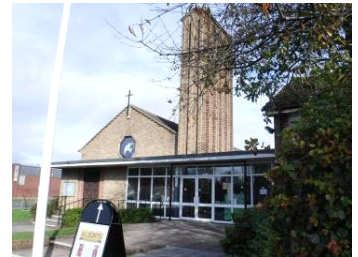
West end:
Internal downpipes on flat roof.

Recommendation: remove, renovate, repair and redecorate the rain water goods, brackets and redecorate the timber fascias. Clear out all gullies and check for free running, consider mesh covers.

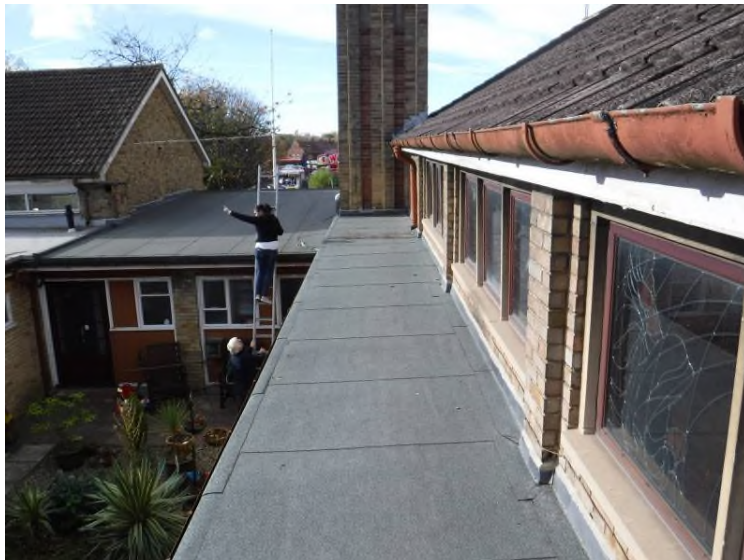
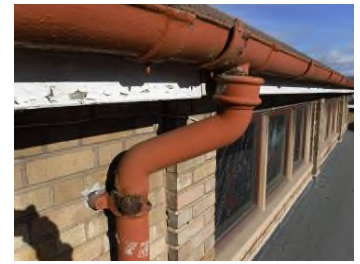
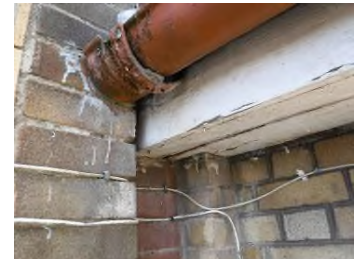
North side plastic downpipes to metal gutters, nave part restored as part of the 2016 nave roof recovering works.

South side last looked at probably when the roof was re-covered in circa 1990's and there is a cracked downpipe and rusting gutters and fixings.

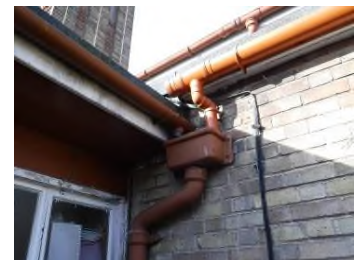
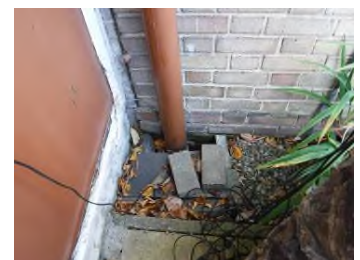
Two downpipes to gulleys that are blocked, one has a temporary Formica cover which is loose.

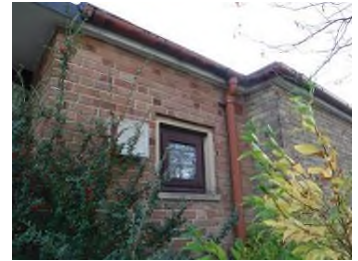
North Aisle: rusting gutters and downpipes.

Choir Vestry: Same as the aisle. Overgrown with planting at the base of the downpipe, looks like there is some rusting on the collar? The gutter has black hand marks from when it has been pointed up with sealant, looking untidy.

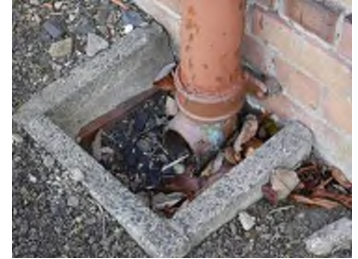
East End:

Rear gutters are same as the choir vestry with silted gulleys

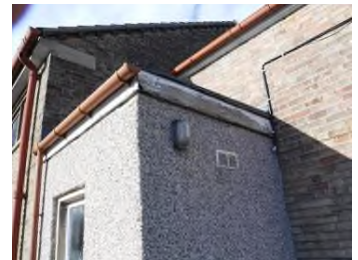
Gutters seem fair with some rusting on the downpipe, bottom shoe loose and the gulley guarding is makeshift.

Plastic gutter and downpipe with paint coming away and a bit loose at the bottom.

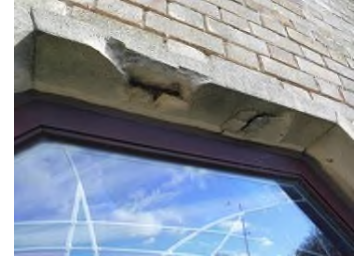
Cracking to the west gable octagonal window frame at the west.

Recommendation: repair spalled frame

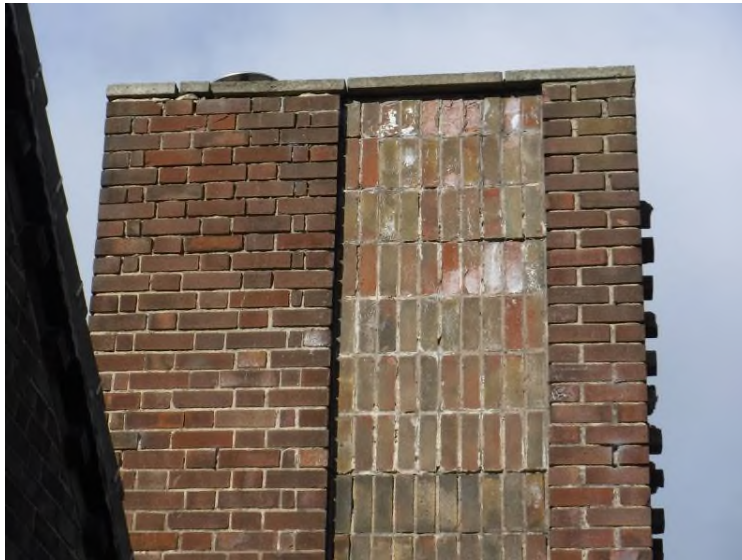
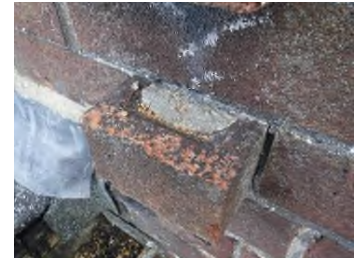
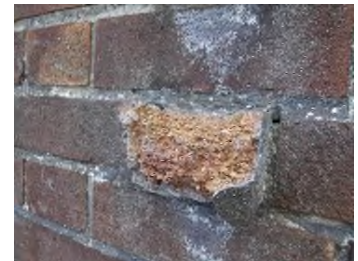
Boiler Flue:

Open joints to the pointing. The capping in concrete flags looks to have open joints and water is causing salting- particularly at the soldier course panel. The projecting headers are eroding (possibly due to freezing water sitting in puddles of the poorly pointed brick frogs- the depression in the bed of the brick). The eroded faces are quickly breaking down. The flue will be a constant repair problem and consideration should be given to its removal. The flue has been superseded by the later tower in providing a visual statement. Of the presence of the church.

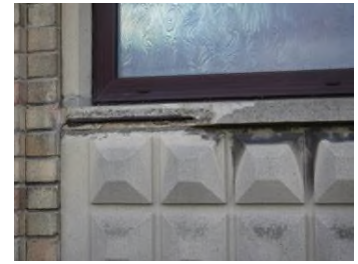
OK, just some weathering underneath the cills to the windows. One cill broken due to reinforcement expansion.

Recommendation: repair spalled cill

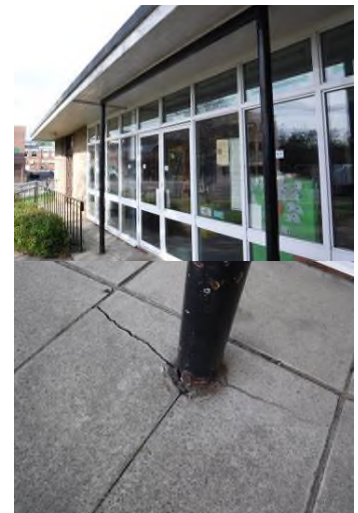
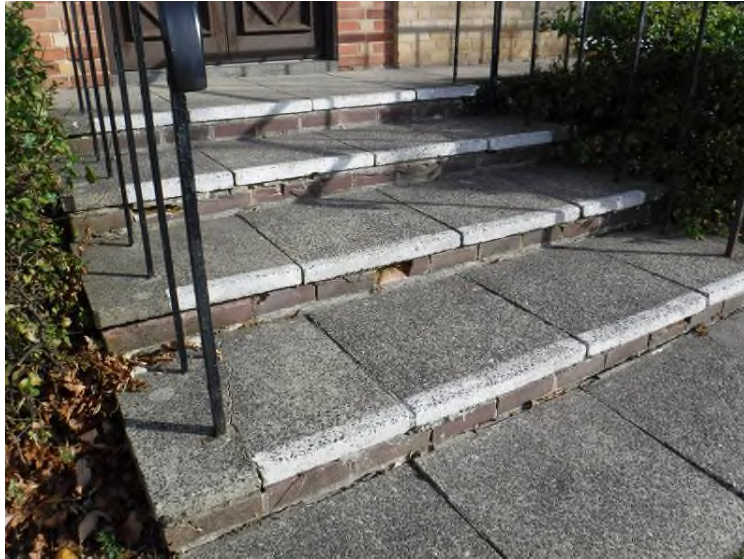
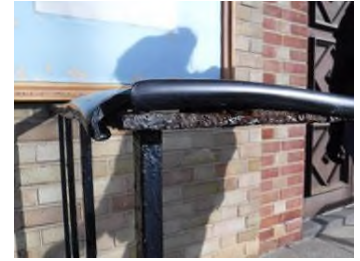
Ramped access to the lobby entrance that has a poor timber ramp. The church entrance has a steel goalpost and this has rust at the base of it. Was this put in in the past when the lobby glass wall was created? Is it holding up the roof? Seems likely, so the rusting feet will need attention.

Open joints to steps and brickwork at west entrance. Handrail cover being forced off by rusting handrail.

Recommendation: open up goalpost and examine condition and its purpose, repair feet and paving, point up paving and steps, renew hand railing, renew ramp

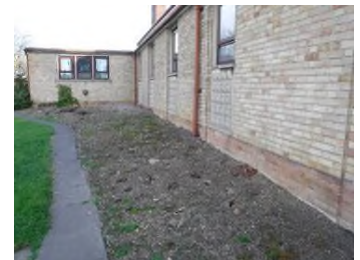
At the north east corner there is a cherry? Tree. It is ok just needs to be kept in-check.

Recommendation: plant up north border, remove conifers,

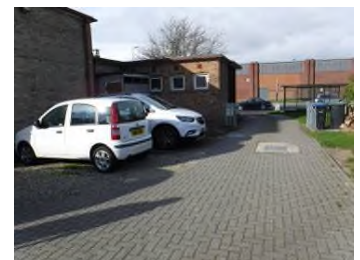
Block paved entrance from the highway with some slight sinking at the wheel tracks. Gravel margin to the east entrance, a little untidy but it will do. Car parking arranged on gravel with some grass growing into it also will do. The boundary to the neighbour is all reasonably tidy, there is a shrub against the church wall that whilst it has been cut back needs fully removing. The gravel is now intermingling a bit with the soil.

Recommendation: remove shrub base

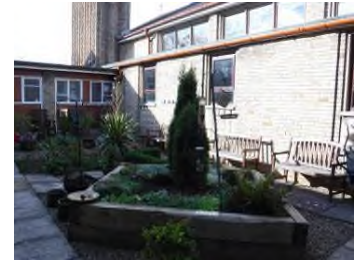
E South Side:
 A paved raised bed garden and a very pleasant amenity space. Paving is generally ok, as is the gravel and the planting. It is used as a bit of a dumping ground for fencing and barrows and the like and maybe a lean-to garden store might be appropriate up against the west Lady Chapel wall.

Recommendation: make a home for the garden equipment and materials

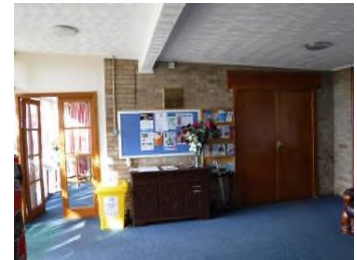
B Lobby:

- Ceiling – Artex ceiling, there is a watermark but I think that it is historical.
- Walls – Mostly fair faced brickwork which is all in good condition. The front entrance is aluminium double glazed units generally ok. Door catching slightly and could do with the glass cleaning.
- Floor – Solid covered in Flotex type carpet all serviceable.

Recommendation: ease door and clean glass

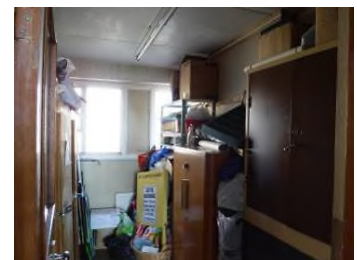
E Store:

- Ceiling – Fibre boards, ok.
- Walls – Plasterboard lined out in the majority.
- Floor – Solid floor with Flotex typed floor tiles.
- General – Room contains Brownies' art materials, general storage shelving and general lumber.

Recommendation: improve shelving

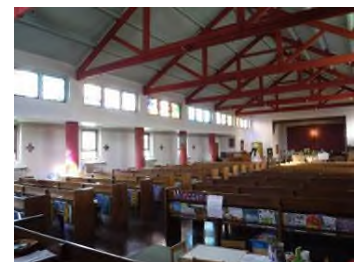
- Ceiling – Six timber trusses supporting four concrete purlins. The panels between them are fibreboard with a band between the trusses but at the truss joints there is a cover lath nailed on and some are coming away and the boarding is buckling slightly. In very good decorative order, they are more noticeable at the gable where you can see them curving. Not yet at a point when it's worth the cost of attending to them.

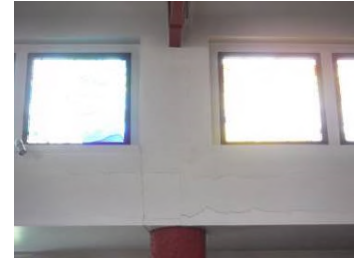
- Walls – Painted plaster and there is some cracking to the clerestory wall plaster above the column positions. The location of the principal cracking seems to major on the second truss in at both ends, so there is a pattern there- perhaps differential settlement when built? The crack goes from the column up to the truss and it is probably because the masonry pier between the clerestories is a bit on the light side (but there might be some steel in it). It does look historic.

Cracking has been clumsily redecorated in the past.

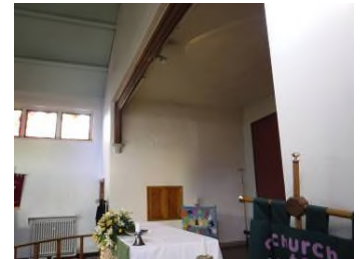
- There is water staining at the east end- could be either sanctuary roof flashing, covering or water in the flue) but is it historic? This has been commented on every QI since 1995.

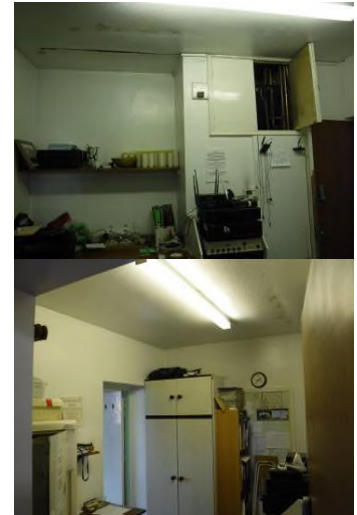
D Clergy Vestry:

Door to choir vestry ok though the lever handle has seen some basic repairs in the past and is very heavy.

Recommendation: redecorate ceiling

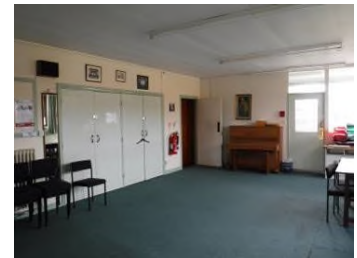
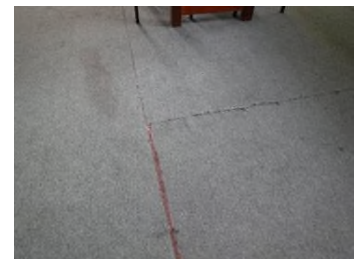
D Choir Vestry:

- Ceiling – Taped fibreboard, fair condition.
- Walls – A mixture of painted plaster and heavily embossed wallpaper.
- Floor – standard type carpet, bonded to the concrete floor and there are some gaps in the carpet and it is beginning to thread up a bit and has some marking to it.
- General – Large open room with some fitments around the perimeter.
- The room is heated by 3 Baxi Brasilia Slimline 85 individually flued convectors plus a column radiator in the corner, there is a supplementary fan heater in here too.

Recommendation: repair carpet

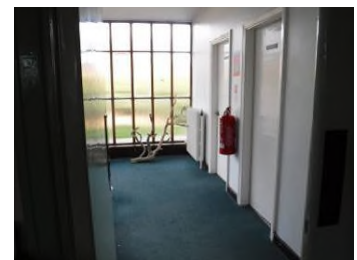
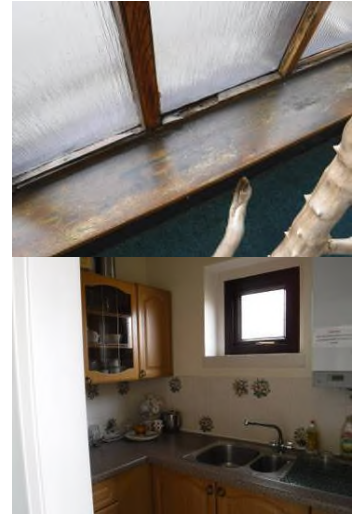
- Ceiling – Combination of painted plaster and fibreboard.
- Walls – Painted plaster some with embossed wallpaper. Woodchip in the toilets.
- Floor – Solid and carpeted throughout apart from the gents W.C. cubicle and the servery.
- Doors & Windows – Panel doors to the W.C. cubicles. The closers don't quite latch the doors. Door to the glazed screen ok. Reeded glass and some more modern looking obscure glass, older reeded glass is cracked. Georgian wired in the double doors. Some slight water penetration down at the bottom of the cills. All looks a bit tatty but serviceable

- General - Simple Servery of sink and storage units and this room contains a boiler which is a Main Mersey Super.
The W.C's are a fairly basic fit out but generally all ok.
Toilet roll holder coming away from the wall in the gent's w.c.

Recommendation: adjust latching of doors, refix toilet roll holder

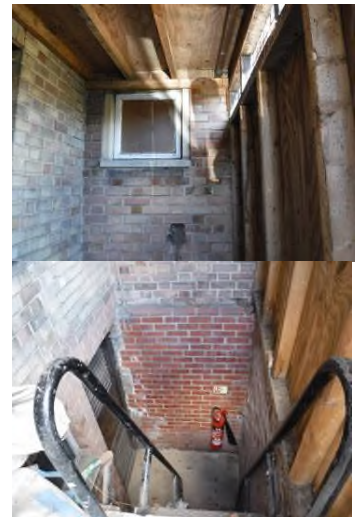
D Boiler Room:

- Ceiling – Shuttered concrete, has some patching to it but looks ok.
- Walls – Painted brickwork, all reasonably sound. Decoration breaking down a little bit.
- Floor – Concrete is fine.
- General – New Ideal Falcon GTS boiler installed 2016. Existing service pipework a bit rusty, lagged in fibre and taped lagging- the church says no asbestos. Some lumbar in the room, a collection of gas heaters to be disposed of and there are some original roof tiles for repairs kept in store here.

Recommendation: remove lumber, overhaul door, tidy up the stair enclosure, block up nesting location.

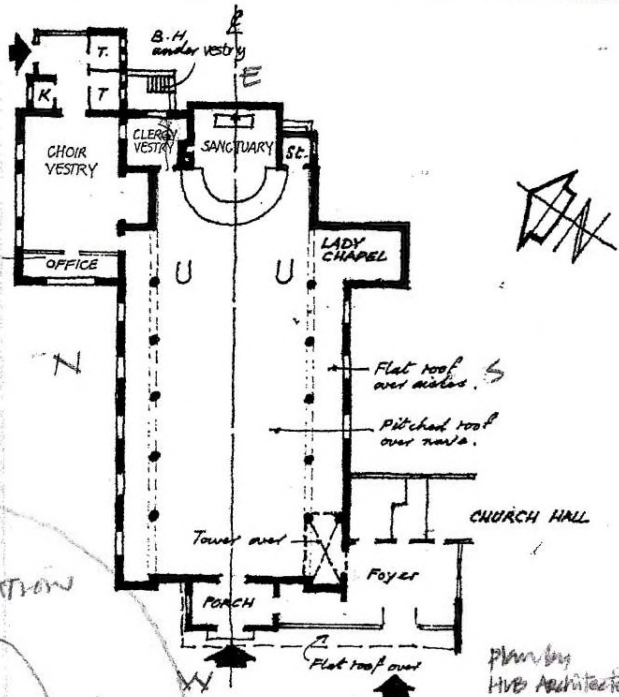
ALL FLAT ROOFS
APART FROM NAIVE.
IN CLAY DOUBLE
ROMAN.
THE S. SIDE WAS
REPLACED IN
CONCRETE DOUBLE
ROMAN - DATE
UNKNOWN

①
RECOVER IN
CONCRETE DOUBLE
ROMAN TO MATCH
SOUTHSIDE

2,3,4,5
REMOVE FELT - ADD INSULATION
IF POSSIBLE - RECOVER IN
ELASTOMERIC SHEET
