QUINQUENNIAL INSPECTION REPORT

CHURCH OF ST. MICHAEL & ALL ANGELS

7 IMPERIAL AVENUE, NORTON, STOCKTON-ON-TEES, TS20 2EW

AUGUST 2022

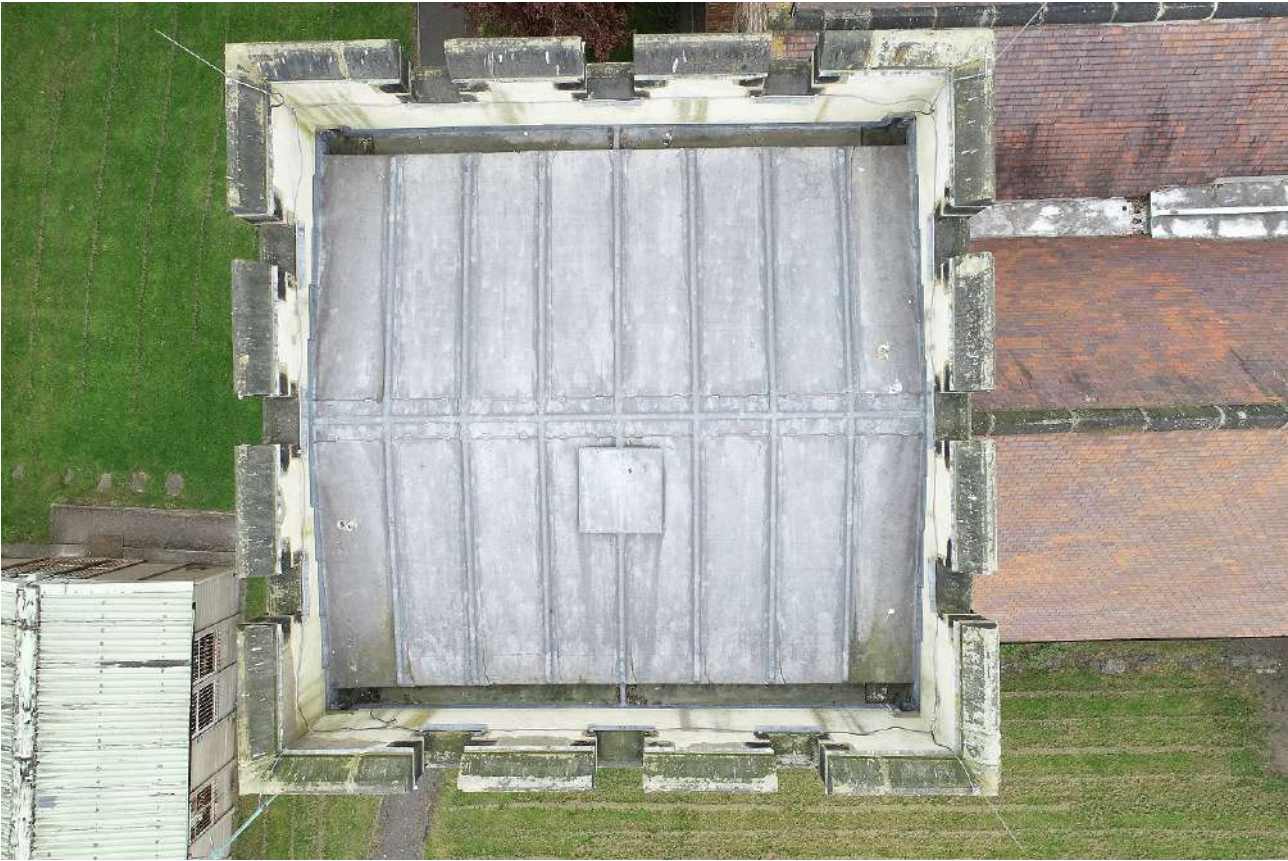
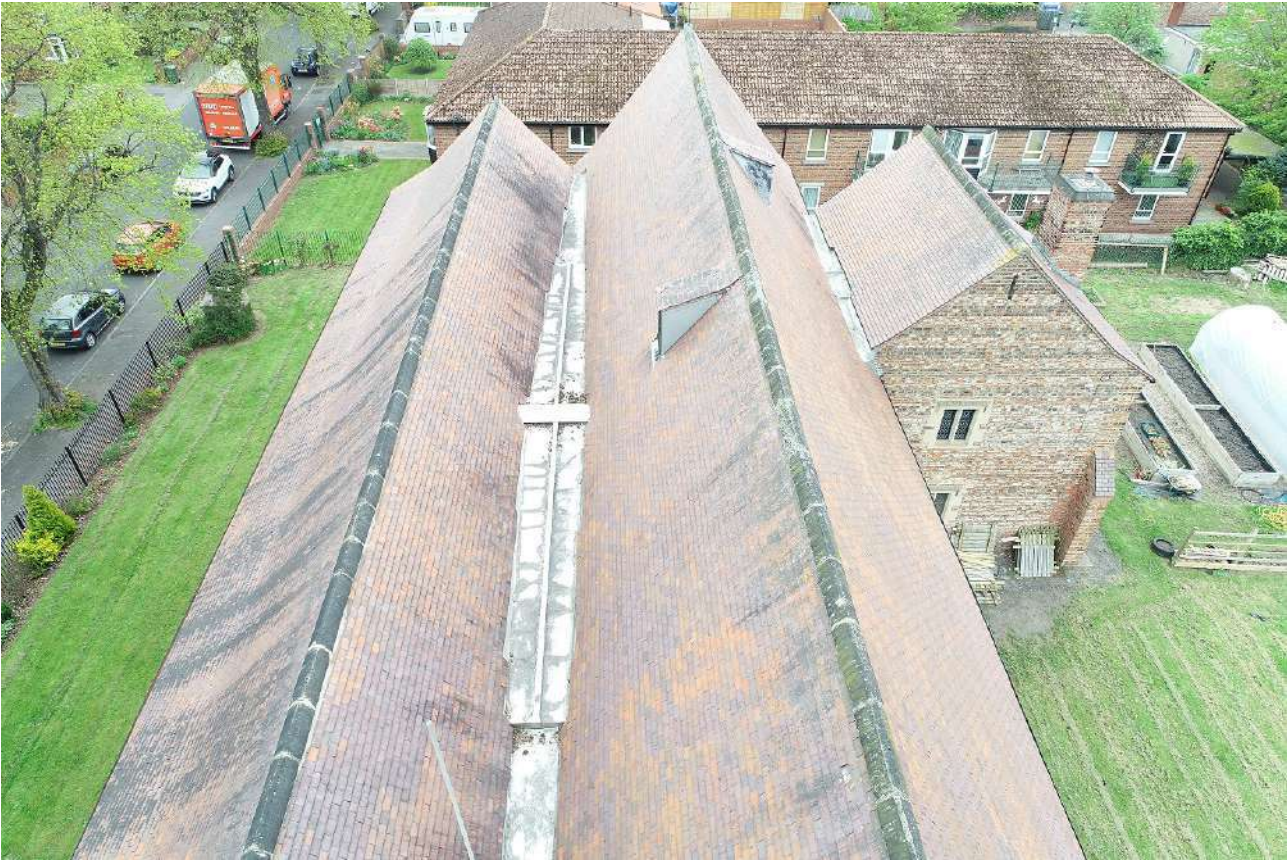
3.2.1 The tile covering all appears to be in a sound, satisfactory condition.

A check of the faculty records indicates that replacement of the tiled roof and introduction of insulation was carried out in 1986. Although it is not clear whether this was a comprehensive roof recovering or partial. This makes the current roof covering 36 years old.

Inspection of the logbook indicates that repairs have been carried out promptly over the preceding quinquennial period. There is the occasional chip and cracked tile, the face of which seems to be vulnerable to delamination due to weathering. There are also singular slipped tiles across the internal valley slopes and a couple of tiles seem to rest at the high point of the valley gutter. From what can be seen from ground level the ridge tiles appear to be satisfactory, mortar bedding generally intact.

M It is recommended that as a routine item of maintenance the roof should be examined, and repairs undertaken on a twice-yearly basis.

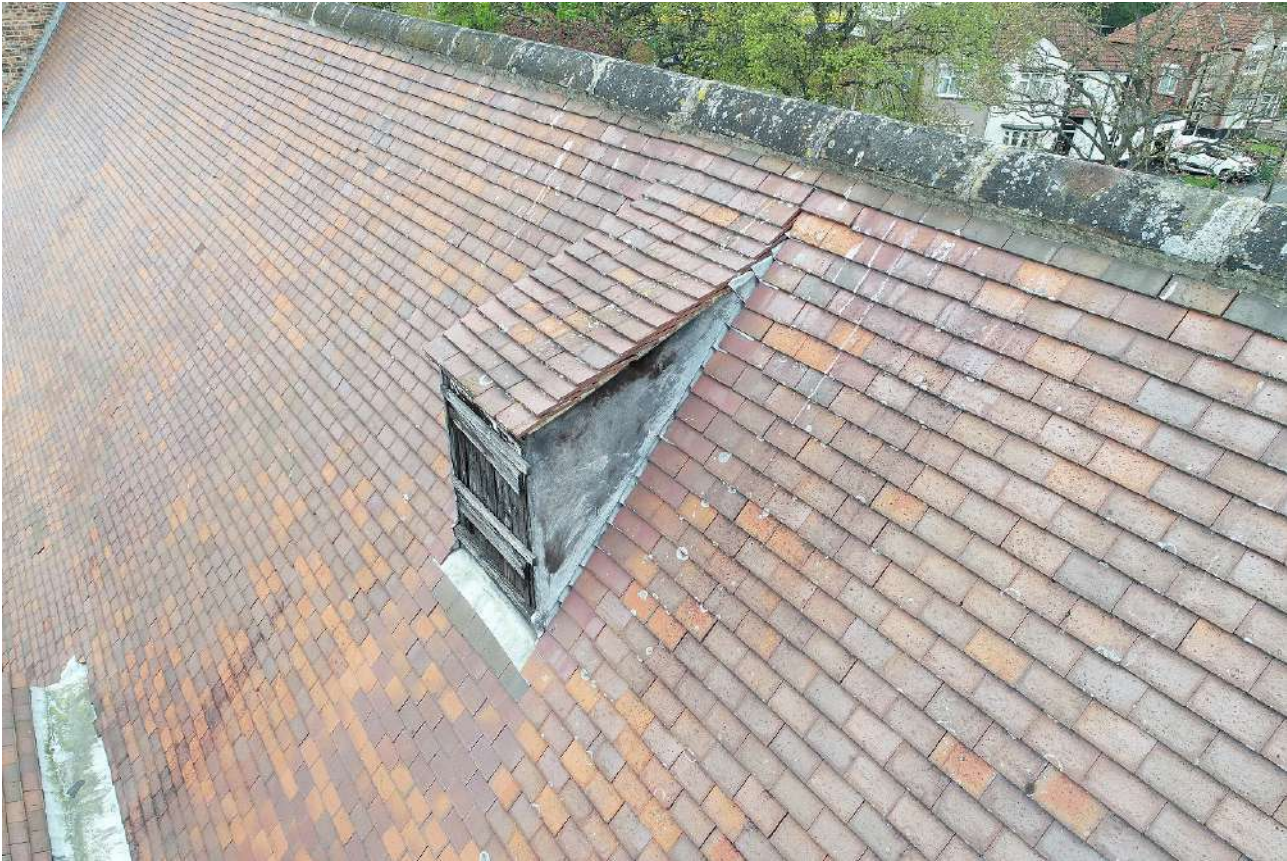
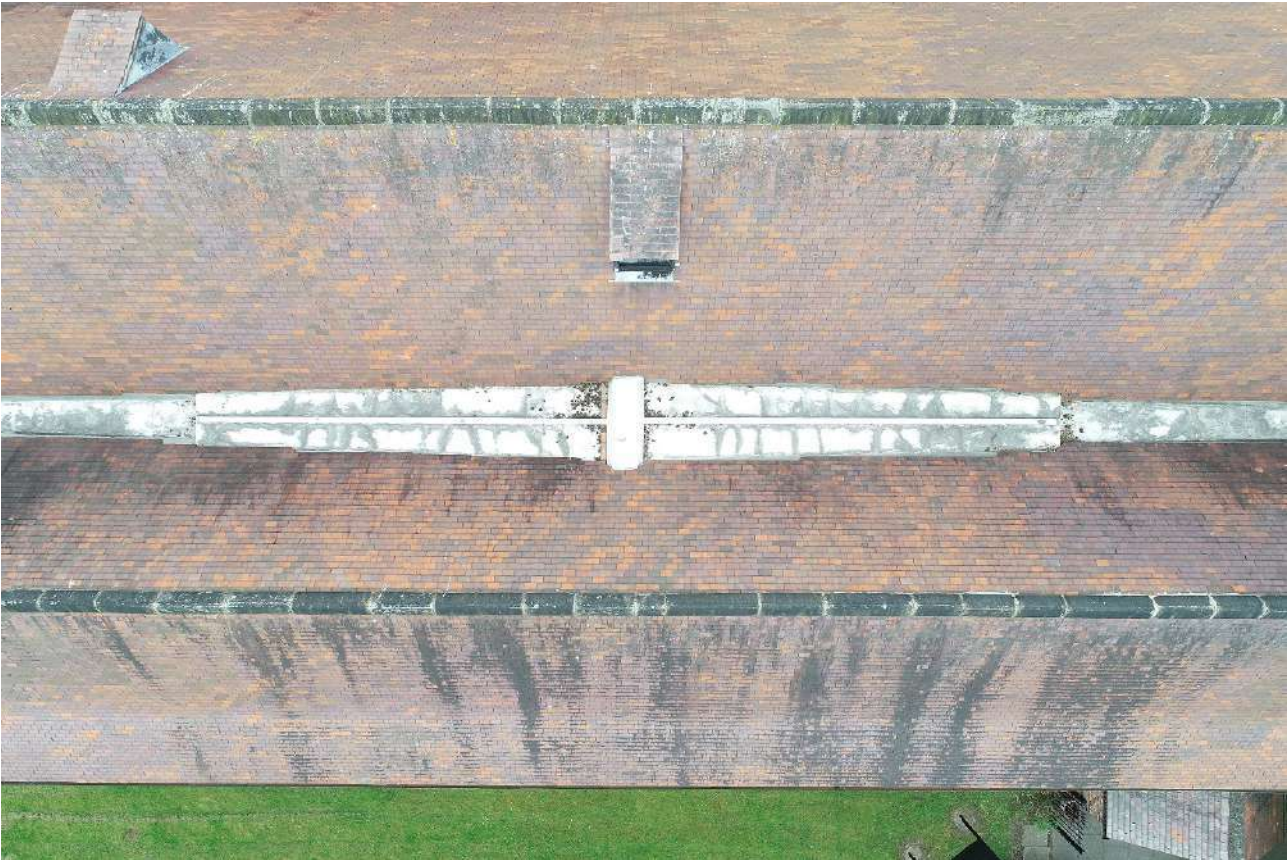
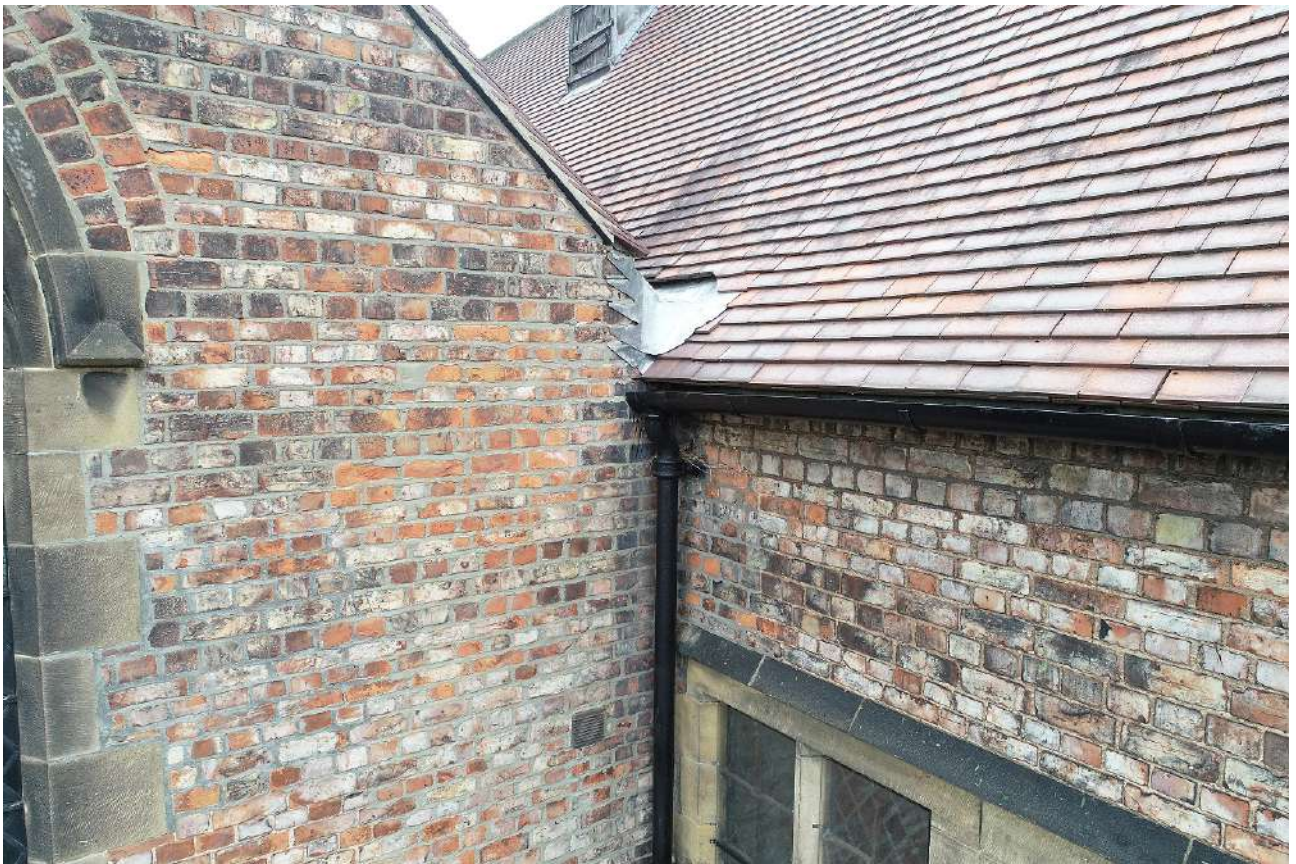
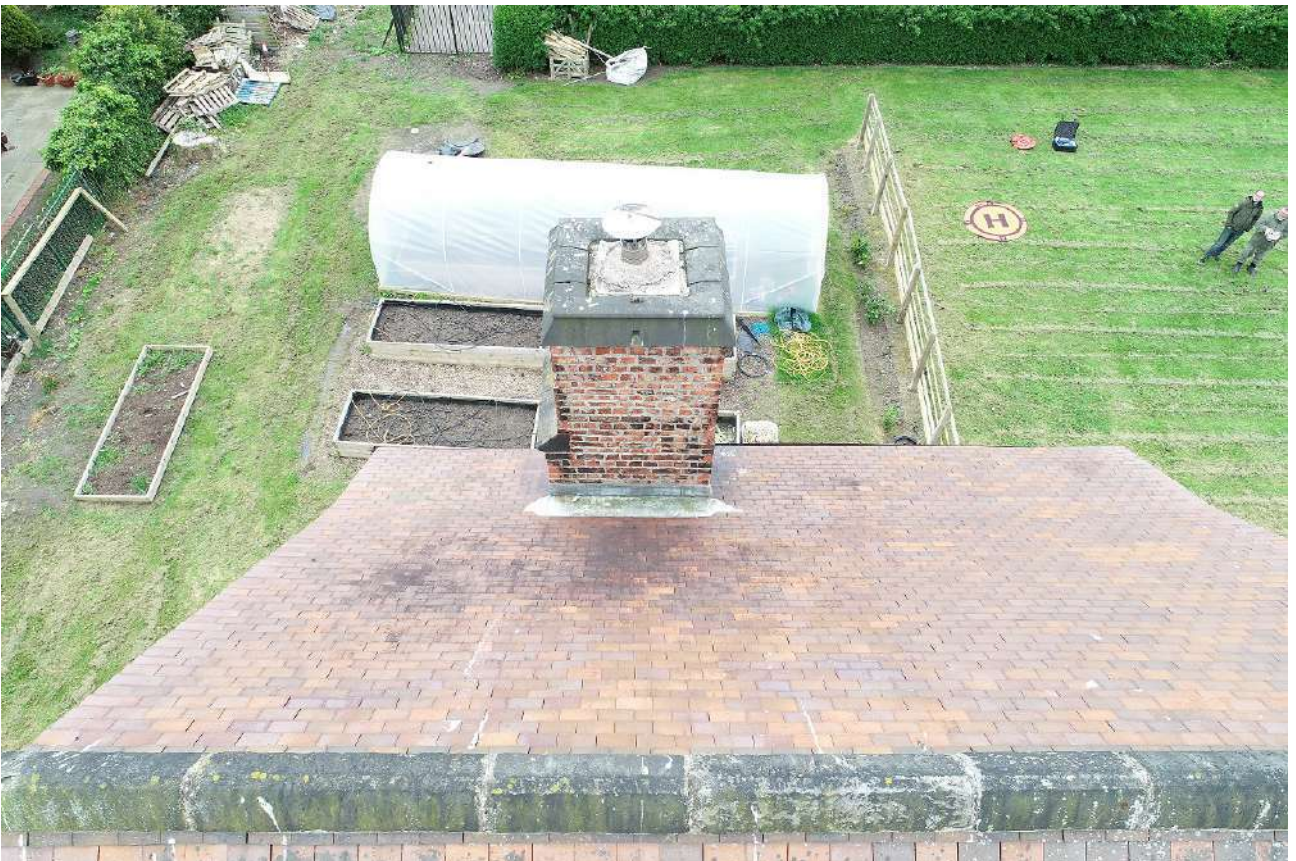
- 3.2.4 The transition between the south slope of the nave/chancel roof which abuts the vestry is achieved in a similar stepped valley gutter but in this instance covered in lead sheet. Presumably not included within the 1986 roof refurbishment scope of work.

There is a small amount of silting to the valley gutter but not to the degree that would cause issues of blockage of rainfall etc. Tarnishing of the leadwork surface exists but again appears cosmetic rather than defective.

Internally there does appear to be the beginnings of breakdown to the walling finish immediately below the east end of this valley gutter. From inspection via drone there are no clear defects evident, a single tile is slipped but covered by a section of lead apron flashing.

In any event, further investigation with assistance from a roofing contractor is warranted to determine the existence of defects which may be leading to water ingress into the church fabric.

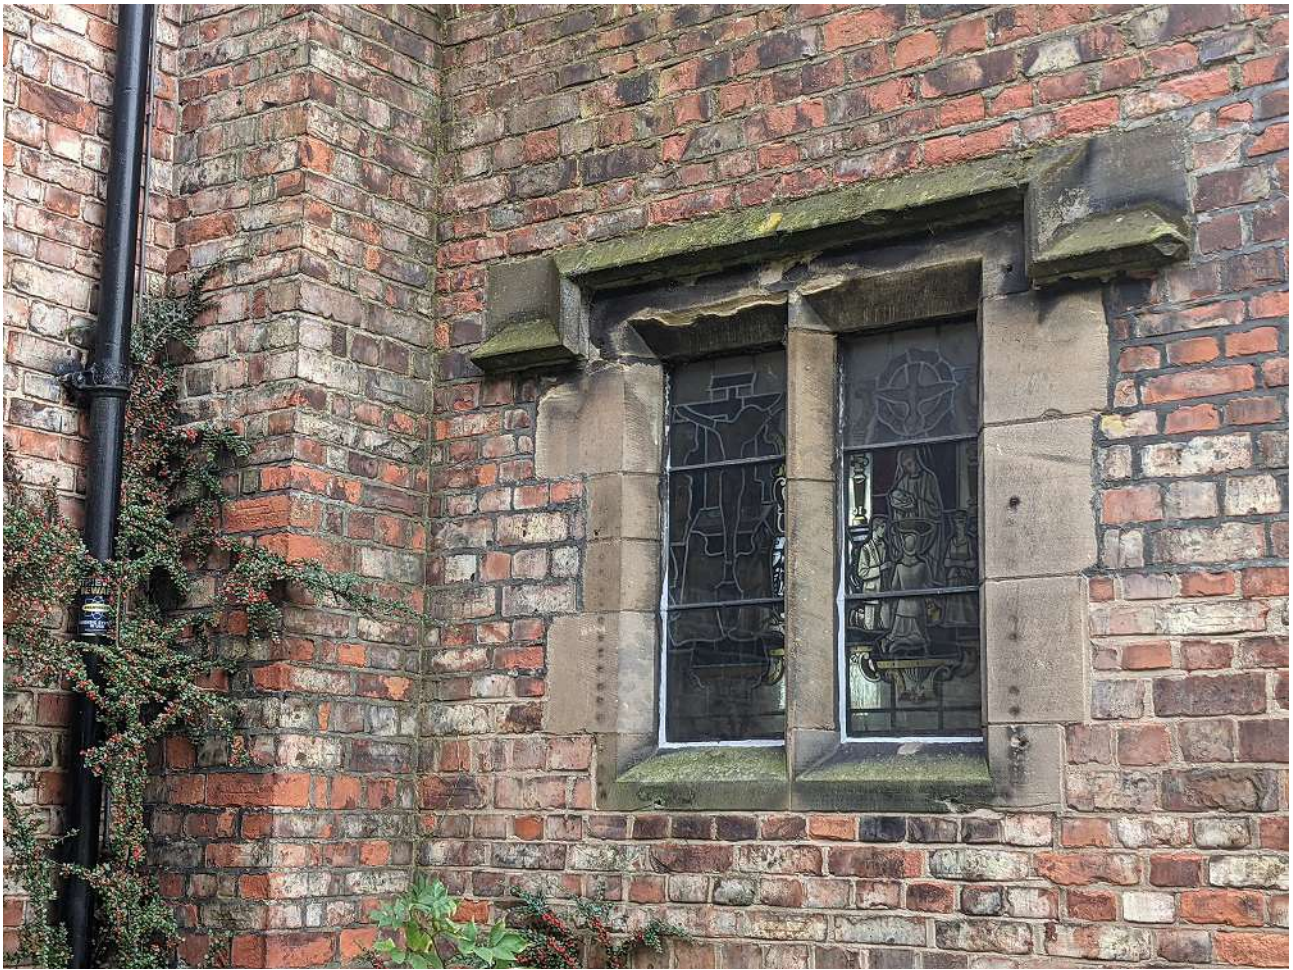
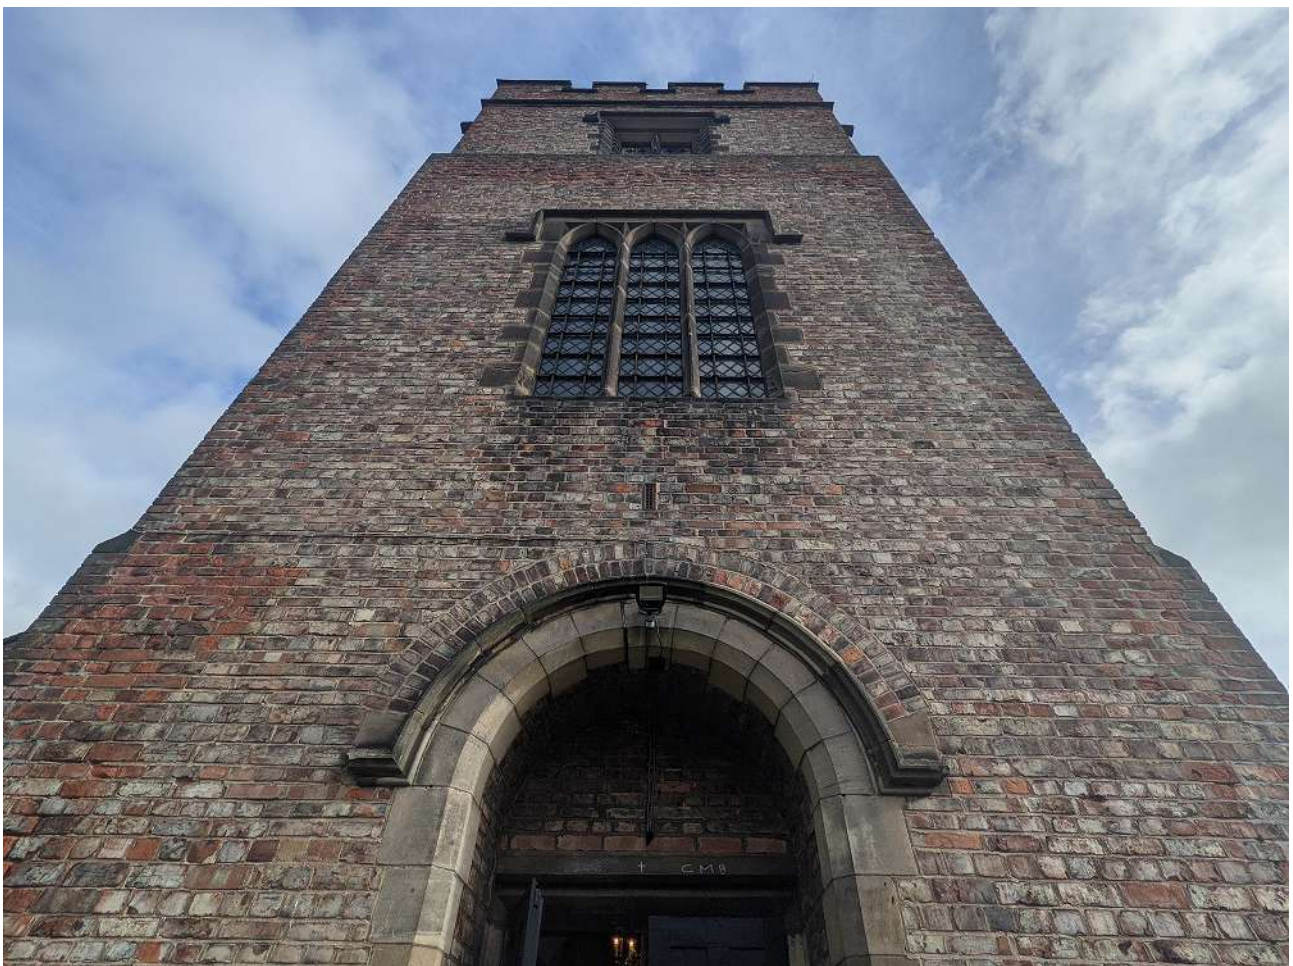
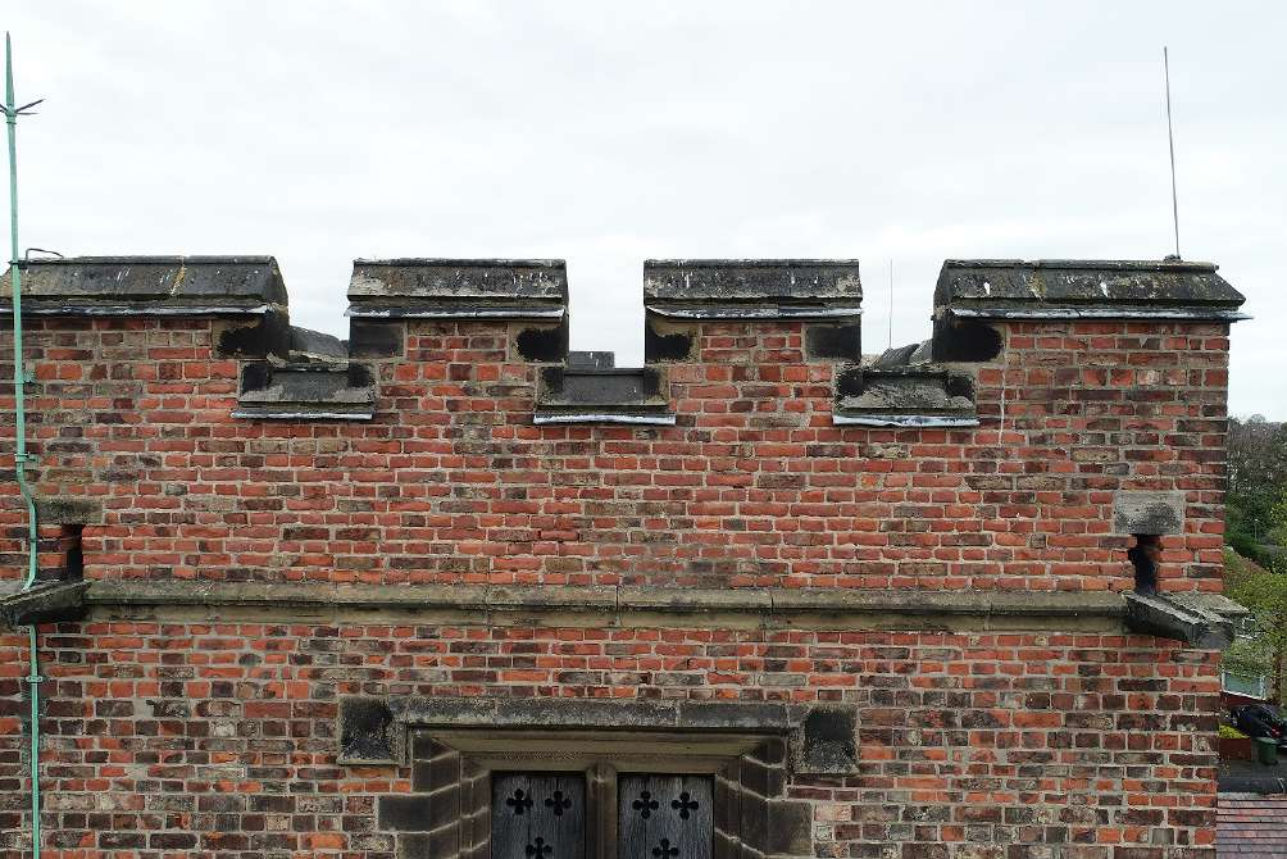
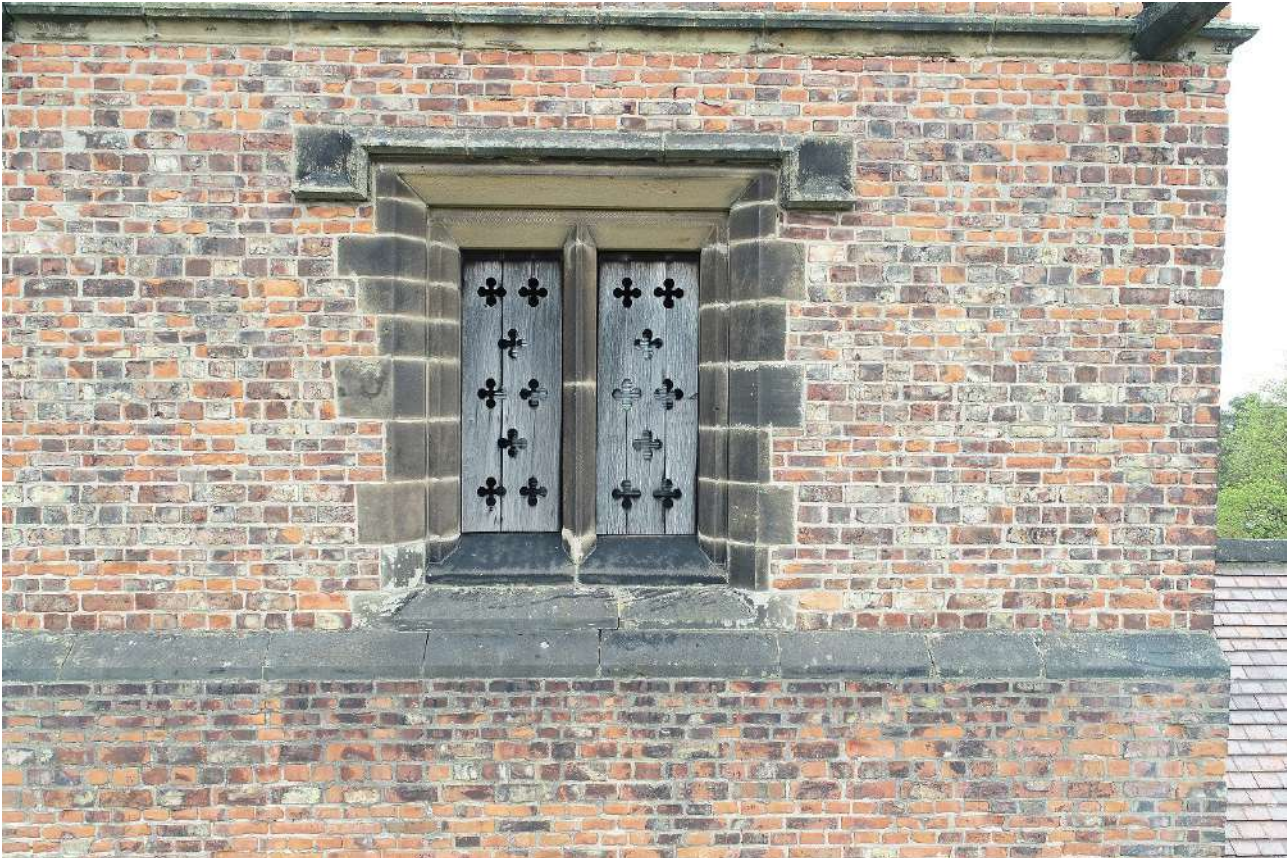
There is deterioration to the head of the stage 1 north window and excessive algae growth over the hood mould. Most probably due to catching water run-off from the tower above and being located on the north side of the church rarely gets any direct sunlight that would allow drying out.

Some open joints and erosion of the underside to the hood mould of the stage 1 west door, predominantly on the north side.

Higher up on stage 2 there is loss of brick face to the south and west elevations, immediately below the sandstone plinth at the base of stage 3. The reason for this may well be linked to open perpend joints to the sandstone plinth above which will be letting water freely into the fabric.

Weathering is noted to brickwork of stage 3, particularly to the south and west elevations. To the east elevation there are scattered loss of brick face beneath the belfry window.

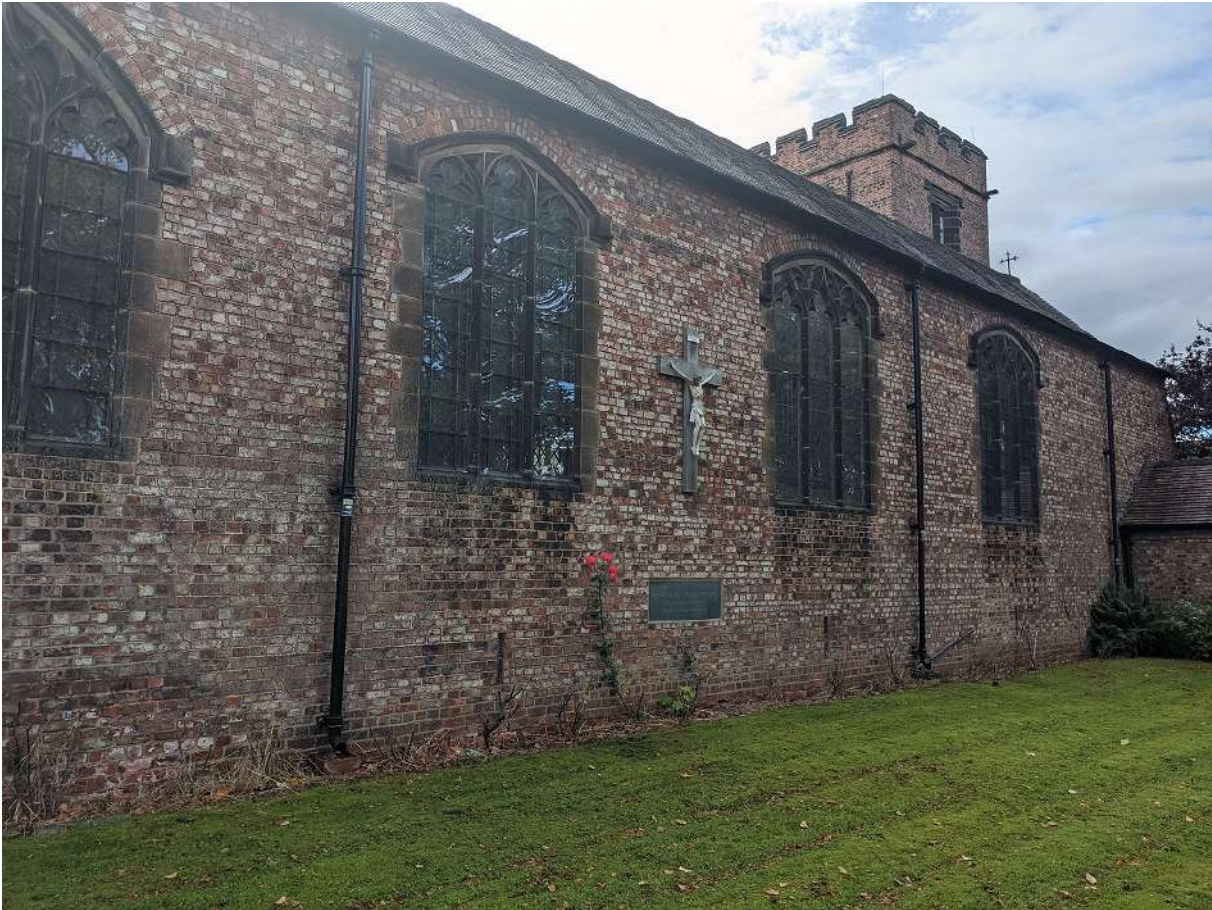
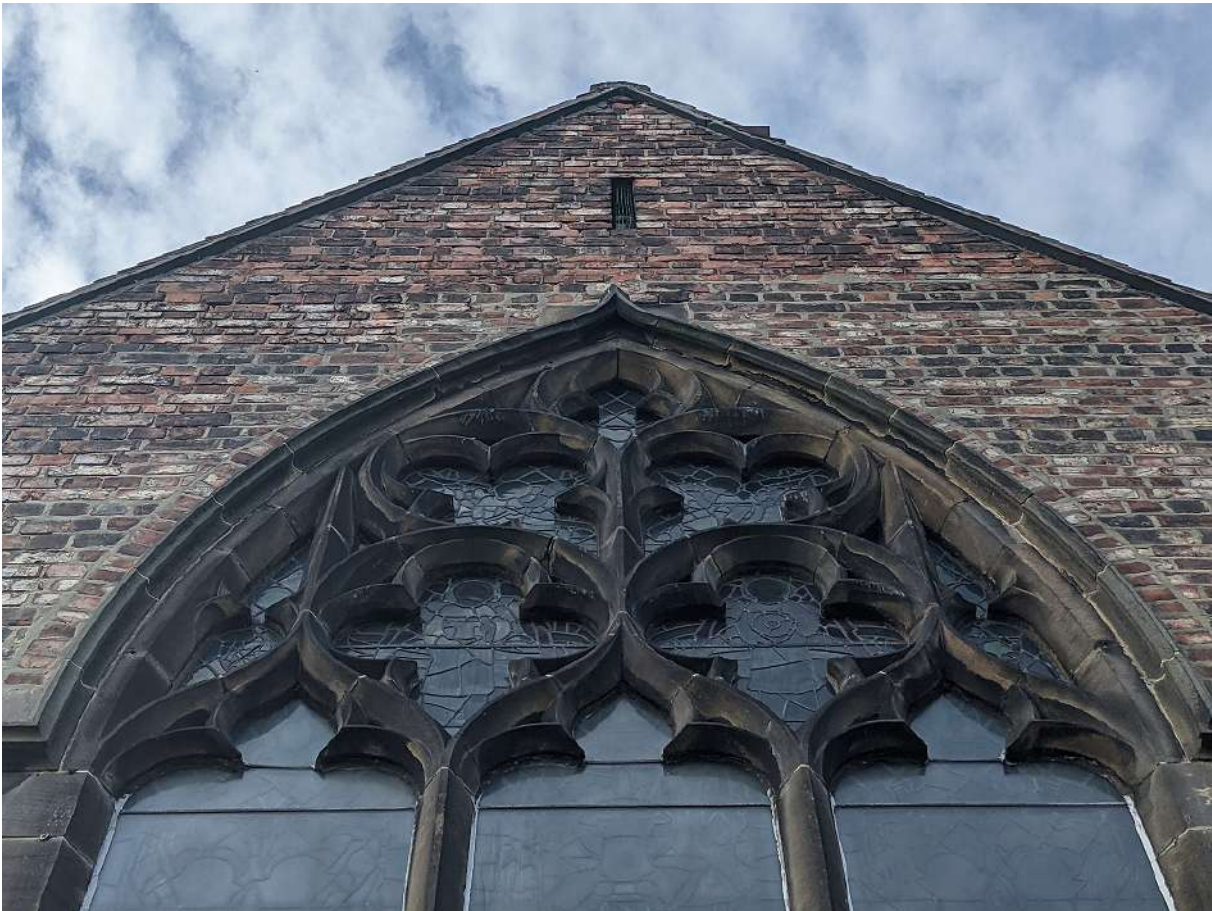
In this time the condition of the brickwork remains sound with little signs of deterioration, unlike the high-level brickwork to the tower. Although an inappropriate material for a traditionally built structure there is no need for action during the forthcoming quinquennial period, that is unless the condition rapidly deteriorates over the next five years.

It is desirable to specify and carry out brickwork repointing in a lime:sand mortar by an experienced masonry contractor.

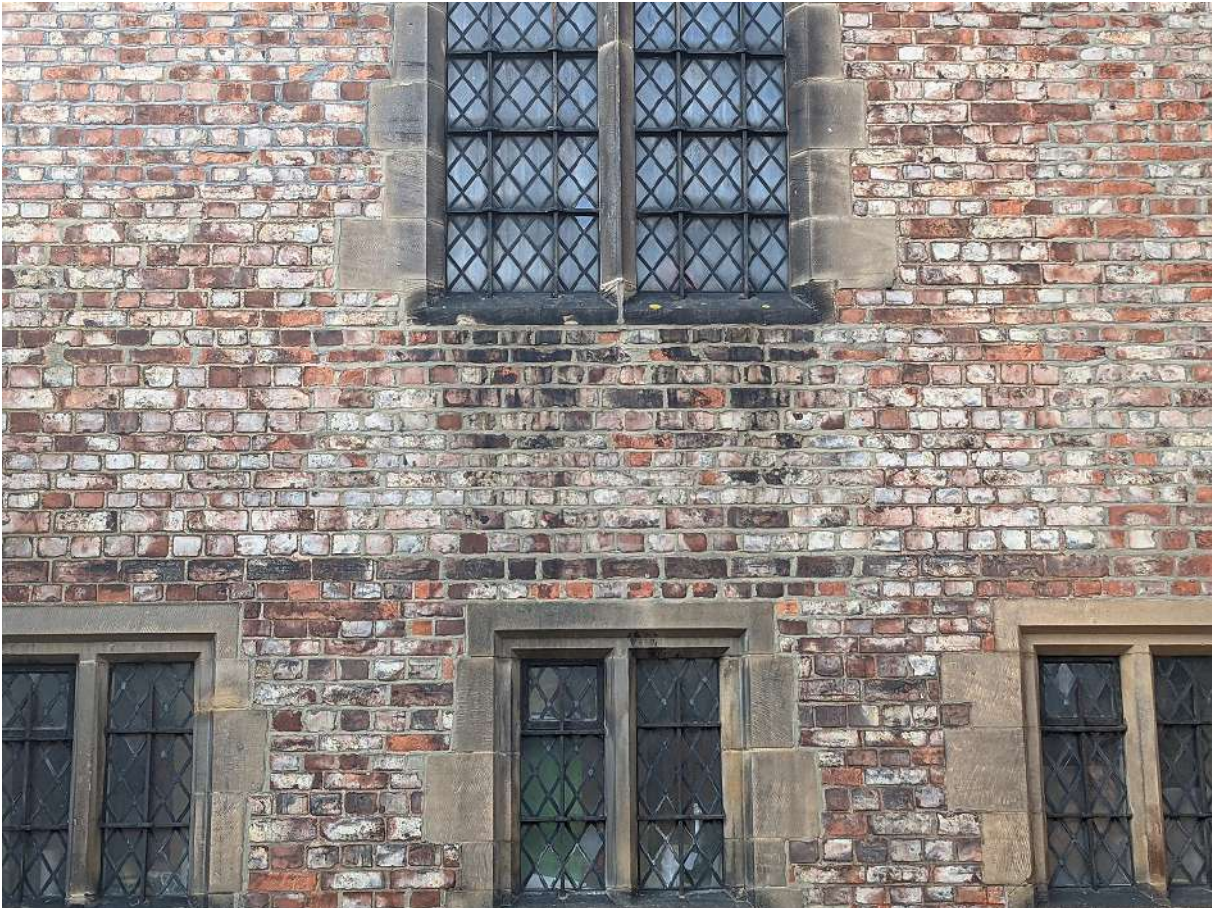
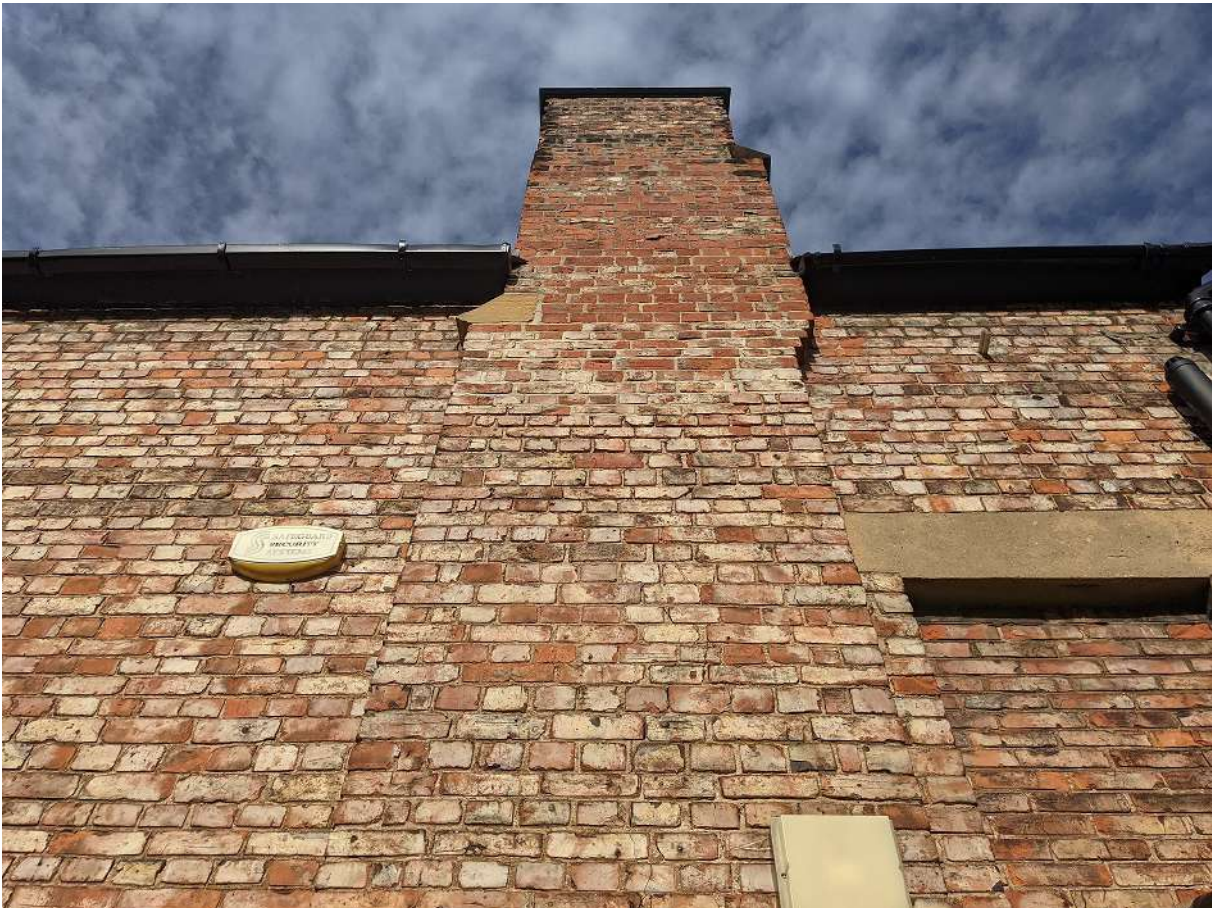
Pointing less so, where there again is use of hard cementitious pointing across all elevations and open joints to the sandstone capping. Some of the hard pointing has begun to crack and fall out, this has been noted to the north elevation where sections of pointing are lying on the lead back gutter. Brickwork weathering is developing as much of the hard pointing is standing proud of the adjoining brickwork.

The finish surrounding the metal flue liner is a little rough and could benefit from re-haunching to direct rainwater towards the weep hole in the rear of the sandstone capping.

R2 It is recommended that a specification in connection with repointing in a lime:sand mortar is prepared concerning the chimney stack.

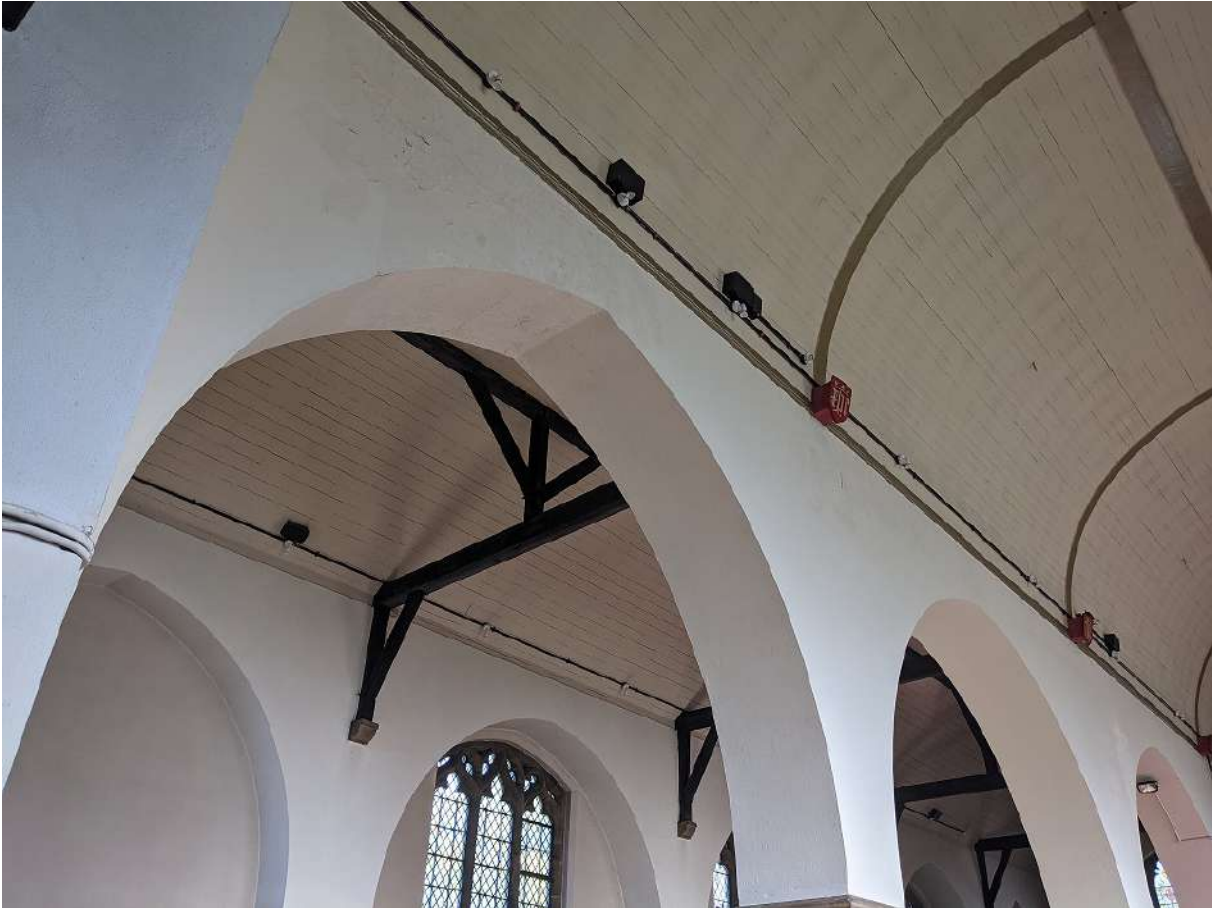
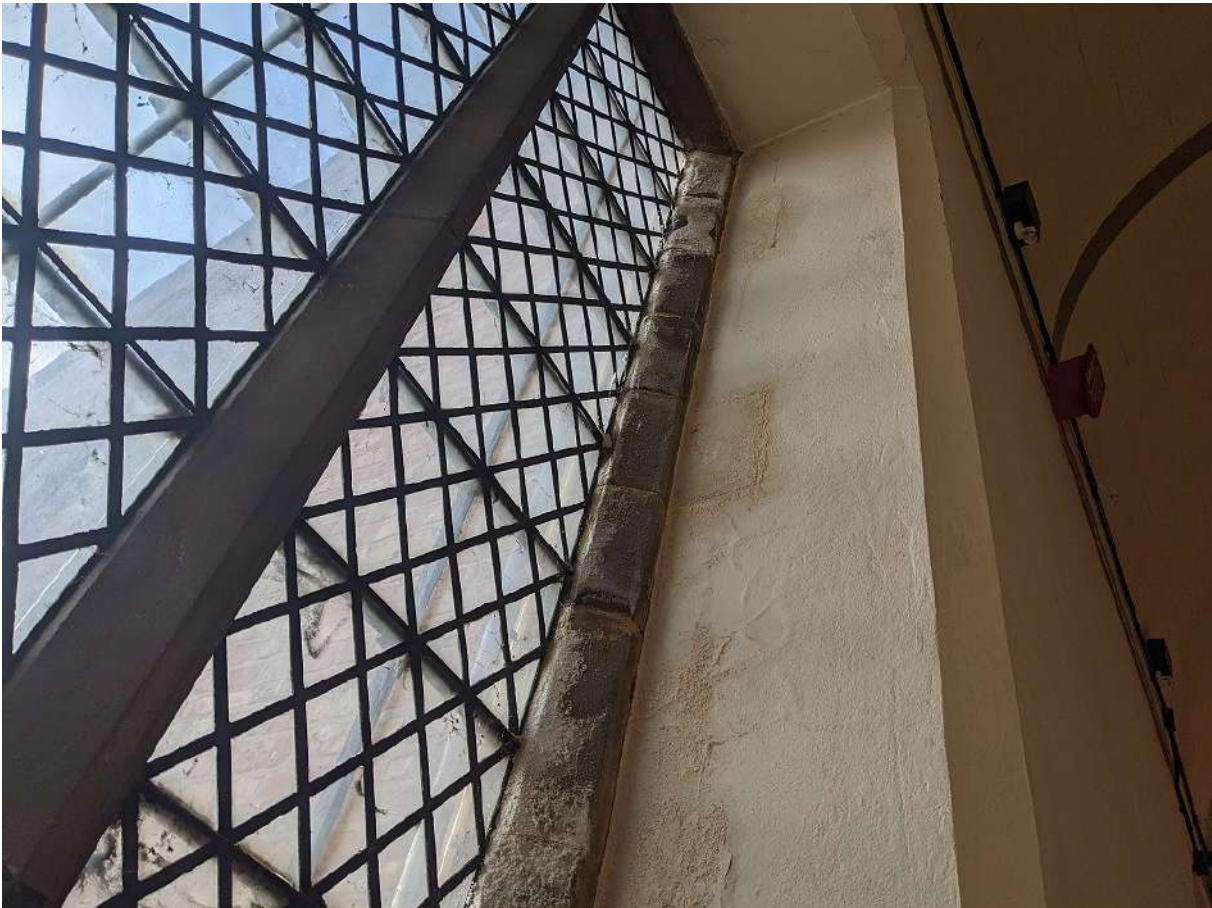
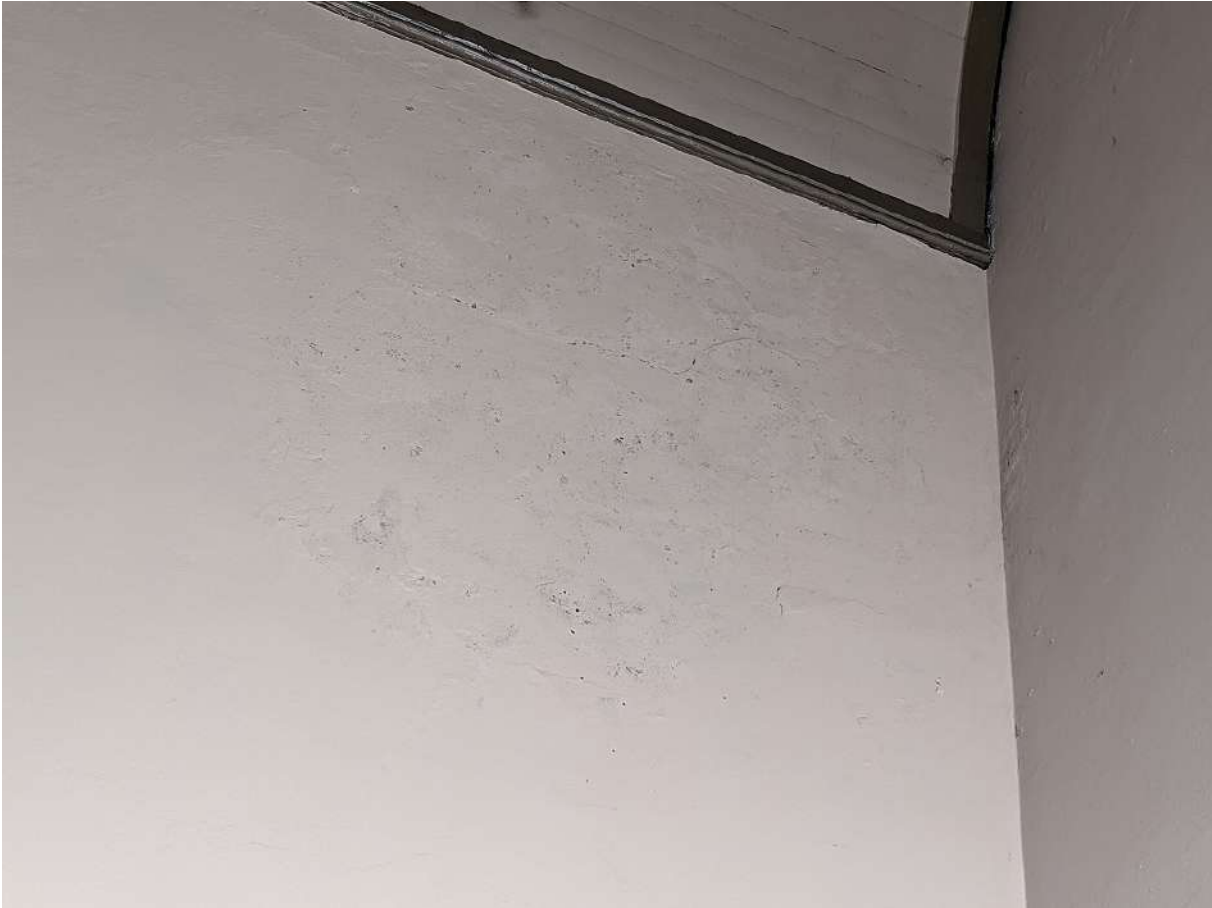
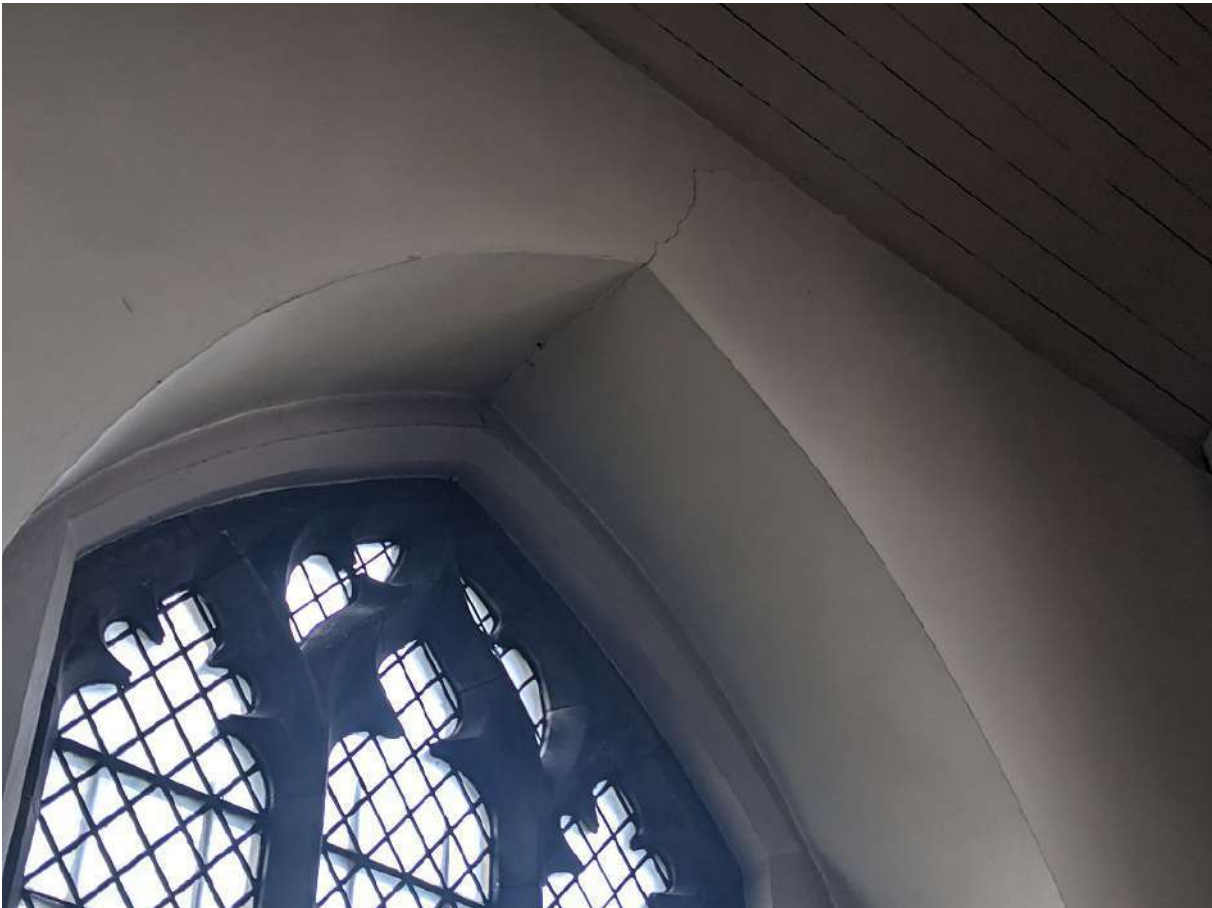
1. Chancel (south elevation): plaster cracking rising vertically from west corner (top) of window opening.
2. Chancel (south elevation): plaster cracking falling vertically from west corner (bottom) of window opening.
3. Chancel (south elevation – choir stalls): hairline cracking rising from arch at approx. 1 o'clock.
4. Lady Chapel (north elevation): hairline cracking rising vertically from apex of arch.

M It is recommended that as a routine item of maintenance regular visual checks are made of the cracking to ensure no worsening of the condition.
