QUINQUENNIAL INSPECTION REPORT
OF
OWTON MANOR, CHURCH OF ST. JAMES THE APOSTLE

**DIOCESE OF DURHAM
ARCHDEACONRY OF DURHAM
DEANERY OF HARTLEPOOL**

**QUINQUENNIAL INSPECTION AND REPORT
January 2017**

David Beaumont BA (Hons) Grad Dip, RIBA, AABC

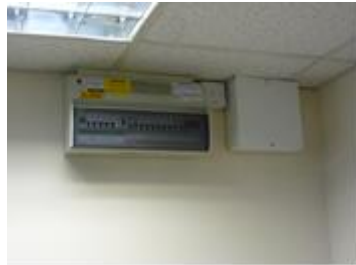
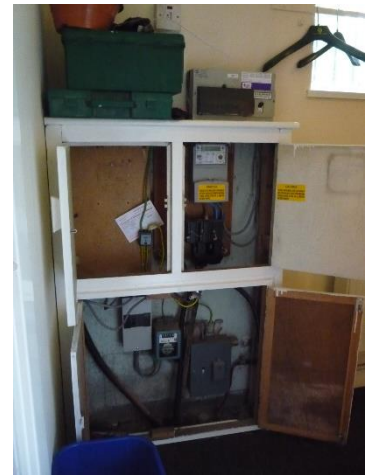
- A** **Electricity:** underground service to consumer unit at east end corridor. Sub main to fuse box in Stella Maris room. Last tested in 2010.

Recommendation: carry out test and the recommendations of the report.

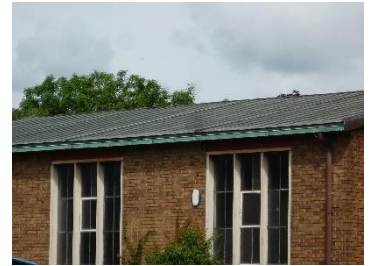
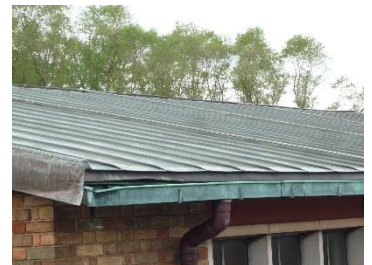
- **Nave:**
 - South slope – standing seam copper roofing. Some slight lifting at the principal seams up against the ridge but sound enough, also the same happening at the apsidal end.
 - North slope – same condition as south.
 - West slope – barge board is in copper, this is good.

Recommendation: none

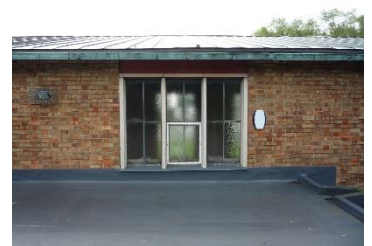
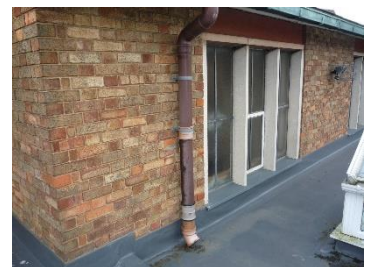
D Stella Maris:

- This has single full ply 'Flagon' roof membrane installed as part of the 2010 extension.
- Condition of the roof is good, there is some slight ponding to the east of the lantern at the higher roof and around the lantern itself.
- The roof does feel slight spongy underfoot with it being laid on insulation boards.
- The flashings to the nave are good.
- The rainwater outlets are all okay.
- A slate could be added to the downpipe coming off on the nave at the eastern end to stop the splash of water directly onto the vinyl.

Recommendation: add slate to flat roof

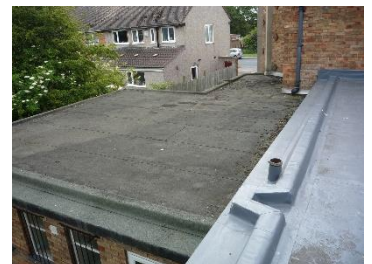
D Ancillary Rooms:

- This has a three layer felt roof in fairly poor condition now. The eaves parapet is breaking up and there are multiple bubbles on the material and it is mostly deteriorating on the junction to the apse. Opportunity to add insulation when recovered.

Recommendation: replace covering

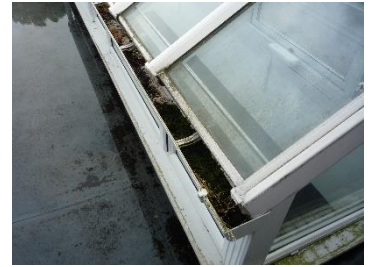
B Lantern Roof:

- A bit green and the gutters need their leaves removing.

Recommendation: remove leaves and clean up

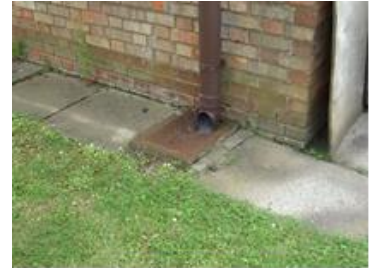
The older part of the building has rusty cast iron downpipes that need repair and decoration. Some gutter brackets have failed at the nave. The porch roof outlet needs sweeping, some gully grids missing and others are adhoc replacements in mesh that is rusting.

Recommendation: repair nave copper gutter brackets, redecorate rusting gutters and downpipes, remove leaves from porch roof outlet, replace missing gully grids

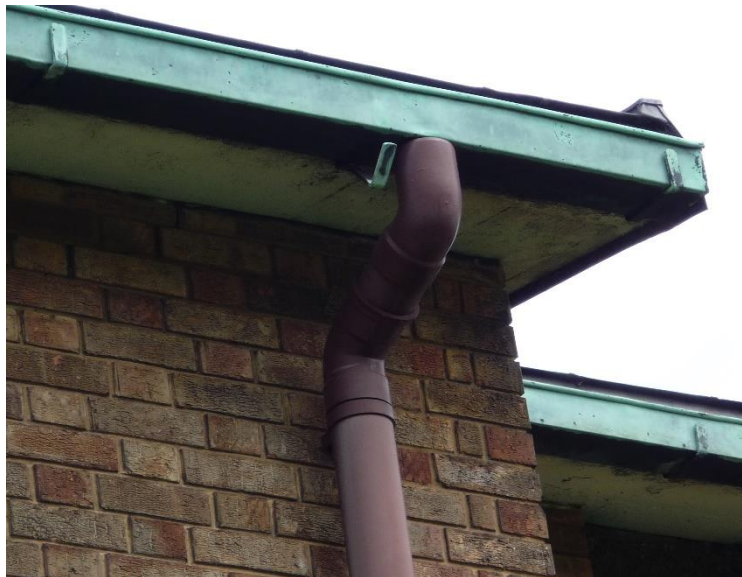
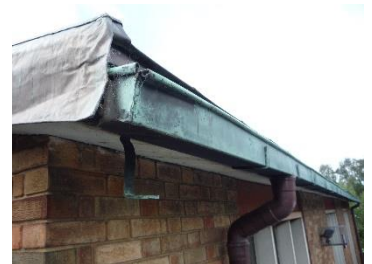
Nave:

- North side – copper gutter leading to plastic downpipes. Gutter bracket loose on eastern nave.
- South side – one bracket loose at the eastern end.

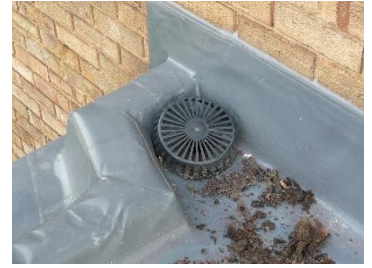
Porch Roof:

- Recovered recently, blocking slightly at the balloon which is oversized at the single downpipe.

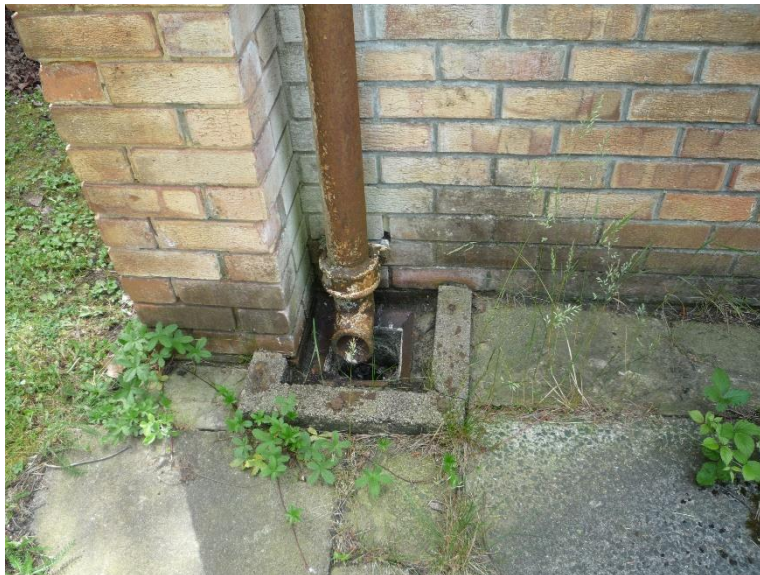
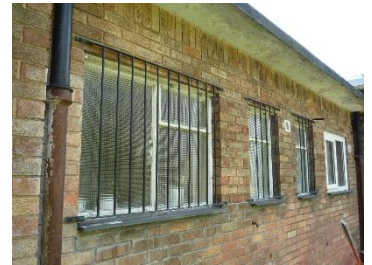
Ancillary Buildings:

- Leaking downpipe on north side
- Missing gully grid

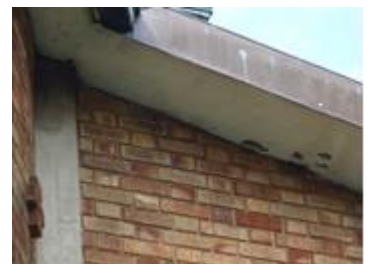
The soffits will continue to spall as rusting reinforcement forces off the slight covering of concrete. The church should carry out a yearly inspection of dropped pieces (the soffits are not over public circulation areas). It may be that they should be repaired in about 10 years.

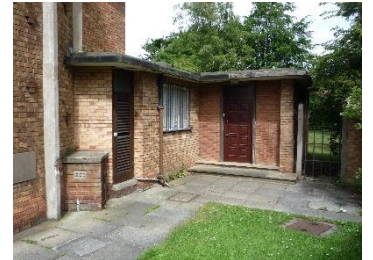
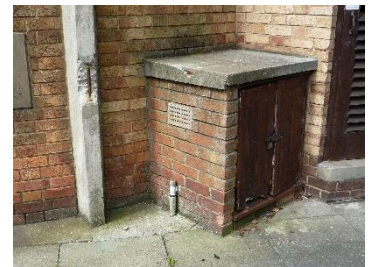
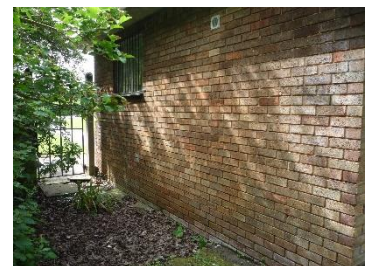
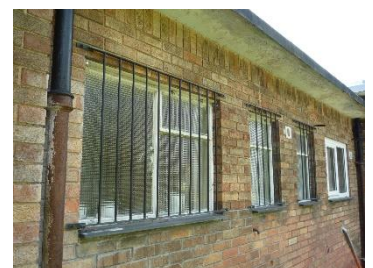
- West side - concrete soffit which is showing some signs of wear. Brickwork is in fair condition. Entrance door to rear is okay, though it could do with cleaning up. Its concrete frame around it is okay though there is some loose pointing to the sides of it. The step below it is okay.

- The brickwork of the boiler room enclosure adjoining it is okay. Guarding to rusting galvanised window with decoration that needs updating. Slight shrubs at the bottom of the floor. To its side is a gas meter cupboard whose door is coming apart.

- East side – brickwork in reasonable condition. Some slight washout of the pointing at lower level and one brick missing it seems where there are leaves. The paving here isn't very good either and one galvanised window needs decoration.

- North side – decoration needed on the eaves overhang, brickwork is fair and has new plastic window to the kitchen and three older galvanised windows whose decoration is breaking down.

Recommendation: redecorate or replace windows, redecorate door and gas meter doors, repair paving

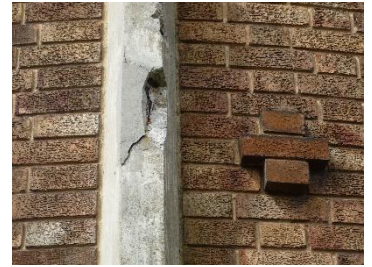
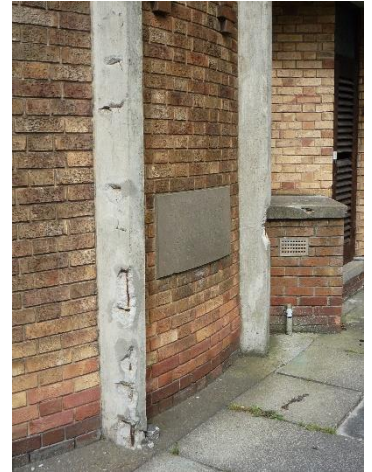
Semi-circular brickwork in good condition with picked out cross symbols in brickwork, some of these have chipped slightly. The structure has reinforced concrete fins leading up to the concrete frame within the roof. These are spalling in many locations. It has been patch repaired in the past, those have come away and so this requires a greater level of intervention than just patching. At the eaves the reinforcing bars are showing at the eastern most point.

Recommendation: see summary comment on repair option

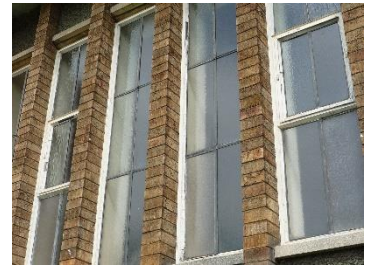
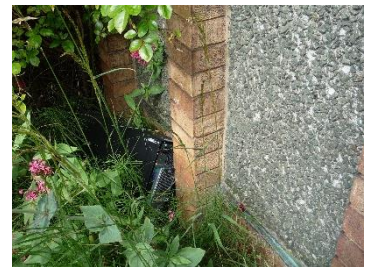
Chancel:

- North side – brickwork in good condition. Slight hairline cracking to the vertical concrete fin
- South side – some slight cracking at the soffit. Wall has brickwork piers with green chipping aggregate panels and these are in fair condition. The lower areas can't be inspected because of shrubbery. Generally, the brickwork here is all sound. Windows within are in varying stages of condition, some with the side pointing coming out and multiple glass type replacements.

Recommendation: see summary comment on repair option

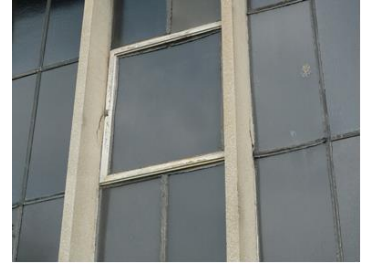
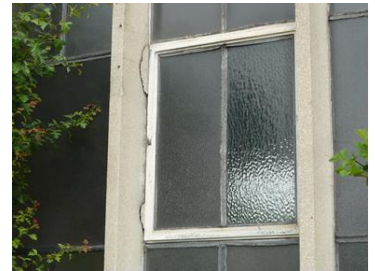
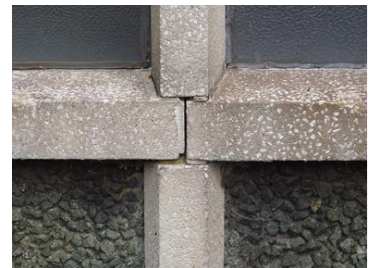
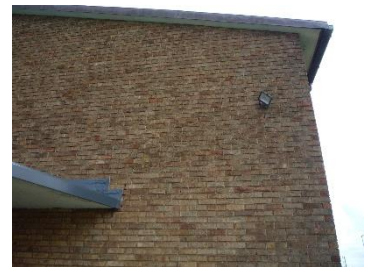
Nave:

- East side – brickwork same as chancel, in good condition.
- South side – some wear to the decoration on the soffit. Brickwork is in good condition, within that are three large concrete framed window apertures and these are showing some historical movement signs, not much since the last inspection. Working from left to right:

- Window 1 – this has a recent cracked pane in it and is in the best condition.
 - Window 2 – framing is in good condition. Generally, the window is okay.

- Window 3 – some slight movement to the base of the mullions to the aggregate panel. Cracking to the fixings to both ventilators.
- West side – brickwork in fair condition, slight cracking on the south west corner that has a glass tell-tale on it which hasn't snapped so there has been no change since the last QI. The open joints really do need re-pointing and properly with a matching mortar. The eaves overhang decoration is just about okay and there is no obvious concrete spalling.

- North side – same design as the south but now enclosed by the Stella Maris room. The condition of the walling and windows is much better on this side.

Recommendation: see summary comment on repair option, repoint open joint on walling west end of nave

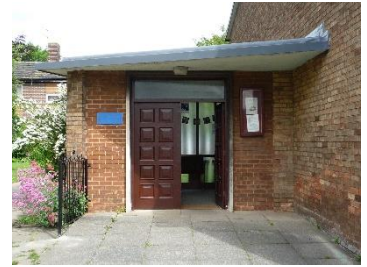
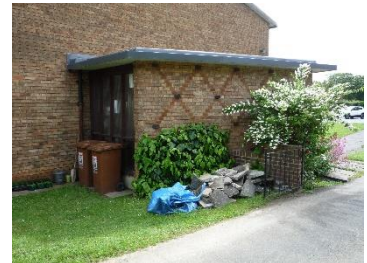
B Porch:

- South side – decoration coming away to the eaves overhang. Brickwork in fair condition. Doorway has concrete surround with some slight cracking to the bottom of it, on the western side. Pair of double doors in good condition, recently decoration on the outside but hinges creaking a bit.
- West side – eaves overhang the same as the south. Diaper patterned brickwork in good condition. Quite a lot of ivy growing at the bottom which needs to be removed to be able to be seen better.
- North side – mostly enclosed by a glazed timber screen in reeded obscure glass. Slight erosion to the frame at the bottom sill but otherwise sound.

Recommendation: oil door hinges, reduce ivy on wall

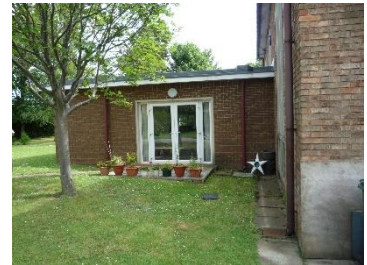
D Stella Maris Room (new construction):

- West side – some paint marks on the brickwork need removing, but generally okay. The eaves decoration could do with updating. Concrete doorframe okay and the operation of the UPVC doors is okay.
- North side – same as west.

Recommendation: remove paint marks to brickwork, update eaves decoration

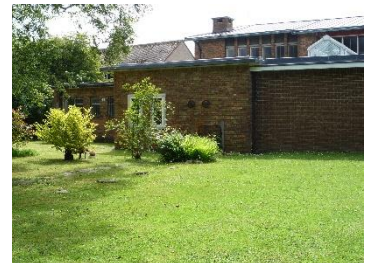
D Eastern Part of Stella Maris Room (original construction):

- North side – eaves overhang decoration failing. Brickwork okay. Some slight loss of pointing to the bottom of the window surrounds. The windows themselves are okay, they are PVCu.
- East side – same as north apart from some damp showing at the bottom of the walls – the ground has been quite damp here in the past but drainage is now reported to be running.

Recommendation: update eaves decoration

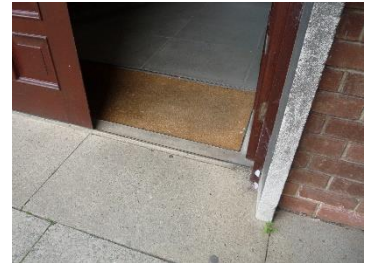
- D **General:**
Some slightly crazed paving at the porch entrance has sunk slightly.
The plastic grille over a road gully by the side of the porch entrance looks as if the original has been stolen. Low brick wall dividing the vicarage with a pair of slightly rusty gates to it. At the vicarage entrance, the area just to the side of the footpath is eroded now.

Recommendation: level entrance paving, redecorate entrance gates, remake drive at footpath

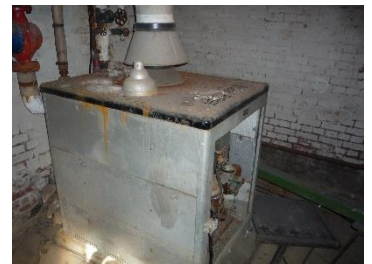
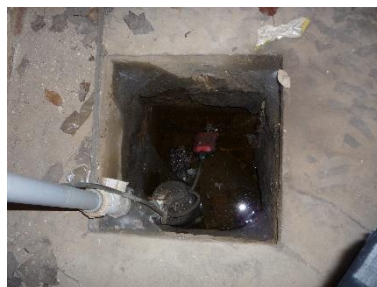
- D **Boiler Room:**
 - Concrete ceiling
 - Concrete shuttering
 - Walls –
 - Floor – concrete
 - The room houses a redundant old boiler and lumber that needs clearing out.

Recommendation: remove lumber and old boiler, repair door, sweep up leaves, check sump pump operation

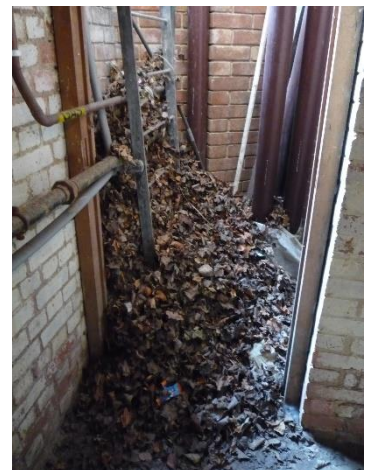
- The room is largely filled up at the end of the ladder. Slightly rusty vertical ladder to the louvered door which has lost a louvre and catches on the concrete sill. The void contains rainwater pipes that could be scrapped.

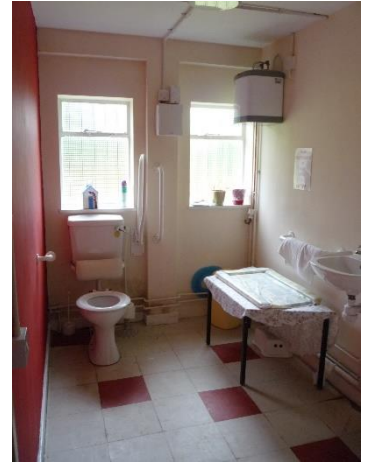
- Recently partially decorated. Damp showing on the north wall by the pan. Basic fittings, possible slight leak on waste pipe at sink. Door doesn't latch into the frame.

Recommendation: fix leak to basin waste, adjust door

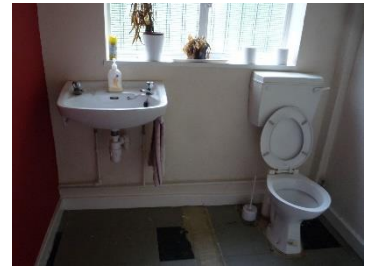
B Alternative WC:

- General – all in fair condition. The pottery looks a little old fashioned now but will do. Locking is by shut bolt and that is not very satisfactory and someone could get locked in.

Recommendation: provide a lock openable from the outside

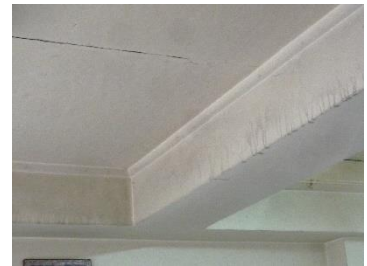
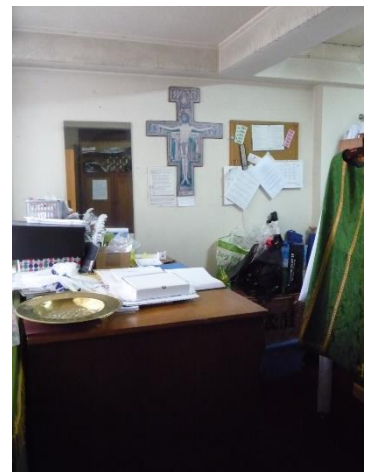
E Vicars Vestry:

- Ceiling – showing condensation marking and water damage.
- Walls – are plaster and decoration is coming away.
- Floor – solid, carpeted.
- General – the room is very full of cupboarding and fittings etc. and really does need completely updating. The room has an ancillary space containing the two safes

Recommendation: update- perhaps after roof repair

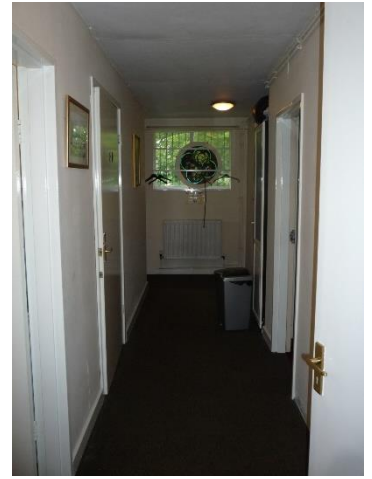
C Corridor:

- Ceiling –
- Walls –
- Floor – carpeted with slight undulations but in reasonable condition.
- General – contains the cleaner cupboard with door that sticks and doesn't close and also the incoming distribution board and meter. Door to the rear access catches on the carpet.

•
Recommendation: adjust doors
