Quinquennial Inspection Report

St Luke's Church, Pallion, Sunderland

Date of inspection: 26 September 2018

Date of report: 28 September 2018

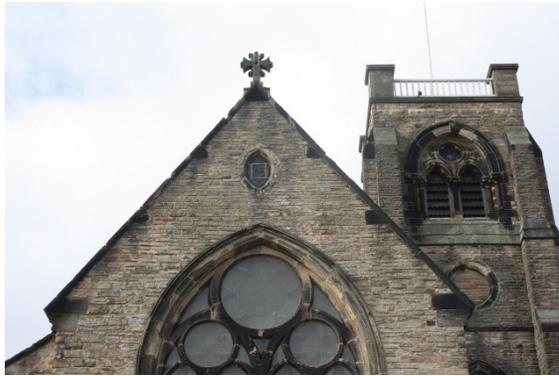
Badly eroded water tabling to Chancel gable

The water-tabling to gables are in poor condition due to frost action on the soft sandstone as reported at the last inspection. The worst affected water-tabling (the Vestry, Chancel and Nave east gable and Porch) should be replaced to prevent water ingress through the wall heads. The chimney stack requires repointing.

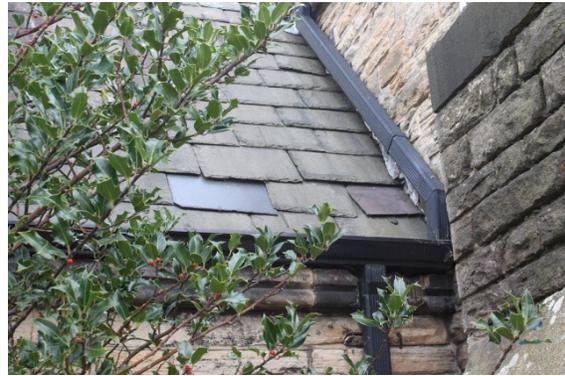
Mismatched slates to Porch roof

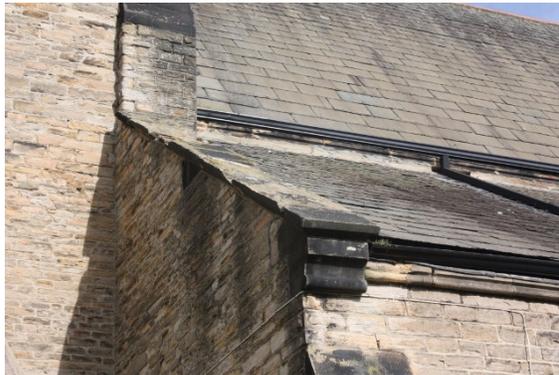
Badly eroded water tabling – Vestry/Organ Chamber

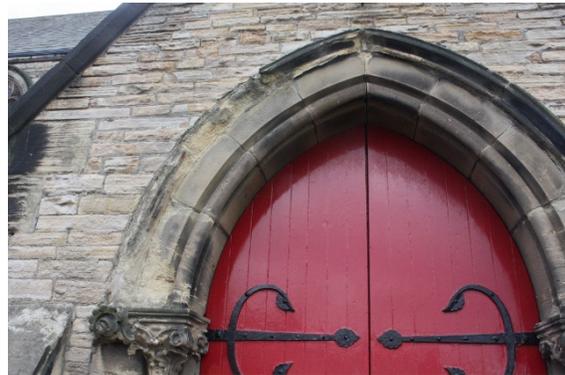
Eroded hood mould over Porch door

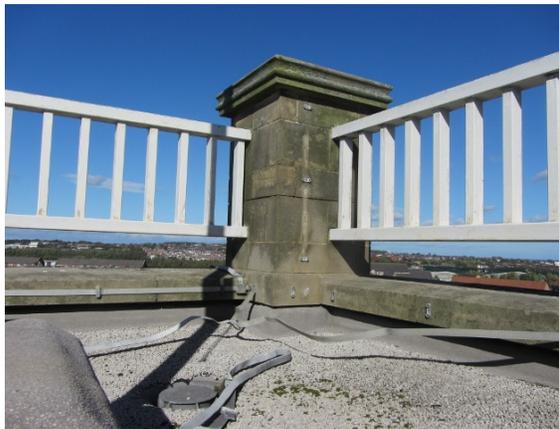
4.5 Lightning Protection		
Comments	A lightning conductor is fitted to the Tower. The downtape to the NE corner pier has become detached (as reported at the last inspection). The tape should be re-fixed as soon as possible. The system has not been tested for over 10 years and should be tested as soon as possible for fire safety and buildings insurance reasons.	B B

Disconnected lightning conduction tape

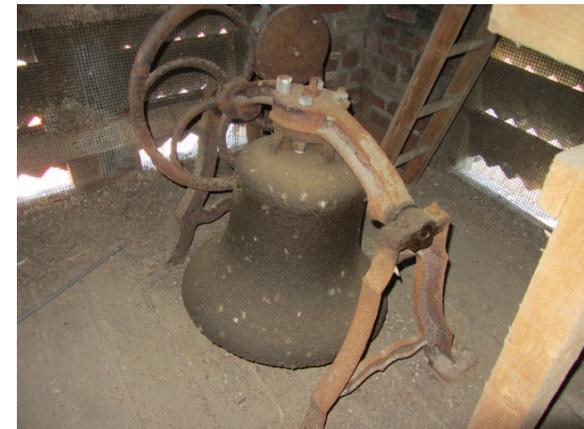
Rusting bell mechanism

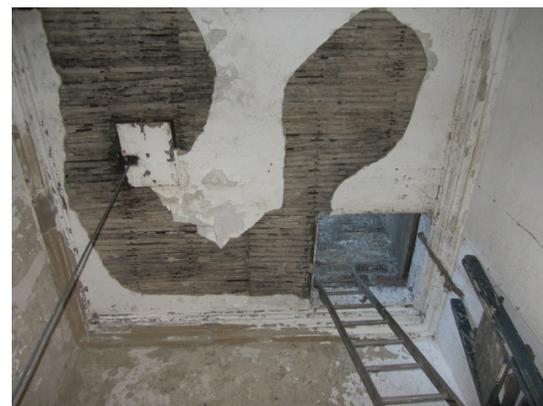
The condition of the church building gives cause for concern. There has been some considerable water damage done to the ceiling at the base of the Tower and 50% of the plaster ceiling has collapsed and come away from the laths. There are water stains at each of the tower floor levels. This is indicative of some flooding down the inside of the Tower. The tower downpipe should be checked for blockages to ensure that it flows freely for its whole length; any leaks at the joints should be caulked to prevent leakage. Once the Tower is water tight and dry the ceiling at its base can be re-plastered and redecorated.

Ceiling damage at base of Tower

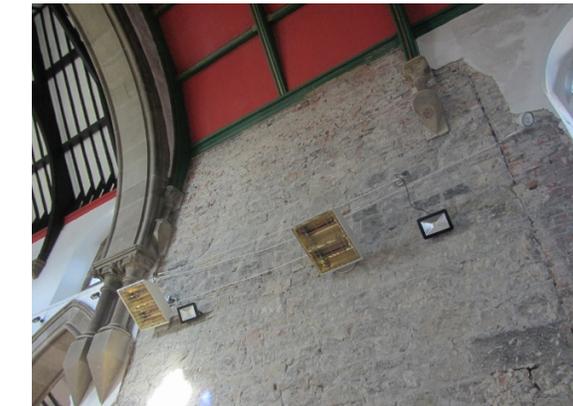
The loose plaster caused by dampness (reported at the previous inspection) has been removed from the north wall of the Chancel backing onto the Tower. The cause of this damp is suspected to be from a concealed valley gutter at the junction of the Tower south wall and the Chancel north roof slope. The outlet is likely to have been blocked resulting in water by-passing the pipe and discharging through the wall head damaging the plaster. This needs investigation and appropriate action to remove the blockage from the outlet. Once the damp ingress has been cured and the wall is sufficiently dry it can be re-plastered and redecorated.

Plaster removed from Chancel north wall

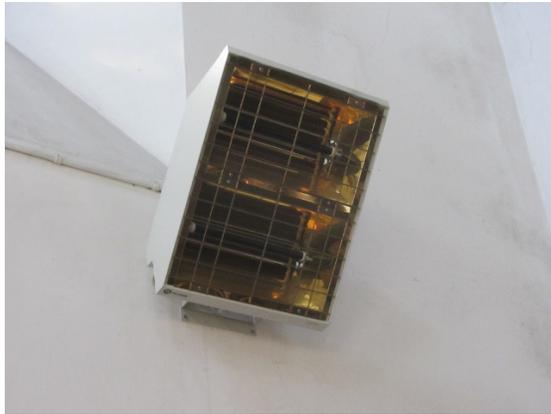
The existing heating system with wide bore pipework served from a boiler has been abandoned in favour of wall mounted 'halogen' radiant heaters. Unfortunately this type of system while giving instant heat for services does not provide any background heat and the structure of the building remain cold. The intermittent heat from radiant heaters will tend to cause surface condensation on the cold wall surfaces resulting in mould growth and blistering plaster and paint. Consideration should be given to introducing a traditional wet system but with small bore pipework and radiators rather than wide bore pipes. The radiant heaters could still be used to boost the temperature for services but the structure of the building can be kept at an ambient temperature the rest of the time to prevent surface condensation.

Halogen wall mounted heater

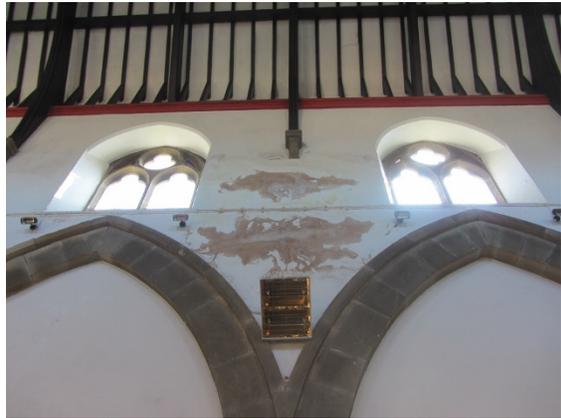
Patch of blistering plaster & paint to Nave S wall

In addition to the internal wall faces referred to in paragraphs 2 and 3, there are historical patches of blistering plaster and paint on the south wall of the Nave. Localised re-plastering and redecoration are recommended.

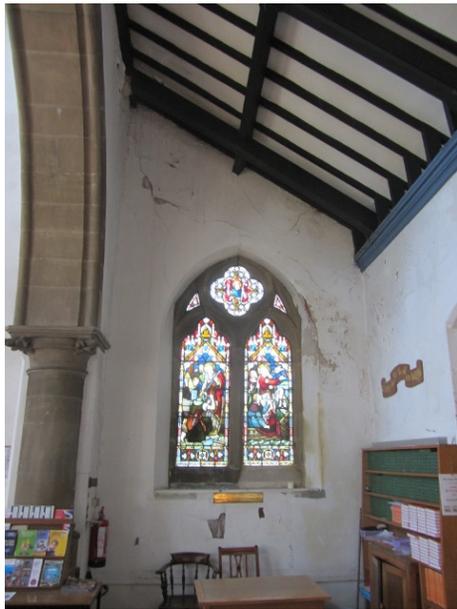
The west gable wall of the North Aisle is also suffering from damp ingress which is resulting in blistering plaster and paint. The gutters to north slopes of both the Nave and North Aisle are blocked with vegetation adjacent to the west gable which will cause the gutters to overflow and soak the walls beneath. The water tabling to the Aisle west wall should be checked and any open joints pointed up. The flashings to the Aisle roof / west wall junction need checking and any repairs made to ensure water tightness. Once the Aisle west wall is dry localised re-plastering and re-decoration can be carried out.

Blistering plaster and paint to North Aisle west wall

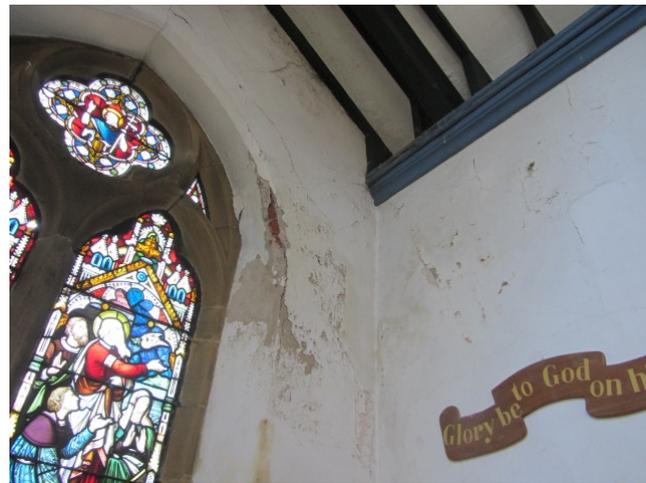
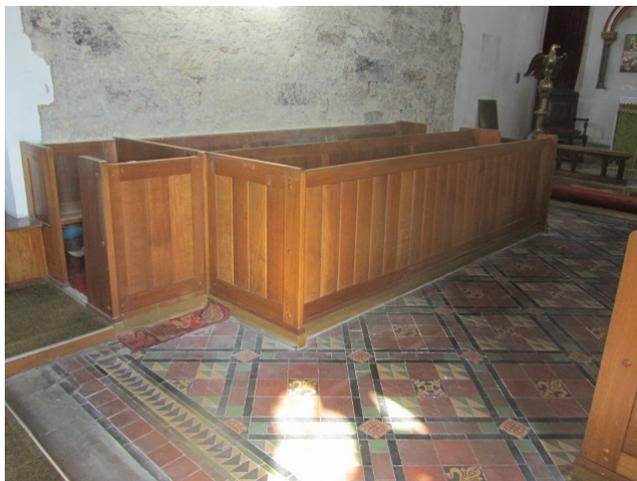
The encaustic tiles to the Chancel and Sanctuary are loose and un-bonded in places. Re-bedding by a specialist is recommended to prevent further deterioration.

Chancel – decorative encaustic tiles
