# **QUINQUENNIAL INSPECTION REPORT**

## **PENNYWELL, ST THOMAS**

**QUINQUENNIAL INSPECTION AND REPORT  
2017**

**David Beaumont BA (Hons) Grad Dip, RIBA, AABC**

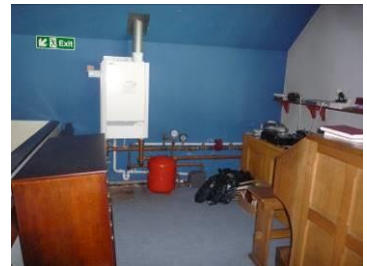
**B**      **Heating:** gas fired low pressure hot water installation installed in April 2005. It has proved troublesome since its installation, though it is now working satisfactorily. The boiler is located in the gallery and it serves small diameter pipework to panel radiators.

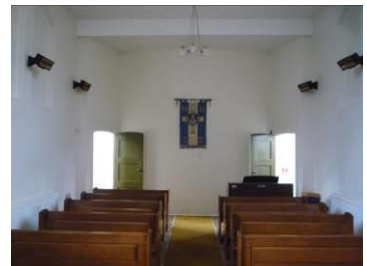
There are six wall mounted infra-red heaters in the lady chapel which are the principal form of heating as the radiators within the space are not effective. They system is tested annually by Heating Services North East and no problems have been recently reported.

**Recommendation:** carry out annual test

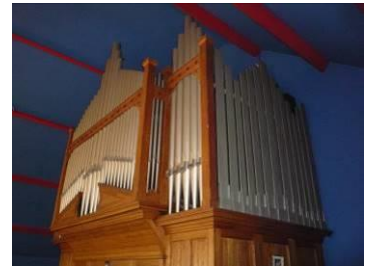
**C**        **Organ:** organ console separate from organ pipe cabinet. There is two manuals and 26 stops. The pipe cabinet is in light oak panels with broken pediment and rather fills the space. Unknown date but will be post the c. 1962 gallery.

The church report that there has been glass in the pipes, probably as a consequence of broken windows and these windows are now over-sheeted with polycarbonate. They back on to the organ and is not an ideal arrangement - if they are letting in damp.

**Recommendation:** investigate the back of the organ at the windows

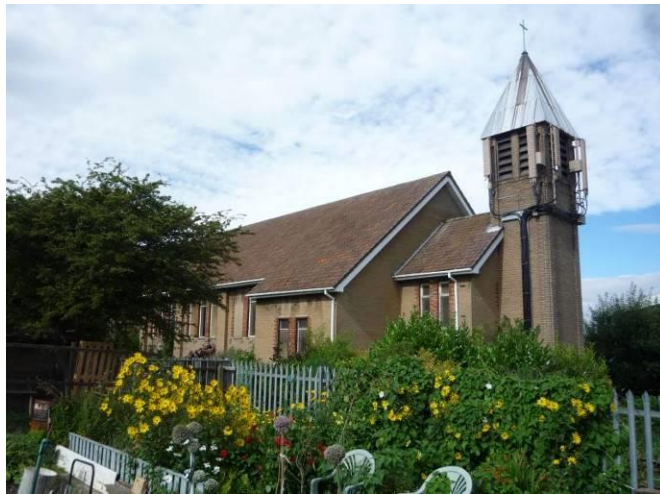
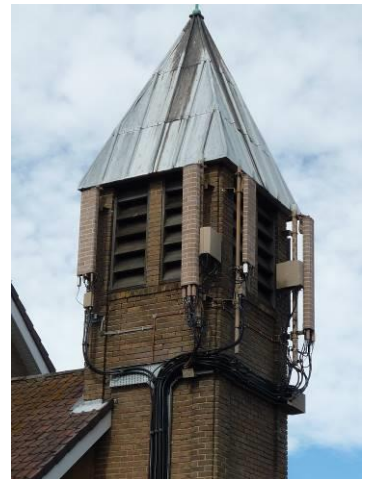
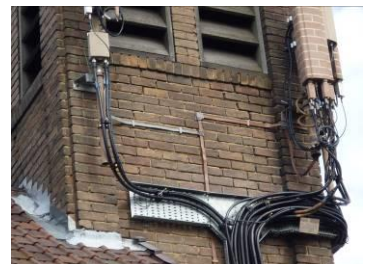
### Tower Outside

- B** **Tower:** Slightly different brickwork to chancel. Lead covered roof. Hip roll is lifting on the south west corner. Doesn't have a gutter but okay. Timber louvres to the belfry appear okay. Brickwork is in reasonable condition but there is an area of open jointing at high level below the louvres at the south elevation.

Looks to be a crack on the west elevation underneath the middle pier of the louvre windows. The area directly below the louvre windows for about 10 feet has worn joints.

**Recommendation:** repair hip roll, repoint brickwork

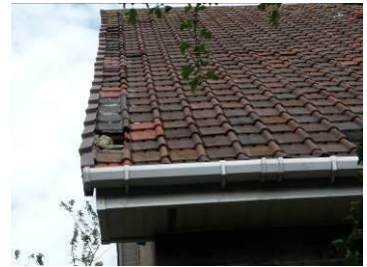
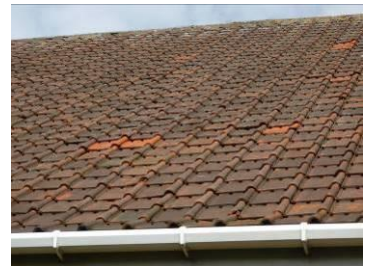
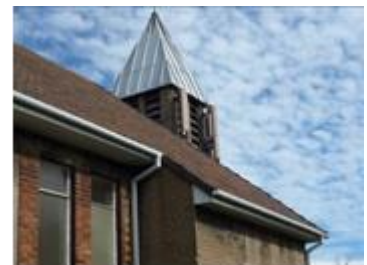
### Nave:

- North elevation – ridge okay.
  - East verge – new verge closures, a couple of tiles laminating but no action needed.
  - West verge – okay.
  - General – all of the tiling is well bedded and whilst there is some slight lamination to it, it looks okay.
- South elevation
  - East verge – as the south.
  - General – ridge has some loss of bedding. The condition of the tiles is poorer on this elevation and perhaps 10% of them are laminating. There is white paint at the eastern end and at the western end, one tile has collapsed in on itself. There may well be a requirement to replace the south tiling in 10-15 years or so.

**Recommendation:** replace missing south tile

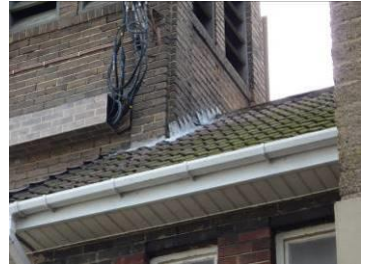
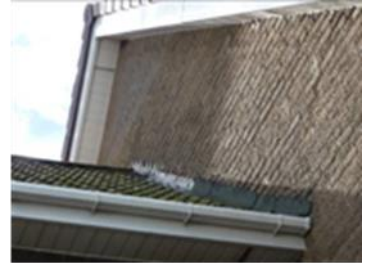
- South elevation –
  - Ridge – some bedding coming away.
  - Tower abutment – leadwork okay. Patent verge okay.
  - General – tiles generally fair, there is one that is not seated properly and another that is cracked.

- North elevation –
  - Nave abutment – lead has been stolen from here and the flashing is made up of both mineral felt and also lead alternative and this should be remade. A full view of the tiling is not possible and there are some cracks to it and some crack repairs in silicon.
  - North verge – as south.

- The western part of this roof connects to the tower and on the north side, the flashing has had attempted theft in the past, and whilst the majority of it is in situ, there is a temporary piece midway up and the whole thing needs remaking. The same applies to the south side.

**Recommendation:** remake the tower and nave abutment flashings, repair tiles and bed ridge tiles

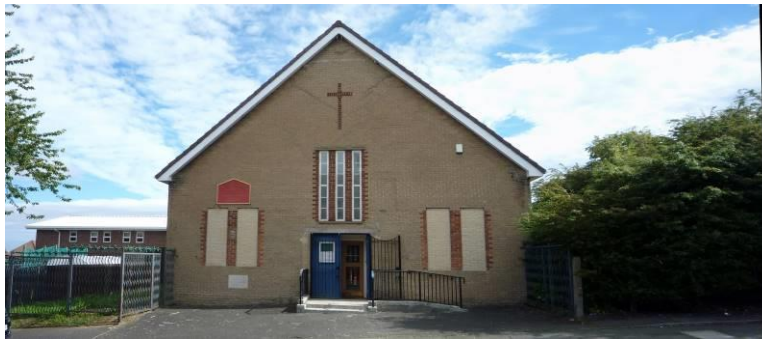
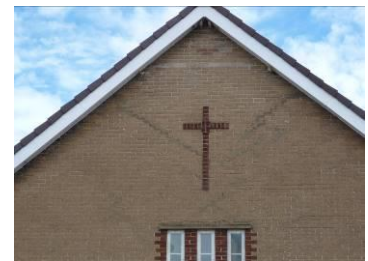
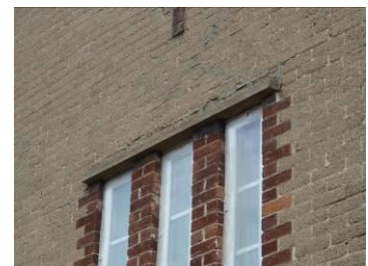
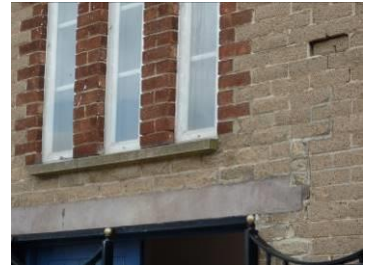
### WEST ELEVATION

- D** Diagonal cracking below the apex which has been botched with cement mortar. Slight cracking also above the central window and below the rendered lintel where one brick is also pushed in (odd!) and cracking to the piers either side of it.

Slight cracking above the northern side double window. There has been some minor repairs to the mortar in cement and this is not in good character with the original cement pointing which is a lighter colour. Ground floor windows have been infilled with stonework (2004) in an attempt to match the brick colour. The damp proof course plinth is okay.

There are four angle irons projecting from the apex, these possibly supported the previous bellcote? The cement pointing at the apex is also cracked suggesting there is still movement. Is there a failure of the lintels? It might be due to the introduction of the gallery in 1962?

The door lintel seems to be a new replacement so perhaps we are looking at historical cracking with a touch of movement due to the new lintel settlement- so it's now settled?

**Recommendation:** assess the structural condition of the gable and determine scope of repair.

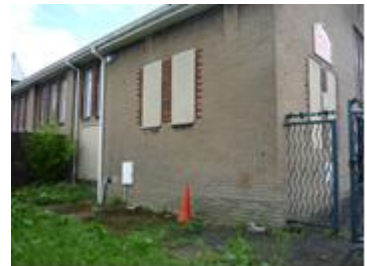
- D** **Entrance lobby:** brickwork in fair condition. Two windows have been bricked in and have been rendered over which is a more successful appearance than the west elevation. This elevation also houses the gas meter and alarm system that appears redundant as there is a wire swinging from it. Two new air bricks have been rather heavily handedly put in with cement. Light cracking to the top of the windows.

East return – damp staining on the wall as a result of blockage of the gutter above and slight open joints at previous gutter positions.

**Recommendation:** check alarm cable, repoint open joints

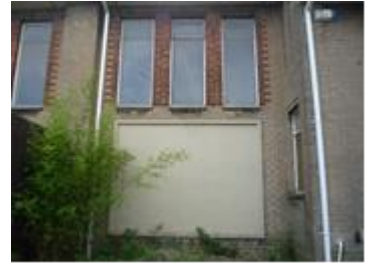
The remaining bays are ok but all windows are in poor condition

**Recommendation:** repoint open joints, repair windows

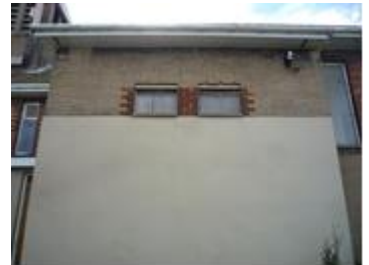
**D Store:** combination of brick at higher level with cracking to the western end of it and below this a rendered panel with slight hairline cracking. This is where the church joined on to the hall hence the render.

Two high level windows boarded in with plywood which is undecorated and laminating. Former detector of some kind, perhaps a telephone point in the top right hand corner is rusting.

**Recommendation:** repair window

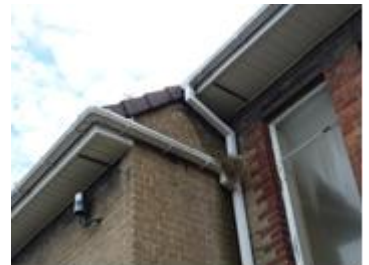
**C Lobby:** mineral felt flat roof and flashings. Masonry is okay, though a couple of the bricks are broken at the lintel support. It is not clear why....drill fixings for guarding perhaps. The window below it is in poor condition. It has steps leading to the rear door. The steps are okay, but the door catches slightly in the frame and its decoration is broken down now.

**Recommendation:** infill brick holes, ease and redecorate door

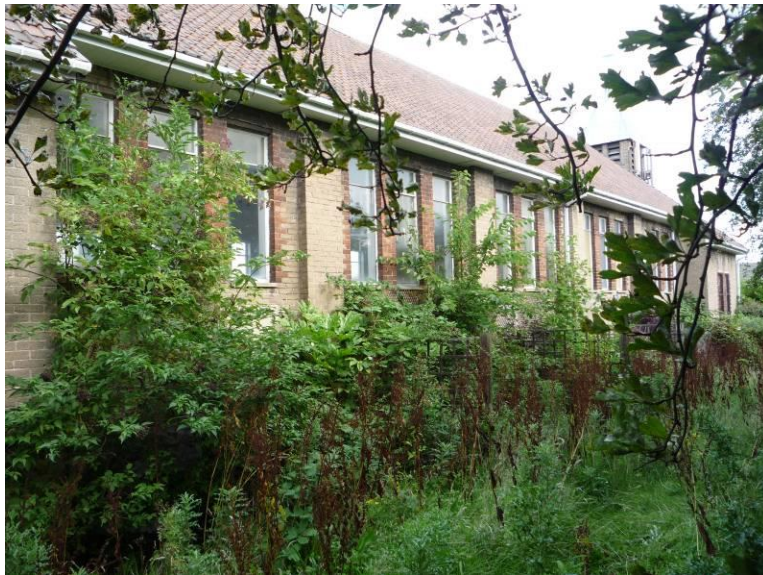
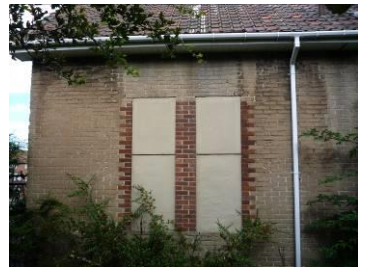
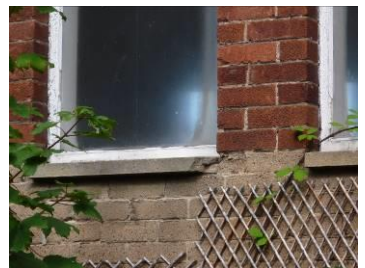
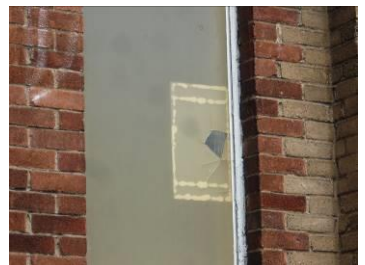
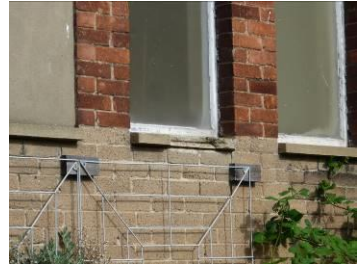
### **Nave:**

Comprises five bays. Most of the lower areas of brickwork are obscured by planting. The windows throughout are in poor condition in that their decoration has broken down. Some of them are glazed in polycarbonate and some are clear glazed. There is putty pointing missing to them and these all need a major overhaul.

One of the windows in bay 4 is polycarbonate glazed and itself has been broken and over glazed temporarily with further polycarbonate. There is a suggestion here as to whether it needs some guarding to it? Open joint below the sills in some instances, particularly in bay 4. At bay 5, the reinforcement is rusting to the middle window sill and has spalled the concrete away.

**Recommendation:** repair windows, add guarding, repair fractured cill

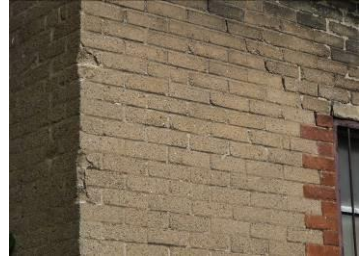
- D Vestry:** brickwork is spalling on the south west corner. 2mm cracking to the window heads and it looks as if these are boot lintels and perhaps their design is not satisfactory. The bricks have been spalled by fixings for the now rusting metal frame, which has been boded into the openings with silicon. The windows are obscure glazed and the glazing is polycarbonate in some instances and the decoration to the frames is broken down. Looks to have had an attempted break in. The western most window glass looks to be coming out.

**Recommendation:** repair windows, repoint brickwork

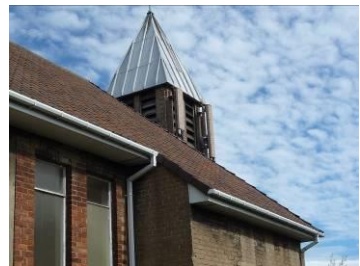
- D Lady Chapel:** not possible to inspect all of the wall as the enclosure at the base of the walls is locked. It holds the telecoms cabinet. Timber windows are in poor condition.

**Recommendation:** repair windows, inspect lower walls

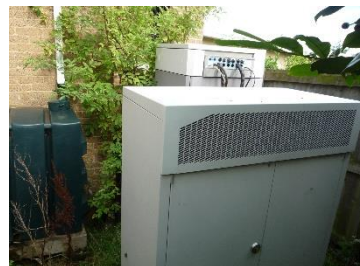
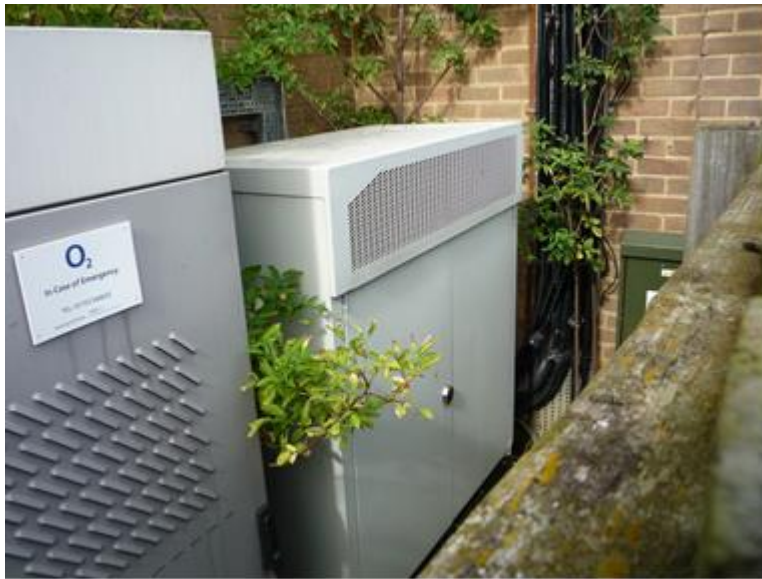
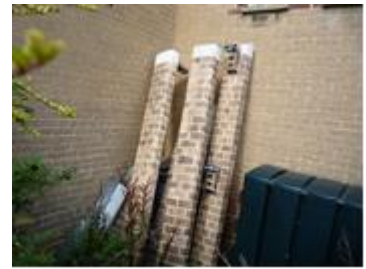
- C Compound:** Area contains an oil tank- redundant as the heating is by gas?  
Loose unused camouflage panels and shrubs invading.

**Recommendation:** remove redundant materials and planting

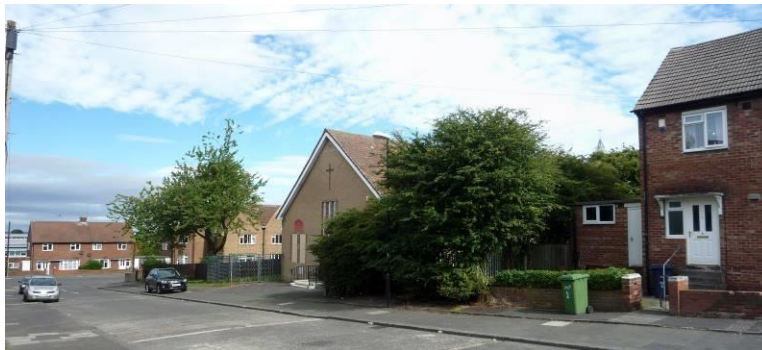
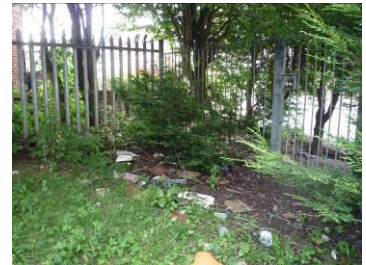
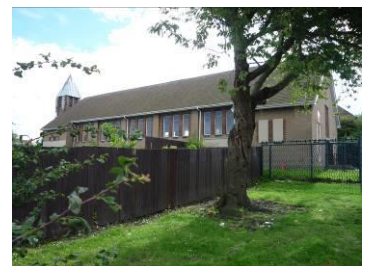
**West Side:**

Large overgrown area of hawthorn on the south. Metal fencing with anti-climb tops is rusting. The forecourt area of tarmac is fair but breaking down. Concrete ramp which has been overpainted and the decoration is coming away now.

Metal balustrade painted black which has graffiti and scratch marks needs redecorating, as does the metal gate that goes over the front of the entrance.

**Recommendation:** redecorate metal gate, fencing and handrail. Redecorate ramp

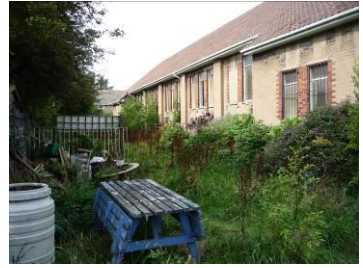
A combination of metal and timber fencing. The land area contained within it is a mixture of tarmac and grassland is rather unkempt – the tarmac is broken up. The boundary is divided into one third and two thirds at the western end by a padlocked gate that leads into a more wild area which has individual planting bays formed by trellises and place has all rather gone to seed. It also contains building materials and is a bit of a dumping ground. There are the remnants of a tarmac path that is really heavily overgrown.

**Recommendation:** clear away planting at base of walls, tidy up

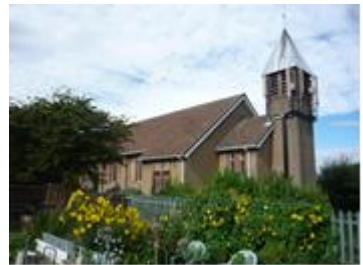
Cinder path leads round to a grassed area which is being maintained and it comes within the youth project gardens. A small enclosure wraps around the telecoms equipment and there is some shrubbery in it.

**Recommendation:** remove shrubs to the telecom compound

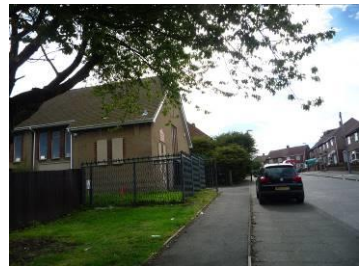
Metal pale fencing to the boundary, one panel is loose. The land enclosed within it is now gone to seed and there are a lot of young sycamore saplings and older bushes growing up against the windows at the more western end.

**Recommendation:** clear away self-seeded planting and repair fence panel

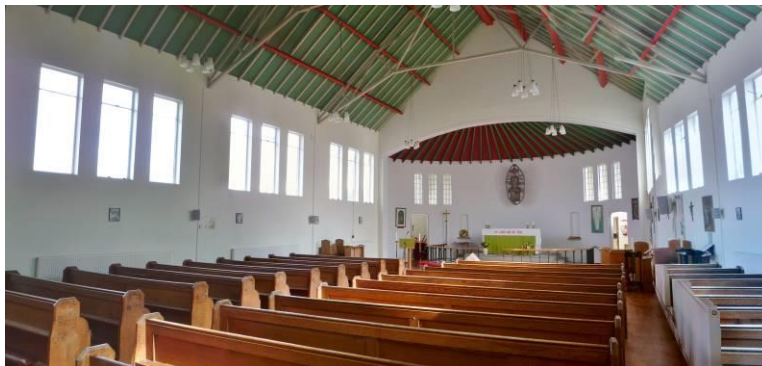
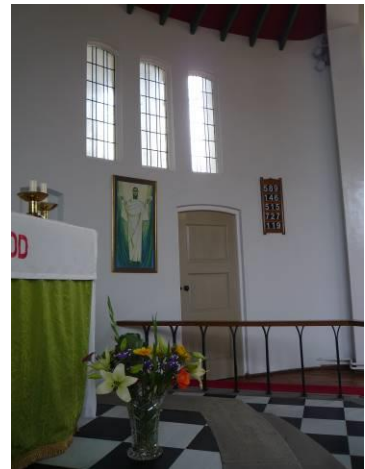
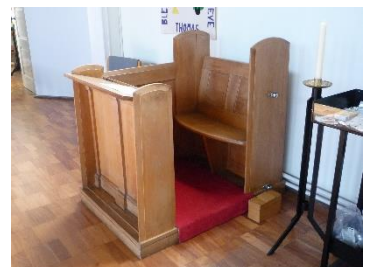
**D Nave:**

Light single open space, metal tie roof of three trusses with exposed ridge purlins and rafters with good decoration scheme to it. Boarding in between the rafters showing some slight ripple of the paper edges and one or two cracks below the upper purlin level. They are steel purlins. Walls have been redecorated and are all in fair condition and a light blue/green colour. The floor is hardwood parquet and in good condition onto solid floor. The circulation area is carpeted and in good condition.

Apsidal end formed in the 1962 reordering made of curved plaster onto brick walls with high level clerestory lighting in feature glass which is in good condition though slightly dirty in places.

**Recommendation:** clean apse glass

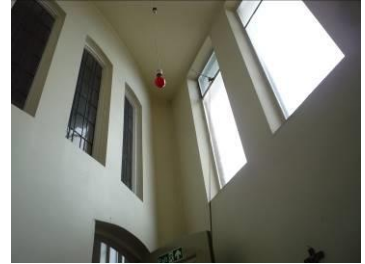
High space, plastered out, some damp showing at low level and in need of some redecoration. Showing cobwebs and marks on the walls etc. Has some lumber in the space. Wood block floor, high level clerestory windows, the glazing is dirty. Single bare bulb red lamp. Door knob loose and jams into the frame.

**Recommendation:** clean windows, clear lumber, ease and repair door, redecorate walls and ceilings

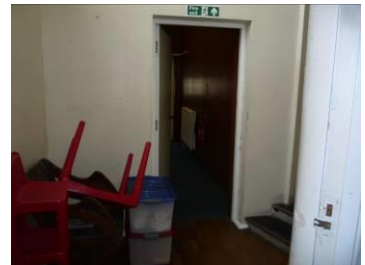
Same design as the north east. Slight hairline cracking, more pronounced over the lintel into the lady chapel but nothing major. Some tile creasing into the door above the nave which catches slightly in the frame and the latch doesn't retract very well. The room contains some lumber and candle stands too.

**Recommendation:** clean windows, clear lumber, ease and repair door, redecorate walls and ceilings.

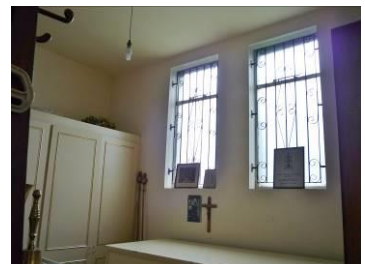
Plastered ceiling and walls. Solid floor with carpet all okay. Slight creasing to the western wall and damp showing at lower level. Some heating pipes have been put through rather heavy handedly. The room is unventilated because the windows are sealed up – they are polycarbonate with decorative metal grills. The room contains cupboarding for vestments, no smell of damp, and an altar cupboard.

**Recommendation:** update when funds allow

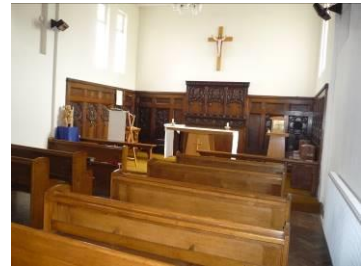
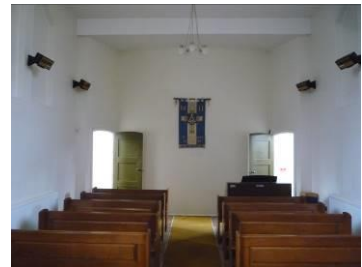
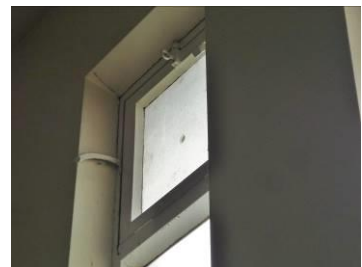
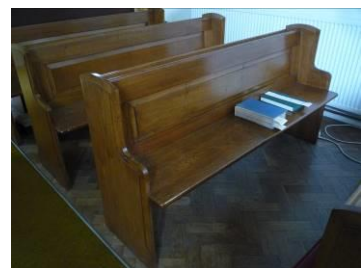
This is formed at the rear of the nave and part of the original design – completely different in character. Flat plastered ceiling with a slight crack at the junction at the step up to sanctuary. Cracking at a beam but isn't a problem. The plastered walls are all fair. These feature clerestory windows at the western most end with obscure or dirty glazing. A tilting ventilating operation at the top. One window has a hole in it and these windows are in timber frames rather than metal as elsewhere.

**Recommendation:** repair broken glass, clean glass,

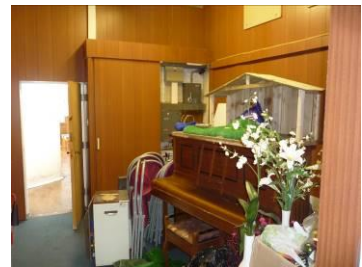
**D Storeroom:** a neglected and forlorn space. Flat ceiling with decoration breaking down. Walls lined out in hardwood fibre board. Solid floor with poor quality carpet. The door catches slightly in the frame and the rear door is no longer fitted. It contains a simple radiator plus a bank of all the electrics. This room is the depository for a lot of furniture – cribs, seating, old gas heaters, piano.

**Recommendation:** remove lumber, update decoration
