QUINQUENNIAL INSPECTION REPORT

PETERLEE, ST CUTHBERT

**QUINQUENNIAL INSPECTION AND REPORT
October 2016**

David Beaumont BA (Hons) Grad Dip, RIBA, AABC

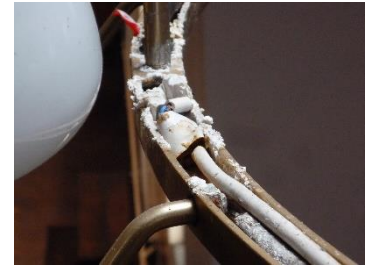
- B** **Lighting:** A new lighting scheme was installed in approximately 1994/5. The nave has twelve chandeliers and two for the gallery. Lighting in the vestry is by fluorescent fittings and tungsten in the toilets. A visual check of the staircase chandelier shows that there is some corrosion to the cabling, explaining why it shorts out.

Recommendation: replace cable to stair light

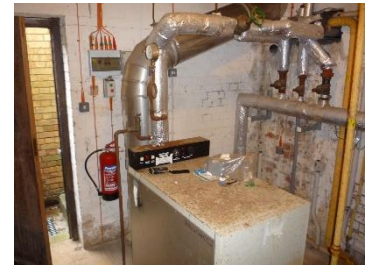
- D** **Heating:** by gas fired Hamworthy Broadstone boiler installed in 1990 and providing heating through large diameter pipes to radiators, serviced in July 2016. Grundfos circulating pump. Sump in the boiler house which is understood to be working. Pressure vessel with low feed cistern on the boiler house floor. The circulating pipework was reinstalled in 2000 and the exposed pipes remain in need of decoration.

Recommendation: check sump pump works, decorate pipework

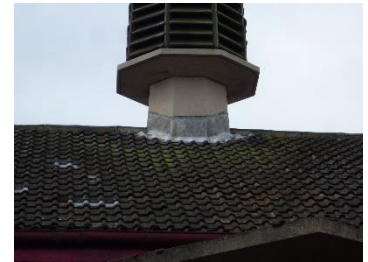
- B** Copper covered spirelet with louvres, to unique design. Louvres have been replaced in the past, though it appears that one is slipping on the south east. Its lead flashing to the roof needs investigation as there is a leak inside directly underneath the fleche.

Recommendation: inspect fleche for leaks, repair louvre

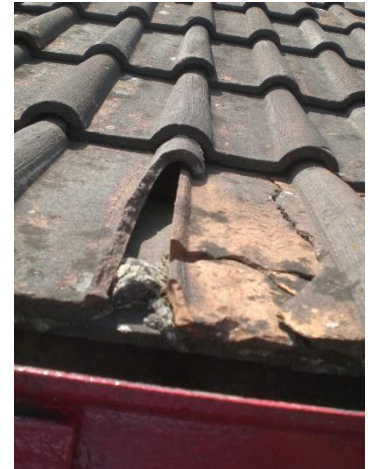
Example of earlier repaired tile

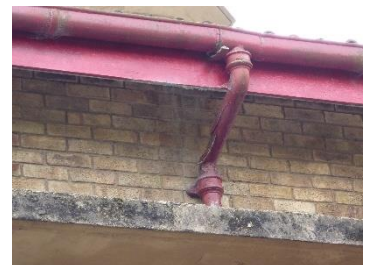
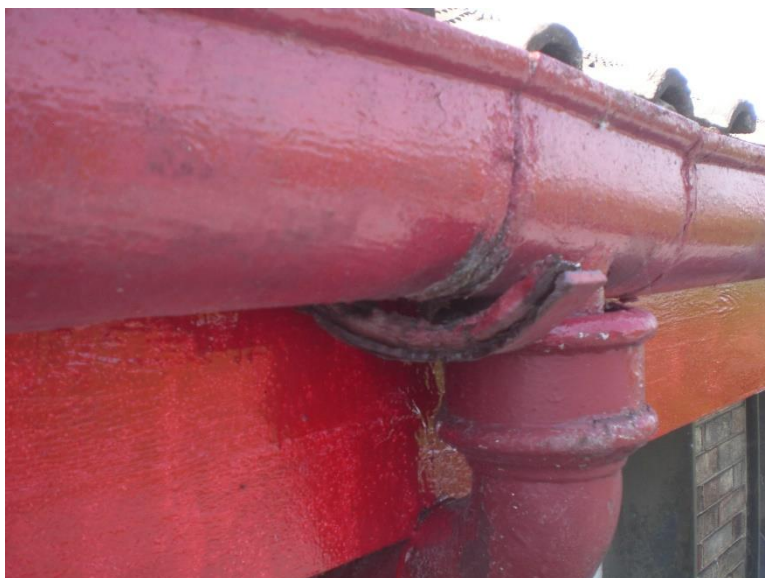
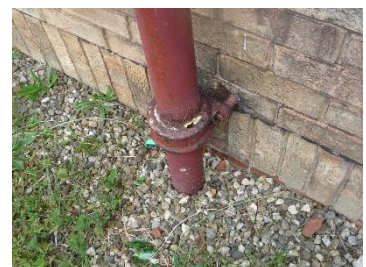
The eaves gutters are 5" x 4" single beaded deep half-round cast iron gutters which discharge to 3" diameter cast iron downpipes to the lower flat roofs. Whilst the gutters are in fair condition, many of the gutter brackets, pipes and fittings are broken and many of the joints leak.

Recommendation: dismantle, replace defective parts, re-paint and re-fix.

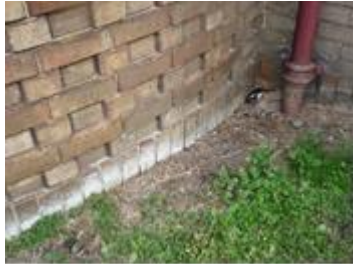
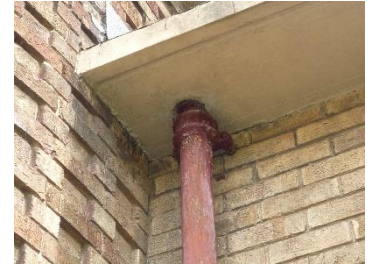
These discharge directly to the downpipes to the ground to gulleys, of which some are missing their grids and have had temporary stones placed over them.

Recommendation: replace gulley grids.

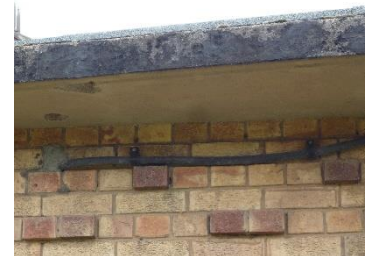
Some slight salting to brickwork below the partition dividing the corridor to the female WCs in the hall. The exposed head of brickwork adjacent to the entrance is okay. The concrete fascia of the overhang is in fair condition, though requires decoration. There have been cement repairs which have spoiled the appearance.

There is an electrical supply cable over the face of the wall which is not very attractive.

Recommendation: redecorate soffit

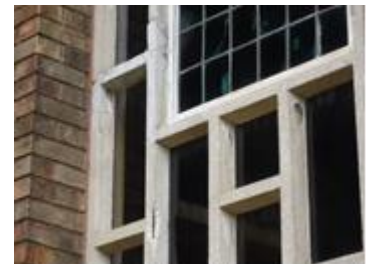
- South aisle – masonry is in good condition. One window is showing spalling of reinforcement and has had cement repair which is beginning to break down.
- North aisle – same as south.

Recommendation: see window section

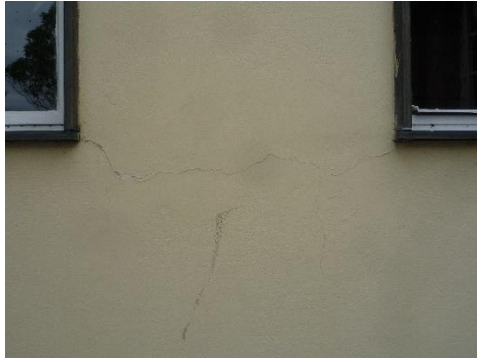
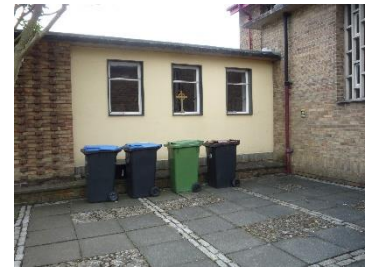
The west elevation is rendered and there is cracking showing at the sills between the windows, but this just requires patching and filling.

The brickwork panel adjacent to this has unfortunately had cement repairs.

Recommendation: fill and redecorate render

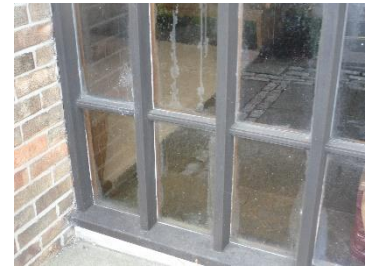
The west entrance doors and glazed screen are stained hardwood, darkening with age. When redecorated, the glass panels and the pointing need repair and the glass is dirty.

The north entrance doors have fine panel work with planted beads and feature hexagonal knobs as the west. However, the opening leaf knob is loose.

Recommendation: clean glass, repair loose knob, redecorate

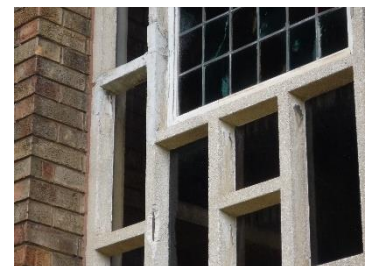
The exterior low level windows are pre-cast concrete frames with special glass infill within glazed metal sashes. Some ventilating hoppers do not operate. The clerestorey windows are simple metal casements. There is a slight crack to a couple of the panes.

Spalling of concrete is caused by rusting reinforcement which requires a specialist repair.

Recommendation: monitor concrete windows. Too soon to embark on a round of frame repairs- see what other defects occur in the next 5-10 years. Paint exposed reinforcement with derusting paint. Strip old silicone and look to re point possibly in a lime mortar- but under architect specification and instruction. The detail needs working out.

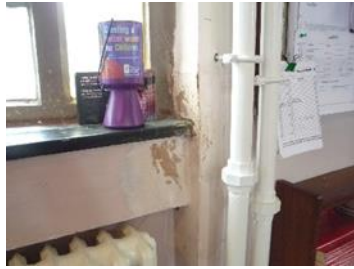
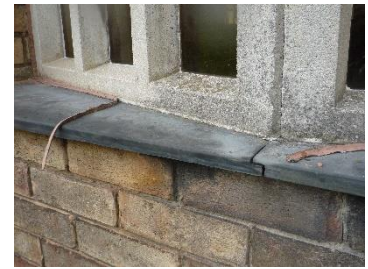
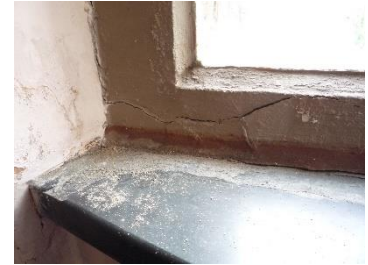
The window frames are sat on continuous slate sills; it appears that there is no weather bar to stop moisture coming through the sills and this has eroded the sills slightly

over time. To reduce water impact, these have been pointed both internally and externally with silicon. This has hardened and has come away.

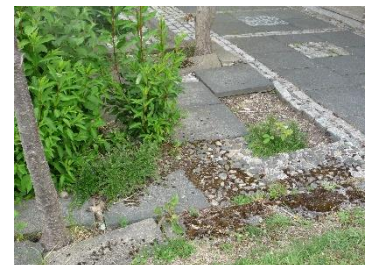
There is a patched tarmac pavement to the steps to the west doors. Steps are stone setts with weeds. There are planting bays within dwarf walls and there are some weeds growing about them. Towards the north-west corner, the paving slabs are undulating rather badly. There have been new slabs put in that don't match the originals and some areas of planting have been left bare.

Recommendation: remake the uneven paving slabs, clear planting beds and weeds.

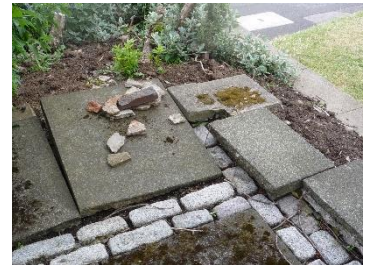
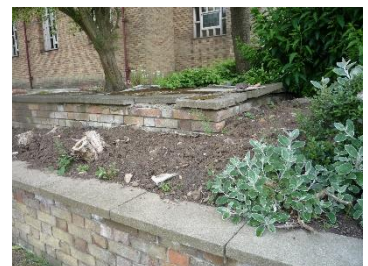
A large terraced area is created with granite set picking out a rectangular pattern with precast flags within, with occasional mosaic or granite set squares, which are part of the architect's original design feature. They are somewhat undulating now. Whilst not yet a trip hazard, if they are not maintained, they will be in the near future.

The north retaining wall is in fair condition, though there are some slabs missing at higher level. The drainage holes in the retaining walls are filling and need cleaning out. It will be important to keep the trees down to a manageable size. In the north-west corner, there is a cherry tree which can only expand. Beyond the north terrace is a large grassed area in good condition.

Recommendation: manage planting and clear out drainage pipes

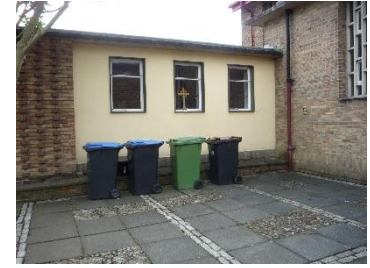
The waste paper and rubbish bins are kept outside the choir vestry and these are not guarded or locked away and can be used by intruders interested in lead theft for gaining access to the building.

Recommendation: consider compound

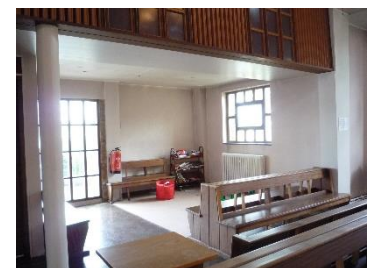
The nave has pre-cast concrete portal frames and these are sub-divided by purlins with a fibreboard ceiling between the purlins. The fibre board is probably to provide some acoustic property and a modest insulation. There is the odd spot of water damage from the past.

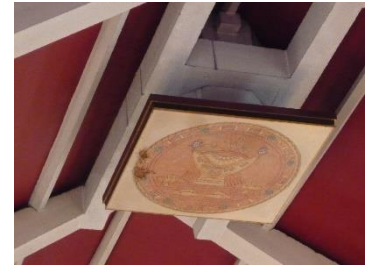
Under the fleche and directly over the font, there is a decorative panel and this has suffered water damage at the side, though it hasn't got worse over the last five years. It is an important piece of artwork that needs to be restored.

It's probable that the fleche is a ventilator and there may be an opening to the outside behind this panel acting as a baffle.

Recommendation: in conjunction with roof covering remedial works, investigate the fleche inside and repair the circular panel, decorate the stair light well

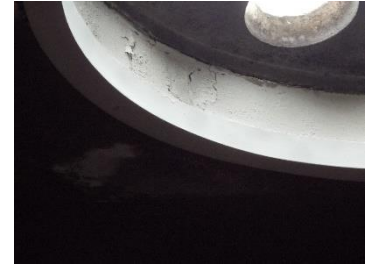
The ceiling under each aisle is in fibreboard. Previously reported to be sagging, but probably as a consequence of the optical illusion of a cable running along the length which itself is sagging.

The spiral stair ceiling has white staining from previous leakage which has been repaired. The skylight is rather dirty.

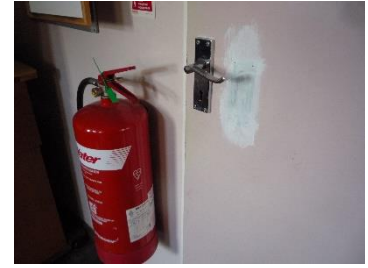
- North entrance – inner glazed doors are satisfactory.
- West end glazed screen is satisfactory.
- Vestry and WC – these are flush doors and painted. Their architraves are chipped as well as the doors themselves. The choir vestry door to the lobby has had its handle replaced and requires decoration.

Recommendation: redecorate Vestry rooms

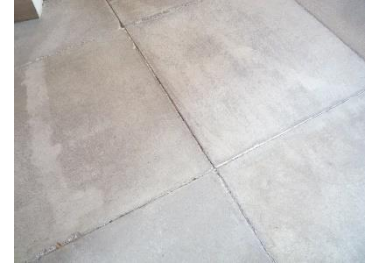
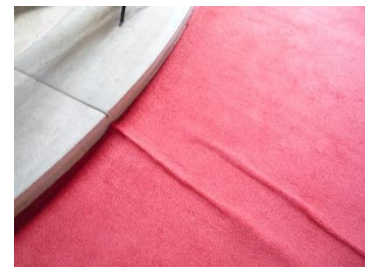
- Nave – polished wood block which is wearing in the circulation areas and shows crazing.
- Baptistry – stone and tiled floor with some open joints.
- Chancel – stone floor with some open joints.
- Sanctuary – carpet is rucked and a potential trip hazard.
- Rear corridor – floor tiles are damaged and some missing.

Recommendation: relay carpet

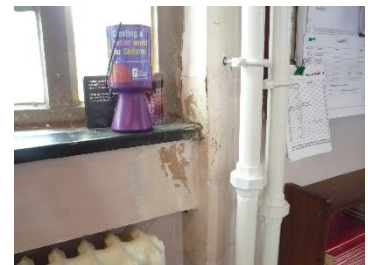
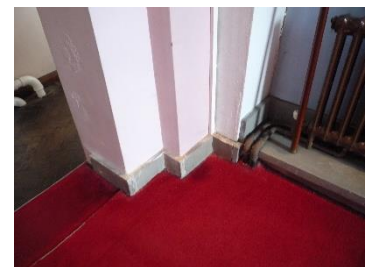
- Nave – the walls are plastered and in fair condition. Various parts of the building are showing marking induced by radiators with dirt going over the surface, particularly noticeable at the children's corner and the sanctuary apse end. Rusting angle beads at some window reveals and the north-east corner of the nave.
- Vestry block – painted plaster. The condition is fairly poor and needs updating.

Recommendation: redecorate when funds allow. The original colours should be maintained

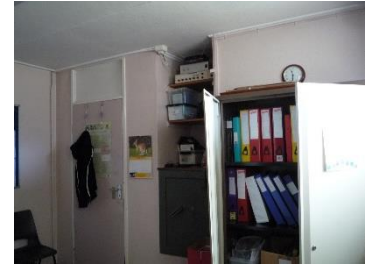
- Ceiling – fibreboard with staining.
- Walls – painted wallpaper in fair condition.
- Floor – parquet in fair condition.
- General – contains filing cabinet, amplifier equipment for the sound system, electronic bell equipment, heating control clock and security system keypad. Lexan security sheeting to the window is rather forbidding.

Recommendation: consider updating fitments and decoration

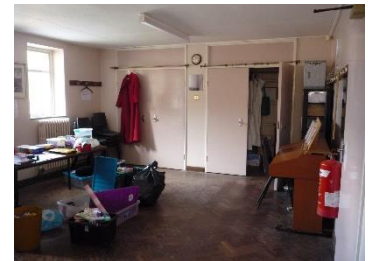
- Ceiling – fibreboard.
- Walls – painted plaster.
- Floor – parquet flooring showing quite heavy wear.
- General – a large room adjacent to the clergy vestry with walk in cupboard for vestments. Fittings include Clavinova piano, music shelves, wall mounted electric transformers for lighting.
- Door – the door to the corridor requires redecoration.

Recommendation: consider decoration

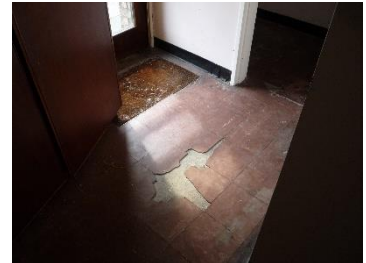
- B **Rear Door Lobby:**
 - The thermoplastic tiles are rather broken up here and a large wardrobe might be impinging on means of escape.

Recommendation: repair flooring and check means of escape
