**Quinquennial Inspection Report
Parish Church of St Cuthbert, Redhouse, Sunderland
Diocese of Durham**

Report prepared by

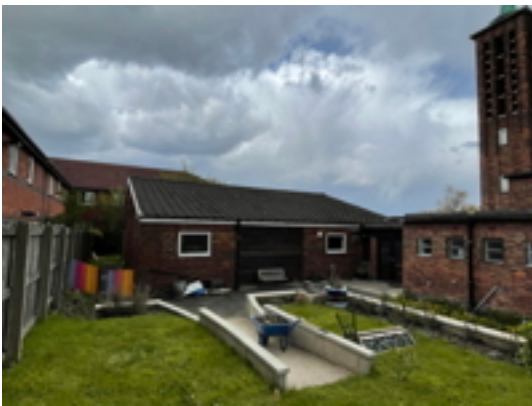
Hall Link Lobby Roof

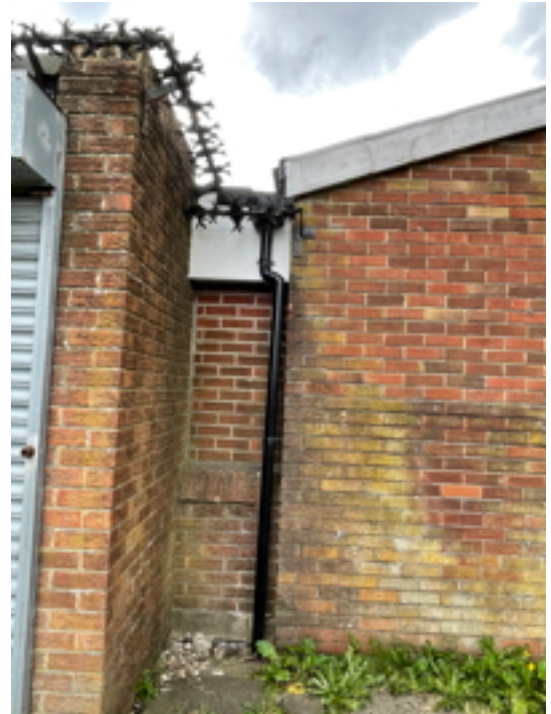
Hall Lobby Link North Rainwater Pipe

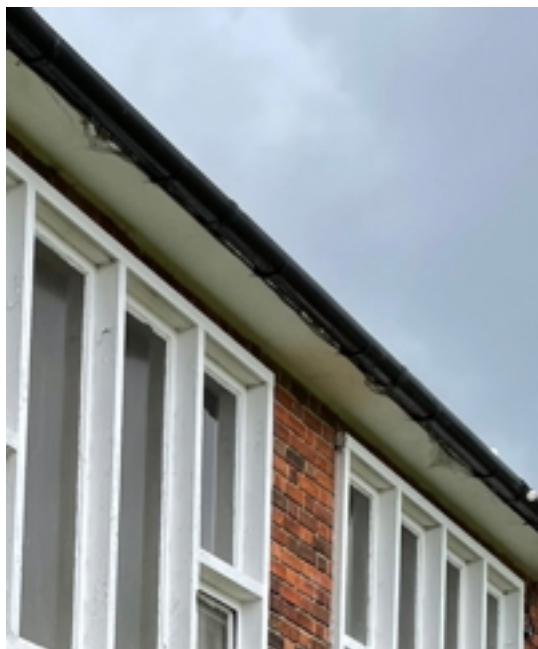
Nave North Eaves Spalling Concrete

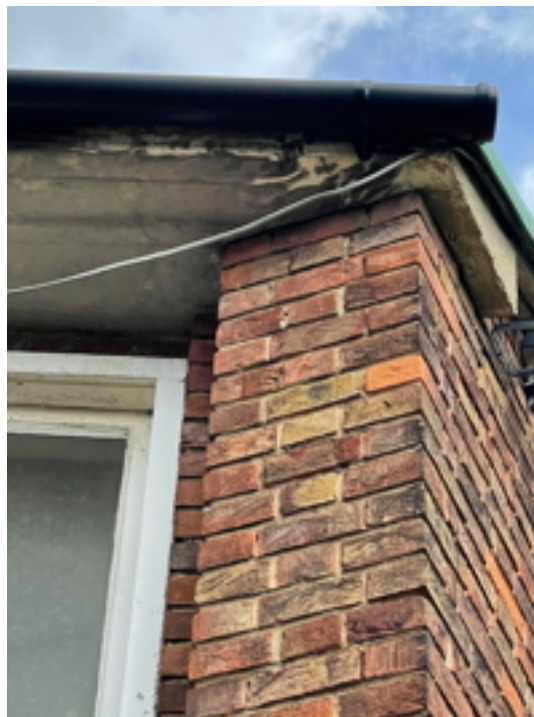
Nave South East Eaves Probably Spalling Concrete

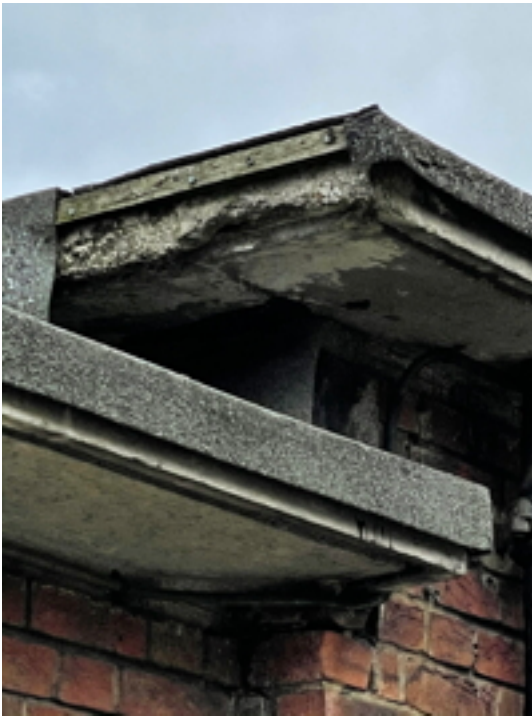
**Choir Vestry/Meeting Room South
West Eaves Spalling Concrete**

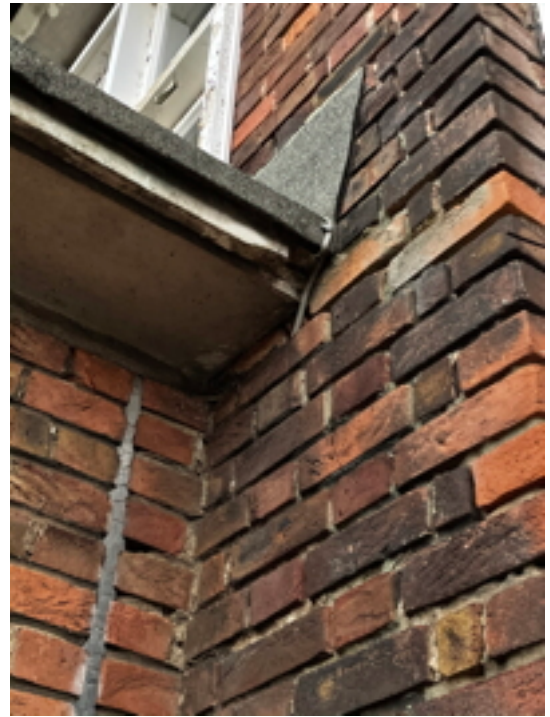
**Vicar's Vestry South East Eaves
Spalling Concrete**

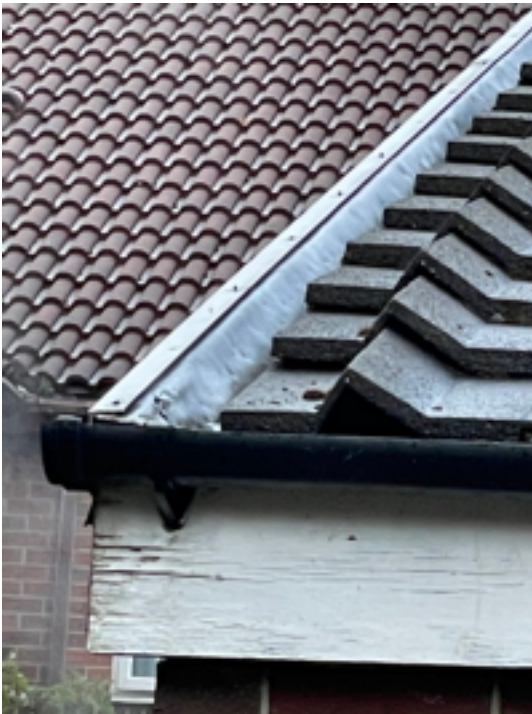
**Hall South East Lead Gutter and
Rotten Eaves**

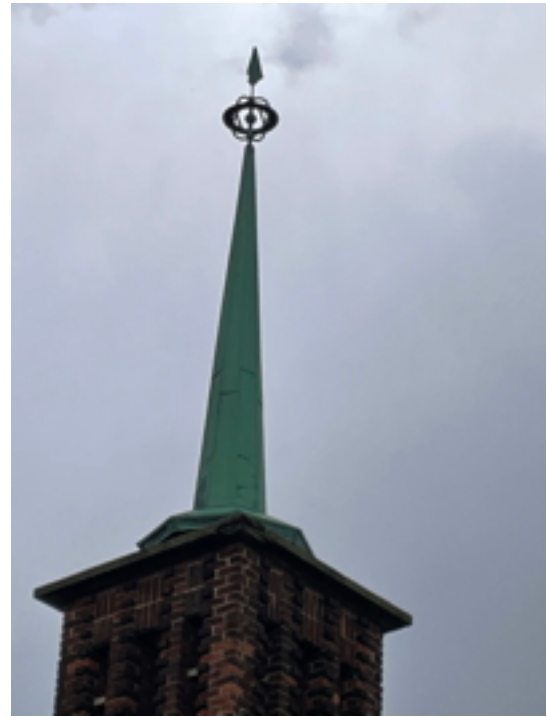
Copper Spirelet to West Tower

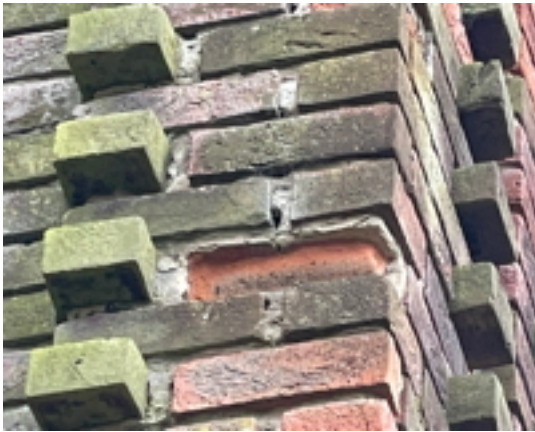
Hall West North West Corner Spalling Brickwork

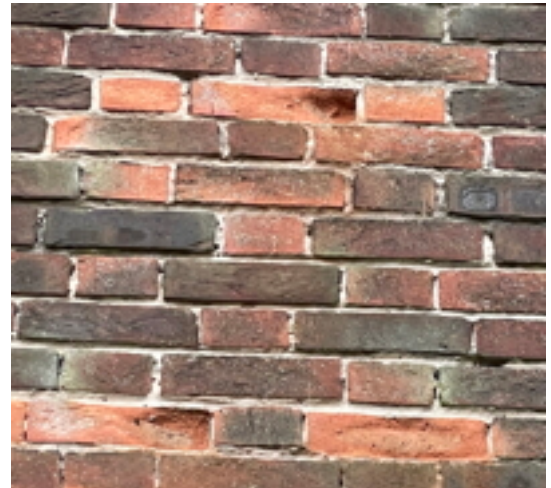
Nave West North West Elevation Spalling Brickwork

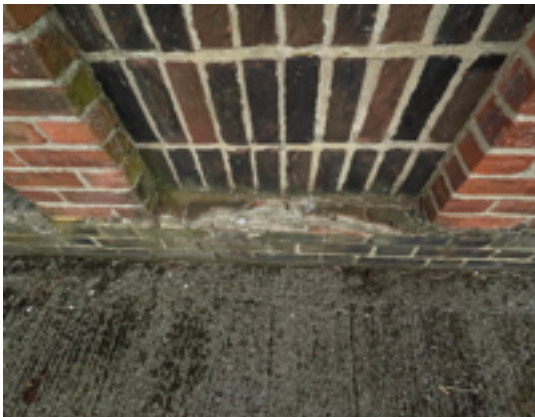
Sanctuary North West Elevation Broken Creasing Tiles

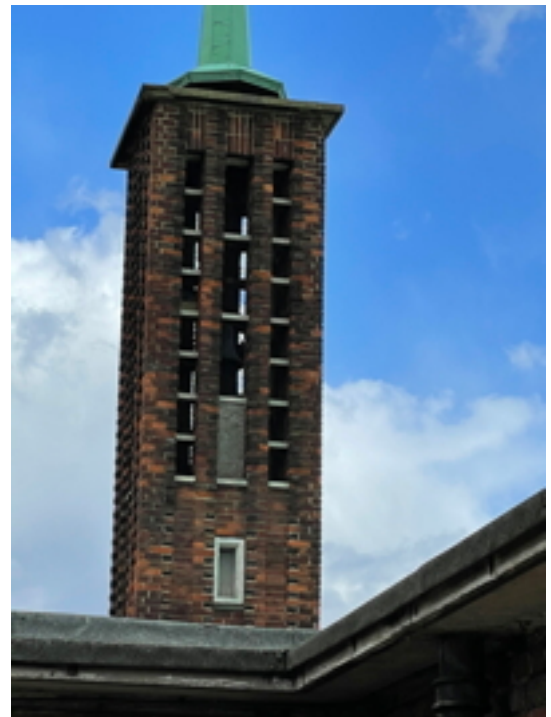
Tower Brickwork Openings

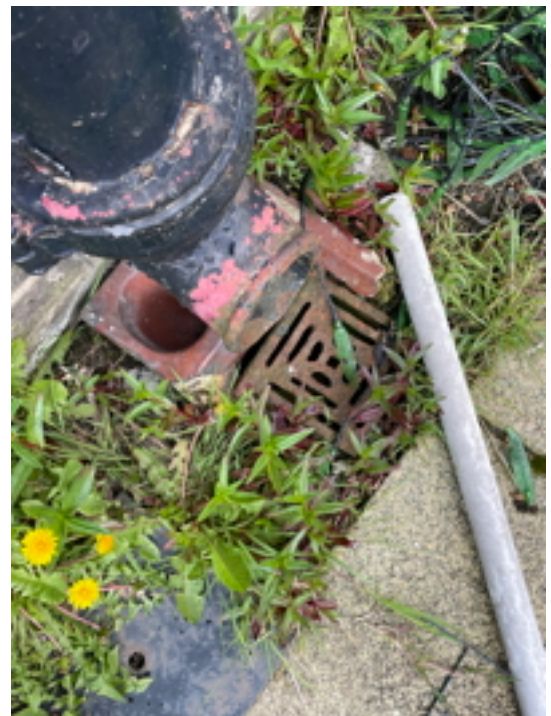
Partly Blocked Gully

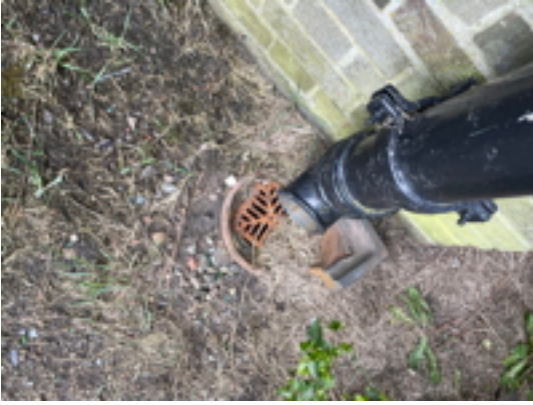
Partly Blocked Gully

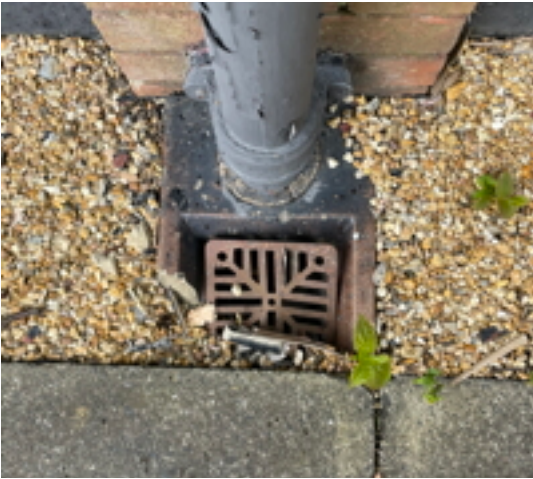
Partly Blocked Gully

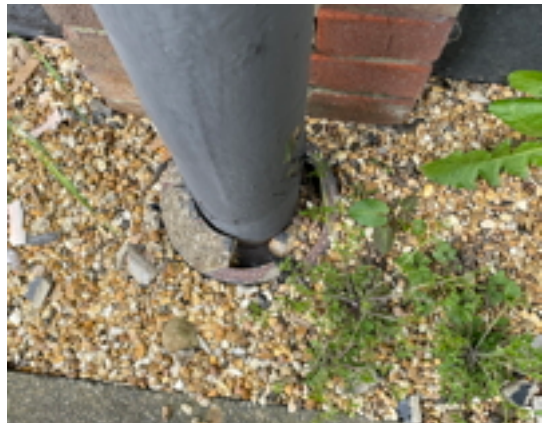
Missing Concrete Haunching

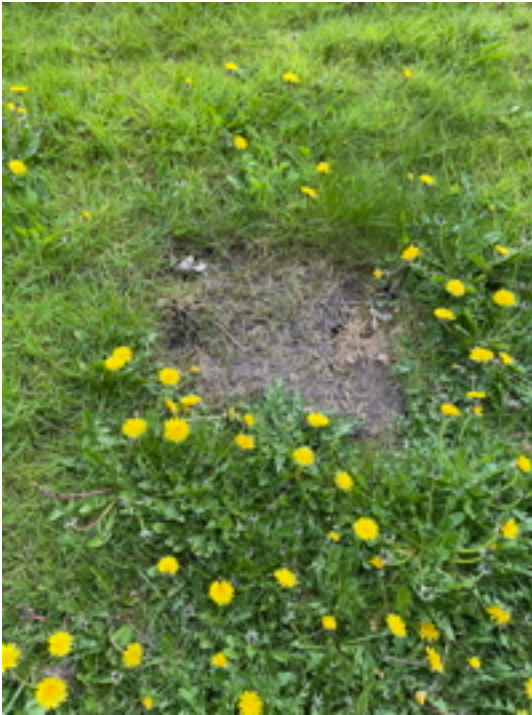
West Elevation Inspection Chamber

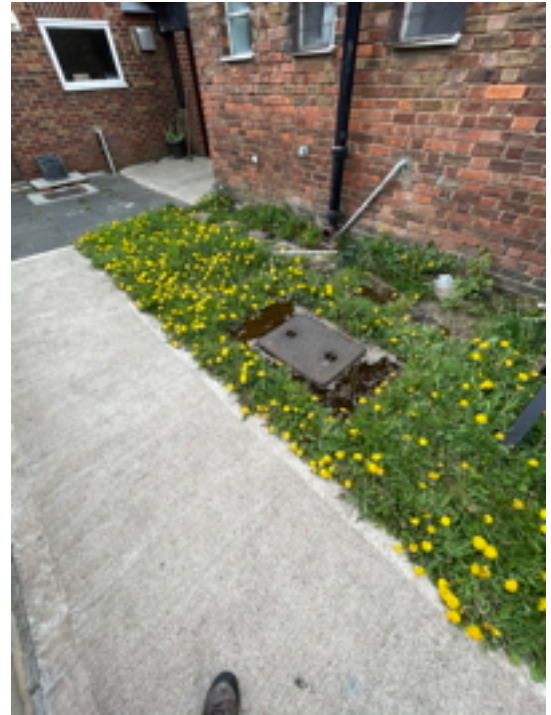
South Elevation Inspection Chambers

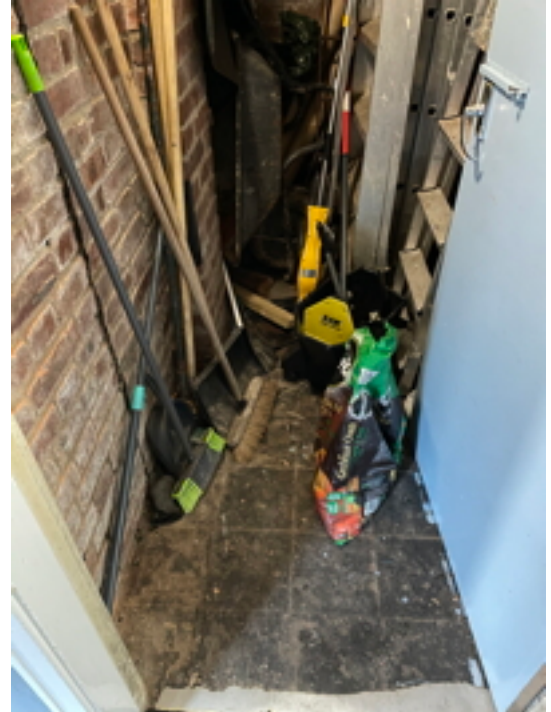
Tower at Ground Level

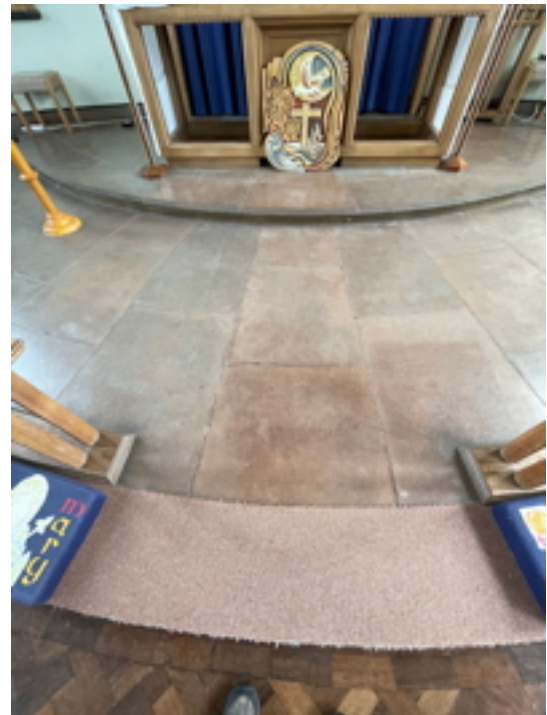
Stone Flooring to Sanctuary

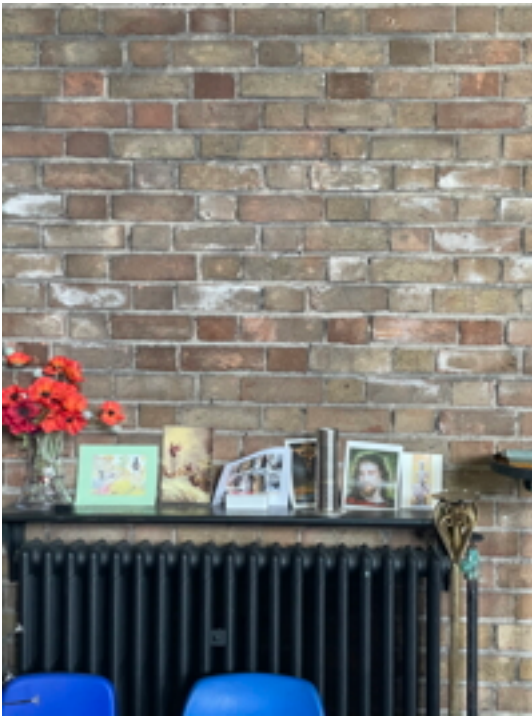
Salts to North West Corner Brickwork

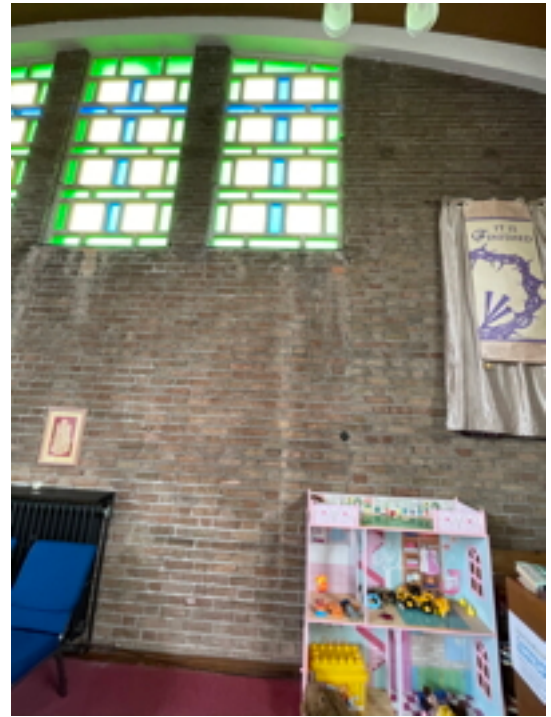
Staining to Brickwork Below West Window

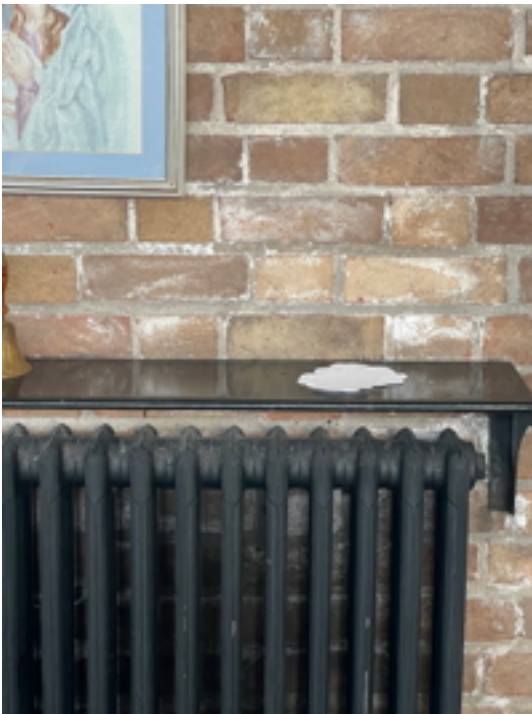
Salts to North Wall, East End Brickwork

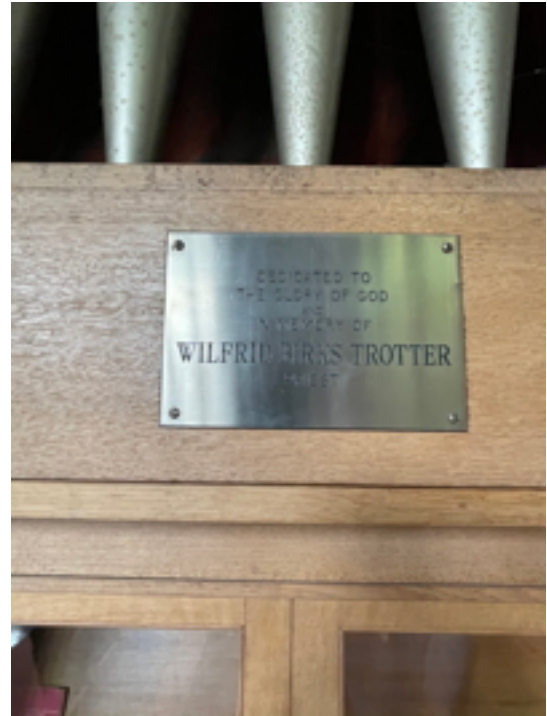
West Window Memorial

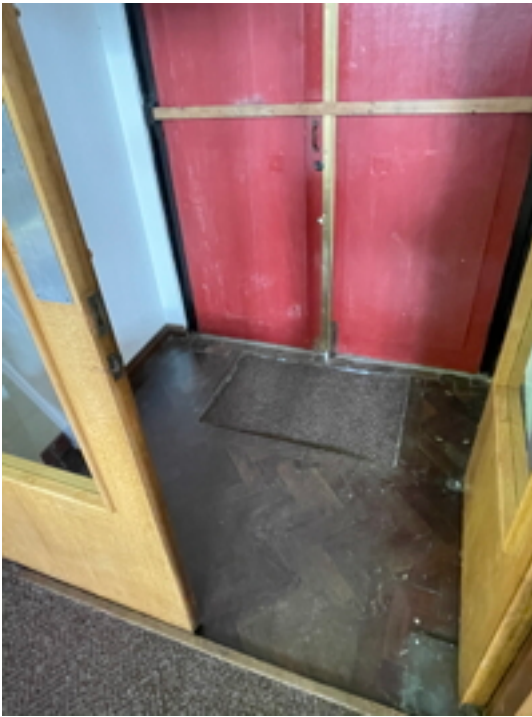
Wood block flooring would benefit from refinishing. External doors require redecoration. Mat level should be raised to same level as wood block as it currently causes a trip hazard.

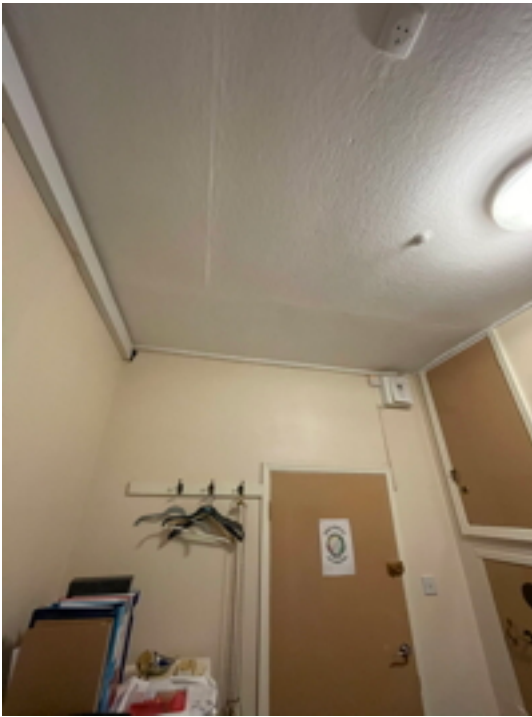
The Vicar's Vestry is generally in satisfactory condition.

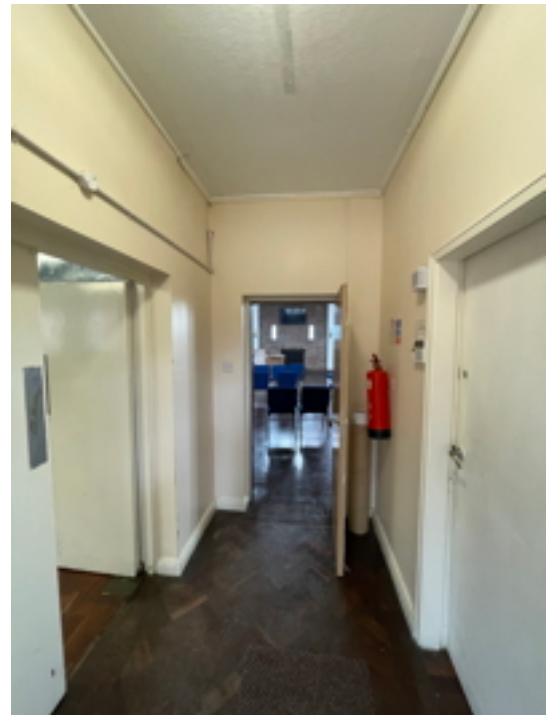
South Lobby Looking North

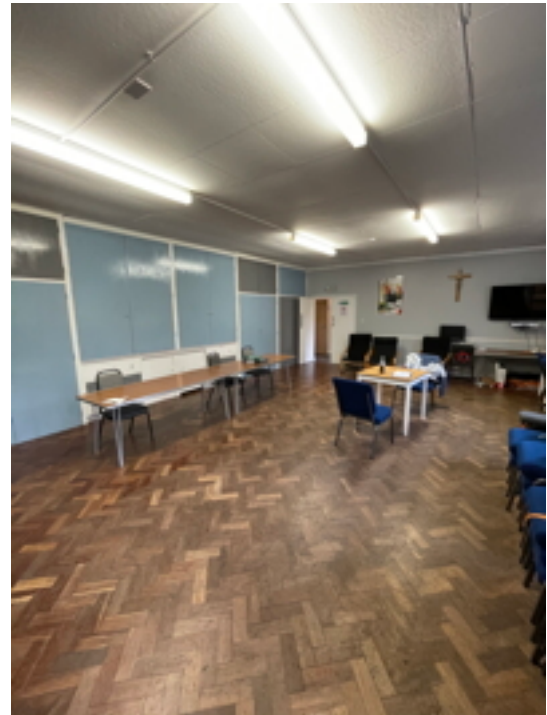
Choir Vestry/Meeting Room

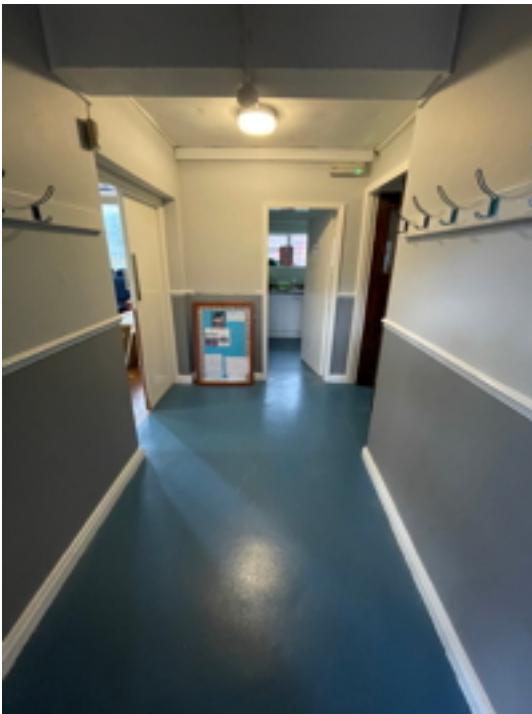
Nave to Hall Hallway

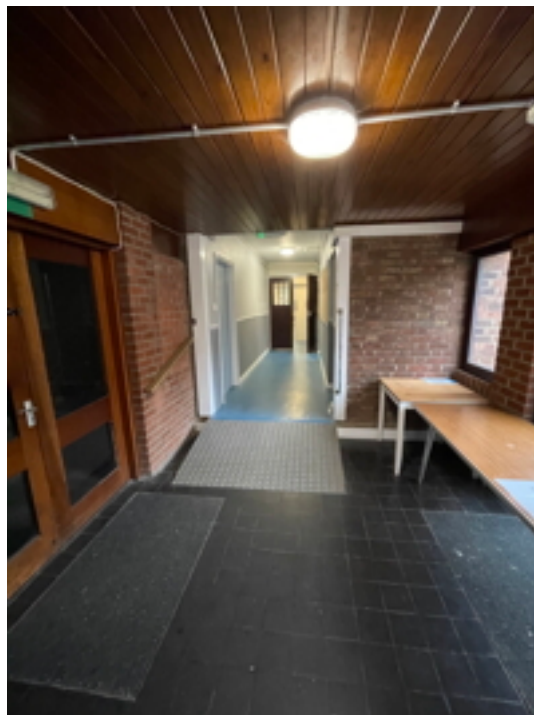
Hall Link Lobby Looking East

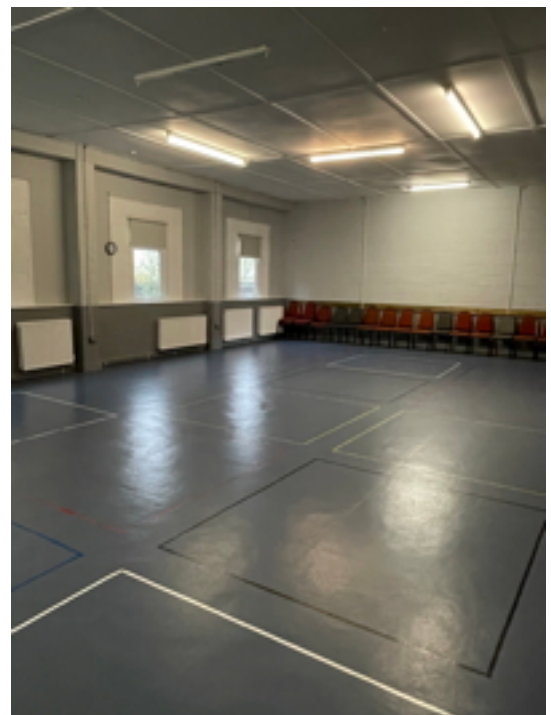
Hall Looking North West

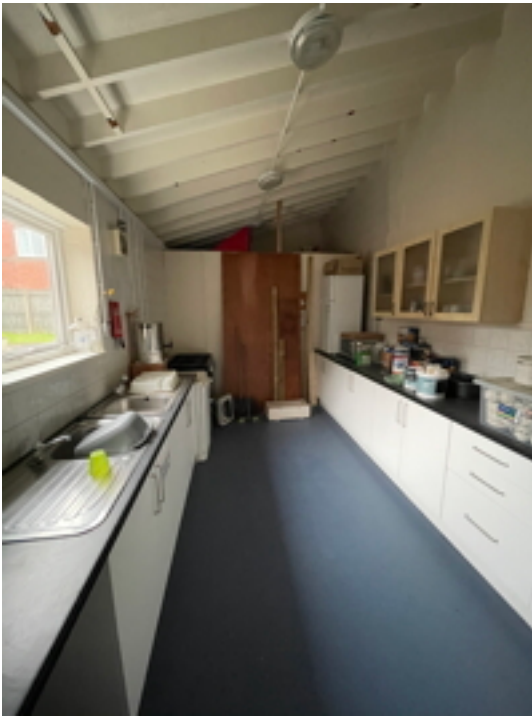
Hall Kitchen Looking South

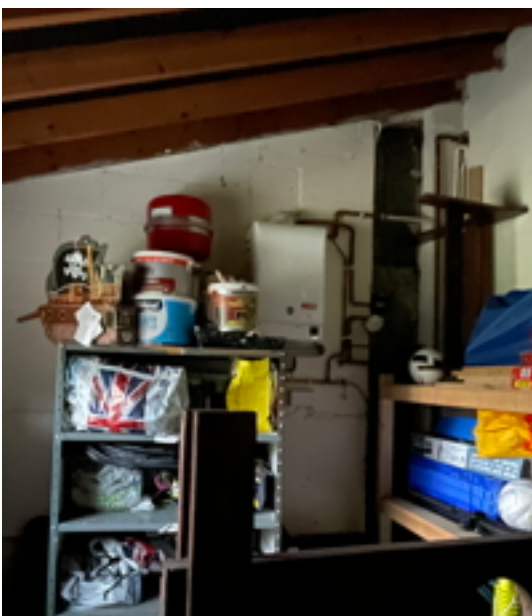
Hall Store Looking South

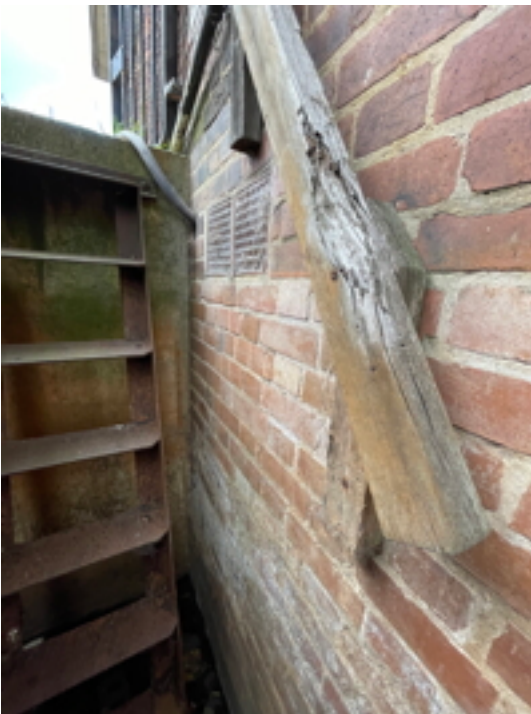
Boiler Room Ladder and Handrail

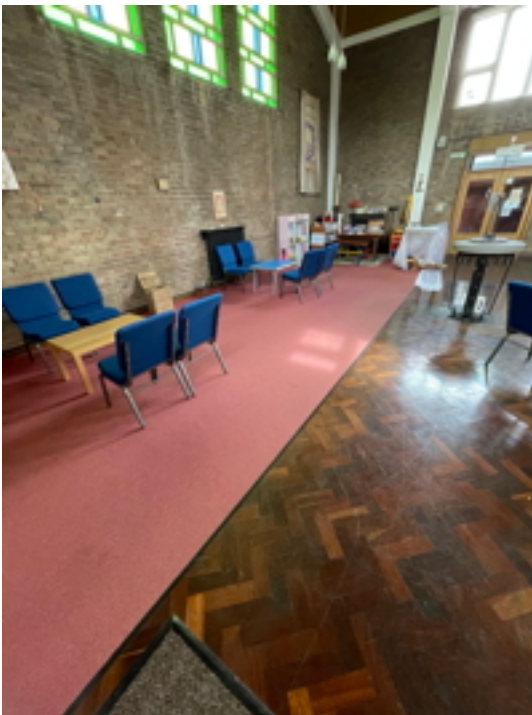
West End Children's Corner

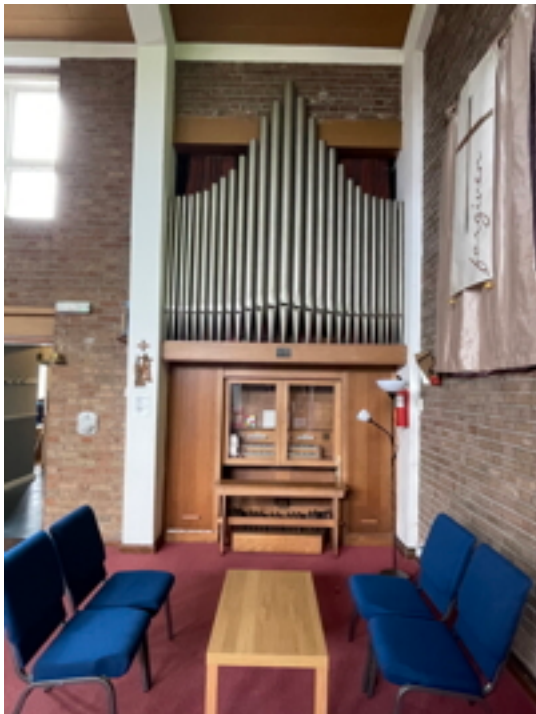
There was no Organ Tuner's Book visible. Further details at <https://www.npor.org.uk/NPORView.html?RI=D06404>.

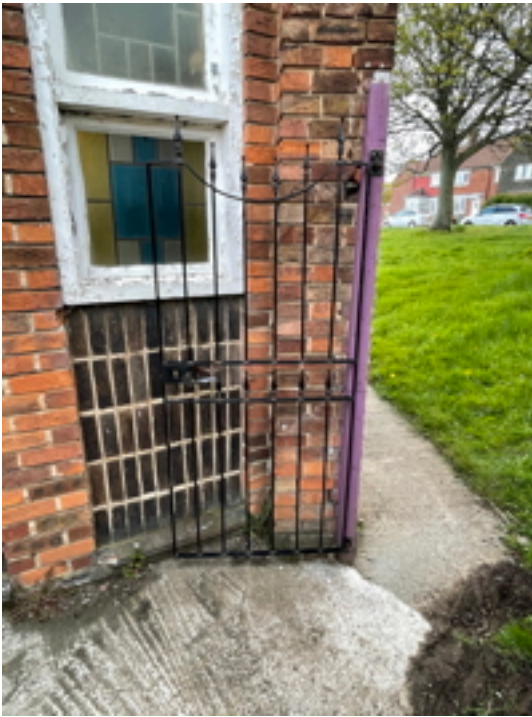
South East Corner Gate

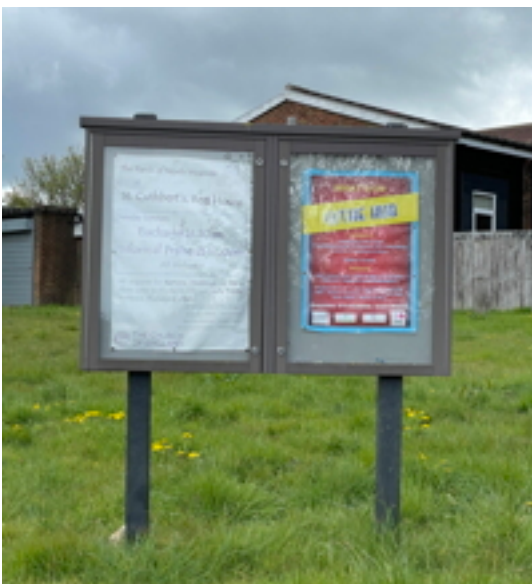
To north west corner of side.

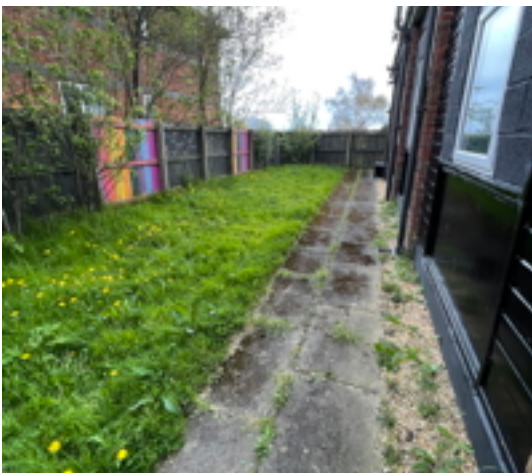
Grass and Paving to Hall West Elevation

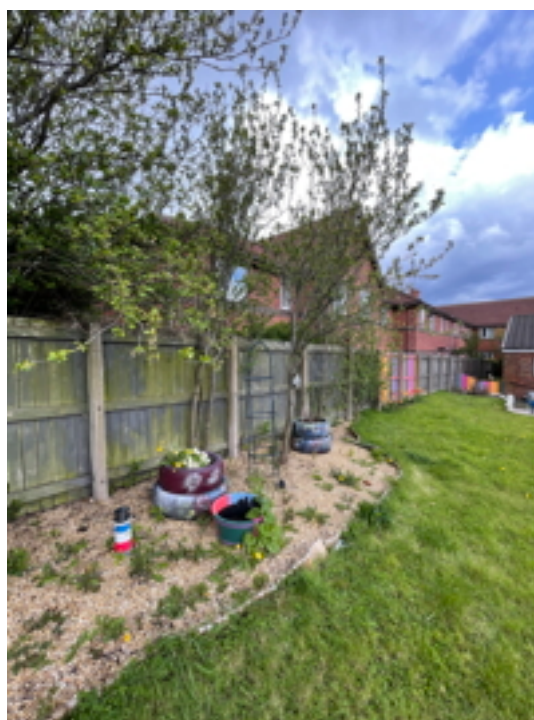
Trees to Raised Garden

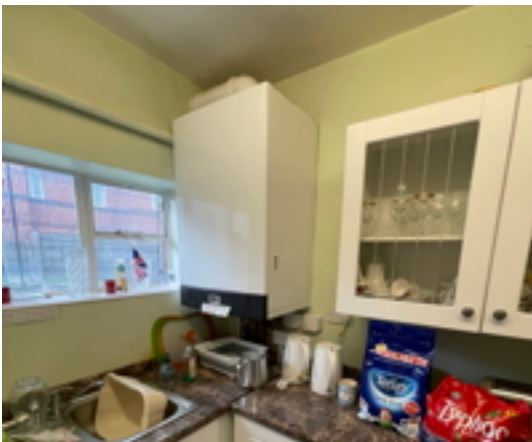
The gas meter is in Hall Store.

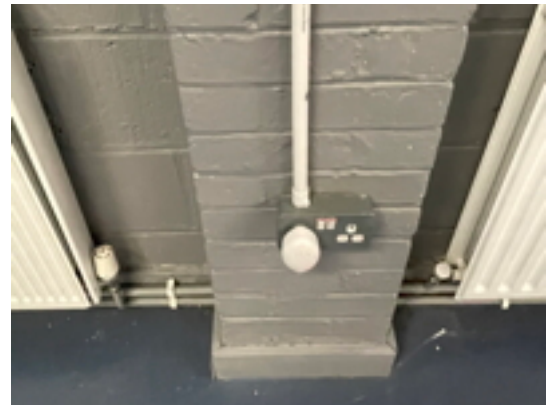
Typical Church Socket

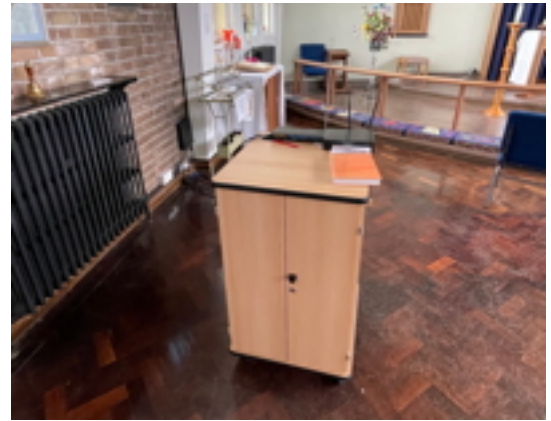
Audio Visual Housing Unit
