# REKENDYKE St JUDE

St Jude's Terrace, South Shields  
(115)

## QUINQUENNIAL REPORT

**6 May 2021**

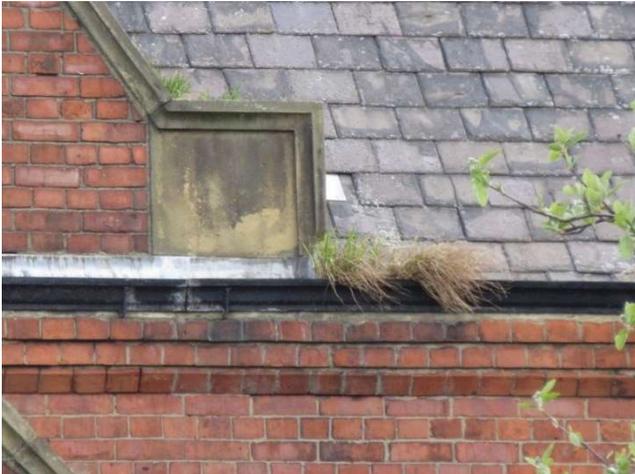
15. The long level gutters are prone to silting and blockage, needing clearance at least once a year. The high gutters (Chancel and Nave) are very difficult to reach. During the inspection all gutters were being cleared of silt and thick plant growth by motorised suction pipe from ground level.

Gutter choked by plants before clearance at the inspection

Clear gutters, gullies and N ground channel at least once a year	15, 22, 25
--	------------

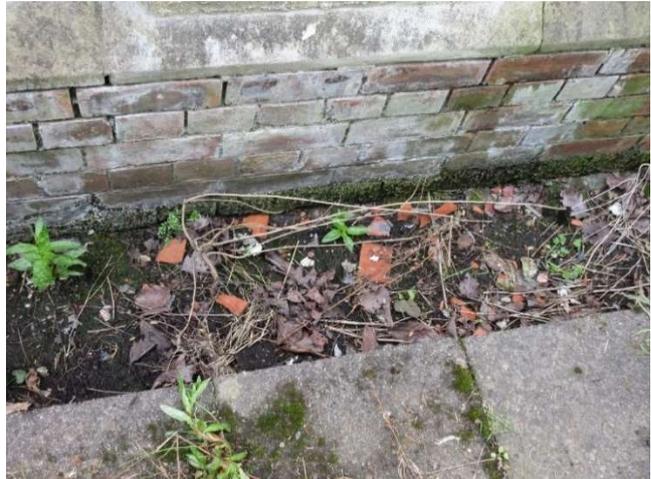
Trench against N Aisle refilling

22. The ground channel along the N side previously dug out to keep the Aisle wall dry begins to fill with debris and rubbish again. Like the gullies it should be kept clear.

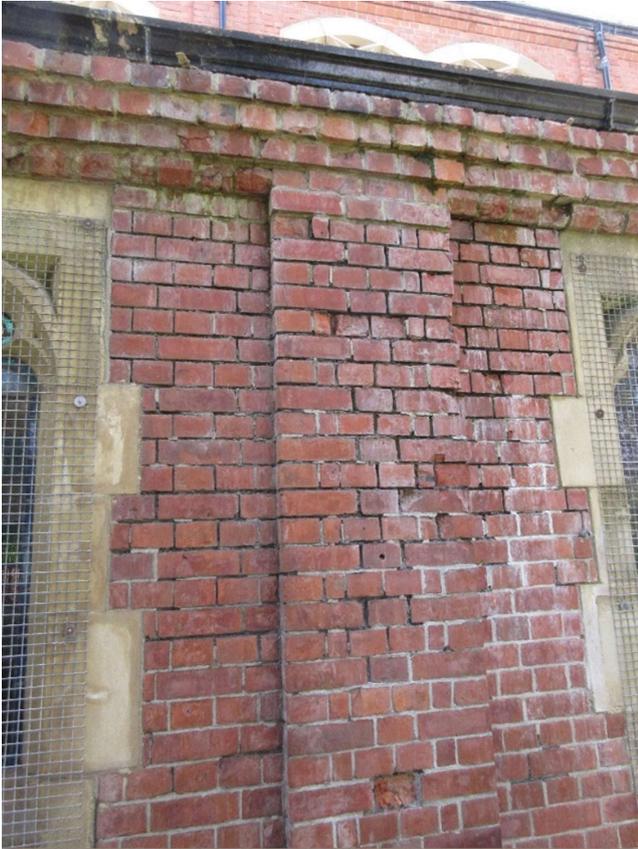
Para 25

24. Deeper brick damage at the eave corbel brickwork at the E end of the N Aisle and down the NE corner of the Chancel apse are no worse than at the last inspection and are probably frost damage from saturated bricks before the 1982 roof and gutter works. Both areas seem sheltered enough not to let water into the core of the walls. No repair seems needed.
25. In contrast the next panel of the N Aisle brickwork (between the Aisle's two E windows) has much more brick and pointing damage than previously - probably frost damage of brickwork saturated due to overflow from a blocked gutter.

Refix part of head flashing at S Aisle roof	10
Refix two slipping Nave slates	12
Rake and repoint N Aisle bricks between two E windows	25, 49
Dig out sapling against the apse wall	27
Obtain a new periodic electrical system test report	79 and Addendum
Obtain a new Lightning Conductor test report	82 and Addendum
Reduce and repair S boundary wall or rebuild with better buttresses	90

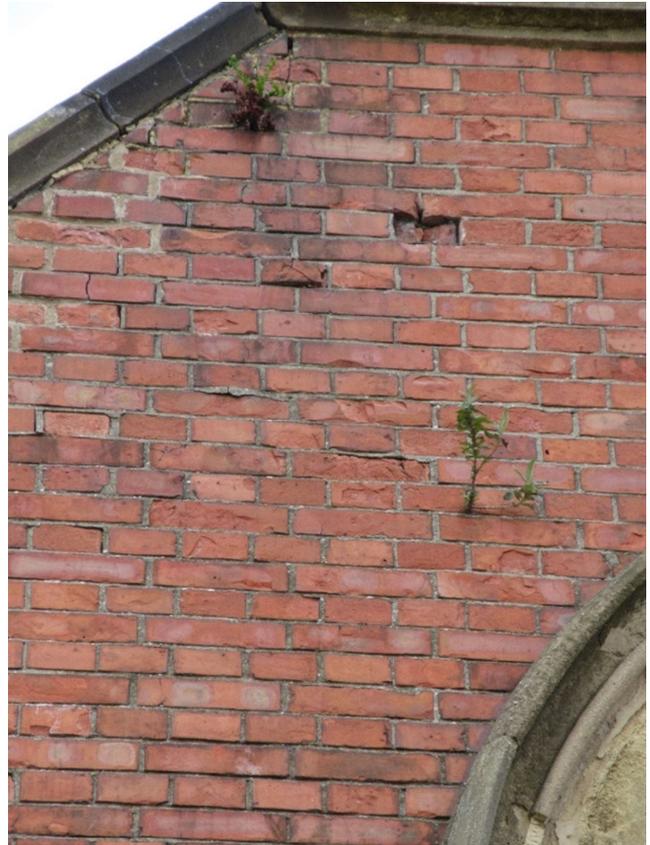
Para 26

26. The large W gable is mainly good but there is damp over the N spring of the arch of the great window, shown by two plants growing out of the wall and several decaying bricks. Cause not clear. Modern pointing of the N watertable joints over appears sound. The brick decay may have started before the joint repair. The S watertable joints appear slightly open. Unfortunately in this exposed position decayed bricks will tend to let water and frost into the wall core, spreading decay. Despite the expense of access, local brick replacement (and checking of watertable pointing) may be a good investment before long. Might be combined with window hoodmould replacements (para 37).

At W gable piece in damaged bricks and repoint above N end of window arch perhaps with renewal of damaged hoodmoulds	26, 37
---	--------

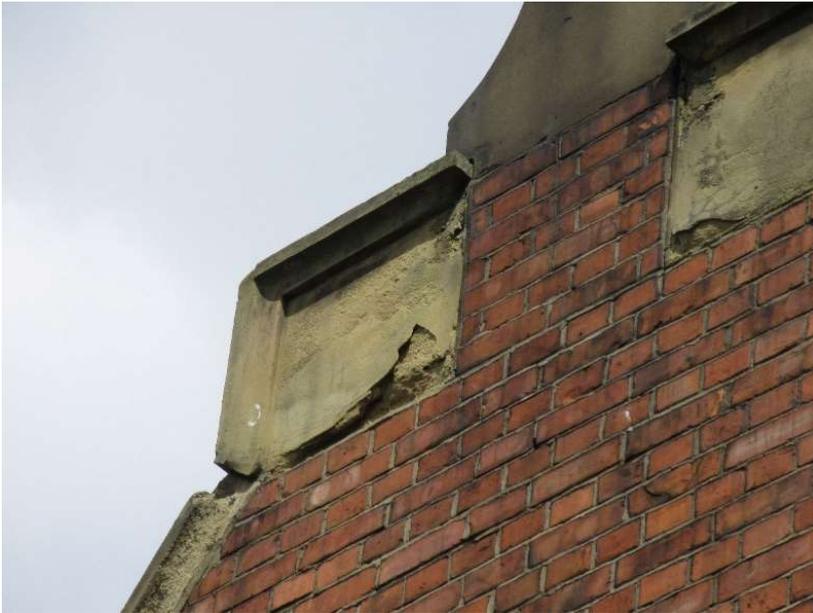
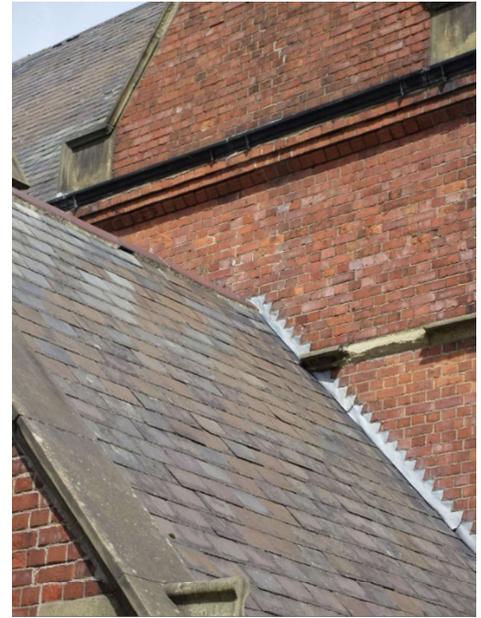
para 29

29. The Chimney cap stones are cramped together with stainless steel. Its W supporter stone decays from its bottom edge.

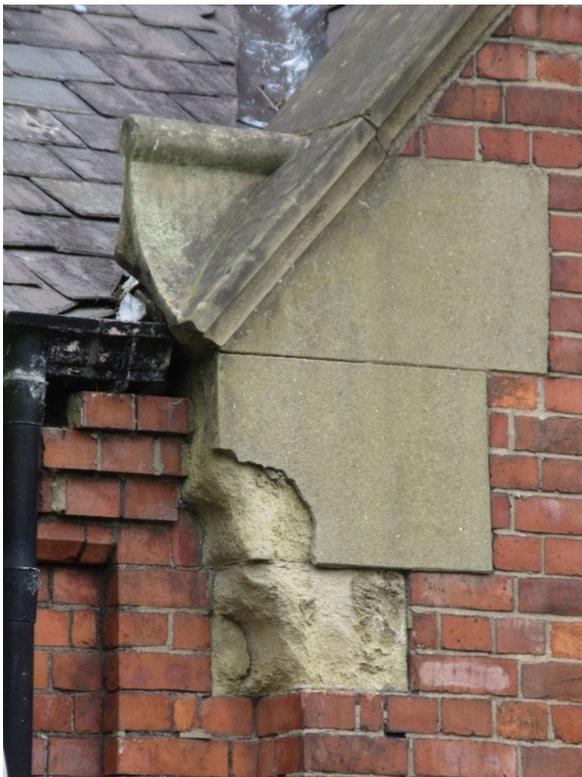
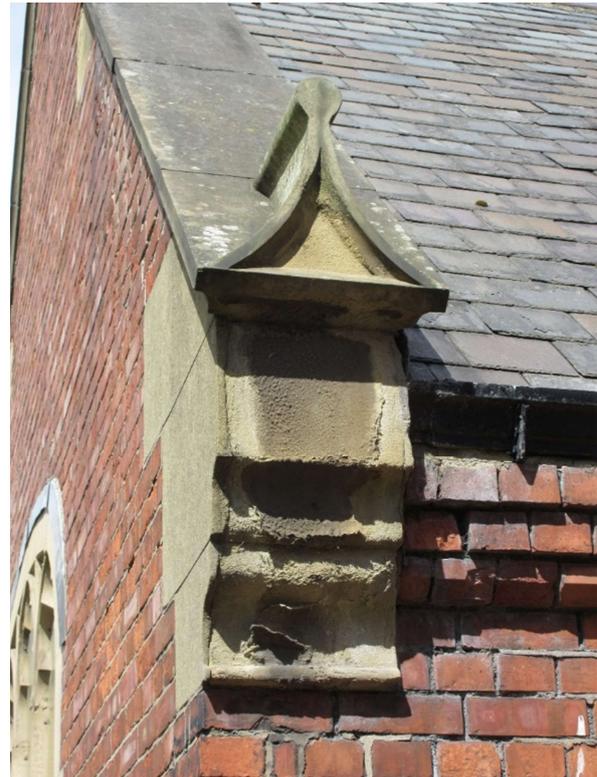
Vestry kneelers

30. The Vestry gable kneeler stone sides have old mortar repairs, part lost at the side of the W kneeler. The stone E face of the E kneeler decays, perhaps due to soaking from the end of the gutter (para 21).

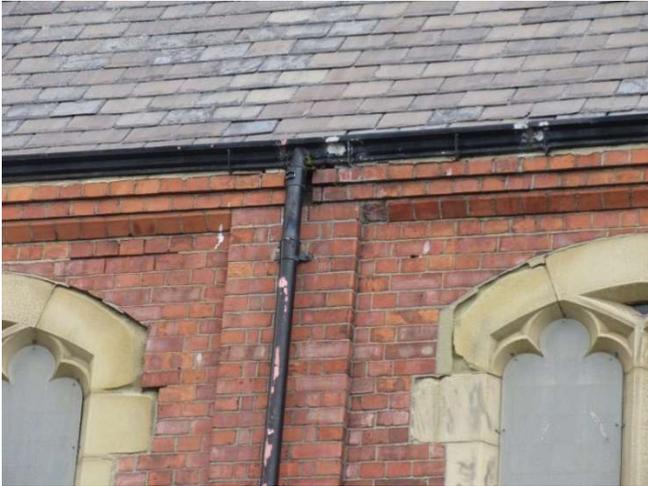
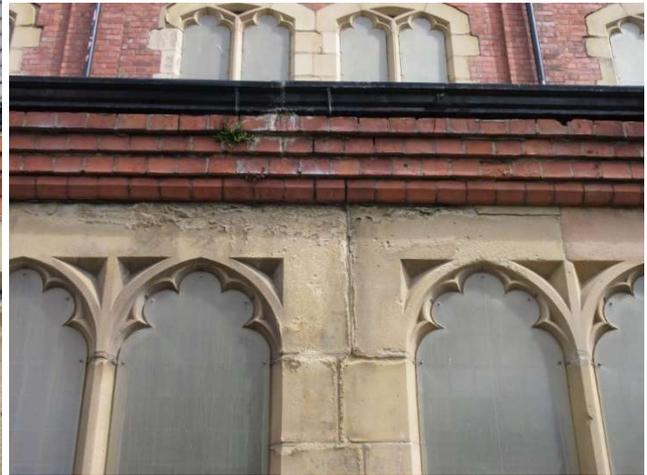
para 34

34. Many windows have aged mortar repairs of the stone which appear in sound condition but parts the remaining stonework continues to decay. At S clerestory there is slow decay of four arch spring stones (especially each side of the gutter outlet over plant growth) (para 18). Repairs in the 1990's of the N and S windows appear sound.

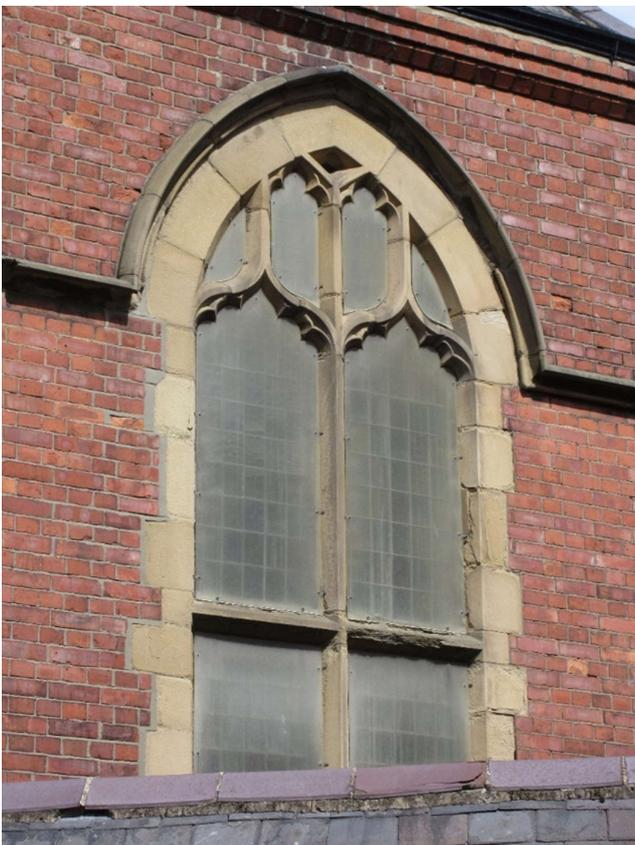
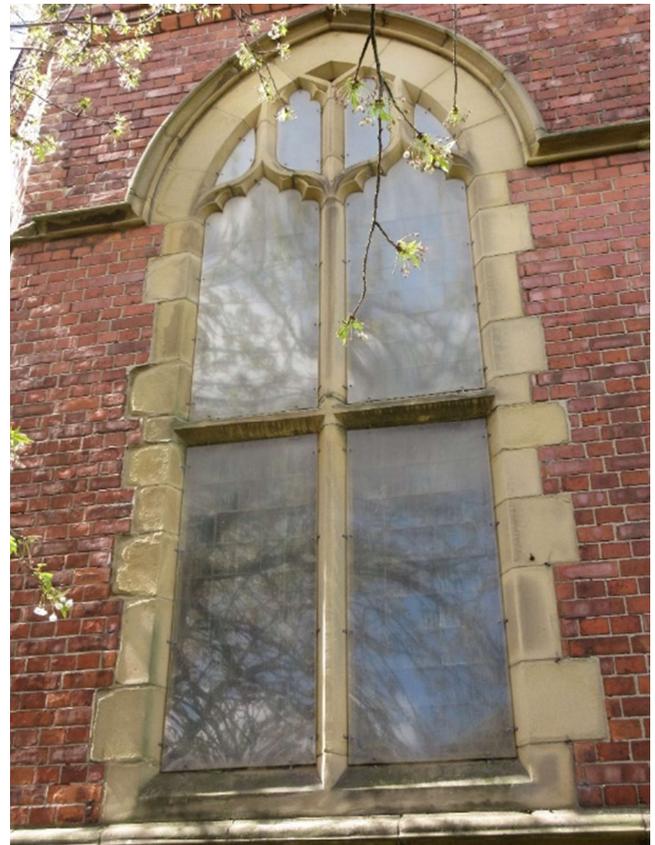
36. At Sanctuary E and SE windows some stone loss at the transoms and mullions and at about 25% of the reveal stones. The Sanctuary NE window has eroded reveals down one side. Little change.

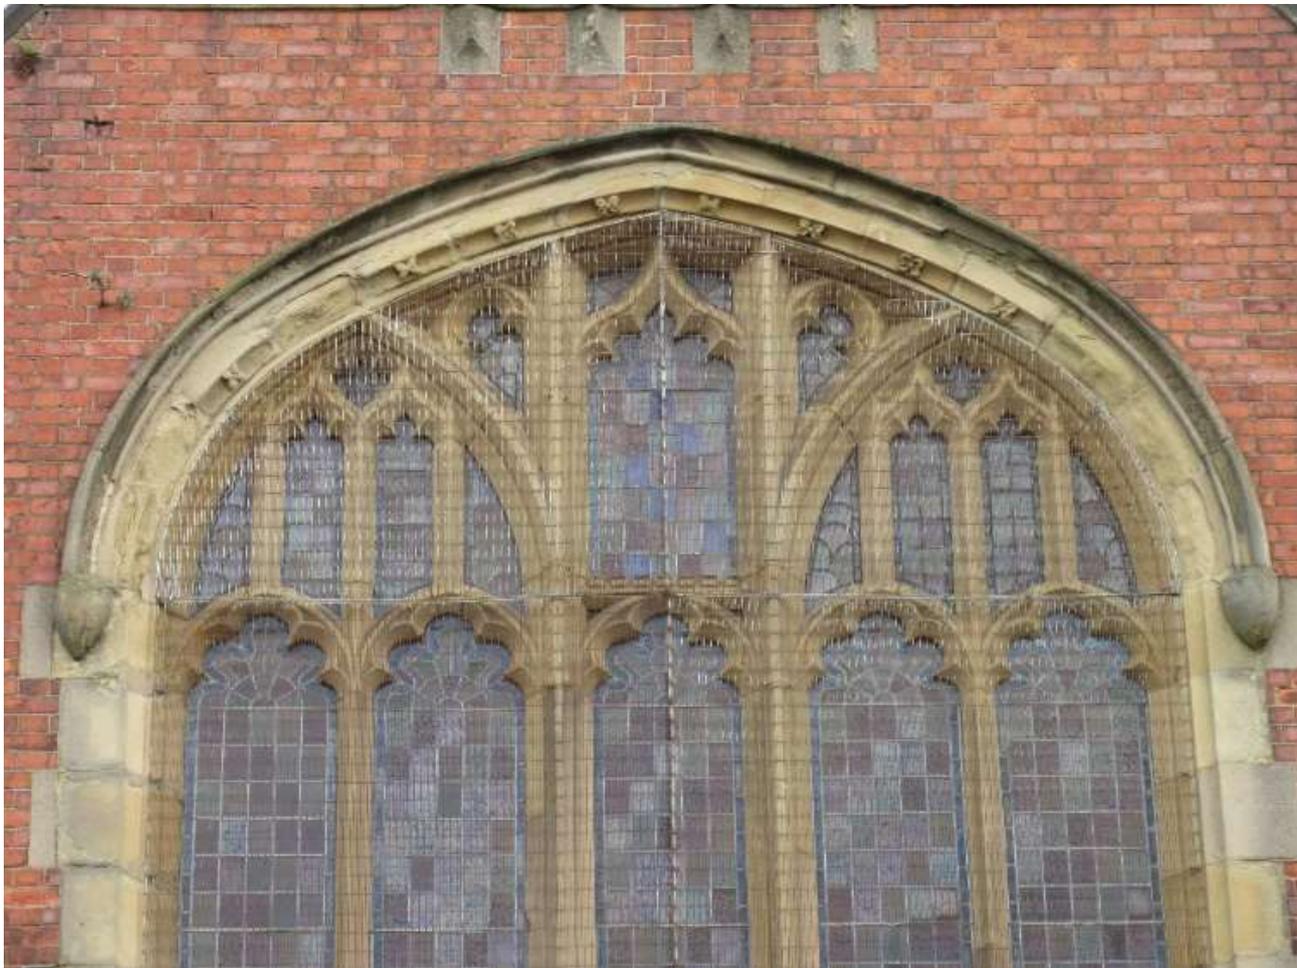
37. The large W window is very exposed to the weather but overall remains in sound condition. Its protective hoodmould has been mortar repaired, perhaps decades ago. Both mortar and stone mouldings have lost material since those repairs and parts are missing but there is no visible further loss since the last inspection.

Similarly about 50% of the arch stones with carved floret decoration have surface decay, deepest at the arch ends. No visible change since last inspection.

The damage can be repaired with new durable matching stone, the priority being the missing hoodmoulds.

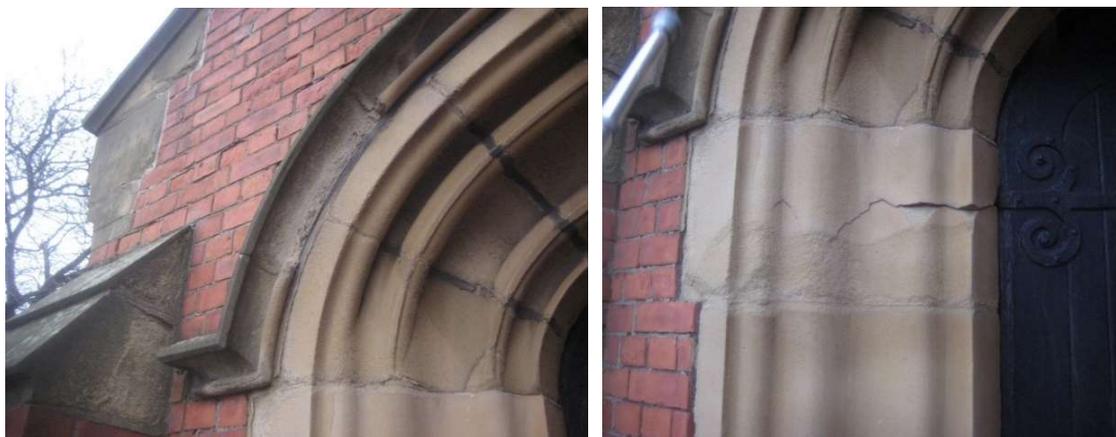
At the N door the top N reveal is cracked, apparently by pressure from the (rusting?) hinge pintel.

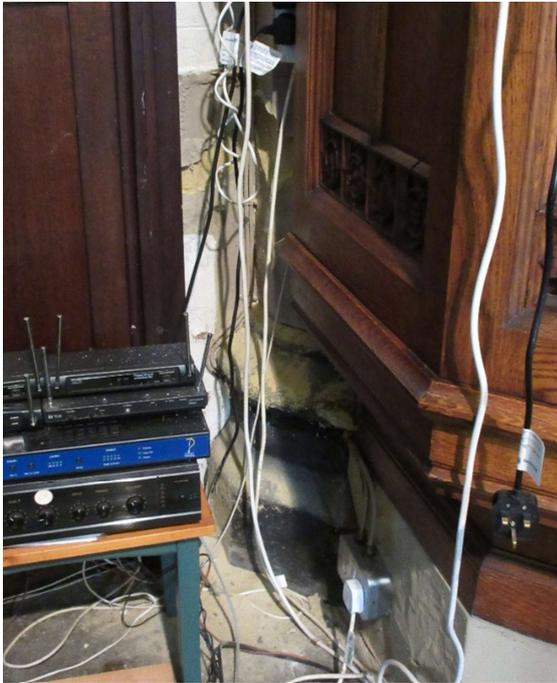
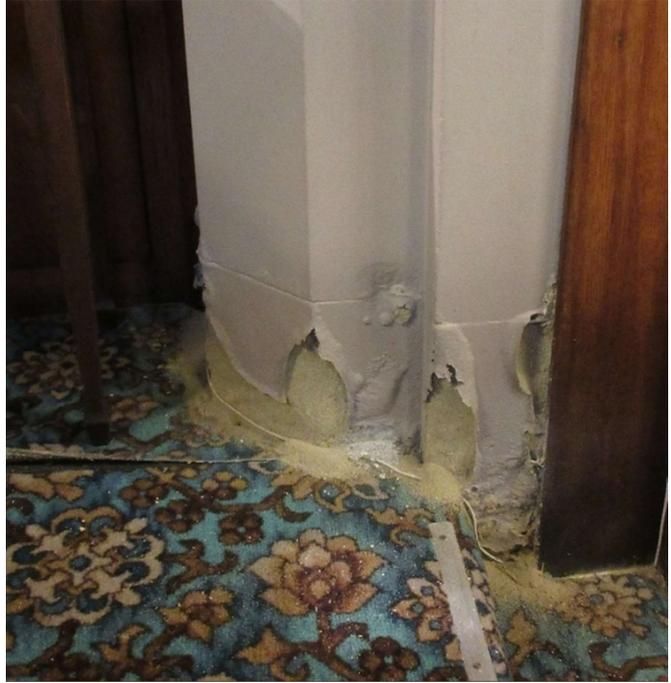
45. Octagonal stone columns and chamfered four centred arches. Matt paint at capitals and shafts, eggshell on bases. Sound except rising damp trapped behind the paint shows as:
  - Most base paint is hollow and parts of the paint and stone surface is missing at SE respond and all three S bases, slightly less at N arcade
  - Worst is NE respond where decay reaches up into the lower two stones of the half shaft behind the pulpit, spreading sand on the respond base and the pulpit floor

Paint and stone loss outside and inside the pulpit continues slowly

- Loss of paint and stone at the arcade columns and their E responds, especially behind the pulpit
71. Since the last report carpet tiles forming a moisture barrier in front of the Chancel steps have been removed, a useful improvement.  
As well as keeping the gullies and ground channel along the N Aisle clear to reduce damp in the ground other steps to promote desirable general evaporation would be:

- Remove any rubber underlay under the carpet around the Nave altar
  - Remove the paint from the stone risers
  - Remove the paint from the column bases and E responds if practical (this will cause further stone loss but leaving the paint will cause deeper long term damage).

Paint external doors	40
Chemically remove paint from internal stone risers, column bases and responds including at the pulpit to ease evaporation	45, 64, 69 - 71
Clean glass, repair minor broken glass. renew clouded protection	53 – 55, 57 – 60

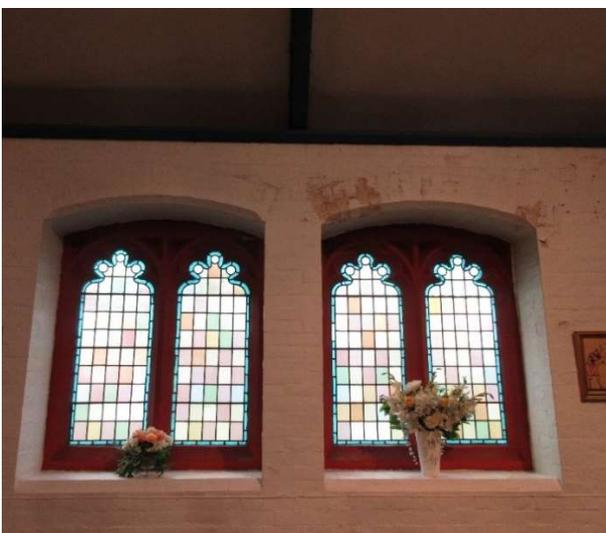
S mid

49. Flaked paint at a few scattered bricks in all walls of the Chancel, at low level in the NW porch and at top middle of the N clerestory  
 at SE corner of the S Aisle  
 at low level at the W end of the S Aisle  
 and damp bricks show through the paint  
 above the 2<sup>nd</sup> pair of S Aisle windows from W end (plants outside para 19)  
 above the 2<sup>nd</sup> pair of N Aisle windows from W end  
 between the 1<sup>st</sup> and 2<sup>nd</sup> pair N Aisle windows from E end (pointing missing outside para 25)

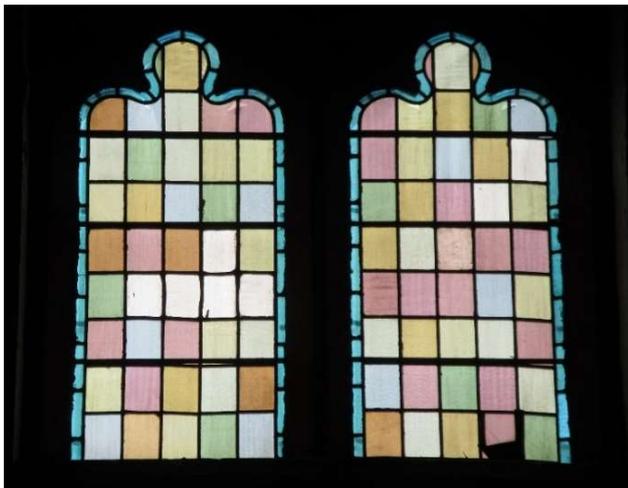
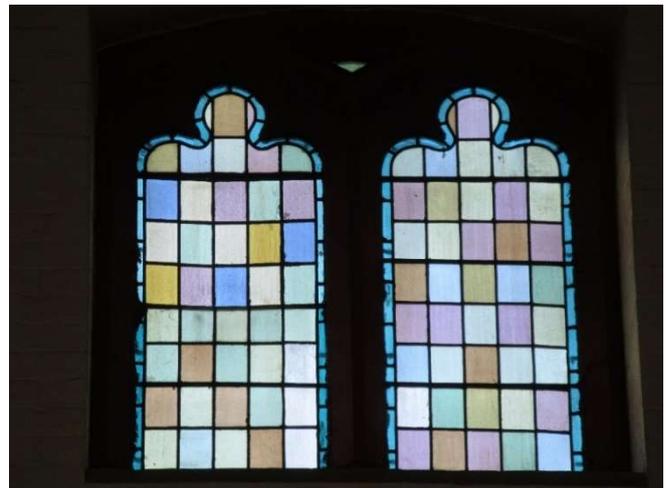
58. Clerestory glass as Aisles but many distorted at borders (see typical photo) and all dirty.  
S – in middle pair one quarry is crudely patched and looks poor  
N – the W light has only one supporting saddle bar but appears intact  
Counting internally from left these lights are distorted down at least one edge, in a few cases with slight gaps between glass and lead :  
S – lights 9, 10, 11, 13, 14, 15, 17, 18  
N – lights 1, 3, 4, 10, 12, 13, 18

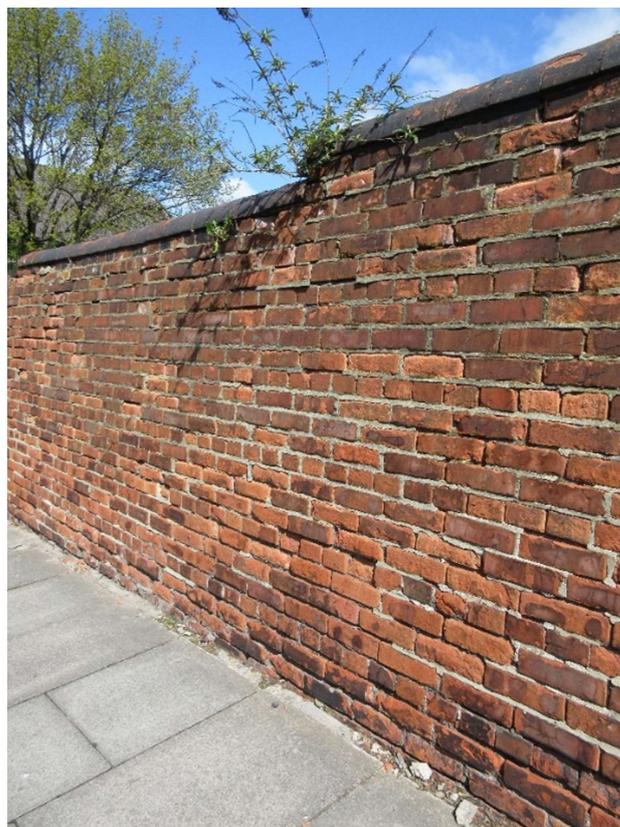
para 90

- 89. Grounds all sides, largest at S. Beds and grass need some maintenance. Used to be continuous with the vicarage which was sold, now fenced off
- 90. Boundaries good except high brick wall along pavement at S leans in severely, lacks a few bricks and parts are poorly pointed with plant growth on top. No obvious change but partial collapse (onto the church's private lawn) is possible at any time.

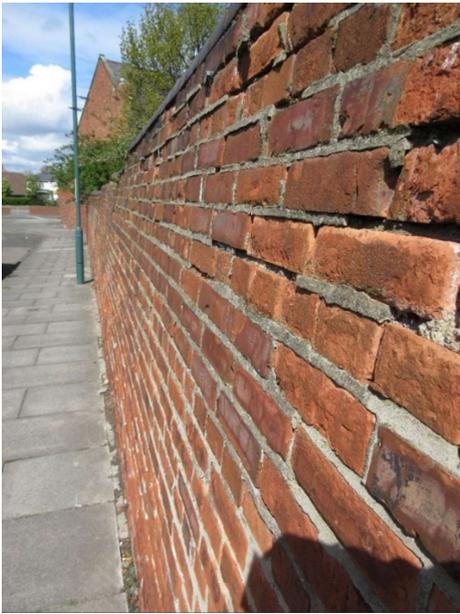
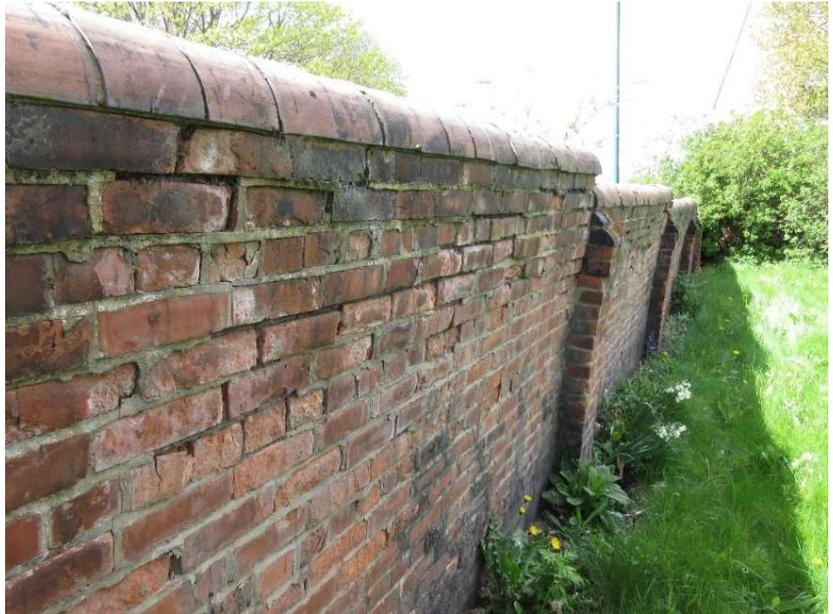
South brick boundary wall decays with significant lean inwards, despite thin piers

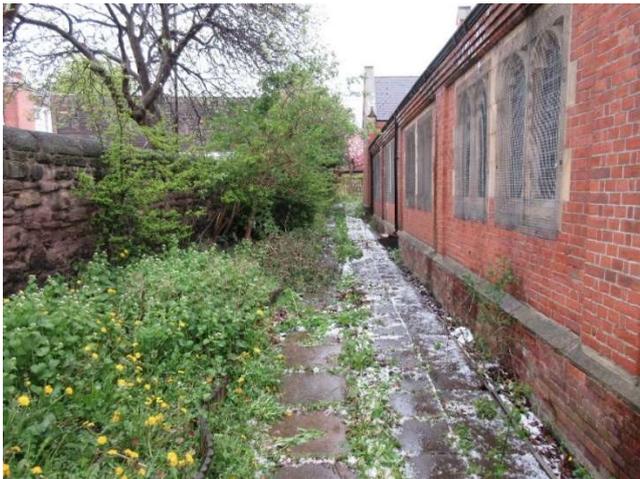
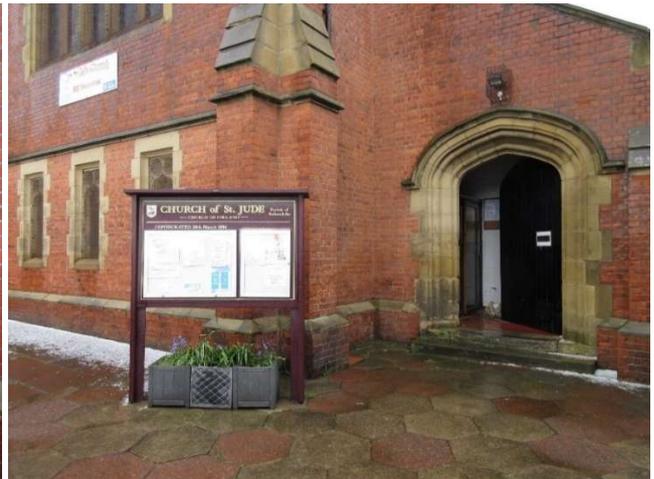
92. A paved W forecourt faces the main road. Steel gates at the boundary wall have fair paint. Older gates by the Aisle corners have some rust needing treatment and paint.

Dismantle and remake one S Nave gutter joint and one at S Aisle with beds of flexible polysulphide	18, 19, 34, 49
Treat and paint steel gates at NW and SW corners of church	92
