**QUINQUENNIAL INSPECTION REPORT  
OF  
RYHOPE, ST. PAUL**

**QUINQUENNIAL INSPECTION AND REPORT**

**February 2022**

**David Beaumont BA (Hons) Grad Dip, RIBA, AABC**

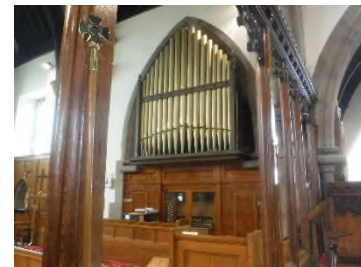
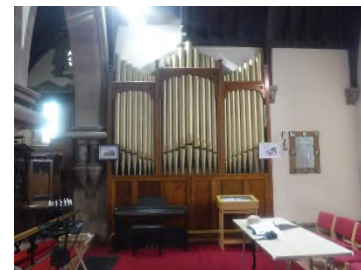
Position **S chancel chamber**  
Postill case retained

**M** **Organ:** Replacement organ by JJ Binns, Filton and Haley of Leeds, installed in 1946. Tuned in 2011-2. Electric piano in s transept and unused harmonium at the n aisle crossing.

**Recommendation:** Service at regular intervals

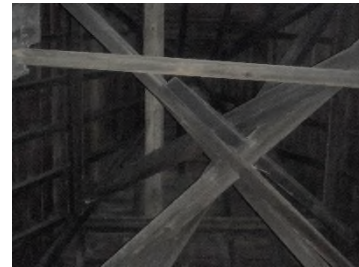
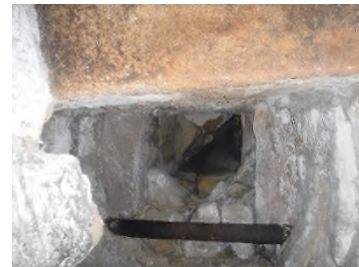
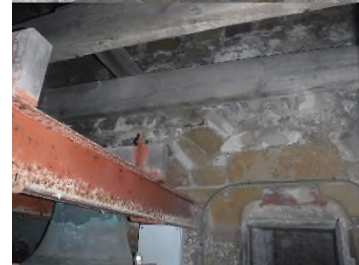
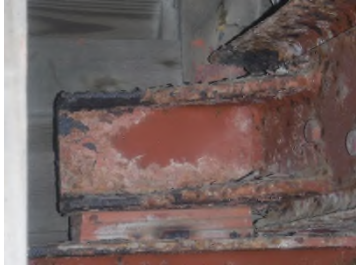
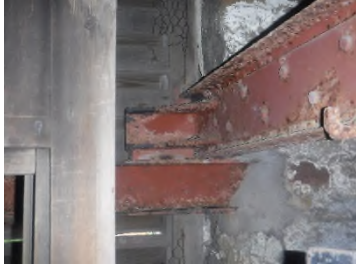
**Ceiling** – Open roof there are some slates missing on the outside but there doesn't seem to be any water penetration on the hips, it seems all reasonably sound.

**Floor** – Looks like it is a boarded floor covered in sand, it is hard to see. The room has got a lot of sand and lumber in it that needs to be cleared out. There's water marking on the ceiling below so there maybe water getting on to the floor. The sand will certainly hold damp and might induce rot.

**Bell Frame** – Is rusting and the decoration has broken down. The connection into the walls is just about ok I think, it is rather a bodged-up affair and the beams are beginning to laminate a bit on one of the lancet openings. The bells themselves have some corrosion on them, it seems they have lost their outer face and they have could be turned as the hammers are denting the soundbow significantly and specialist advice should be sought.

Door to the room can't be closed because of the sand.

**Recommendation:** renew louvere mesh, sweep up floor, redecorate bell frame and turn bells if specialist advises

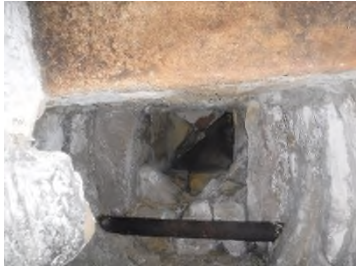
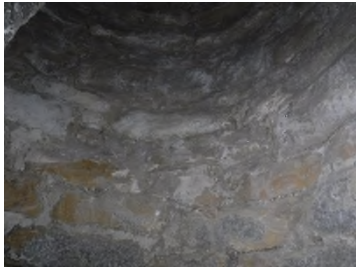
**Stair Tower:**

Daylight visible in the roof, large rusting bar across it, stairs are covered in sand, slight open joints up at the top.

**Recommendation:** repoint roof. establish use of tie bar and whether it needs repair.

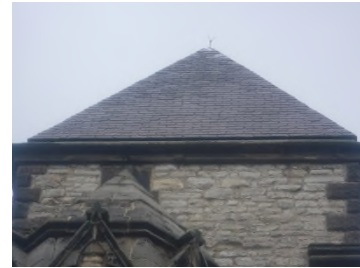
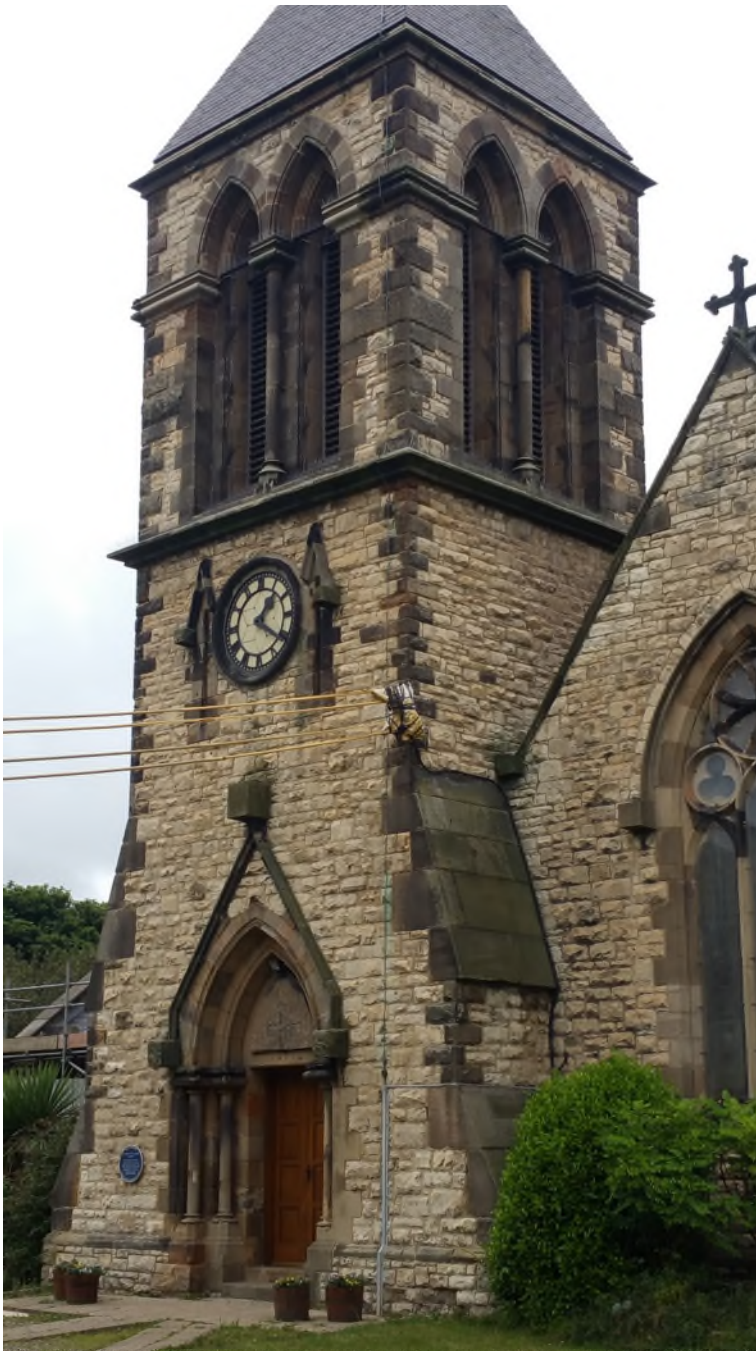
- B** **Apex roof:** Some slates missing across the width of the roof as well as at the hips and some patching needed. This roof covering is always giving trouble and an assessment is worth carrying out now- reslate with lead hips? Remove the roof?

**Recommendation:** repair failed slating

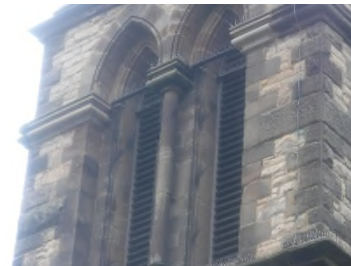
**Belfry Stage:**

Now has pigeon spikes, has had steeplejack masonry repairs, louvres look alright, arches seem ok, they have had some reinforcement there is a single on the E and double on the S, some erosion to the joints as the lightening tape comes down on the S side, there isn't a belfry opening on the W- that is the stair

tower and the one at the N is not easily seen. I'm worried that there might be some open joints to it.

**Recommendation:** obtain steeplejack debrief on their repairs to understand future repair needs better.

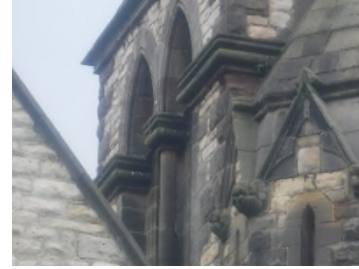
- **Clock Stage:**

Seems ok there doesn't seem to be any cracking to it, the clock dial polycarbonate is yellowing a bit now.

**Recommendation:** none

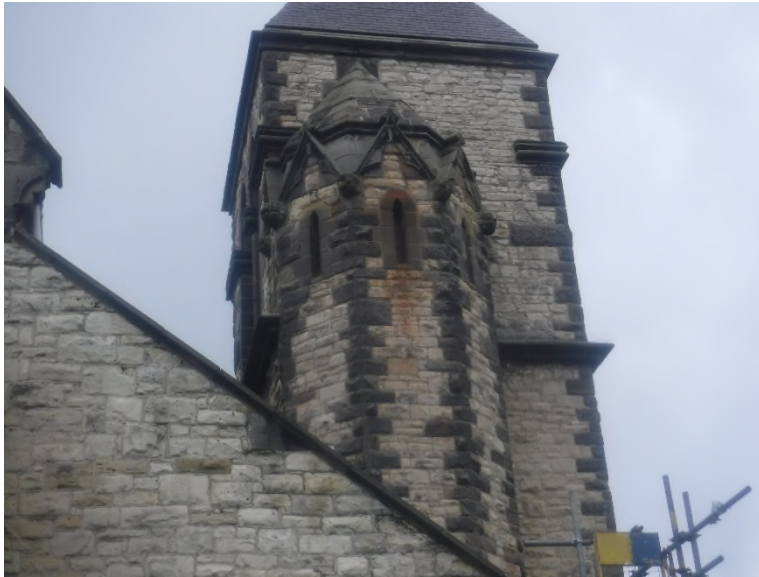
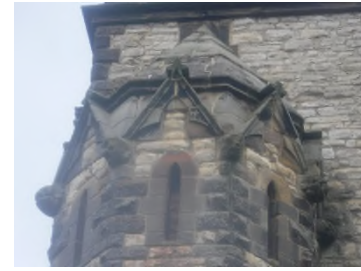
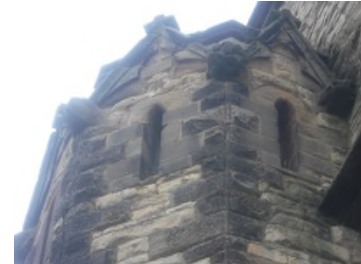
### Stair Tower:

There is daylight visible inside, so the roof must need repointing (that was part of the steeplejack work to do), there is some hairline cracking to the facets, it is as we have seen before. The glass that has chicken wire in it- the obscure glass- is rusting, there is some rust staining as well. No pigeons about which is good.

**Recommendation:** repoint roof

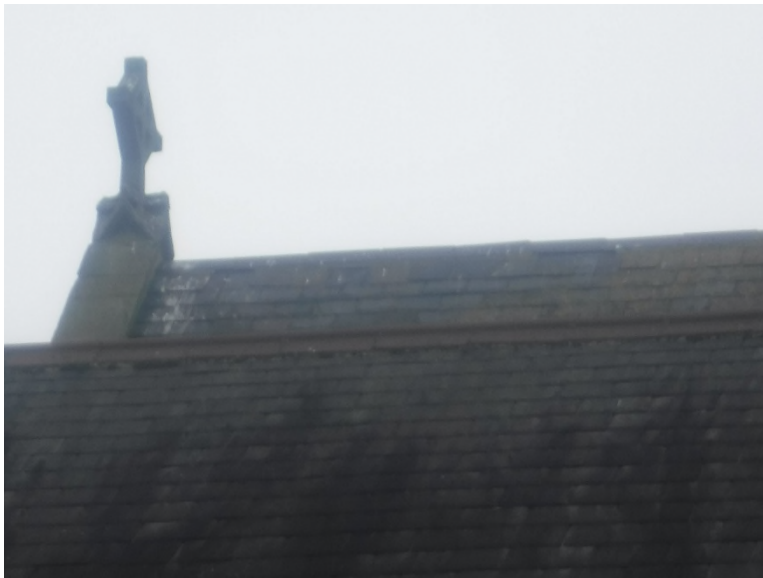
The tower hipped roof has seen multiple repairs and there are missing tiles on this as there are around the main roof, and the question is how do you go about maintain this tower because the hip slates are coming away? By steeplejack? or do you go even further and take the top off and turn it into a flat roof to reduce maintenance?.

During the inspection the S aisle box gutter to the back of the tower was being repaired.

**Recommendation:** consider phased plan of roof covering replacement

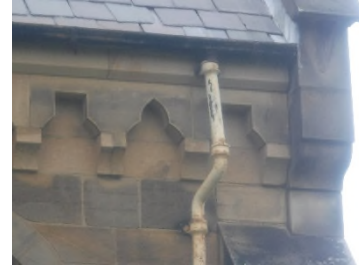
**chancel:** metal rust

**Recommendation:** replace plastic rainwater goods and repair existing cast iron

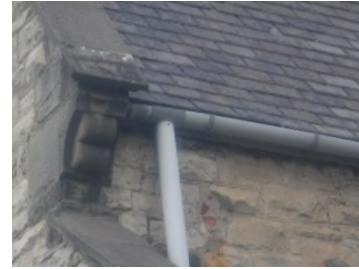
**Nave:** plastic

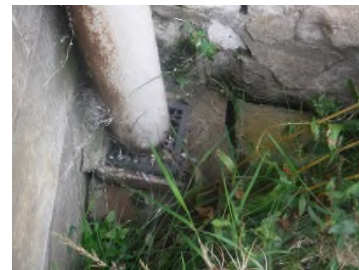
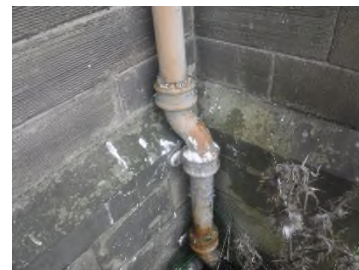
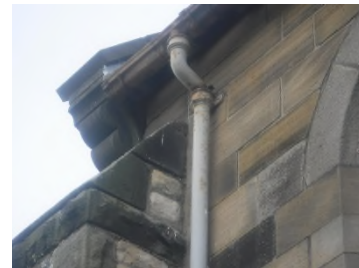
**Transept:?** broken gully surrounds

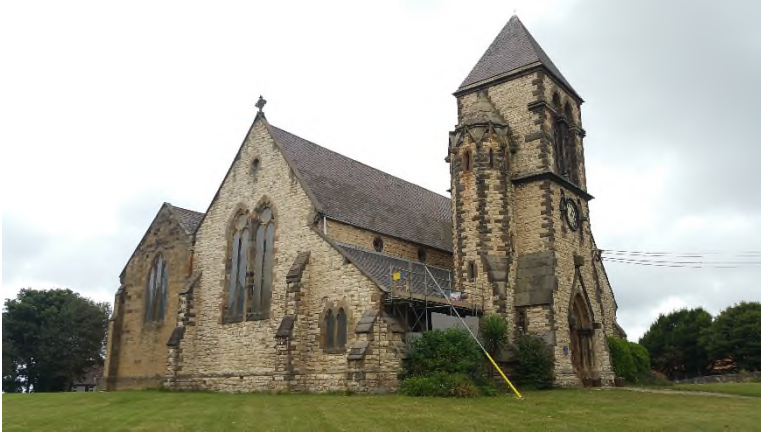
- **South Aisle:**

Mostly covered with scaffold during inspection, buttress has some open joints and Ivy growing in it. On the W side a little bit of cracking by the kneeler. The watertables are replacements in concrete.

**Recommendation:** point up open joints as noted below

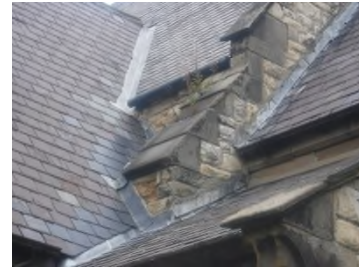
- Nave: small triangle of masonry at gable. Has a plant that needs removing.

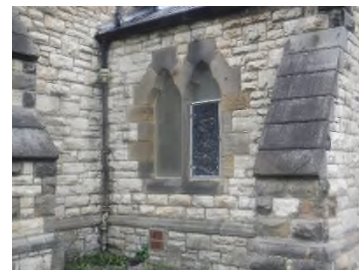
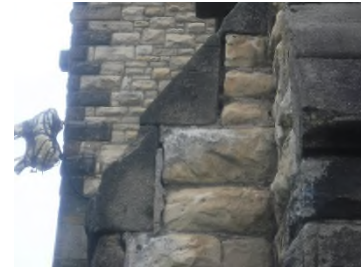
**B Organ:**

**East** – Original stone watertable eroding, some of the joints in the walling are opening up particularly at the built-in mid stage kneeler, rather heavy handed cement pointed to the cill of the two light lancet window has some retrofitted air grates both above and below the plinth line.

**South** – Some open joints to the wall. Principal feature is terrible aluminium wood boarded window with a broken catch it is an invitation for intruders.

**Recommendation:** make organ window secure

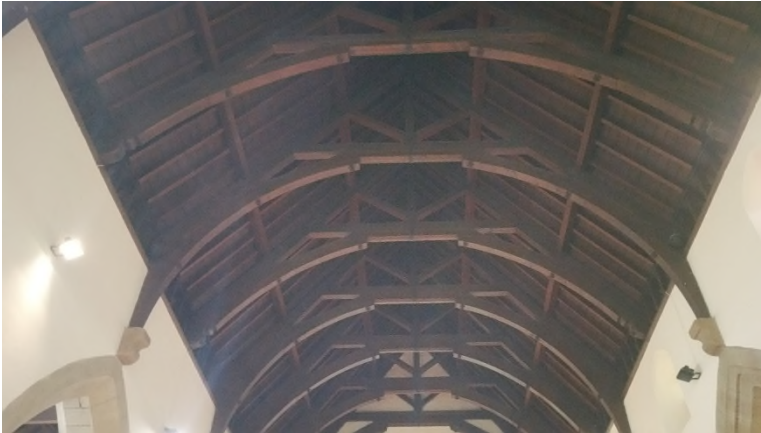
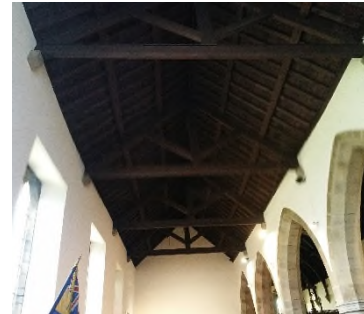
### 7.5.1 ROOF TIMBERS

- Open ceilings throughout and the nave has five principle trusses and secondary trusses within them which is supporting purlins and rafters and sarking boarding all of that looks ok. Both of the aisles are of the same design and principle.

**Recommendation:** none

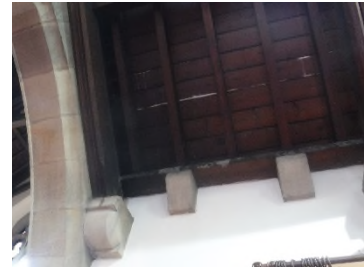
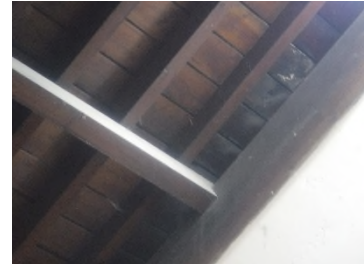
### 7.5.2 CEILINGS

- Open boarded ceilings throughout with some slight marking of timbers to the S aisle over the entrance porch. The back rooms have suspended ceilings and the clergy vestry suspended ceiling metal frame is rusting probably due to a roof leak.

**Recommendation:** none

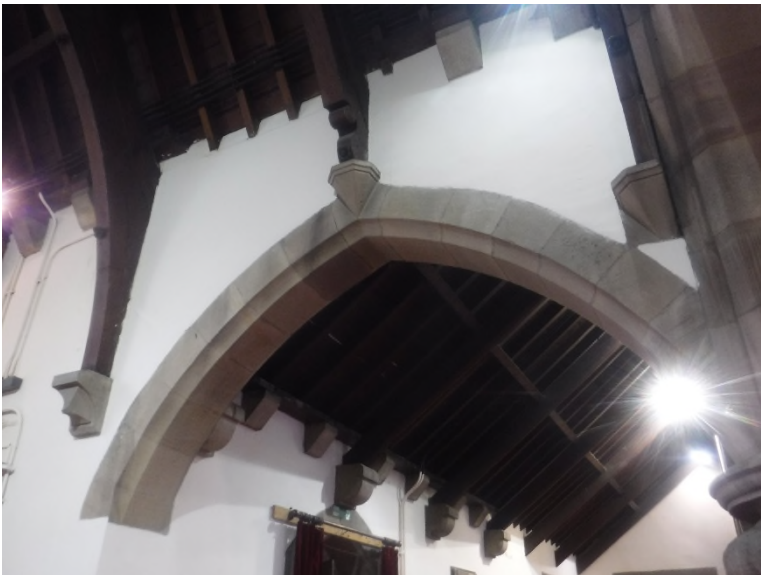
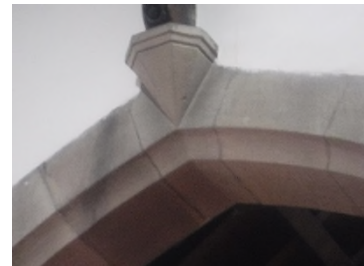
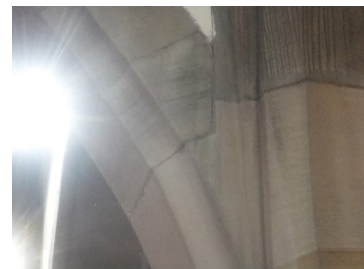
- **Chancel Arch:**

Lofty pointed arch with quite a few cobwebs on which make you think if might be cracking but there only seems to be one possible one which is just down from the apex on the nave side and this has been repointed in the past I think it is just settlement otherwise I think the arch is fine. The chancel arch stops on twin supports and that then leads down to a chamfered base and there is some erosion to that.

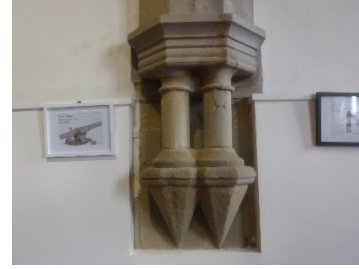
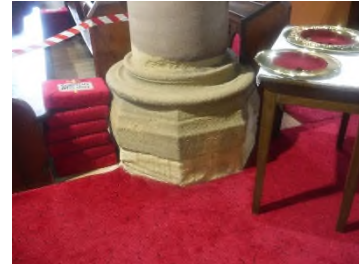
Cross arch, slight crack as it supports the truss but that is looking ok.

**Recommendation:** none

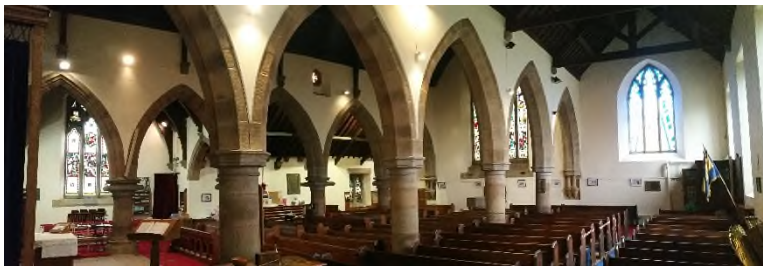
**Arcades:**

All of the arcades are good, they sit on massive bases on the S side and whilst there is some stone erosion through damp they are all sound. Bases are not so big on the N side, they are eroding but they are alright. Couple of repairs in black pointing in the past, arch to choir vestry is ok.

**Recommendation:** none

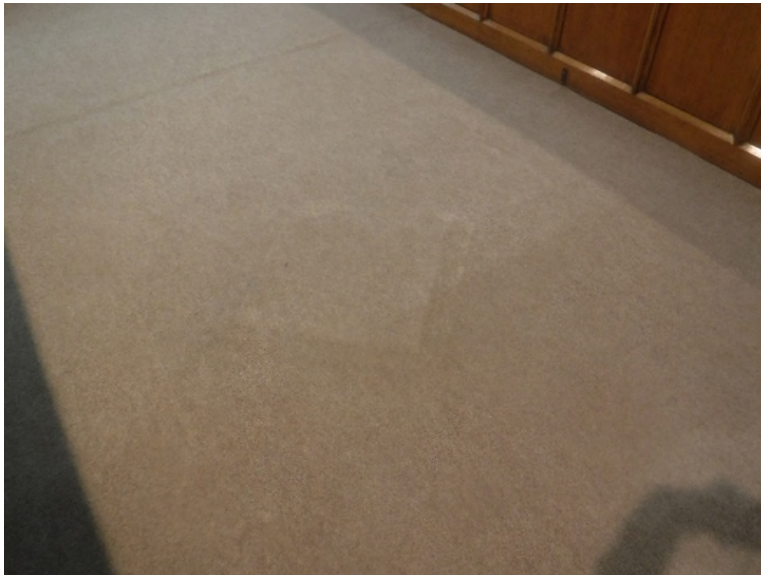
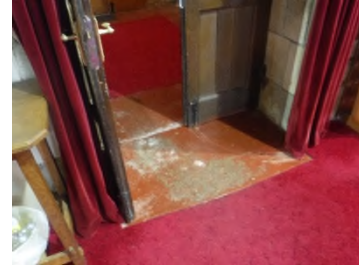
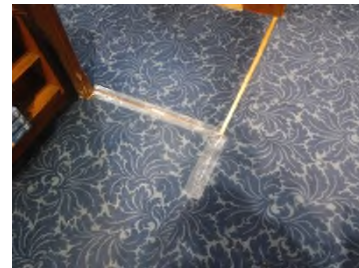
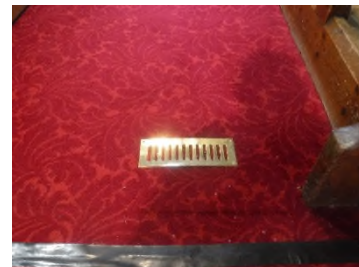
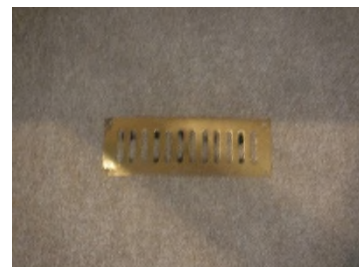
## 7.5.5 FLOORS

**B** It appears to be suspended timber throughout, level pew platforms, carpet in the circulation areas that's covered heating floor grilles which has left some undulations. Carpet is taped down at some points and that is wearing away. Chancel is ok, slight trip hazard at the archway into the sanctuary. Sanctuary marble flooring a bit stained but ok.

**Recommendation:** fix down loose carpet

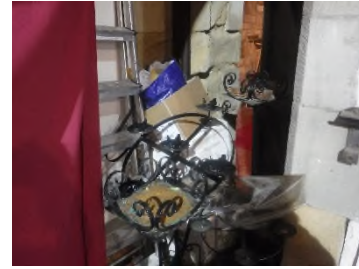
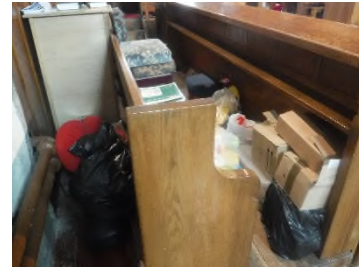
**D**      **Partitions:** None. There are hidy places around the tower that collect lumber, that should be cleared out

**Recommendation:** remove lumber

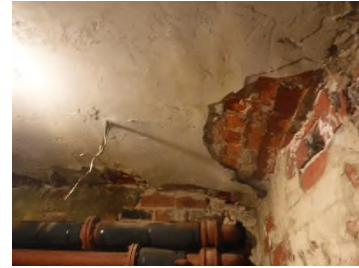
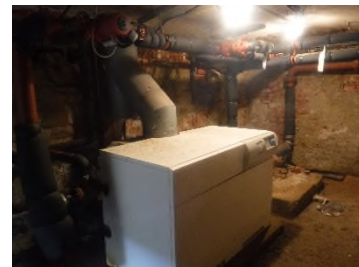
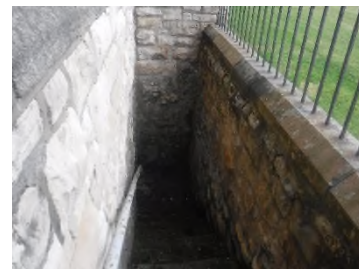
**Ceiling** – curved brickwork barrel vault, bit of erosion to the masonry brickwork which has been covered with remedial render which is failing.

The room contains the Ideal Concorde CXSI boiler and all the controls, the pipe work looks recent really. Room has a 9kg powder fire extinguisher. Metal door catching in the frame slightly, the bottom of the stair is covered in leaves, the steps are a little bit mossy and the handrails rusting. Wall enclosure is fair.

**Recommendation:** repair door and balustrade, sweep up.

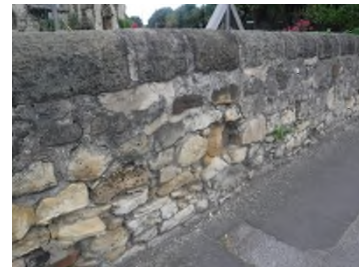
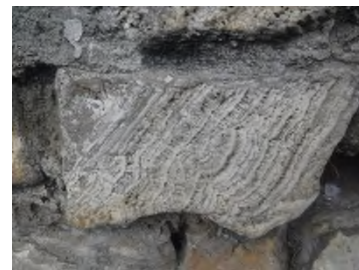
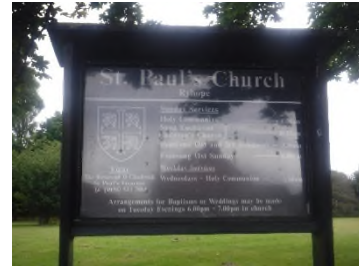
Whole of the site is grassed apart from the circulation which is modern concrete pavers and an area of gravel getting a bit mossy by the entrance porch now. The road side of this wall needs repointing (it is a fine example of concretionary limestone walling).

Signboard: timber decoration breaking down

**Recommendation:** repoint south boundary wall, repair broken memorials, repaint sign board
