# CHURCH OF ST CUTHBERT, SATLEY

## QUINQUENNIAL INSPECTION REPORT 2018

**Date of inspection:** 22.01.18

**Ref:** 17020

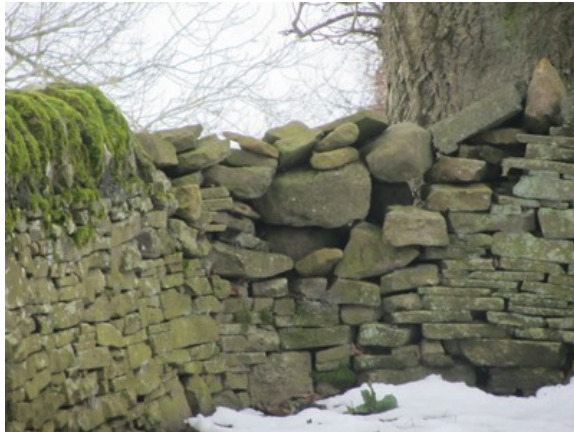
**Walls** The churchyard boundary walls are generally constructed in dry stone walling with the exception of the east boundary adjacent to the Hall which is bedded and pointed in mortar. Generally the walls are solidly constructed and in a good state of repair. However the stone work on the north west corner of the new churchyard is poorly constructed. Localised reconstruction is recommended. D

Wall to NW corner of churchyard (12.3)

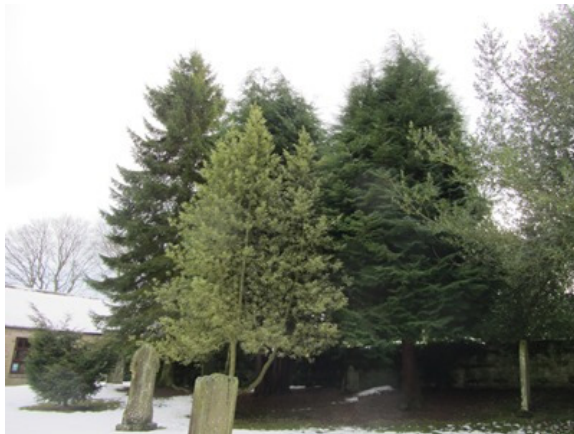
Concerns have been raised by a neighbour about the height of the pine trees to the south of the churchyard. While they are in good condition these trees which may also limit daylight into the adjacent Hall as well the plot to the south. The PCC are advised to check whether these trees are subject to a tree preservation order, consult with the DAC and obtain a Faculty before any are removed. E

Pine trees to south boundary (12.4)

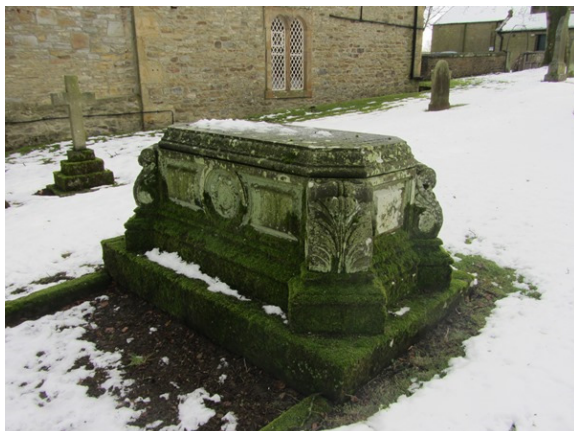
**Tombs** The Greenwell tomb to the north east side of the Vestry appears to be in a stable condition but removal of moss is recommended. M

The Greenwell tomb (12.5)

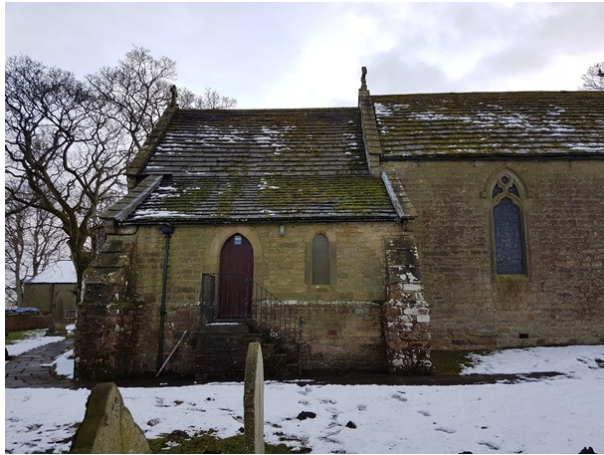
<b>Priority Ref. See 13.0</b>
<b>Ridges</b>	Some of the Nave ridges have open perpend joints which require re-pointing to prevent water ingress.	B
<b>Slates</b>	<u>Nave</u> : There is a slipped slate on the south slope and a slipped slate on the north slope.	B
	<u>Chancel</u> : there appears to be a slipped slate on the north slope.	B
	<u>Vestry</u> : A water leak to the plaster of the Vestry indicates a slipped slate or other problem. This isn't visible from the ground and requires investigation.	B
	<u>Generally</u> : the slates are covered with moss which should be removed to reduce the weight resulting from the retention of water.	B
	From the maintenance records there are ongoing problems with the stone slates slipping. This would indicate that the oak pegs (or bone fixings) are failing. Consideration should be given to a programme of re-slating should the slate fixings continue to fail. Grants may be available to cover the cost.	E

Moss on roofs/ slipped slates (6.1)

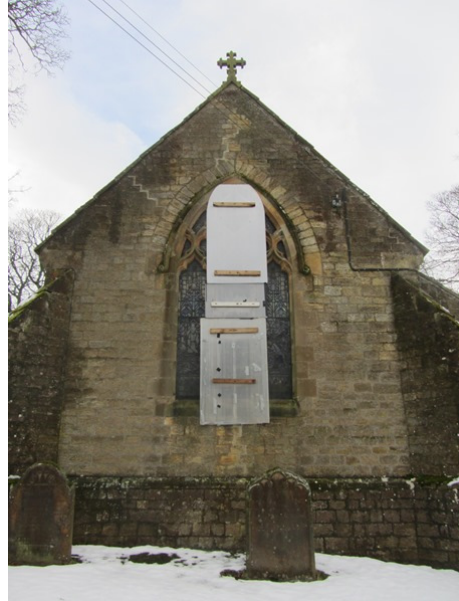
Chancel east gable: the water tabling has large gaps between the stones and the bedding is cracked allowing water ingress through the wall heads. It is recommended that the water tabling be lifted, the old mortar removed and the water tabling then re-bedded and re-pointed.

Chancel east gable: There has been historic movement if the east gable wall where the wall has settled to the north and south creating stepped diagonal cracks above the arched lintel to the east window and a crack from cill running down to the ground. These cracks have been filled and re-filled over the years and there is still some movement with hairline cracks in the filled joints. This should be monitored.

The movements in the east gable wall described in 6.6 have resulted in the leadwork pulling away from the glass in the middle window and central upper tracery. The stained glass has been removed for conservation.

Chancel east gable (6.6 and 6.7)

The tracery has some open joints internally. It is recommended that all the joints in the tracery are raked out and re-pointed in lime mortar.

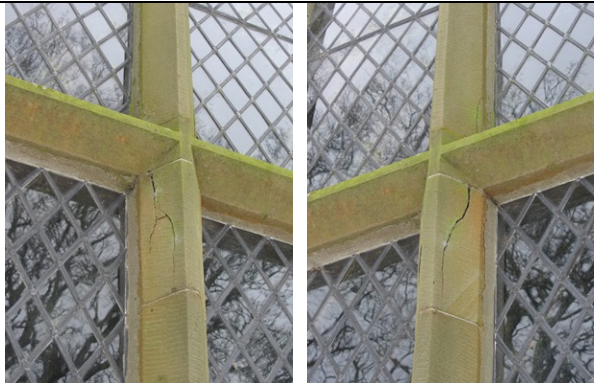
The mullion sections above and below the transom are cracked. This is thought to be due to the rusting and expansion of the iron reinforcement. The affected sections will need to be cut out (back to the glass line) along with the rusting ironwork; new stone indents will then need to be inserted using stainless steel fixings. *NB It is important that this work is carried out by an experienced conservation stonemason under the direction of the architect and following his drawings and specifications.*

Nave north window n(v) – cracks to mullions (6.7)

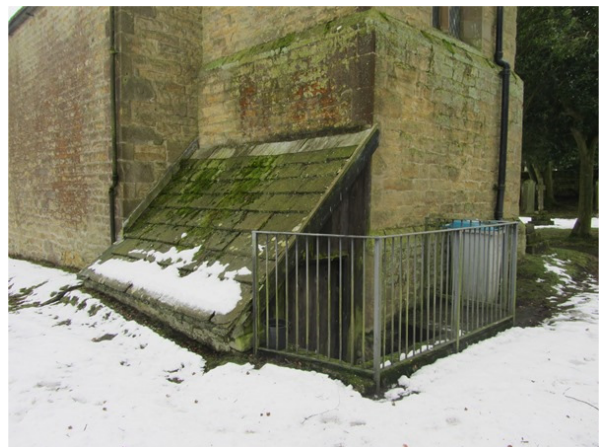
<u>Boiler House</u> : the roof would benefit from a gutter to prevent water ingress to the walls adjacent. This could discharge into the gulley recommended for the Nave north wall downpipe.	B

**Boiler House:** The softwood battened and boarded door is adequate. It is recommended that the door be sanded down and stained along with the softwood cladding to the west gable wall during the quinquennium.

**Fences** The metal fence and gate around the Boiler House are in fair structural condition but the paintwork is chipped and flaking in places. Rubbing down and re-decoration are recommended. D

Boiler House (6.2, 6.8 and 12.3)

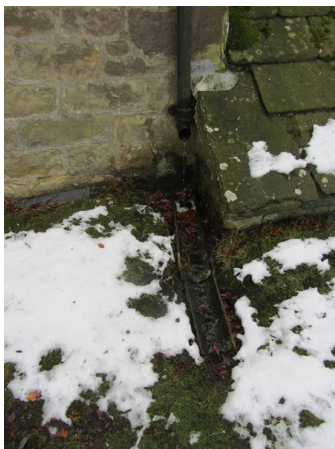
Drainage by Nave north downpipe (6.2)

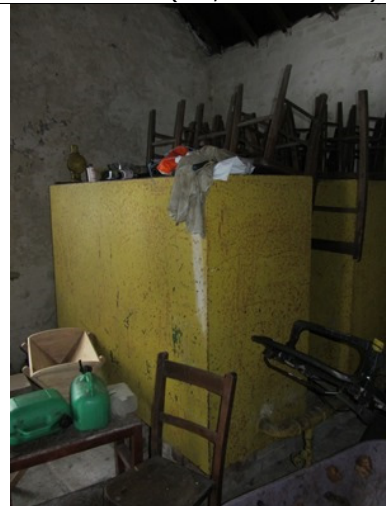
The oil tanks in the outhouse are single skinned and rusting thus posing a risk of leakage and pollution. Oil pollution can carry heavy fines. It is recommended that the old tanks are replaced with a double skinned tank complying with current regulations. The oil line in the Boiler House is rusty and should be replaced. The boiler is over 17 years and while working satisfactorily should be considered to be reaching the end of its expected service life. The PCC are advised to budget for its inevitable replacement.

Two oil tanks are located in an outhouse on the south west corner of the churchyard and the oil line runs underground from there to the Boiler House. The oil tanks are somewhat old and rusty and they are single skinned with no bund wall. The tanks are therefore considered at risk of oil leakage and pollution. Heavy fines can be imposed for pollution from oil tanks and the PCC may not be insured against this risk. The PCC should consider replacement with a double skinned tank complying with current regulations and the oil line from the outhouse to the Boiler House checked and replaced if necessary. D

Rusty oil tanks (8.1)
