CHURCH OF ST CUTHBERT, SATLEY

QUINQUENNIAL INSPECTION REPORT 2023

Christopher J Blackburn BA BArch (Hons) RIBA SCA EASA
Director/ Specialist conservation architect

Date of inspection: 19.01.23

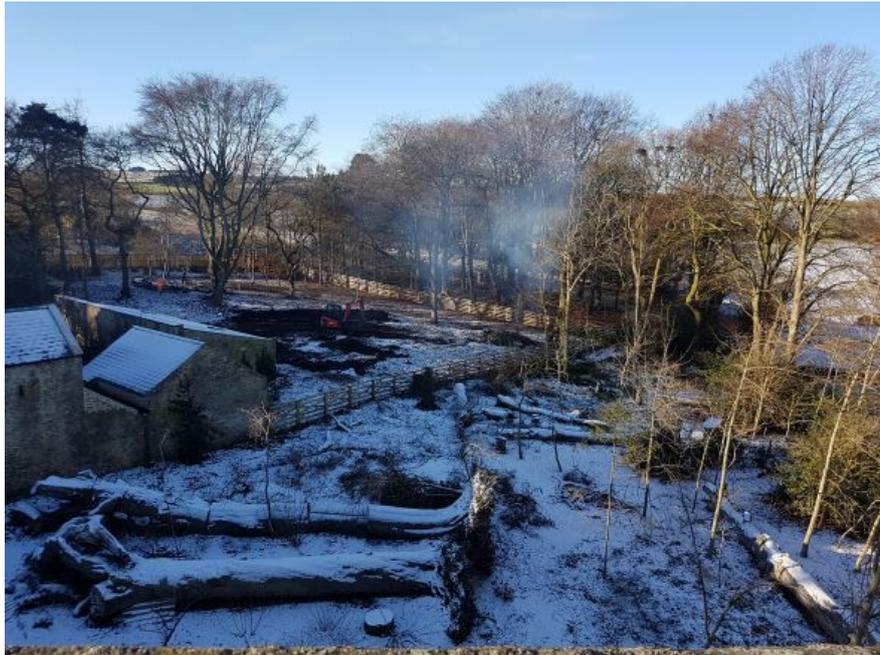
View from Tower showing fallen trees (12.4)

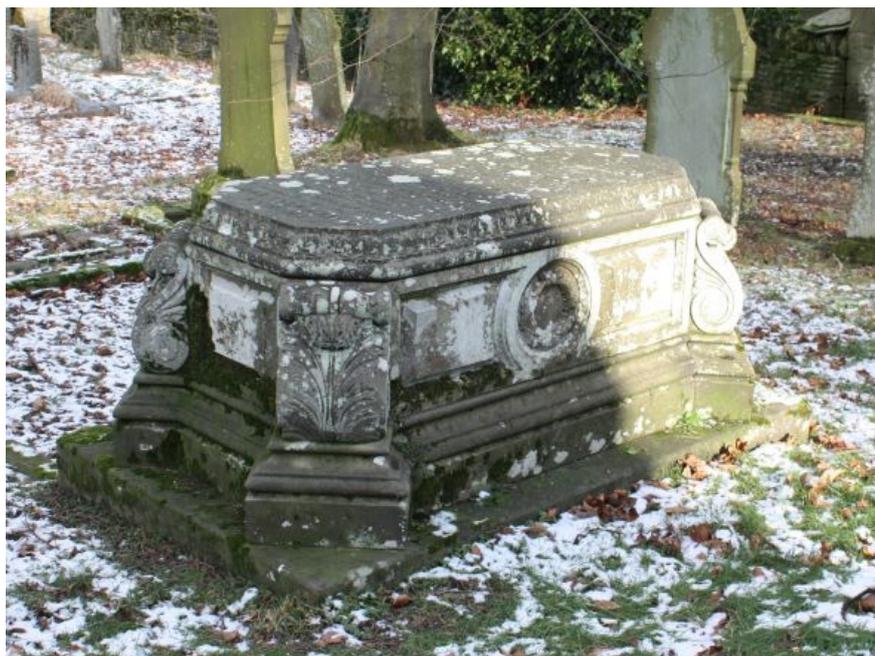
Tombs The grade II listed Greenwell tomb to the north east side of the Vestry was partially obscured by snow and the inspecting architect cannot state it is free from defect.

The Greenwell tomb (12.5)

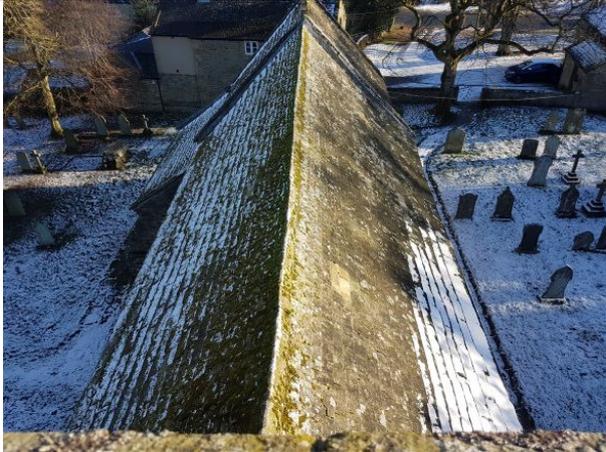
Priority Ref. See 13.0
Ridges	Ridges stones generally well bedded and pointed. However, two ridge stone on the Nave roof appear to have lost their bedding. Localised re-pointing is needed to prevent water ingress.	B
Slates	Stone slating generally fair condition. However, the north roof slopes have moss build up which should be removed to reduce the weight resulting from the retention of water.	D
Leadwork	The leadwork to the raking roof abutments to the Porch, Tower, Chancel east gable and Nave east gable all appear to be intact along with the Boiler house top flashing and raking roof abutment flashing.	
Verges	The verge pointing to the Nave west gable and Porch south gable are in good condition.

View of Nave and Chancel roofs from Tower

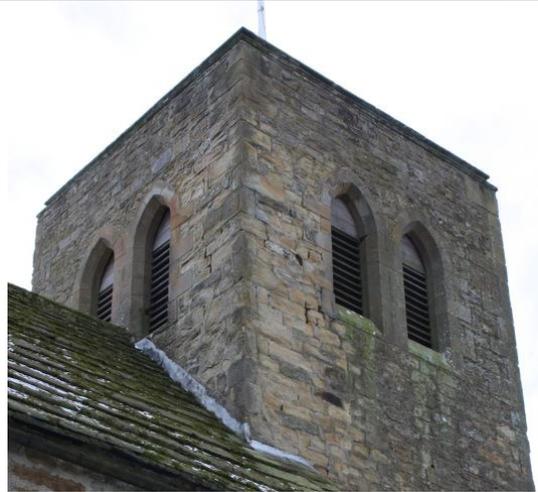
Tower – large open joints (6.6)

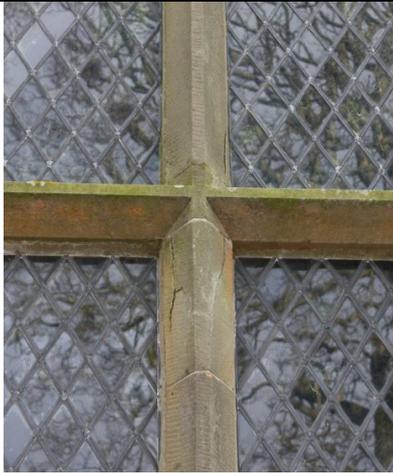
Nave window n(v)

As reported at the last inspection, the mullion sections above and below the transom are cracked. This is thought to be due to the rusting and expansion of the iron reinforcement. The affected sections will need to be cut out (back to the glass line) along with the rusting ironwork; new stone indents will then need to be inserted using stainless steel fixings. *NB It is important that this work is carried out by an experienced conservation stonemason.*

Nave north window n(v) – cracks to mullions (6.7)

D	Nave north window n(iv) – repoint open joint beneath hood mould (6.7)	50
D	Nave north window n(v) – masonry repairs (6.7)	3,500
D	Vestry door – redecoration (6.8)	75
D	Sand and stain Boiler House external door (6.8)	75
D	Tower cupboard door – redecorate (7.2)	50
D	Tower staircase walls – redecorate (7.3)	250
D	Replace & relocate rusty oil tanks with double skinned tank (8.1)	2,000
D	Fit sump pump to Boiler House (8.2)	250
D	Fit insulation to cold water tank and pipework in Vestry (8.3)	150
D	Fit handrails to pulpit and Boiler House steps for safety reasons (10.0)	400
D	Re-oil oak entrance gates (12.3)	75
D	Redecorate metal balustrade by Vestry door (12.3)	75
D	Removal of felled trees from churchyard (12.4)	?
D	Reduce length of holly tree branches (12.4)	?
E	Consider replacing grp glazing with leaded glazing to Vestry window n(iii) (6.7)	1,500
E	Consider replacing Gallery door & screen glass with toughened or laminated (7.2)	2,750

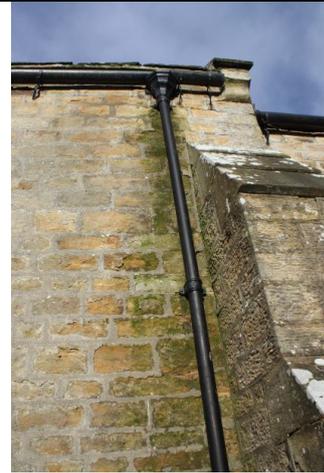
Gutters and downpipes	Generally, the cast iron gutters and downpipes are in good condition. However, there is some green staining adjacent the downpipe on the South side of the Nave. This indicates that the hopper is blocked and overflowing. The Vestry hopper has some twigs etc poking out of the top. The hoppers need cleaning out ASAP.	B
	The Porch has no rainwater goods and runoff discharges onto the ground adjacent the walls which has resulted in rising damp. It is recommended that rainwater goods taken to gullies and soakaways to prevent this.	C
	The Nave north downpipe discharges directly to the soil with an open channel. Consider replacing this with a gulley and soakaway.	C
	It is recommended that the gutters and downpipes are cleared of all blockages and checked for leaks bi-annually. The downpipe joints should be checked and re-caulked if required.	M
	It is further recommended that the gutters and downpipes are redecorated every five years.	M

Wall staining from leaking Nave south hopper (6.2)

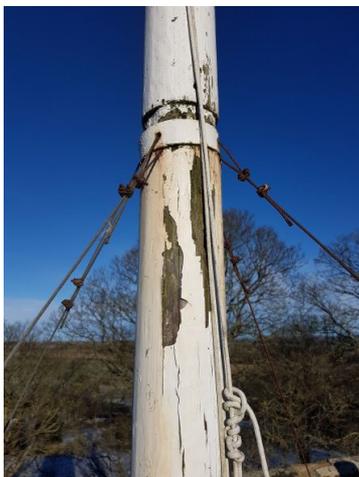
The concrete roof structure provides a robust construction. The asphalt finish to the roof and upstand walls has been coated with a paint finish and is in good condition.	
	The concrete flagpole base is in good condition but the paint is flaking on the timber flagpole and some of the tie wires are starting to rust. It is recommended that the flagpole is redecorated and the wire ties are monitored.	C

Flaking paint to flagpole (6.3)

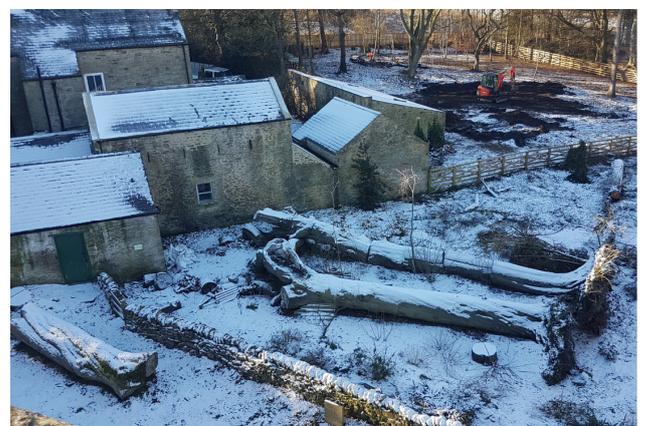
Trees felled by Storm Arwen (12.4)
