# **ALL SAINTS    SOUTH SHIELDS**

**Boldon Lane West Harton  
(111)**

## **QUINQUENNIAL REPORT**

**25 July 2025**

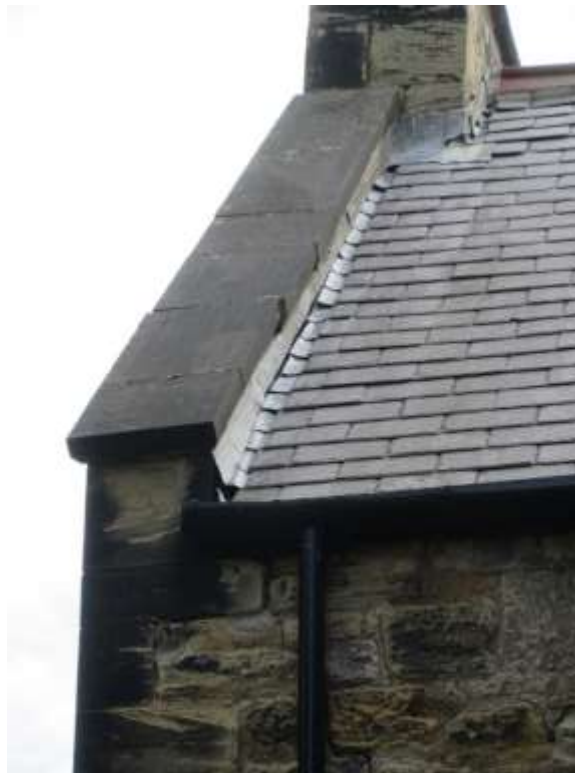
W side of Organ Chamber – lead flashings pulled apart show the gable has moved away from the slate roof

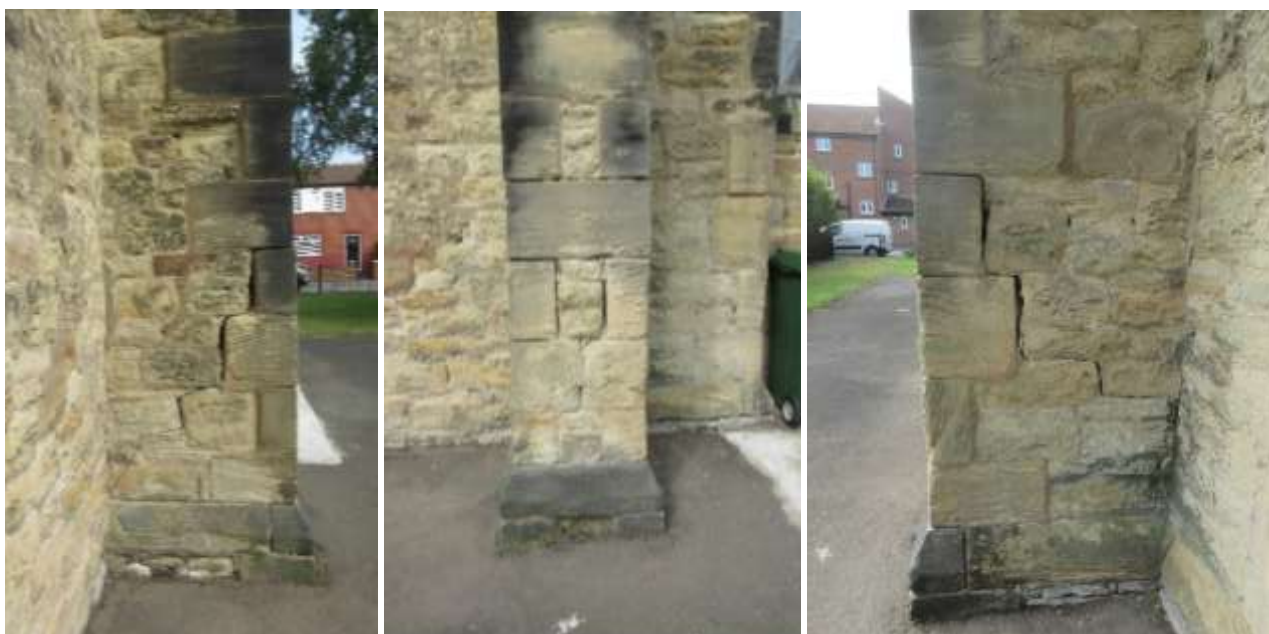
NE buttress

A much wider crack in joints and stones through the bottom of the N buttress, caused by past local subsidence, may be slightly wider. It should be grouted and pointed in lime mortar

a) to show clearly in future whether movement continues and b) to keep out weather which may be widening the cracks by very slow decay of the exposed internal surfaces.

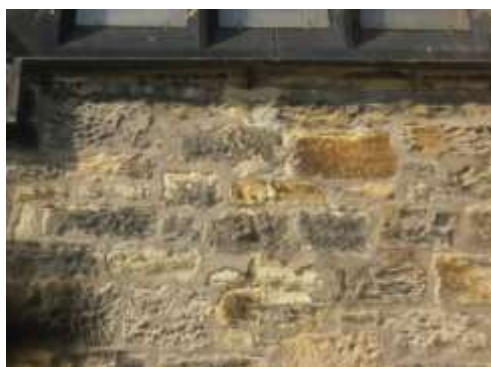
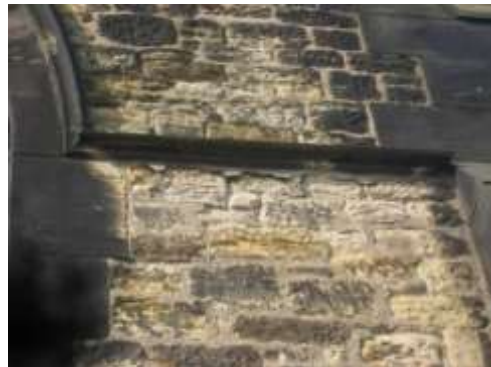
stone decay next to over-hard pointing under the E window and under the string course near the N buttress

A skilled mason should rake and point the whole gable, buttresses, parts of the window tracery and Vestry E wall in low strength lime mortar to protect the stone and reveal any future movement.

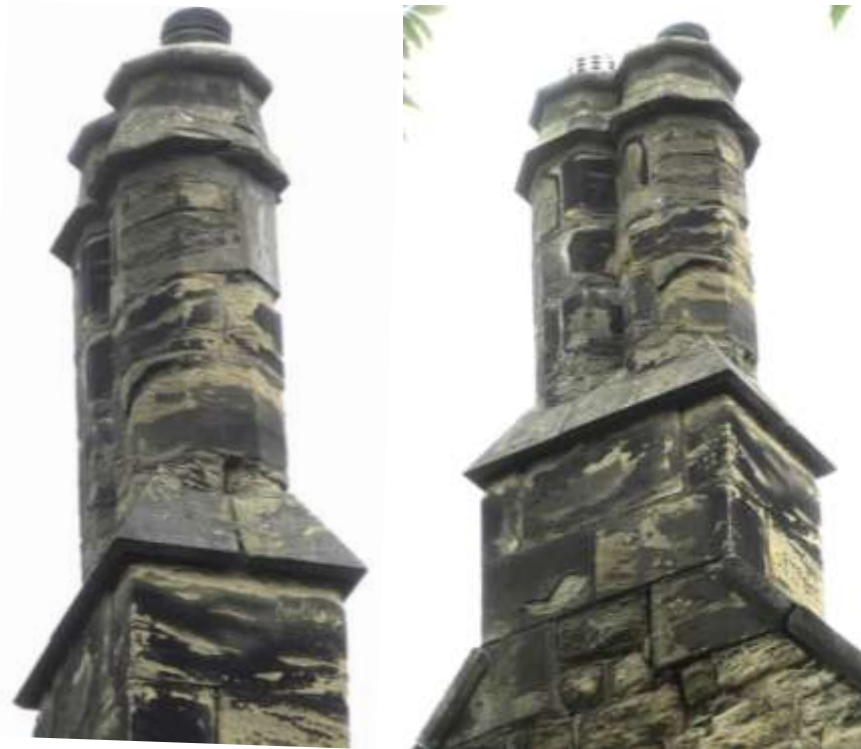
From NW – two N flue stones decaying and hole and open joint between sloped cap on base

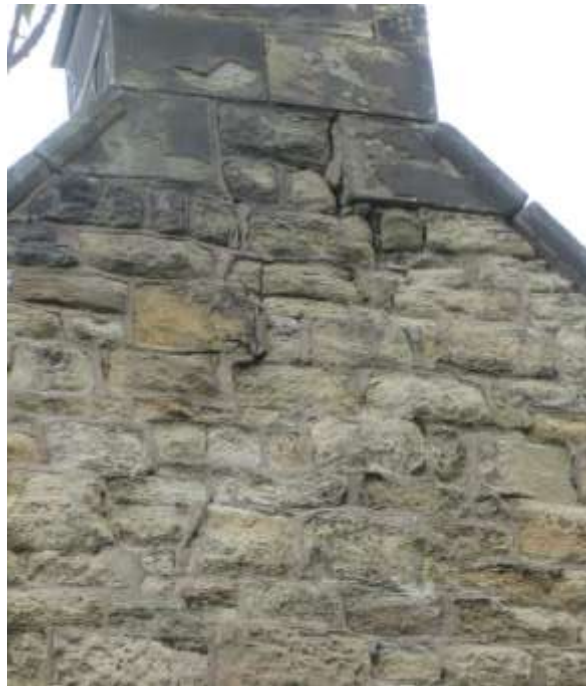
36. Under the chimney a patch of deeply weathered open joints and decayed stones in the top of the gable are beyond repointing and need stone replacements to keep out the weather and the chimney stable.
37. Organ gable watertable joints open (one with fern growing) and one watertable out of alignment, perhaps due to the movement. General walling fair but some open joints especially at the old diagonal structural crack full height of the gable. Pointing the watertables and open joints would slow decay and show any further movement.

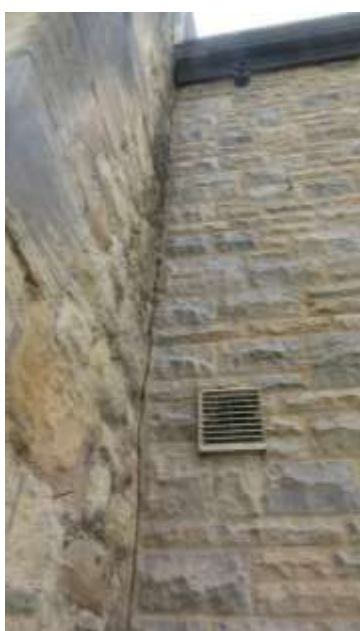
Cracked joint at N side

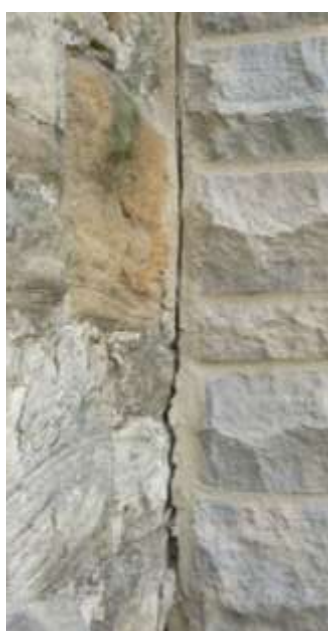
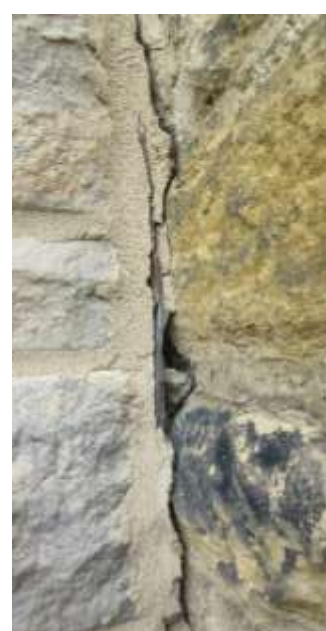
Cracked joint at S side

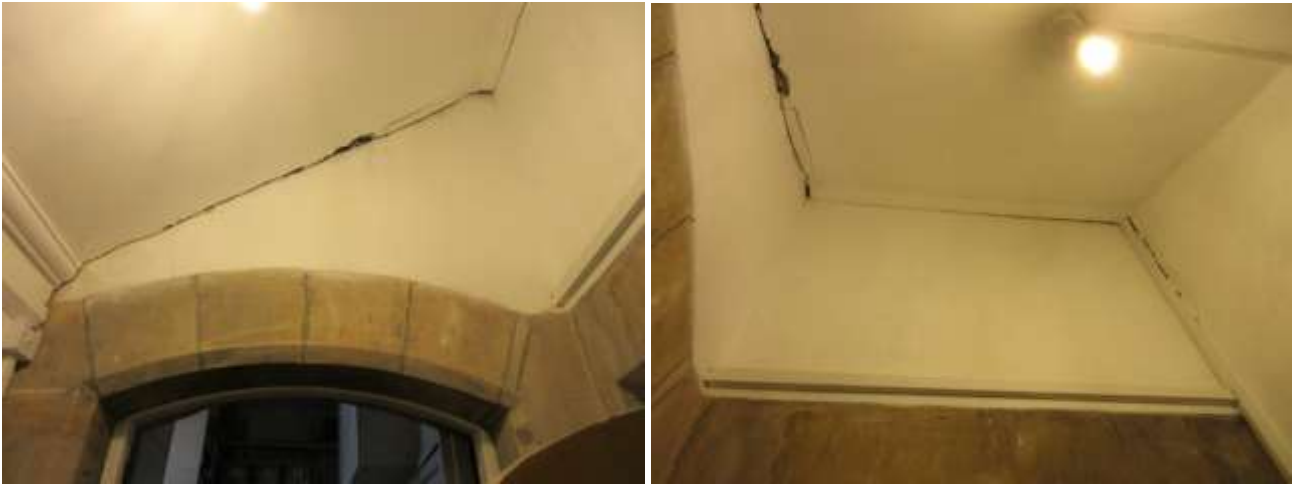
Cracked plaster at all sides of the N Porch

Decide plan for a rebuild of the small N Porch	11, 39, 47, 56
Scaffold turret and top of Nave W gable and repair turret, bell, loose flashing over extension roof and point Nave W gable, test Lightning Conductor and improve if necessary	32, 43, 44, 109

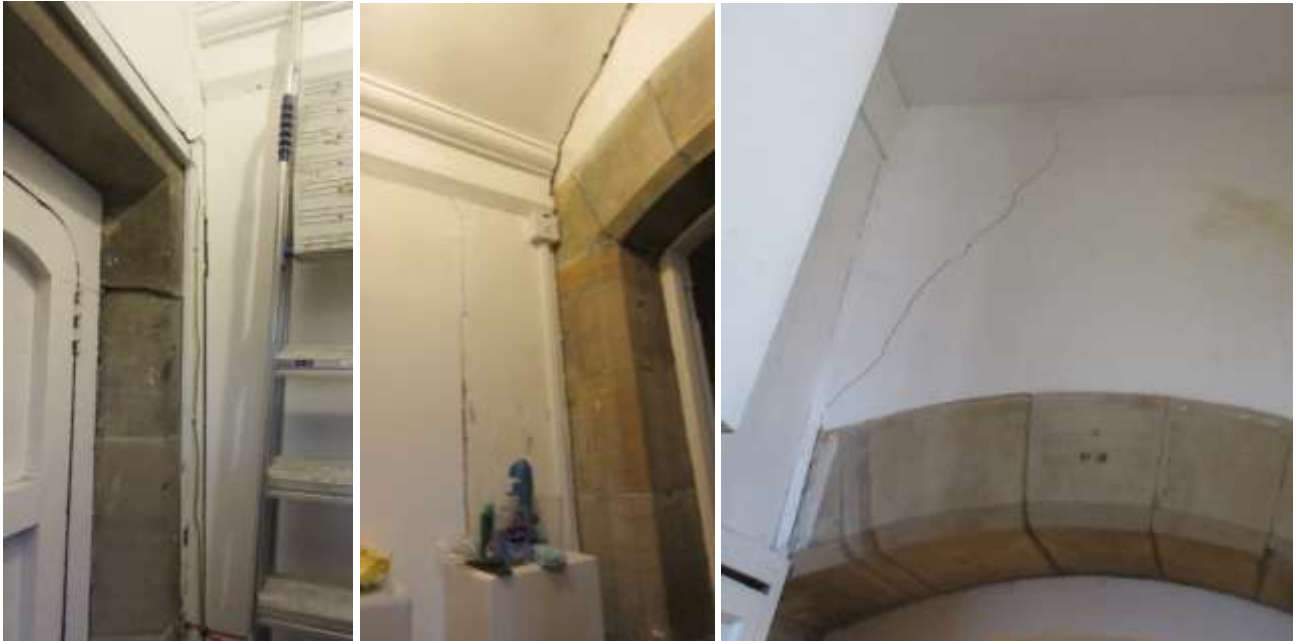
Hairline crack at Organ side of arch to N Porch (para 10)

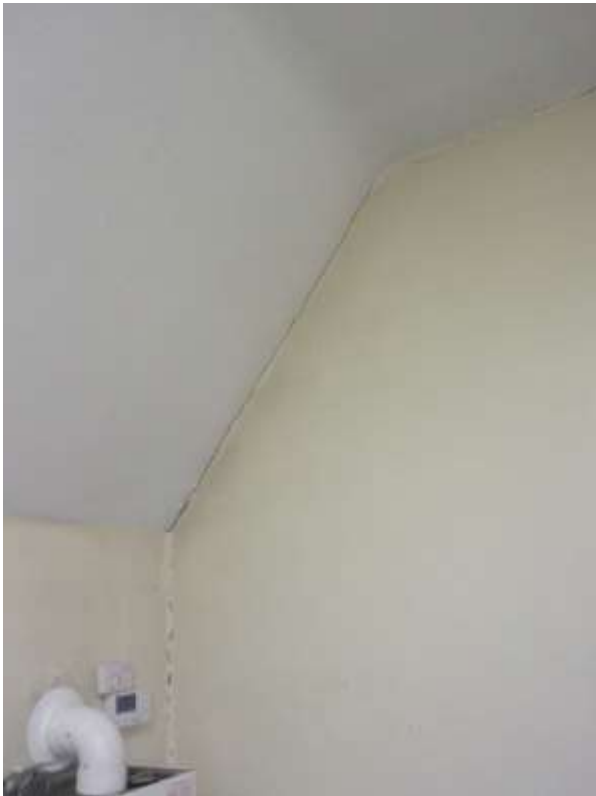
upper kitchen

72. The extension walls are painted plaster, sound except corners between walls and sloping ceilings are cracked where the extension meets the original building, another sign of movement between them. More visible at South side over the stair than in the upper Kitchen at the North side.

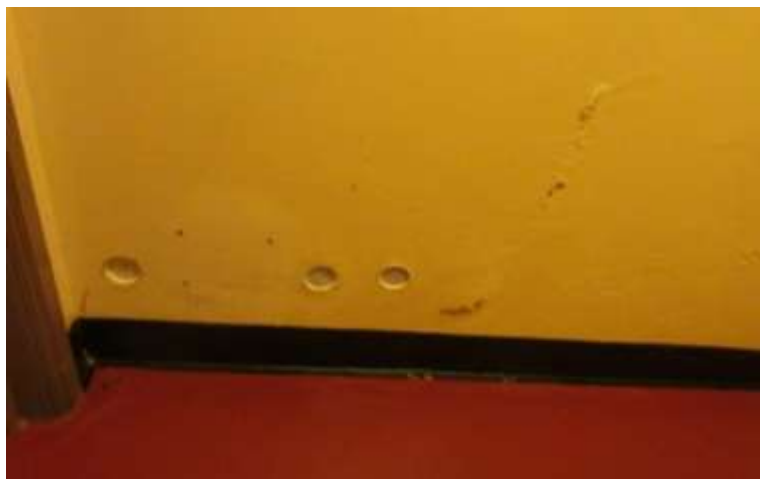
ladies lobby

73. At Kitchen, coffee bar and wcs vinyl sheet splashbacks over the worktops and basins.  
In Ladies lobby damage by rising damp at original W wall of Nave has been repaired with added plaster vents. Very minor paint damage is unchanged.
