**Quinquennial Inspection Report
The Church of St Michael and All Angels, South Westoe
Archdeaconry of Sunderland
Deanery of Jarrow
Diocese of Durham**

David Jowett - Architect, BA, DipArch, RIBA
25 Roseworth Avenue
Gosforth
Newcastle upon Tyne
NE3 1NB
Tel: 07788 710 204
email: david@davidjowett-architect.co.uk

17 September 2025

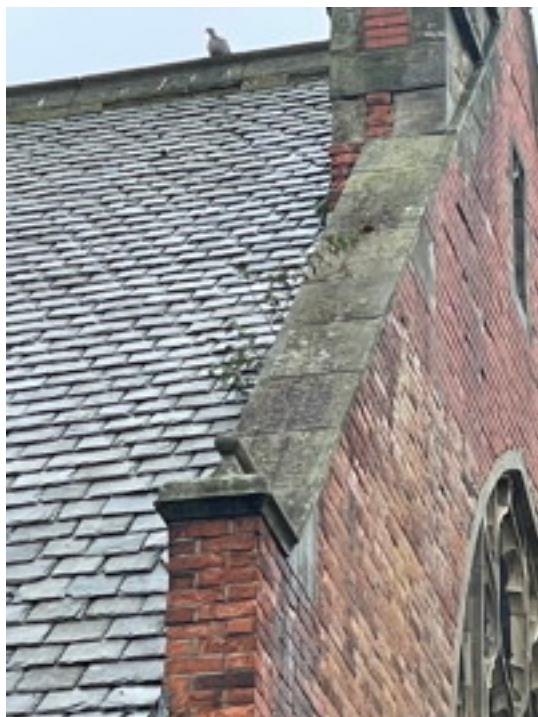
Overall the slating appears in reasonable condition, as are the flashings and most of the ridges. A few sections of ridge tiles have missing mortar pointing and require repointing. There was no access to view the flat roof areas and the heavy tree cover obscures several sections of the pitched roofs.

Missing Ridge Pointing

Category B, Requires attention within the next twelve months

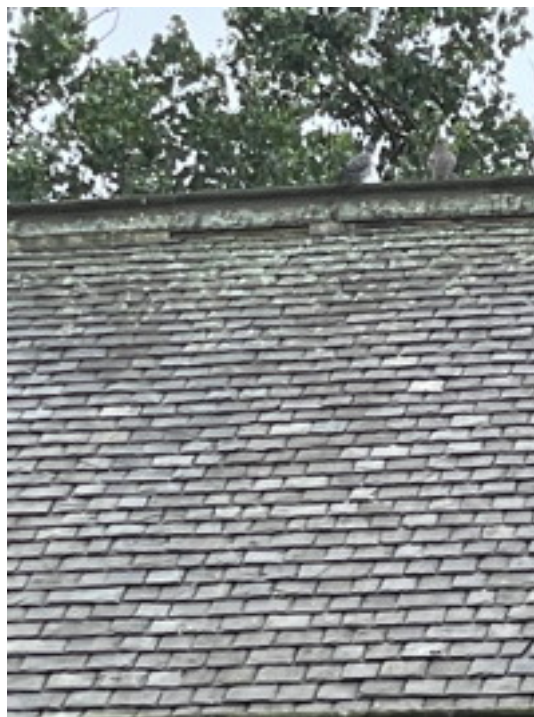
Missing Ridge Pointing

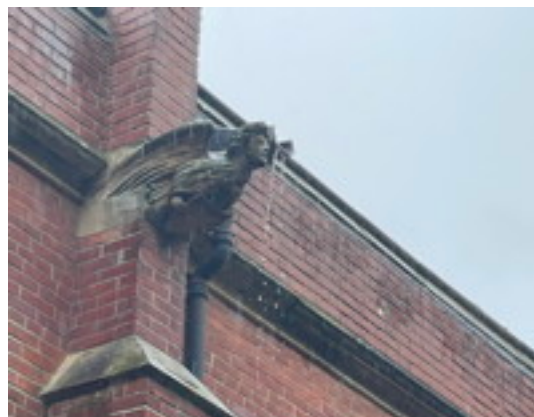
Everything appeared watertight at time of the inspection. One blocked parapet outlet to south elevation. All cast iron rainwater goods are in urgent need of decoration.

Blocked Parapet Outfall

Repair Needs, Category A, Urgent, requiring immediate attention

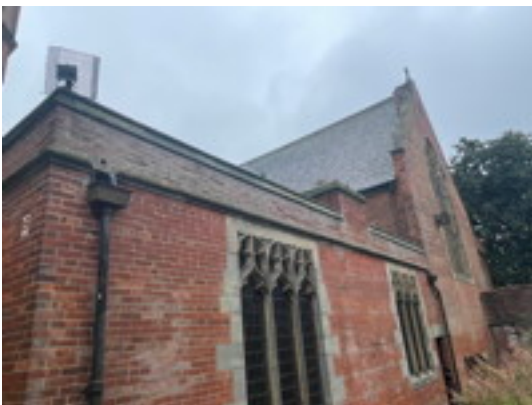
South East Corner Deteriorating Brickwork

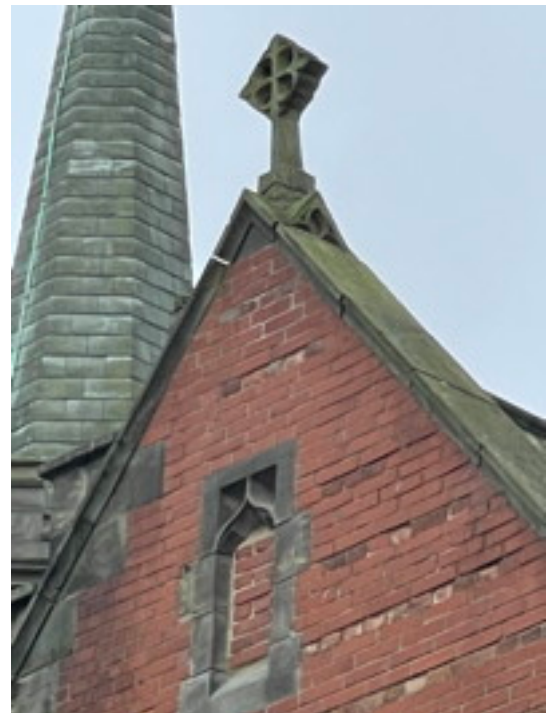
East End Finial Cross

Repair misaligned water tables to east end removing buddleia. Cost Band 2– £2,000.00-£9,999.

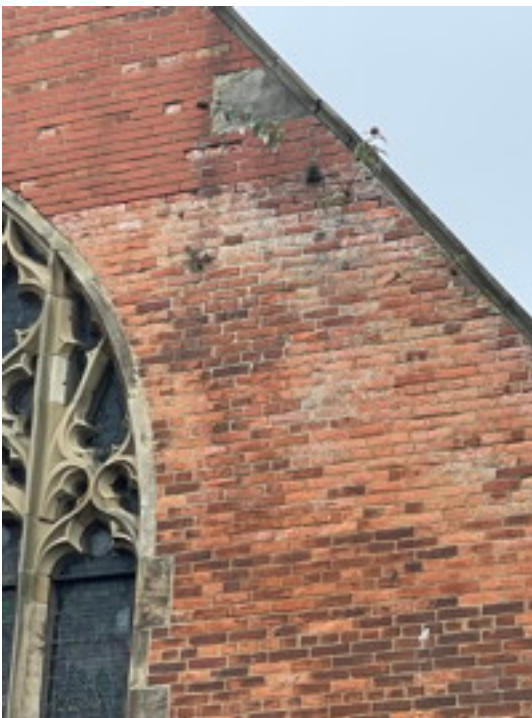
Brickwork repairs to all elevations with large areas beneath water tabling to east and west gables. Some stone repairs in both natural stone and mortar patching. Buddleia growing from east gable north side. Decaying brickwork most noticeable on east gable. Decaying stonework most noticeable on south gable lancet window, to base of stone arcade to west wall and to campanile doorway.

East End Gable

Arrange inspection with qualified stonemason to advise and report on necessary stone and brick repairs to slow decay and minimise replacement. Cost Band 1– £0.00-£1,999.

Monitor existing areas of stone and brickwork decay and any slightly open joints. Delaminating stones should be brushed down and washed with clean water as loose and friable stone holds water that can freeze in cold weather, accelerating the delamination. Cost Band 1– £0.00-£1,999.

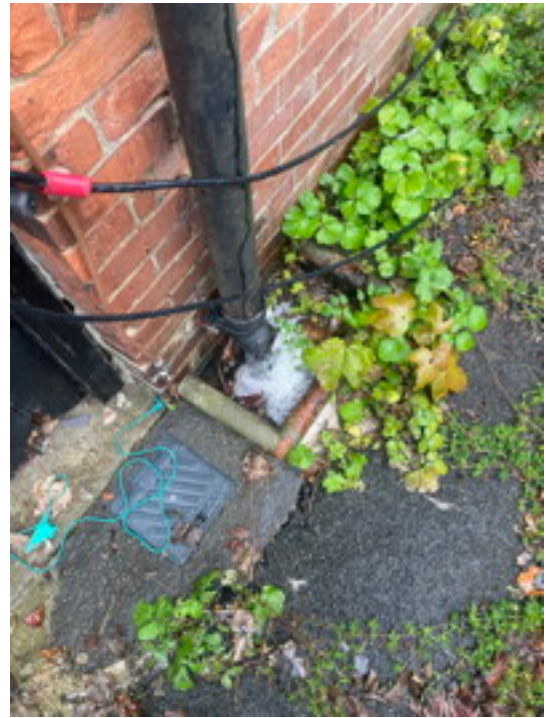
Boiler House Gully

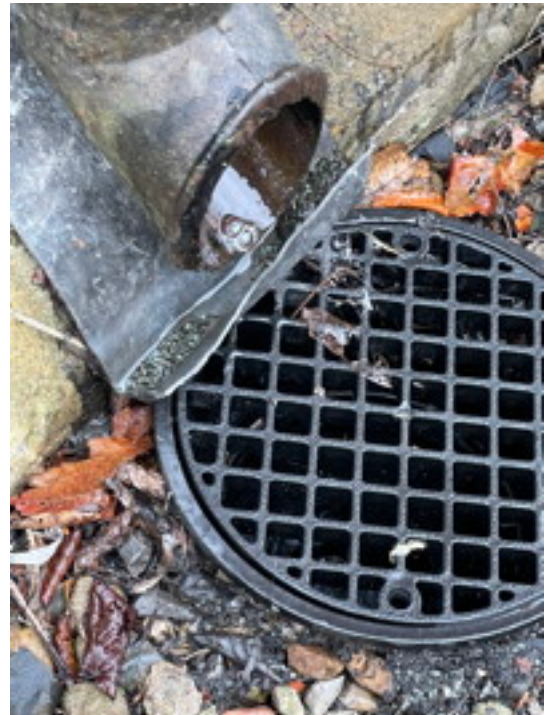
Turned up lead to South East Corner Gully

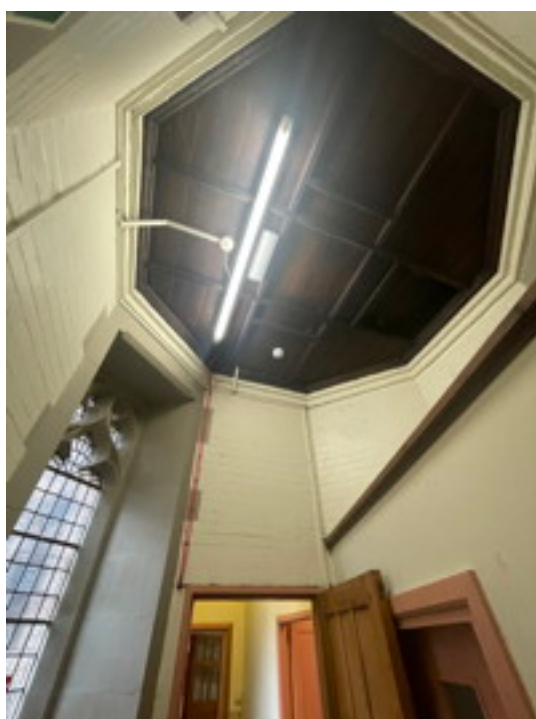
Level 1 accessed through a hatch above the Campanile WC roof. No guarding, and access unsafe so not inspected. Ceiling boarded with exposed paired beams/joists and perimeter bearers. Walls are an octagon of exposed brickwork. Timber boarding to floor. Bricked up door opening on north east wall. Cast iron internal rainwater pipe from above on north wall discharging to vestry roof gulley. Fixed ladder to level 2.

Campanile Access Hatch Above WC Ceiling

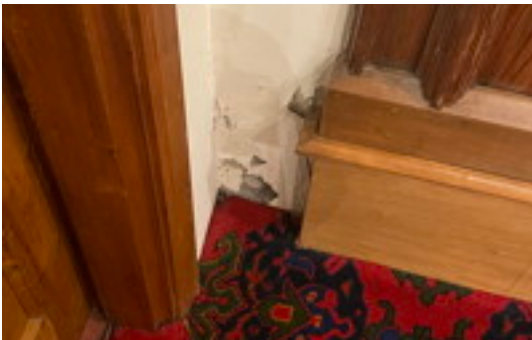
Slight damage by rising damp on south aisle south elevation east end. All others areas are satisfactory.

South Aisle Rising Damp

Repair needs, Category M, Routine Maintenance

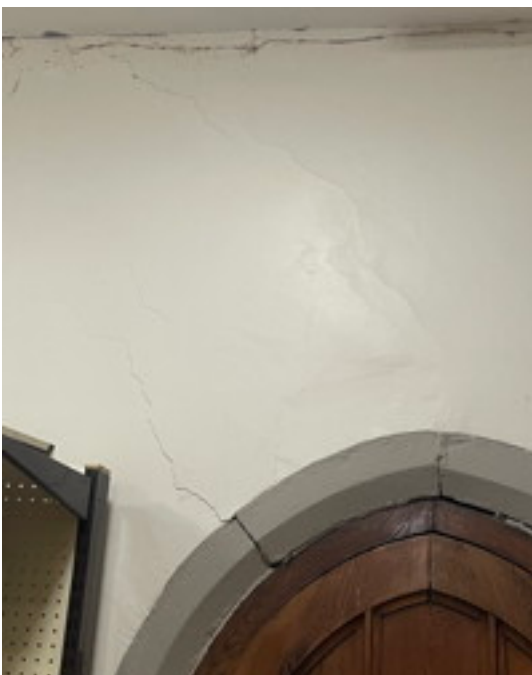
Cracking over the doorway to the South Porch

Monitor cracking to doorway. Cost Band 1– £0.00-£1,999.

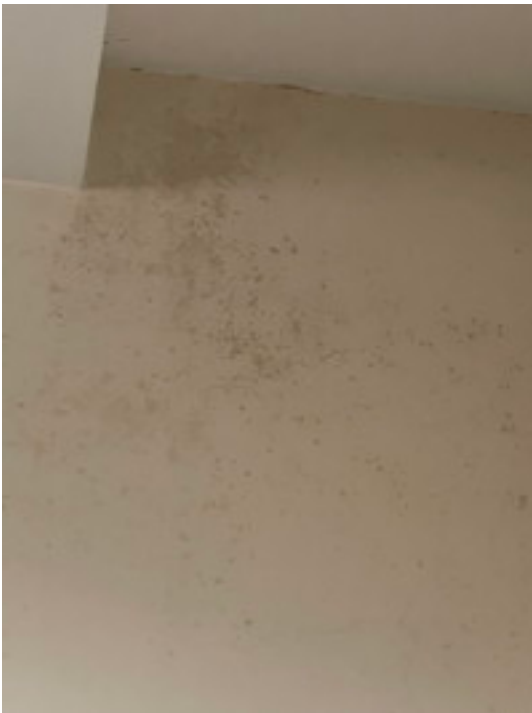
Church Office/Store High Level Mould

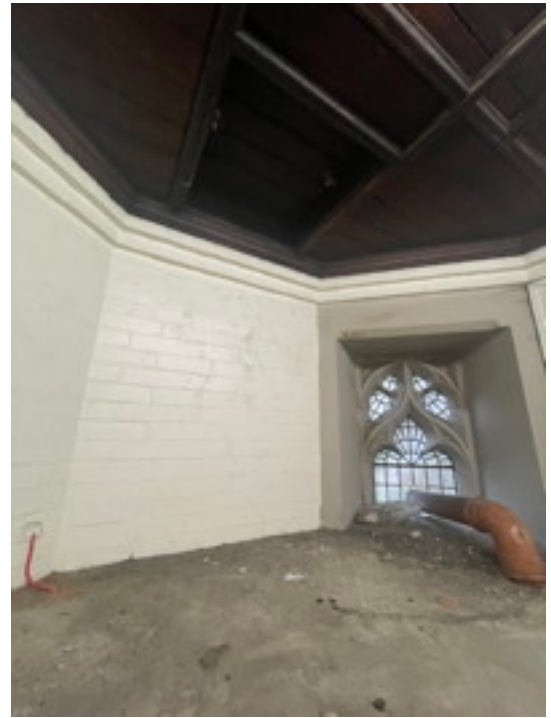
Condition generally fair but vent not sealed through window and therefore extract is largely to the inside. Either seal vent to glazing or, ideally, make good to glazing and put vent through brickwork. WC internal roof requires cleaning.

Campanile Lobby WC Vent

Category B, Requires attention within the next twelve months

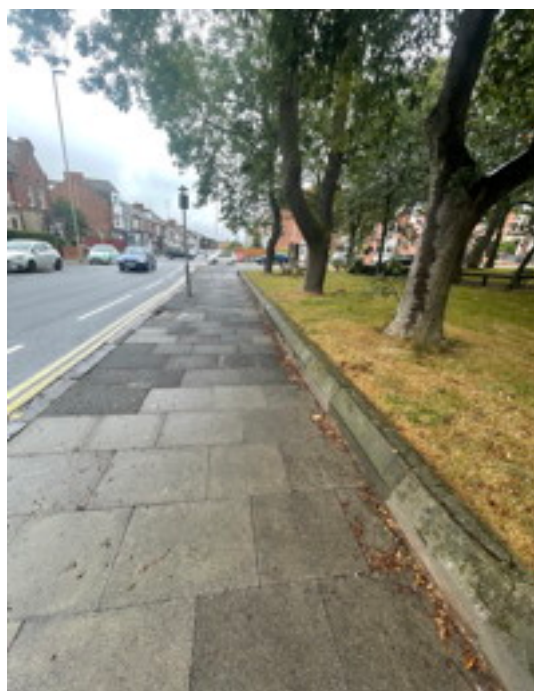
Displaced Plinth Stone

Western Boundary Stone Plinth

Approach Local Authority with a view to having plinth stones rested. Repair frame to gate. Cost Band 1– £0.00-£1,999.

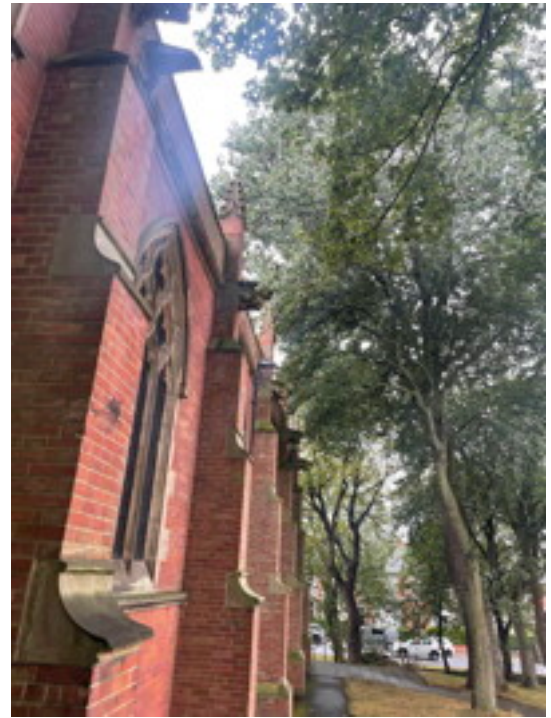
Overhanging Trees to North Elevation

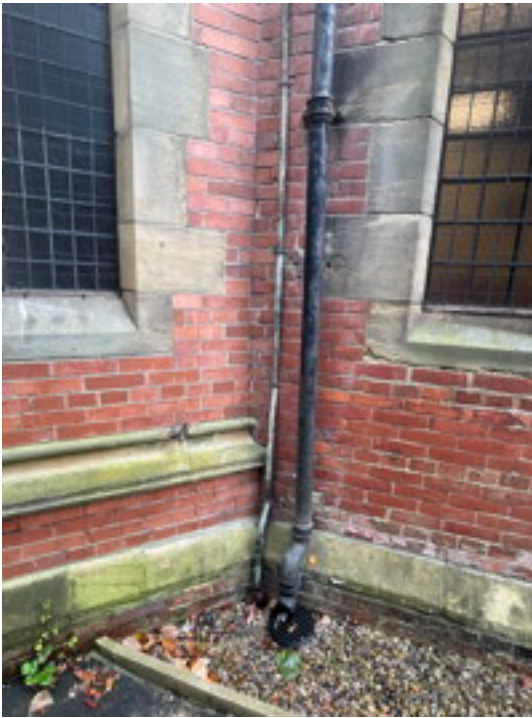
There is a lightning conductor with copper tape down the north elevation of tower. All appears complete but the lack of low level protection risks theft.

It is reported that the system has just been inspected but that this is not yet noted in the Log Book.
