**Quinquennial Inspection Report
Holy Trinity Church, Southwick, Sunderland
Diocese of Durham**

Report prepared by

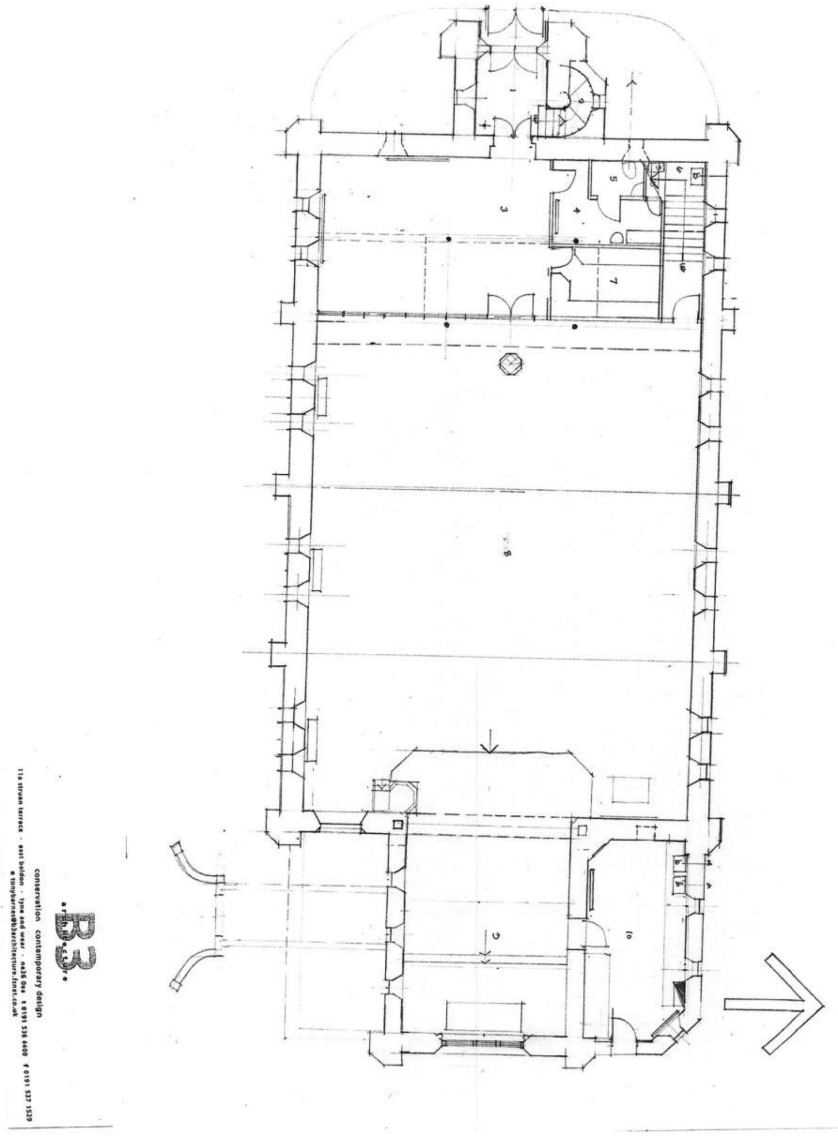
conservation contemporary design
B3
 111 Spear Street - San Francisco, CA 94105
 Tel: 415 774 1111
 Fax: 415 774 1112
 www.b3.com

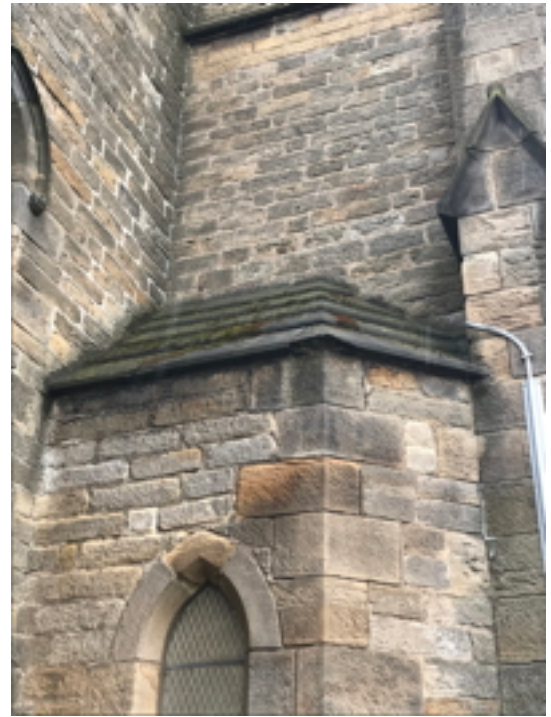
Tower Staircase Roof to Tower

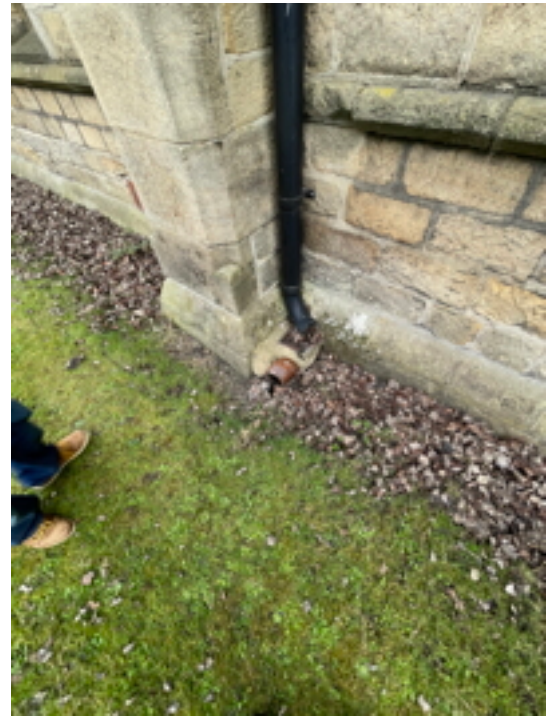
**Rainwater Missing Gully North
Elevation**

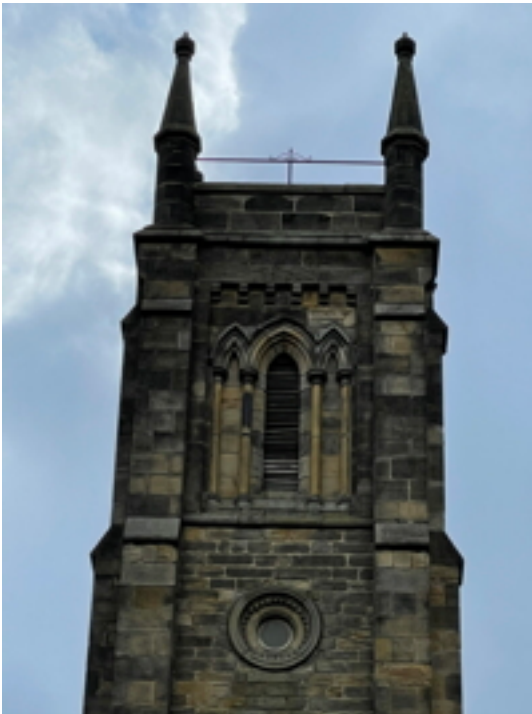
Stone parapet cappings at west and east ends of nave with stone finial cross to east end ridge and stone pinnacles to west end corners. Chimney to centre of parapets both sides to nave east end. East end stone parapet cappings with stone pinnacles to ends and stone finial cross to ridge at chancel. Chancel final cross appears to be a modern replacement. Tower to west end with buttresses reducing to angle buttresses on upper stages and stone Pinnacles to corners.

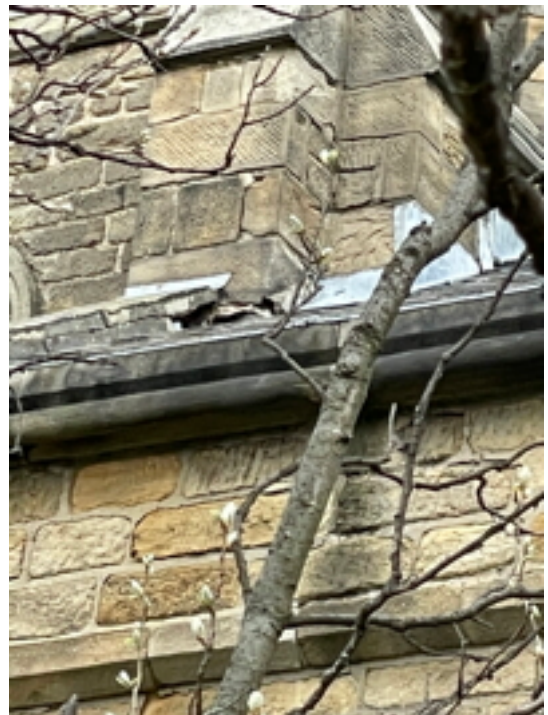
West End Missing Mortar Fillet

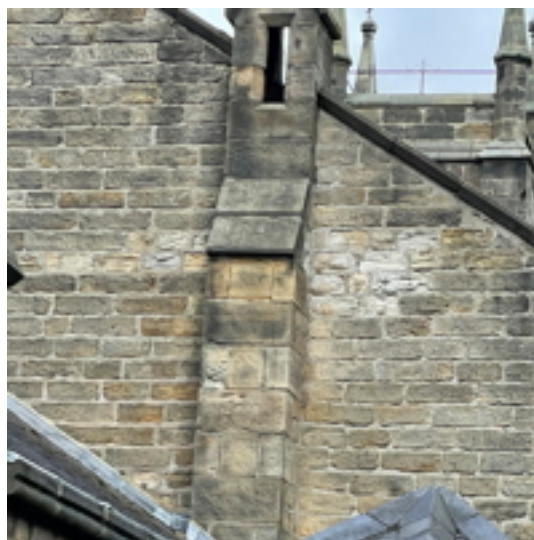
Nave North East Elevation Deteriorating Stonework

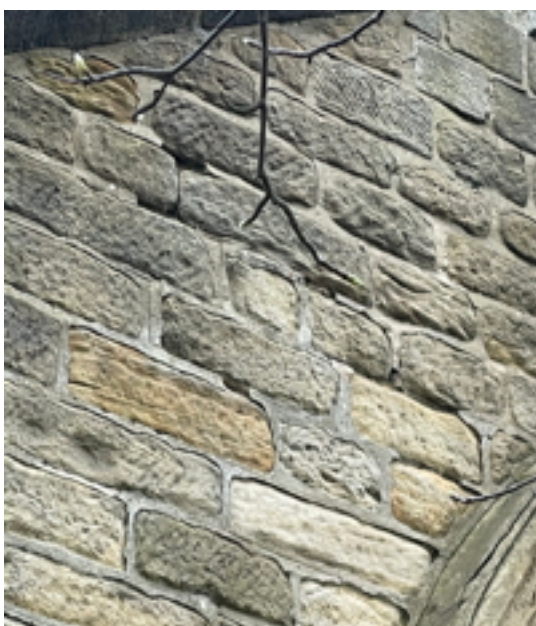
Nave South East Elevation Hard Mortar Pointing

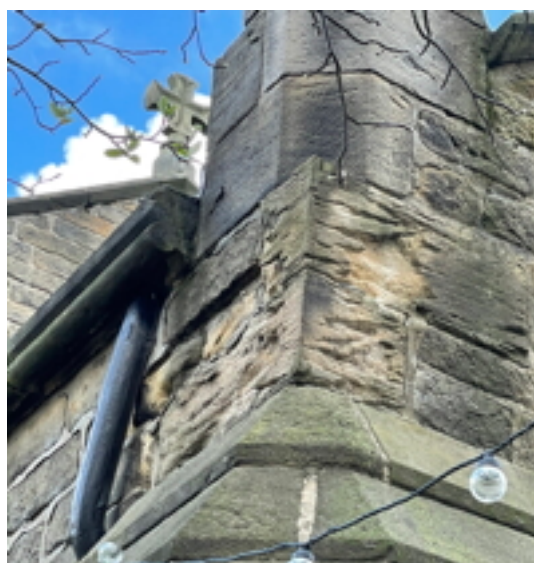
Chancel South East Pinnacle base Deteriorating Stonework

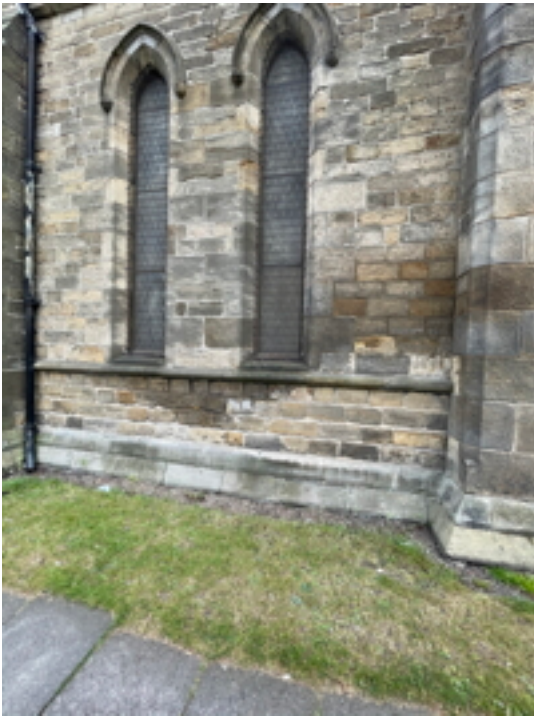
Staining Middle Section South Elevation

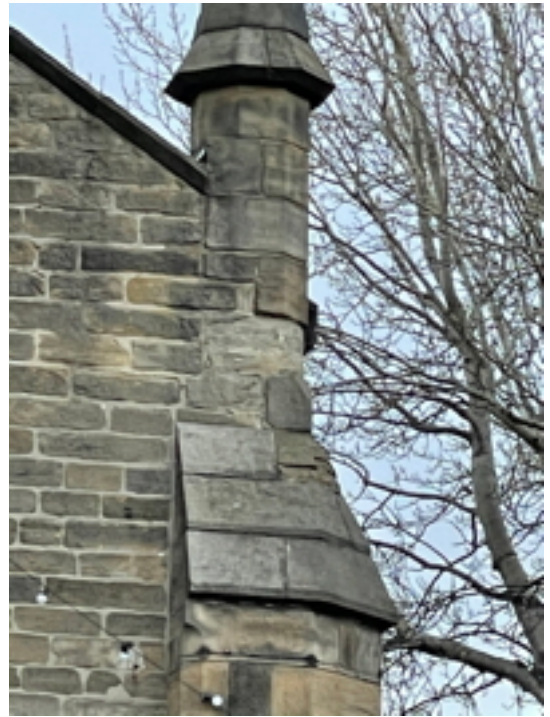
Nave South West Pinnacle base Deteriorating Stonework

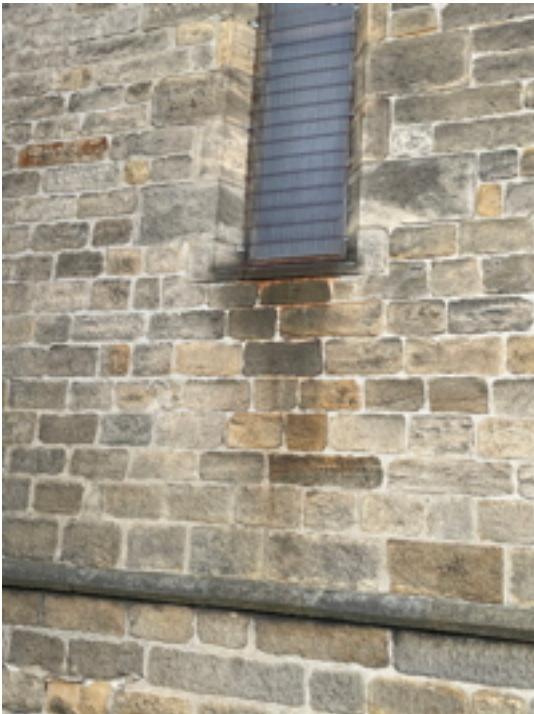
Staining West Elevation South Side

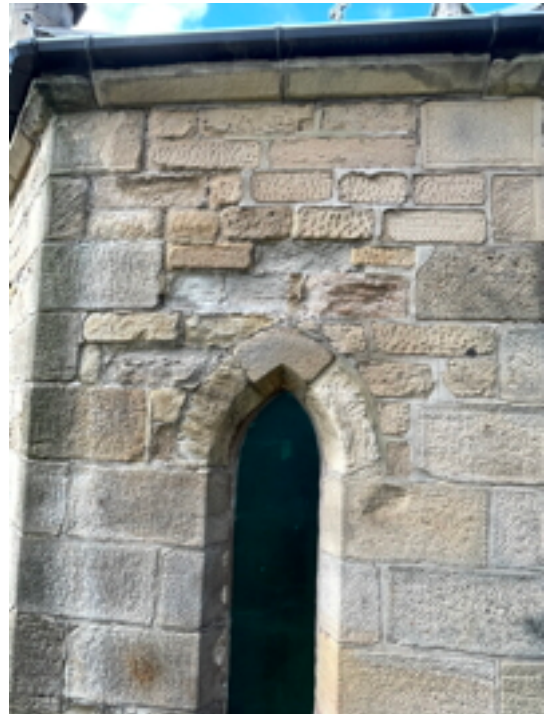
Vestry Deteriorating Stonework

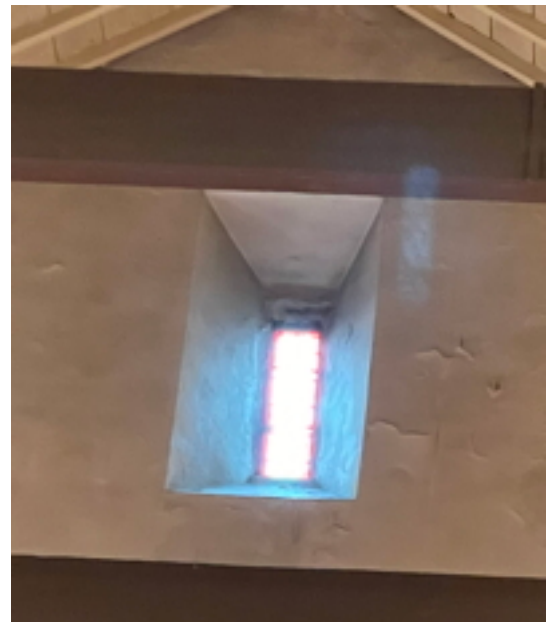
Nave East Gable Window Clear and Coloured Glass with Lead Cames

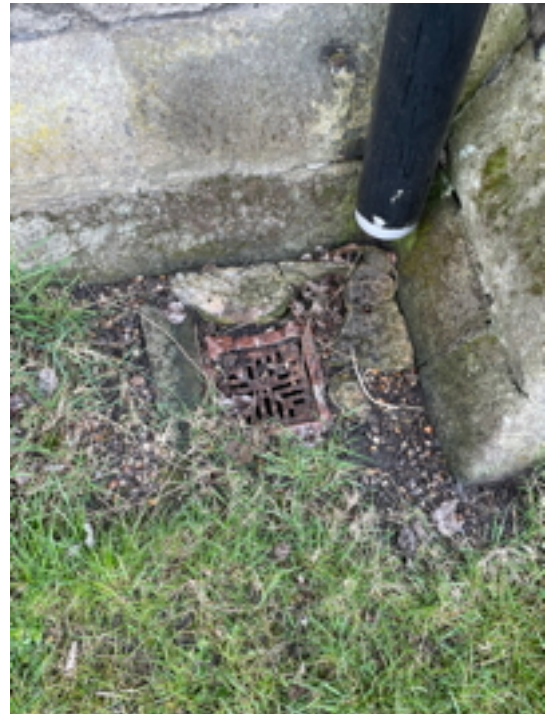
Rainwater Gully with cracked concrete surround

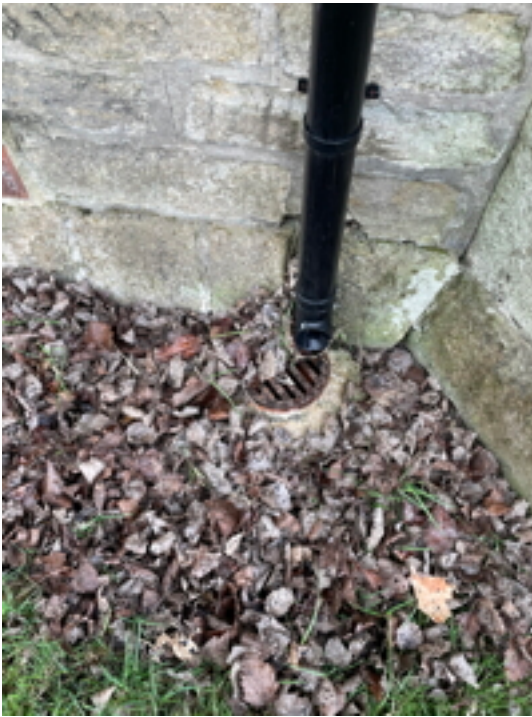
Rainwater Gully Partially Blocked with Leaves

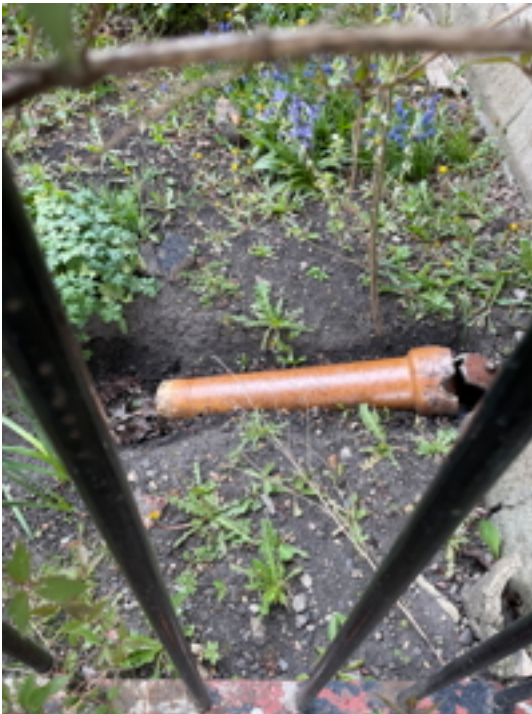
Broken Gully Pipework

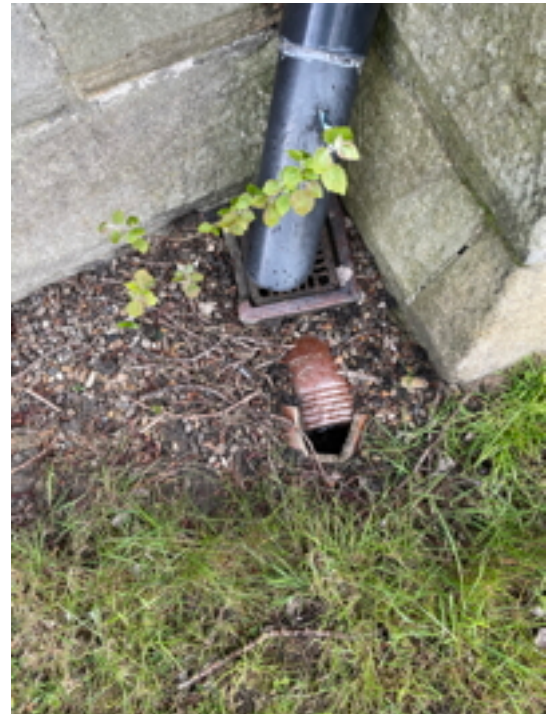
Broken Gully Pipework

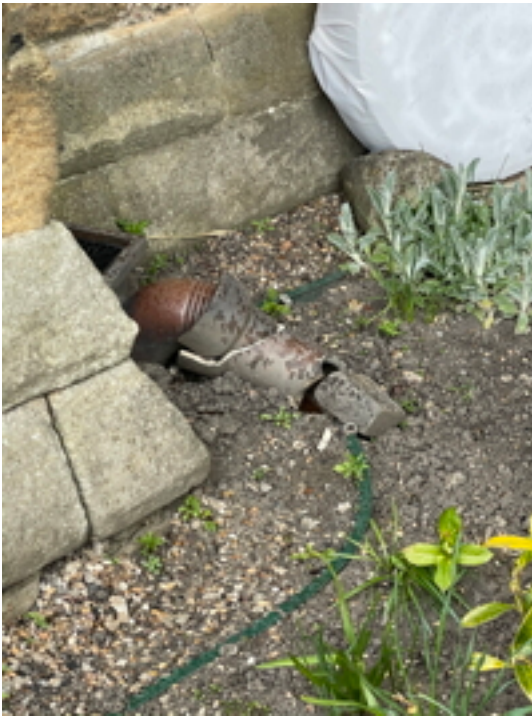
Broken Gully Pipework

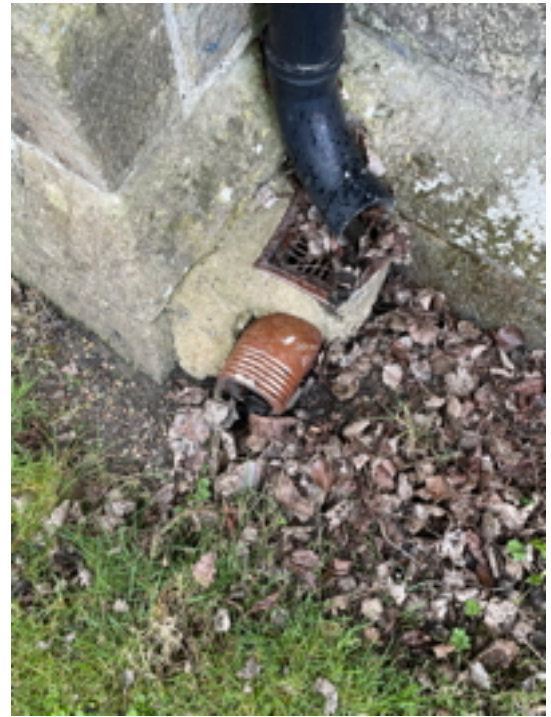
Broken Gully Pipework

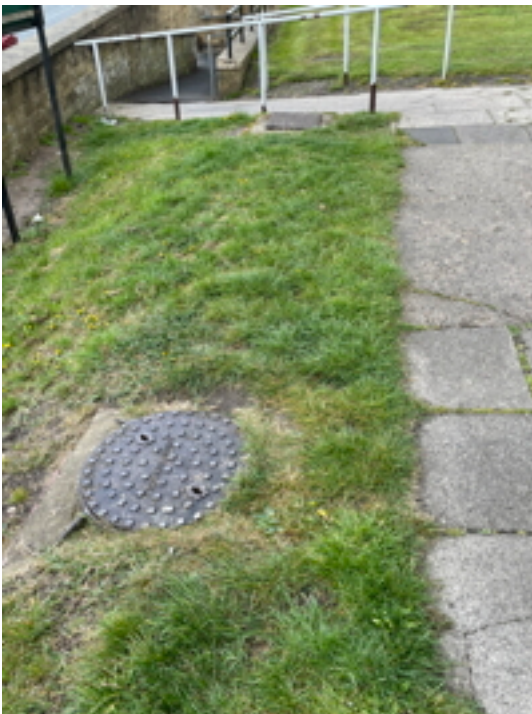
West End Inspection Chambers

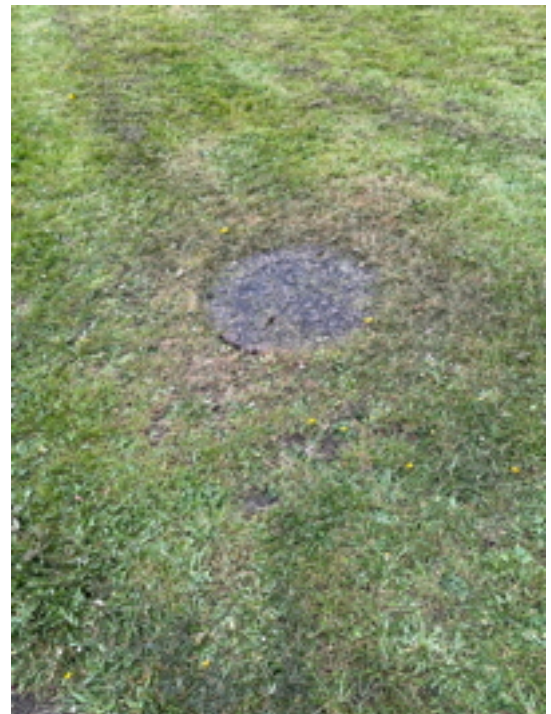
West End Inspection Chamber

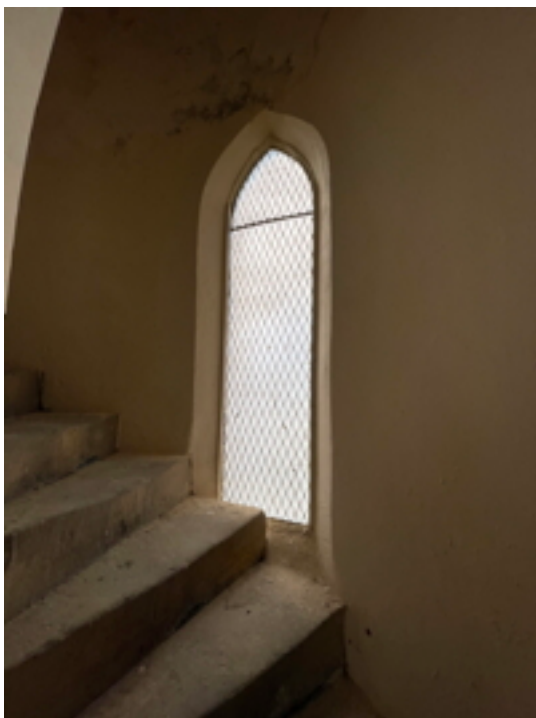
Stone Spiral Stair Leading to Ringing Chamber

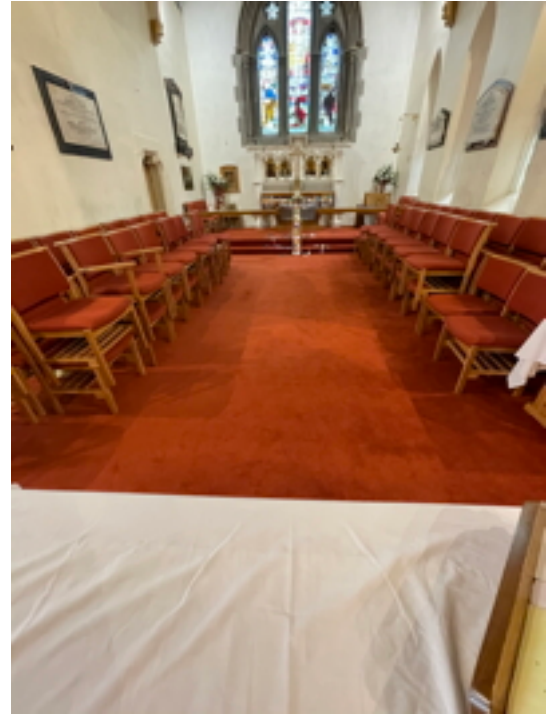
Chancel Carpet Flooring

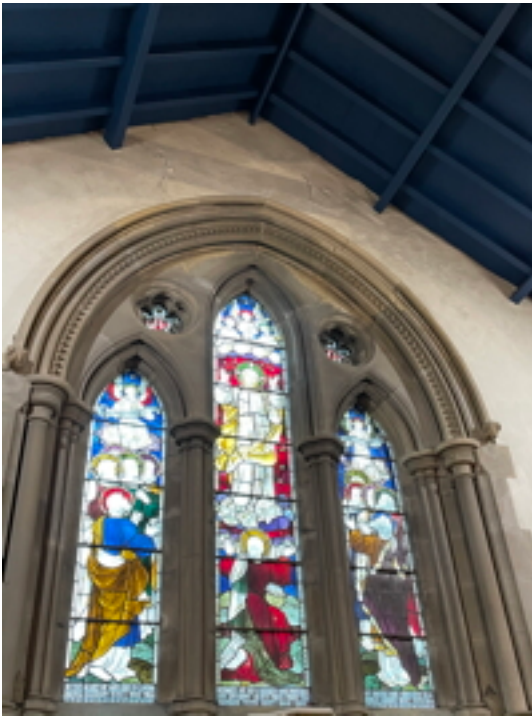
Chancel East End High Level Water Penetration

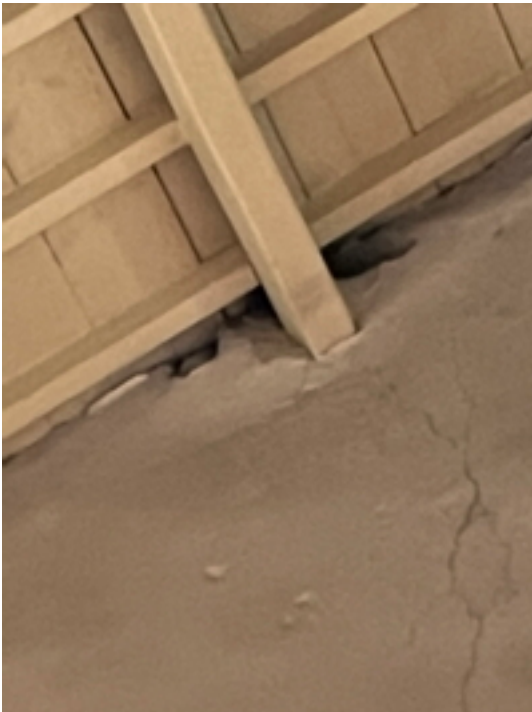
Nave North East End High Level Loose and Cracked Plasterwork

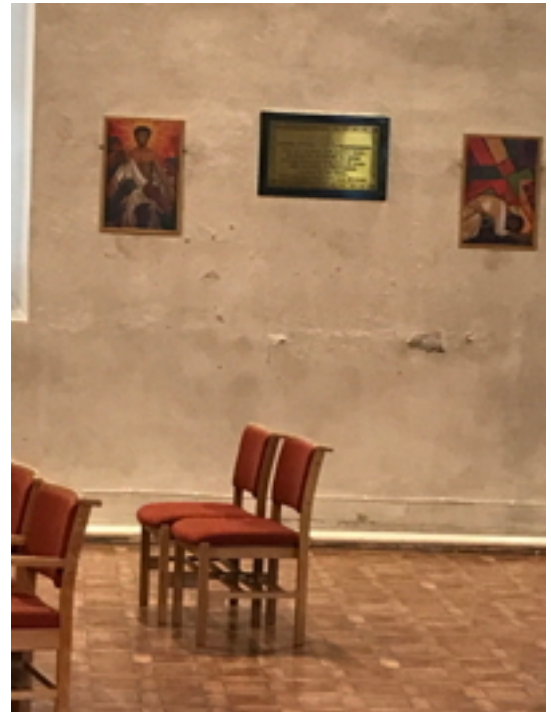
Nave South Elevation Low Level Damp Plasterwork

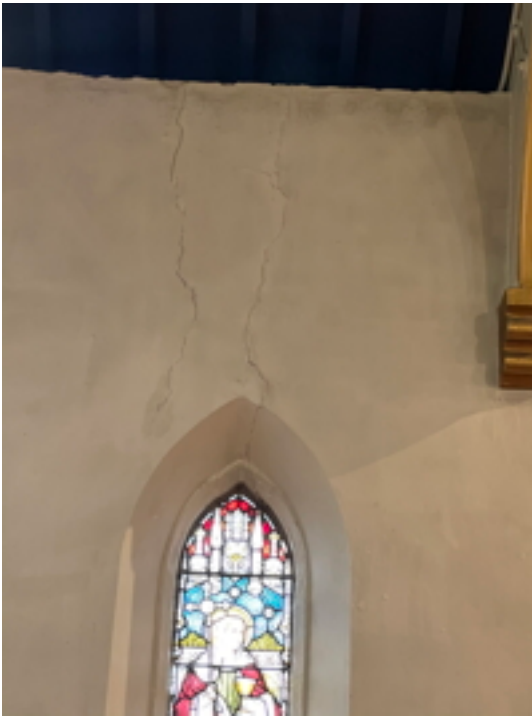
Historic Cracking over Chancel South Windows

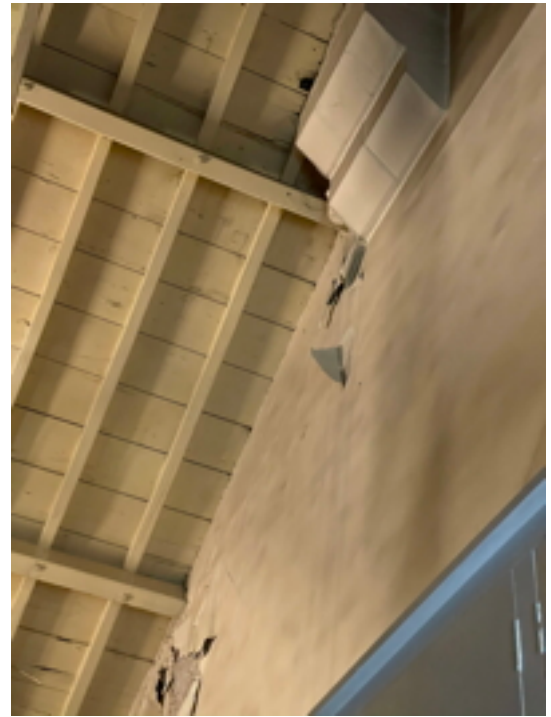
Gallery South West End High Level Water Penetration

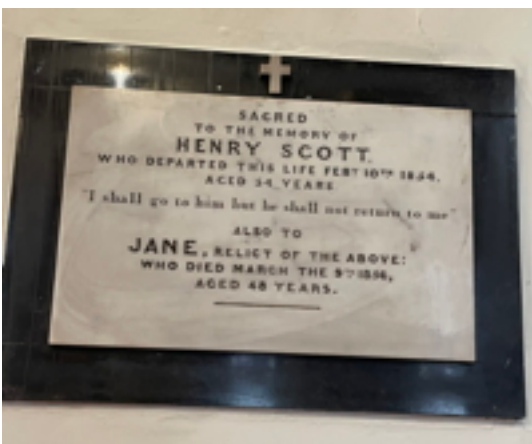
Henry Scott 1854, Jane Scott 1856

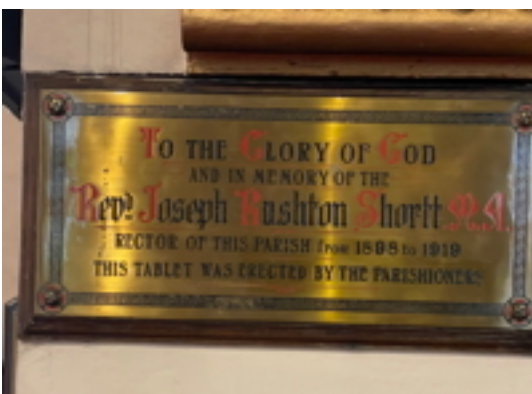
Joseph Shortt Rector 1898 to 1919

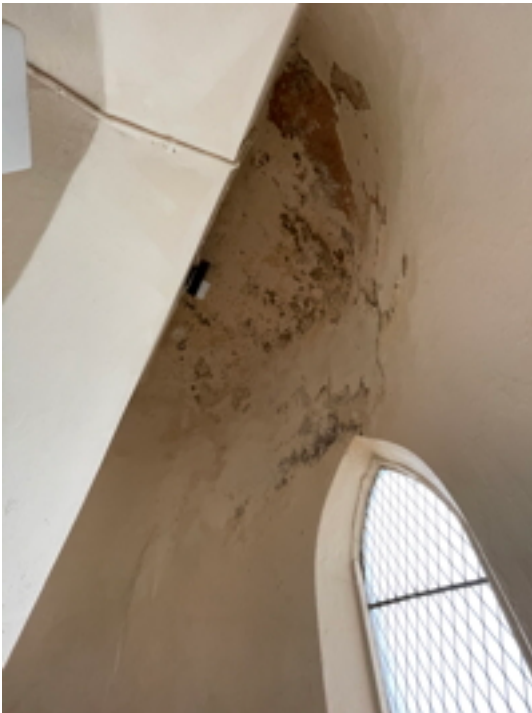
Tower Staircase Ceiling

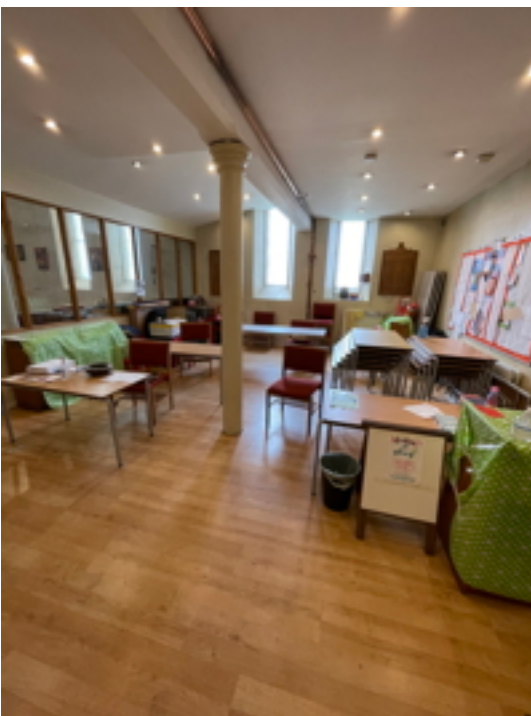
Meeting Room Looking South

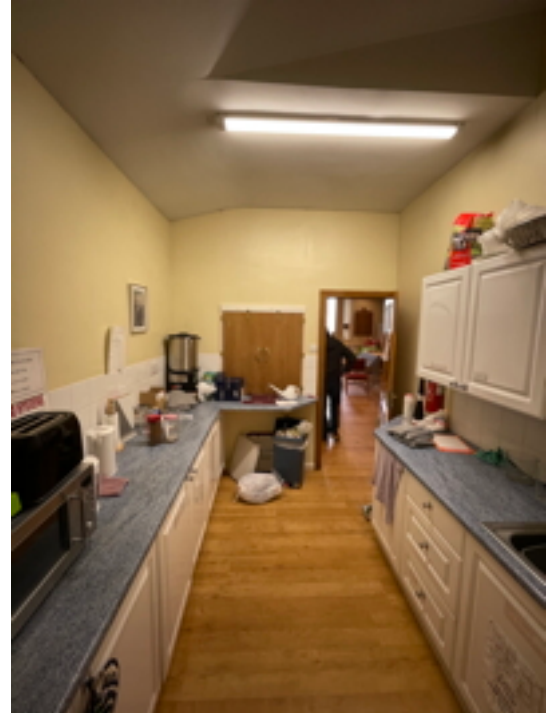
Kitchen Looking South

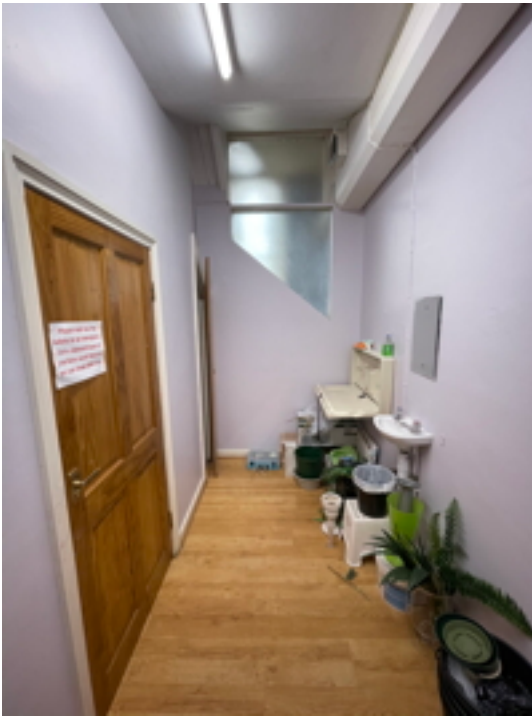
WC Lobby Looking North

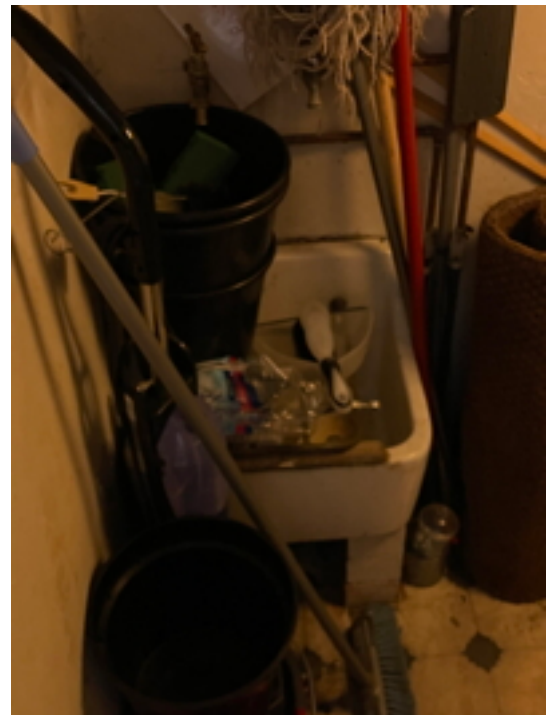
Boiler Cupboard/Cleaners Store

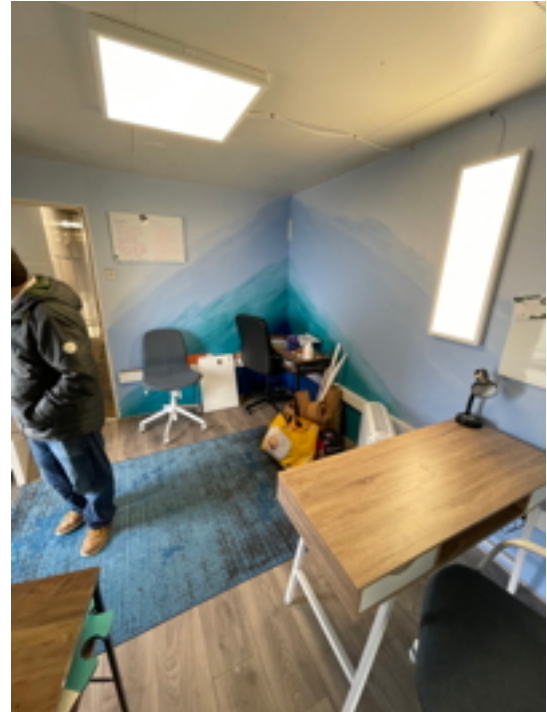
Gallery Meeting Room Looking North

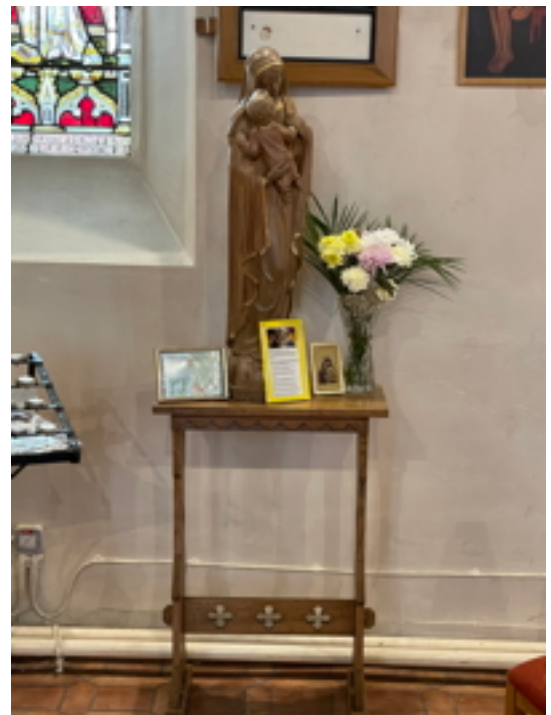
Table and Stature of Mary Holding the Baby Jesus

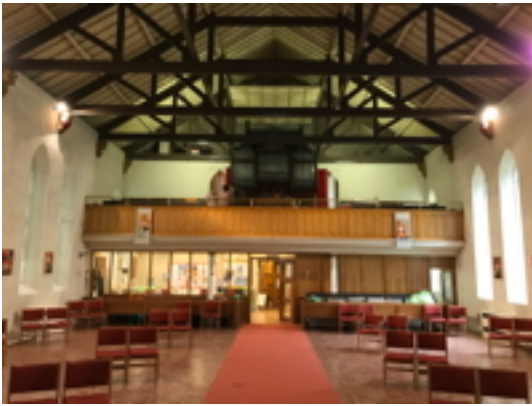
Upholstered Chairs and 2 pews to West End and Assorted Storage Boxes

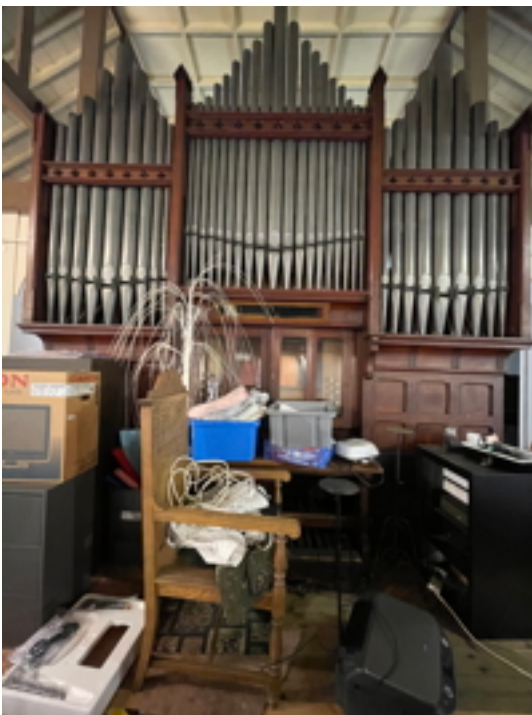
Organ to West Gallery

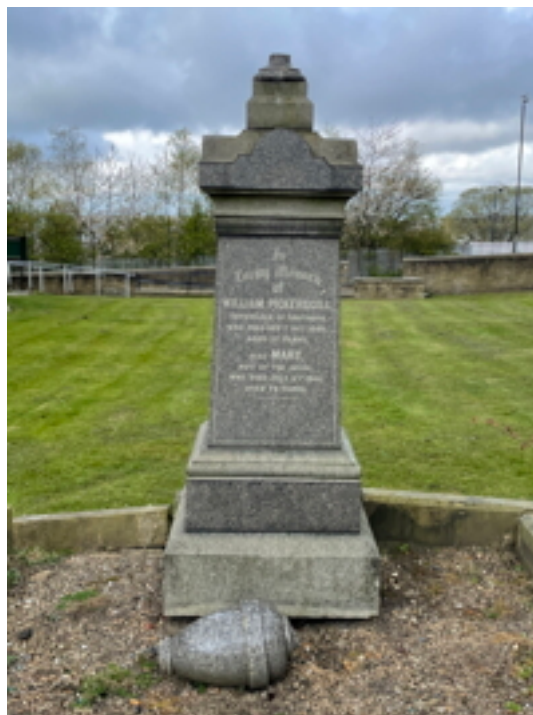
Charles Pickersgill Tombstone to North

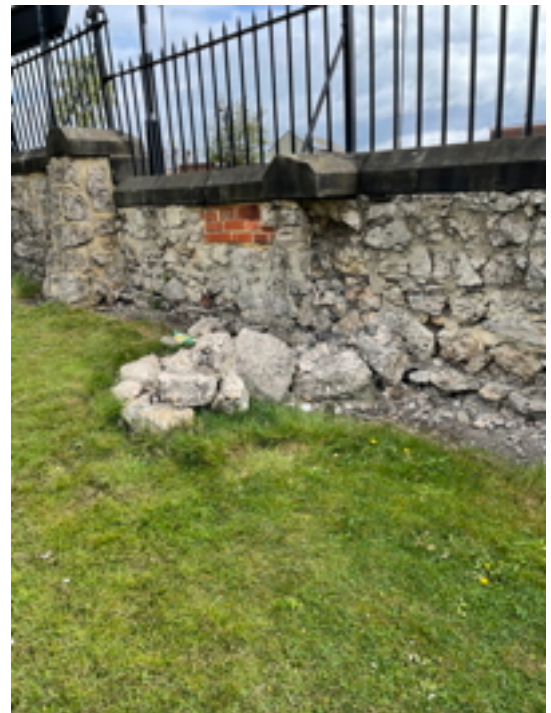
East Wall Damaged Section

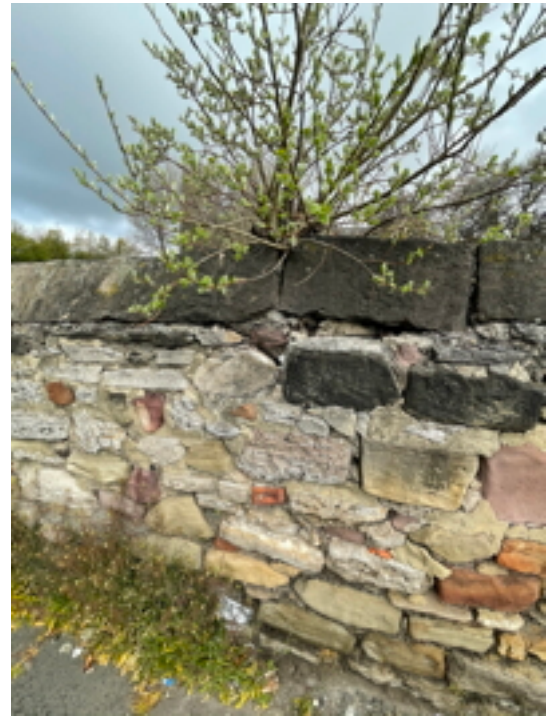
South Wall Damaged Section

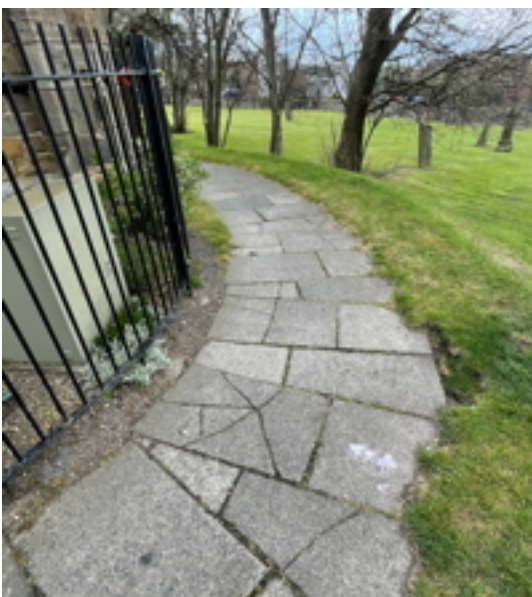
**Pathway at South West Corner
Broken Flags**

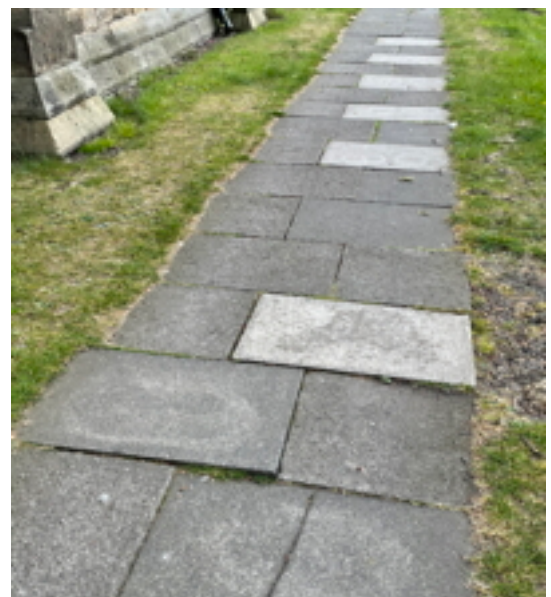
Pathway at South Uneven Flags

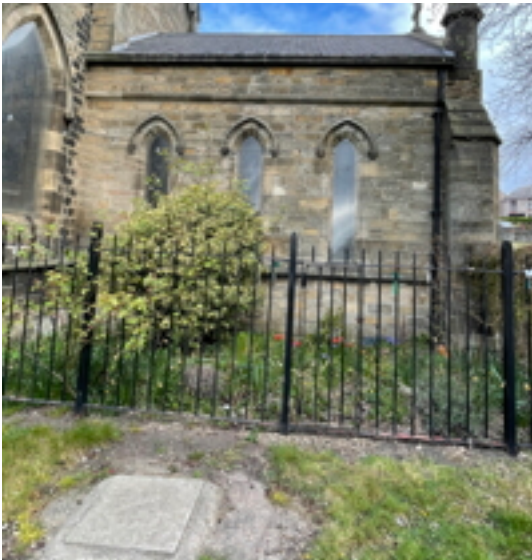
South West Corner Garden

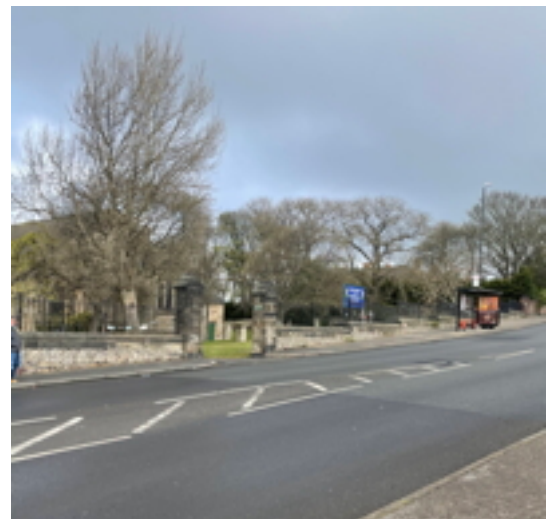
North and East Area Trees

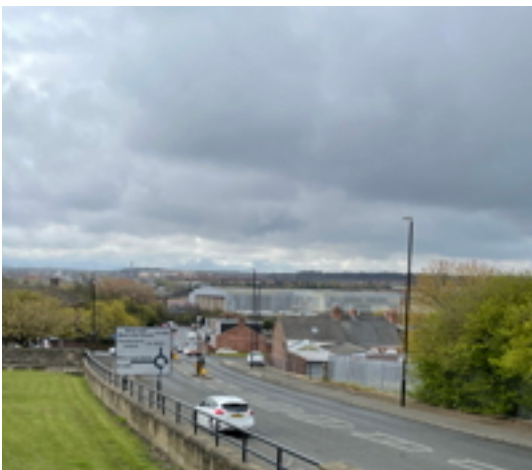
Ship Repair Yard on South Bank of the River Wear

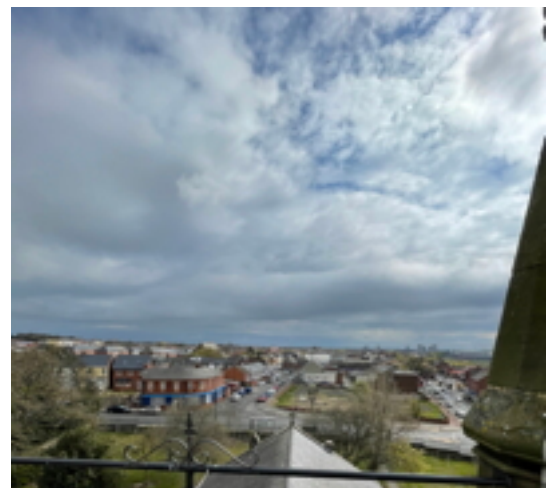
Towards the North Sea and the Mouth of the River Wear

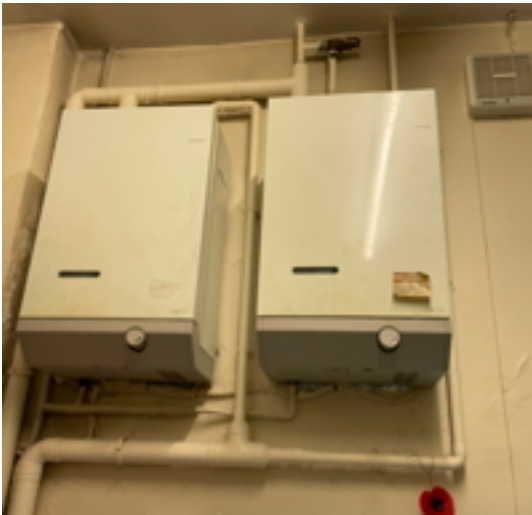
There are two separate heating systems. There are twin Potterton Profile wall mounted gas boilers in the vestry serving steel/iron pipes and fan convectors and radiators around the main church and vestry with balanced flues through the north wall. The gas meter in Vestry. There is a third Main Eco Elite gas fired wall mounted boiler in the boiler cupboard that serves radiators in the Kitchen, WC, Meeting Room and Gallery staircase. Boilers last noted as serviced in the Log Book 11 December 2020. There are room thermostats including in the Boiler Cupboard and North Aisle. There is a Fireangle carbon monoxide detector in the Vestry.

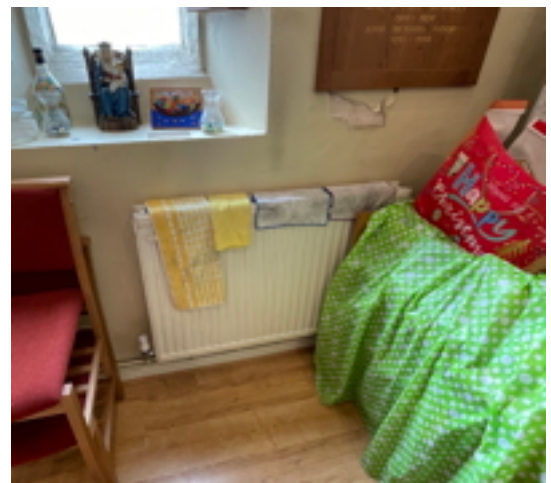
Typical Meeting Room Radiator

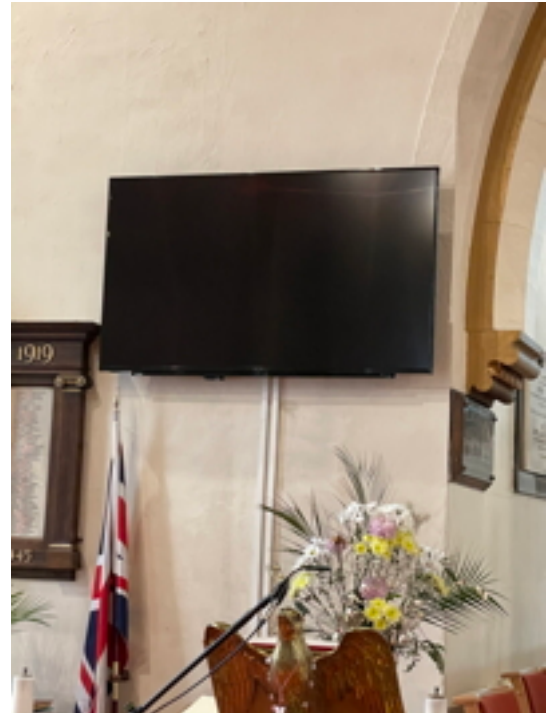
Wall Mounted TV North East Nave
