St. Paul's Church, Spennymoor

Quinquennial Inspection Report
July 2022

Priest in charge: Rev. Matthew Paul Tarling

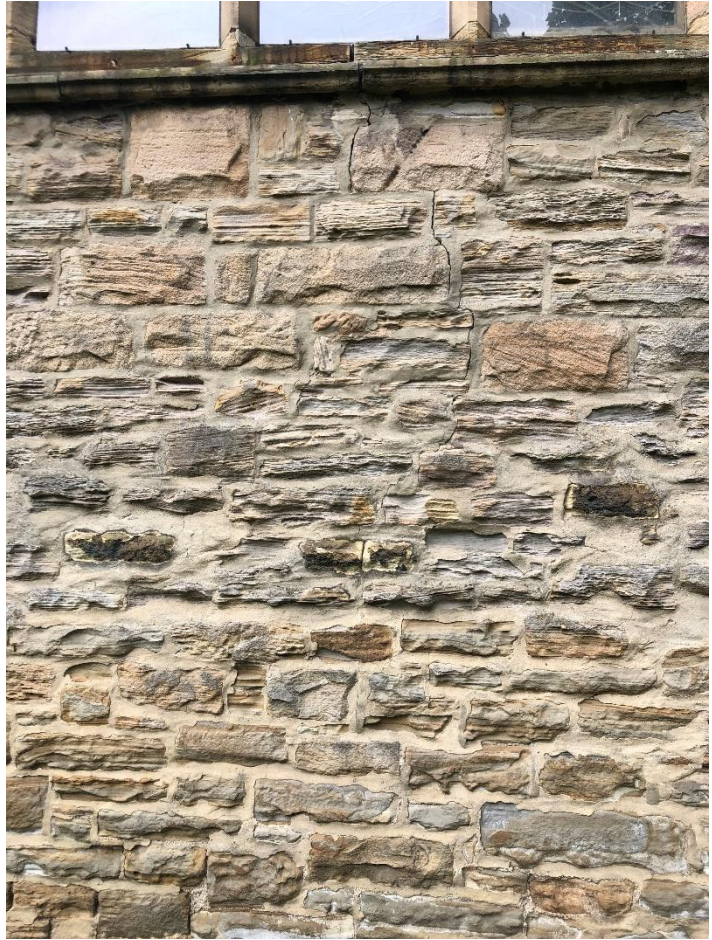
3.0	<p>General Structure:</p> <p>All walls are load bearing and appear to be generally sound except for a slight settlement crack (see Appendix B, P1) which follows the joint link under the centre of the east window; and internally there is a slight shrinkage / movement crack to the plaster under the east north aisle window which follows the thrust line of the chancel arch. These do not appear to have worsened since the last inspection.</p>

P1 (IMG 7703):
Settlement crack under east window

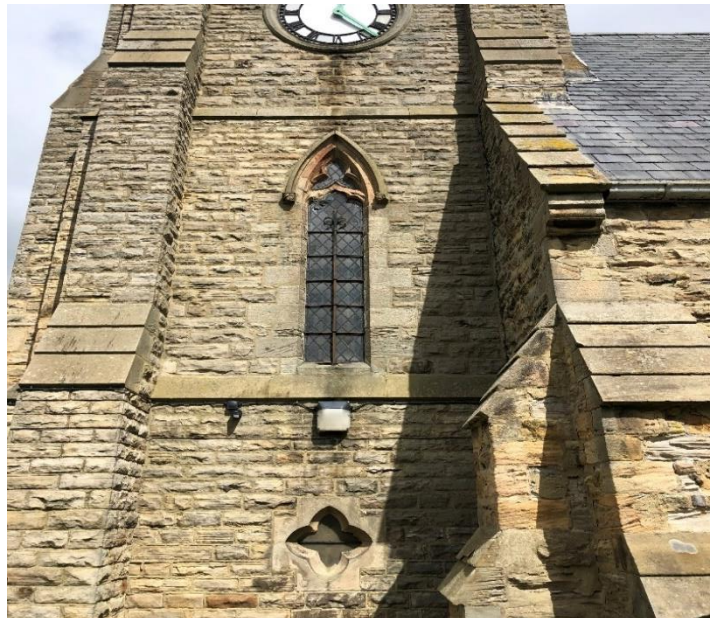
4.2	<p>South Elevations:</p> <p>Tower: Sound except for eroded and cracked tracery to head of lower tower lancet (see Appendix B, P2). There remain two pieces of debris that appear to have fallen from the underside of the stone belfry louvres and been caught by the bird mesh.</p> <p>Nave: Generally sound with some small areas of lean pointing under the first window to the right of the porch and to the left side of the right-hand buttress. There are also areas of over-pointing present where the masonry has become eroded. A few sections of the string course are delaminating particularly to their lower edge under the windows. The stone to south elevation has eroded substantially more than the latter north elevation. Easternmost buttress, upper level shows signs of salts liberated by moisture ingress.</p> <p>Porch: This was repaired in 1999 and is sound. The apex cross is missing and the apex plinth stone is cracked (see Appendix B, P3).</p> <p>Chancel: Sound except for a few individual eroded stones, particularly close to ground level (see Appendix B, P4).</p>

P2 (IMG 7699):
Cracked tracery head, lower
Tower lancet window

Replace gratings to two gullies at east end/point up surround to ensure flow to drainage	6.0	200.00
Clear debris from valley gutter between the nave and aisle roofs.	6.0	240.00
External Stonework – cracked and eroded tracery to head of lower lancet to south side of tower, and damaged tracery to lower lancet to west side of tower.	4.2 / 4.4	1200.00
Seal gap to top edge of asphalt up stand to east side of upper vestry roof.	5.1	240.00
Replace temporary repairs to slates on south face of north aisle with new slate.	5.2	240.00
Repair damaged slate work adjacent to valley gutter.	5.0	120.00
Replace cement haunching with a “flexible” pointing compound to abutments to east gable, chancel gable, and east/west abutments to north aisle where these are loose, cracked or missing.	5.1 / 5.2	175.00
Re-fix or replace loose or missing slates to north face of north aisle and to north side of chancel adjacent to end of upper parapet.	4.2	120.00

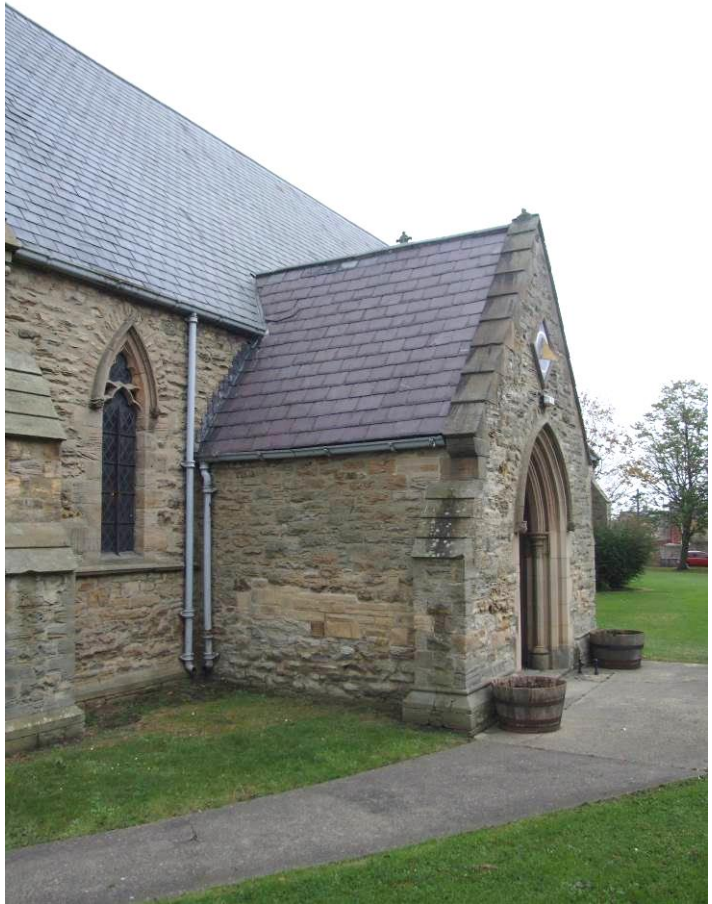
P3 (IMG 458):
Porch, with missing apex cross

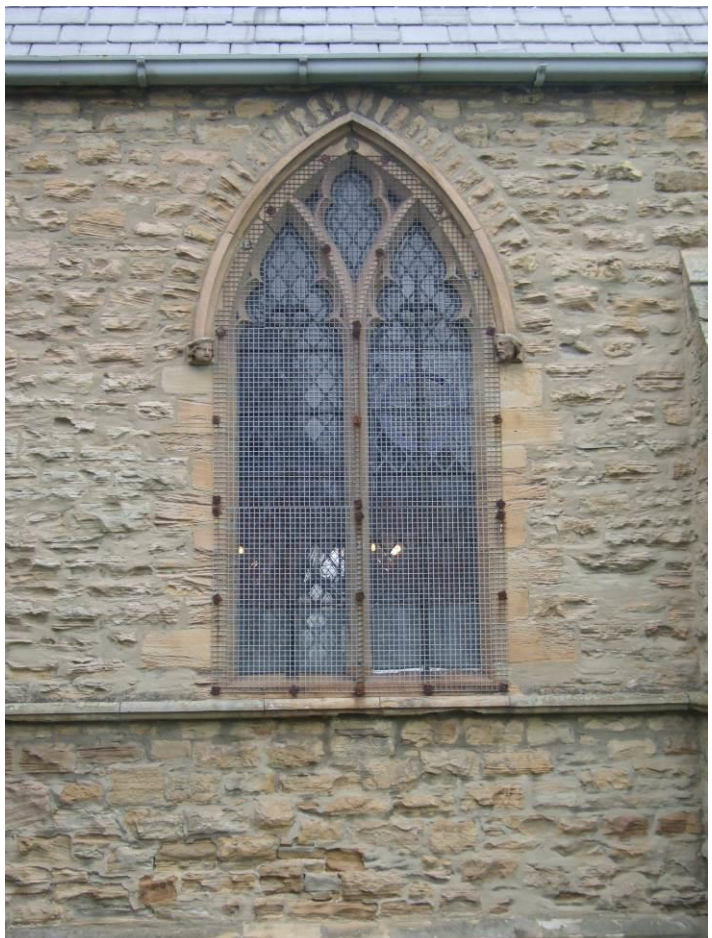
P4 (IMG 487):
Chancel window, with eroded
stones near ground level

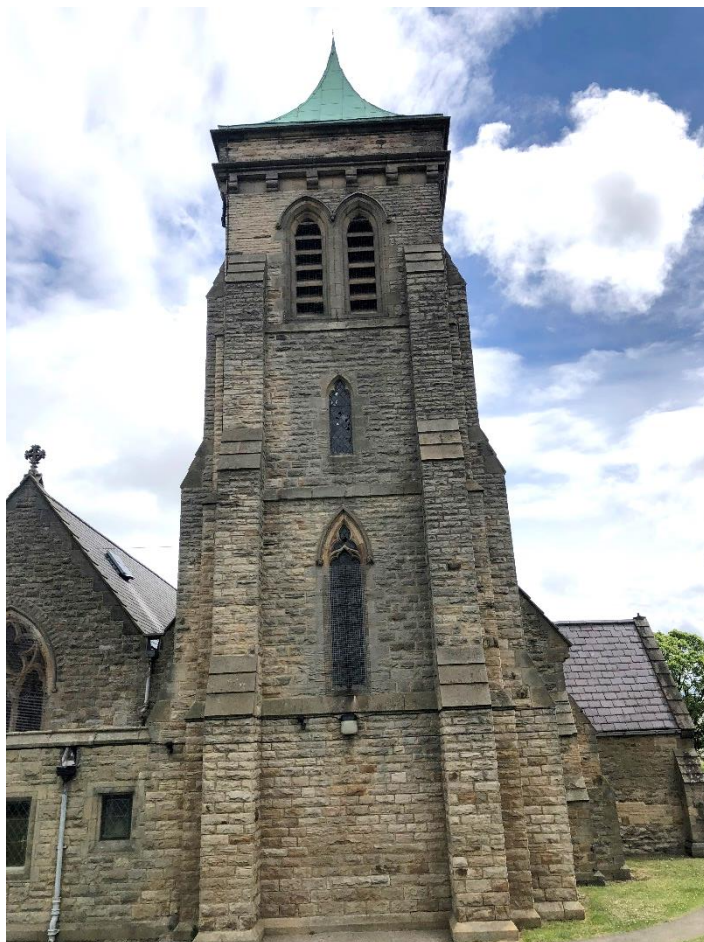
4.4	<p>West Elevations:</p> <p>Choir Vestry: Sound.</p> <p>North Aisle Gable: Sound.</p> <p>Tower: Sound except for damage to the stone tracery and glazing of the lower lancet window, and also more extensive glass damage to upper lancet window (see Appendix B, P5).</p> <p>Nave: Concern on integrity of valley lining and discharge over hopper head to downpipe over kitchen roof.</p> <p>Porch: Sound.</p>

P5 (IMG 7674):
Tower, with damaged tracery
to lancet window and extensive glass
damage to upper lancet window

Repair broken sections of glazing on west and south sides of tower.	7.1	175.00
Replace missing rung to access ladder to tower and provide secure fixing for both access ladders; make trap door operable.	9.3	300.00
Check undersides of all stone louvres and remove any loose stone. Remove loose pieces of stone caught behind bird netting.	9.0	175.00
WORK RECOMMENDED TO BE CARRIED OUT DURING NEXT 5 YEARS - Category 3		
Re-point / repair small area of open joints to north elevation of vestry.	4.1	175.00
Re-point / repair small areas of lean pointing to south side of tower above roof junction and to nave under first window to east of porch, and left side of right-hand buttress.	4.2	240.00

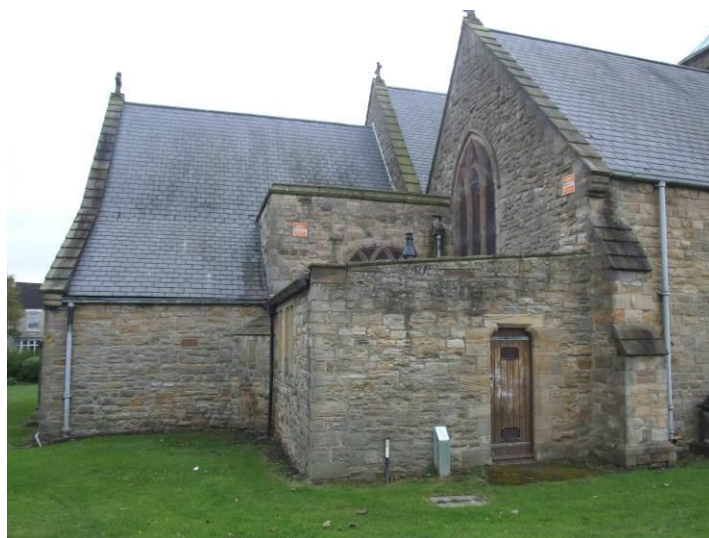
5.1	<p>North Elevation:</p> <p>Chancel: Sound except for one broken/slipped slate adjacent to the end of the upper parapet. The mortar haunching to the east gable is cracked and loose (see Appendix B, P6).</p> <p>Nave: Generally sound except for some minor damage to the lower courses adjacent to the valley gutter.</p> <p>North Aisle: There are around 15 cracked or displaced slates to the north aisle. The cement haunching to the east abutment is missing or loose.</p> <p>Tower: There is a missing slate at the lower end of the east gable of the tower adjacent to the abutment flashing.</p> <p>Flat Roofs (high level): Mastic asphalt generally sound with slight build-up of debris adjacent to fall pipe. The top edge of the up-stand is open on the east side.</p> <p>Flat Roofs (low level): Asphalt with mineral felt edging appears sound.</p>

P6 (IMG 476):
Chancel, north elevation

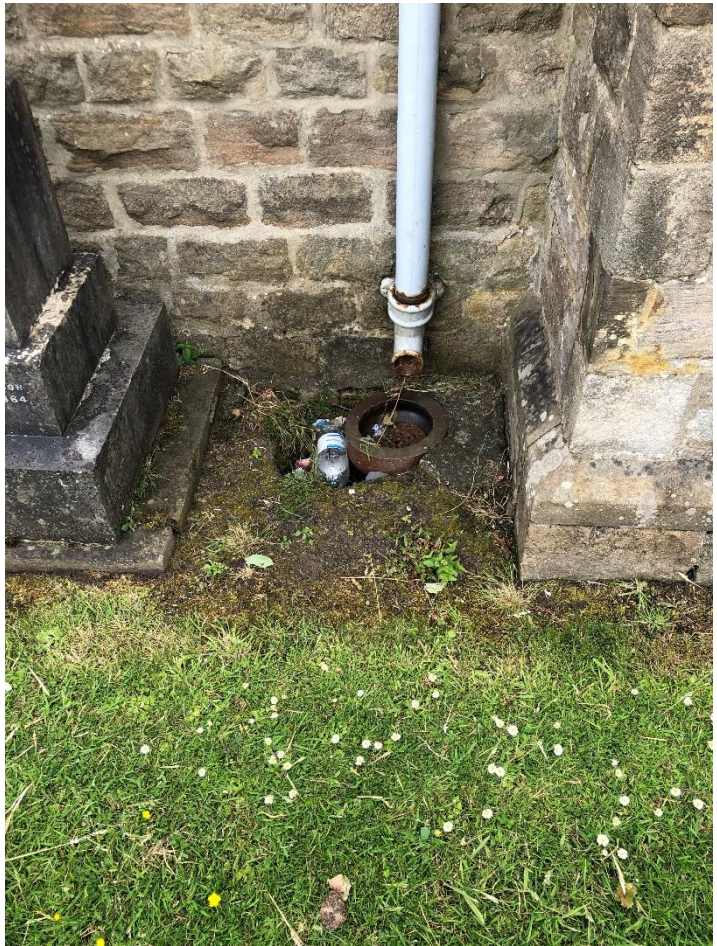
P7 (IMG 7684):
Ground gully choked with
vegetation/litter

Ref	Price (£)
URGENT WORKS REQUIRING IMMEDIATE ATTENTION - Category 1		
None		
WORK RECOMMENDED TO BE CARRIED OUT DURING NEXT 12 MONTHS - Category 2		
Lightning conductor to be tested in accordance with the requirements of BS6651. Any defects to be repaired or replaced or reported to the Architect and a copy of the Test Certificate to be placed with the Log Book.	20.3	175.00
Electrical installation to be tested by competent electrical engineer, and a resistance and earth continuity test obtained on all circuits (as prescribed in the IEE Regulations for Electrical Installations). The engineer's test report and certificate should be kept with the Log Book.	20.1	175.00
Heating Installation – provide carbon monoxide alarm within the first clergy area and provide gas safety certification.	19.0	300.00
Check fire extinguishers annually.	21.1	175.00
Clear vegetation etc. from drainage gullies at ground level.	6.0	120.00

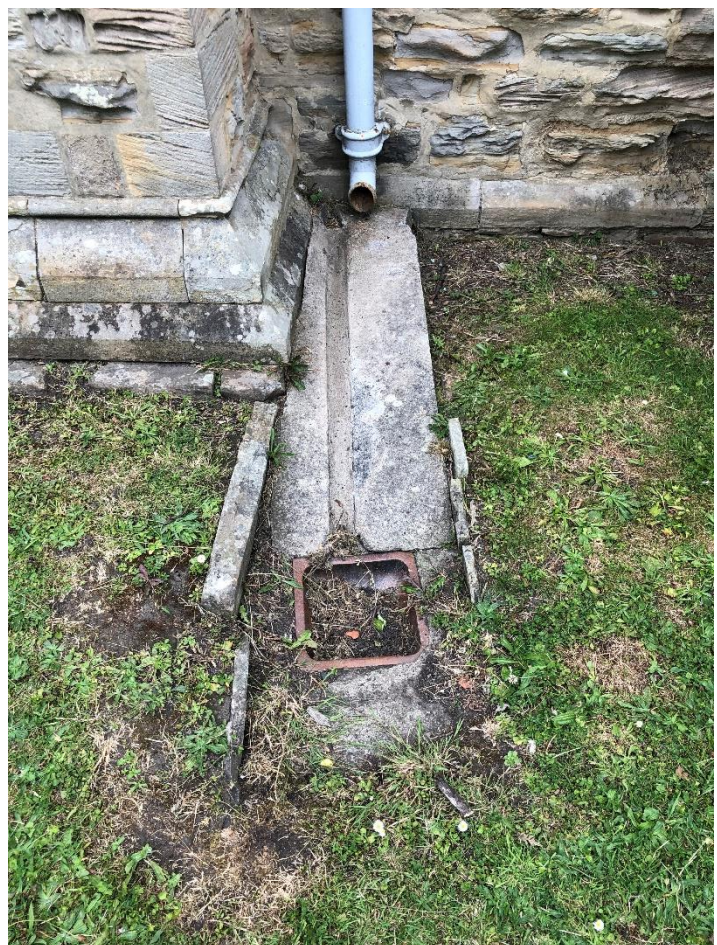
P8 (IMG 7709):
Ground gully choked with vegetation

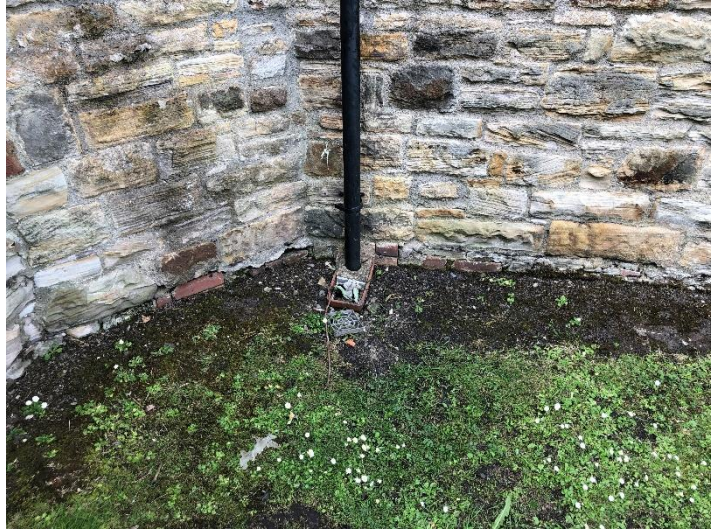
P10 (IMG 7698):
Damaged surrounds to gully,
to be repointed

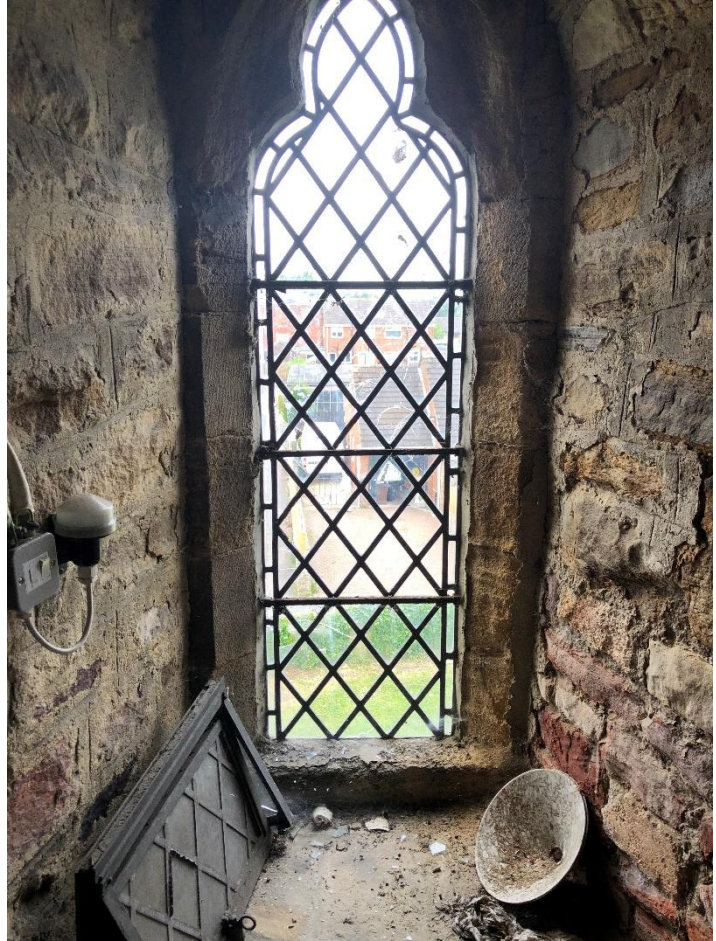
7.0	External Windows and Doors:
7.1	<p>Windows: Generally sound except for the following:</p> <ul style="list-style-type: none"> a) 3 no. panes are broken to the clock room floor on the west side (see Appendix B, P11) b) 2 no. panes are broken to the lower west tower lancet window c) 2 no. panes are broken to the lower south tower lancet window

P11 (IMG 7607):
Tower clock room, west elevation,
showing 3 no. broken panes

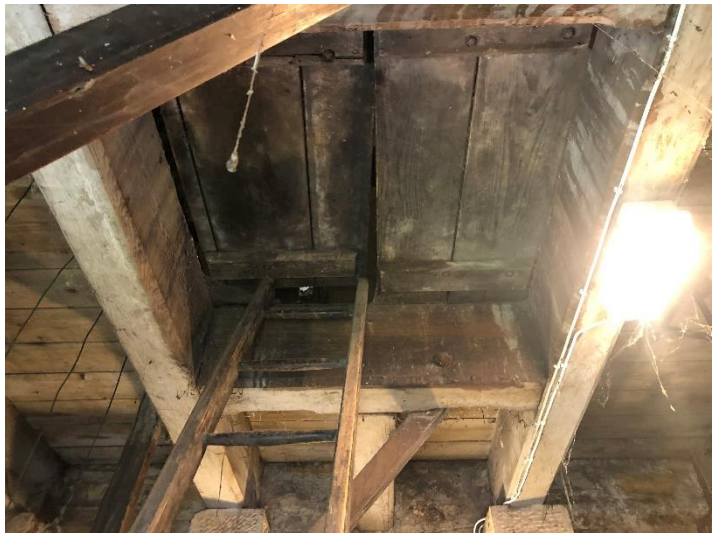
9.3	<p>Belfry: The internal side of the belfry louvres are fully lined with polythene sheeting and chicken wire. Access ladders to the upper levels are not fixed and the tower ladder is missing a rung. The nature of the ladder (unfixed and missing a rung) and the loose boards which cover the opening could present a significant safety hazard, especially to a lone worker. I would suggest that a hinged trap door arrangement and a fixed ladder be installed. Consideration should also be given to obtaining specialist advice on the potential feasibility of restoring to use the tubular bells (which are an uncommon feature).</p> <p>In the event, the spire space was not inspected due to the inadequate, damaged state of the access ladder (see Appendix B, P12).</p>

P12 (IMG 7612):
Damaged/unsafe spire access ladder

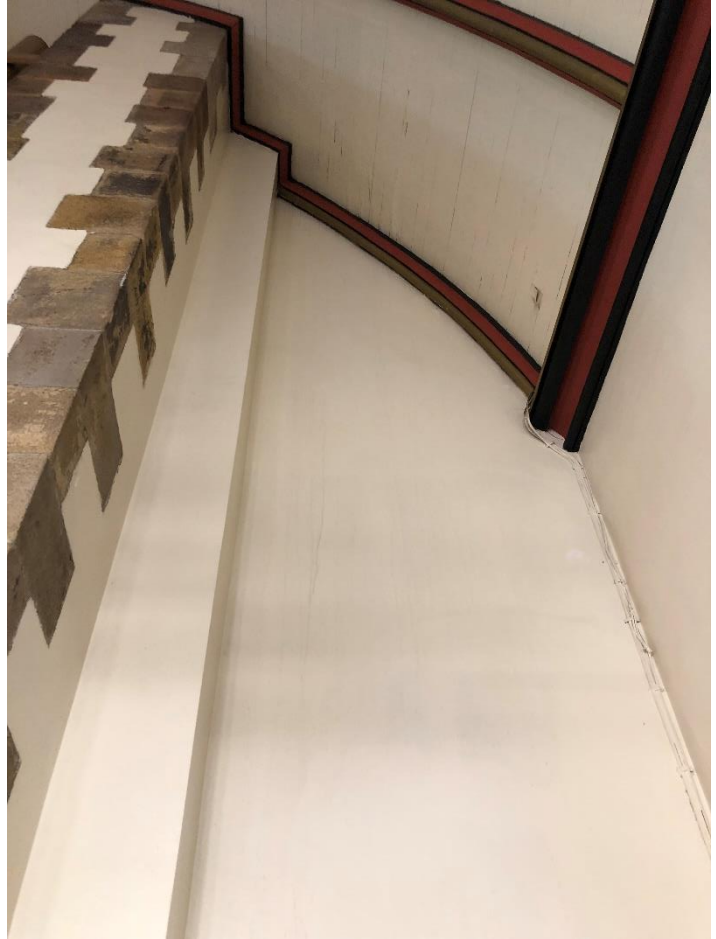
12.0	Internal Ceilings:
12.1	Church: Plain painted timber boarding which is sound except for slight surface damage adjacent to tower abutment above the organ pipework, where there is occasional water ingress. There is a damp stain in northwest corner of the aisle (see Appendix B, P13).

P13 (IMG 7603):
Damp stain, northwest corner of aisle

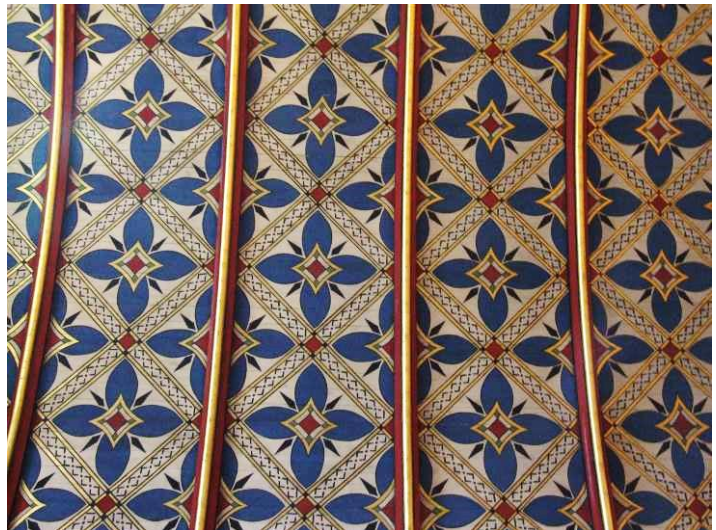
12.2	Chancel: Ceiling is decorated and in good condition (see Appendix B, P14).
12.3	Clergy Vestry: Newly re-plastered.
12.4	Former Choir Vestry (kitchen): Painted plaster onto concrete deck, generally sound with slight surface flaking.

P14 (IMG 498):
Chancel ceiling
