## Church of St Anne, Bishop Aukland

### Quinquennial Report

**24<sup>th</sup> July 2022**

Date of report – August 2025

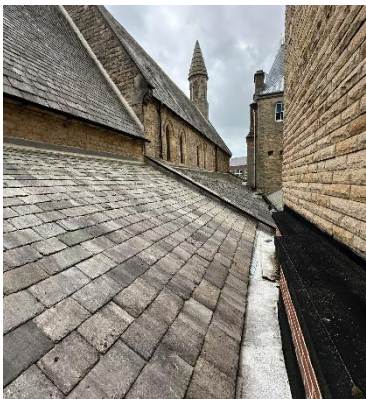
Figure 1 – All north roofs

- 6.1.2 Westmorland slate of random widths, laid in diminishing courses, to a very steep pitch. Generally, the condition remains good, with some moss growth towards the top.

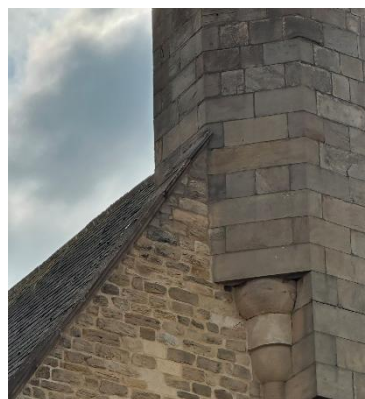
Figure 2 – Coping to NW Nave

- 6.1.4 Sandstone ridge tiles, all in good condition as far as can be seen from the limited view.
- 6.1.5 The flashing at the west end is reportedly 'Nicholson's Masterform' and appears in good condition, however the top coping stone appears not to be fully bedded, this should be checked and the joint re-pointed if seated correctly, or re-bedded<sup>1</sup>.

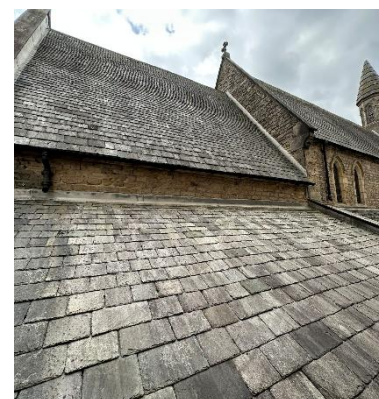
Figure 3 – N Chancel and vestry

- 6.2.1 As per the Nave, this has Westmorland slates in random widths and formed part of the re-roofing scheme. Some undulation, thought to be due to the differentiation in the thickness of the reclaimed slate, in addition to many slates with chipped corners. None appear broken enough to warrant replacement and given they were second-hand slates, this may have been their condition as fitted.
- 6.2.2 Ridge is again in sandstone and appears ok from the limited view.
- 6.2.3 Abutment flashings are neat and undisturbed.

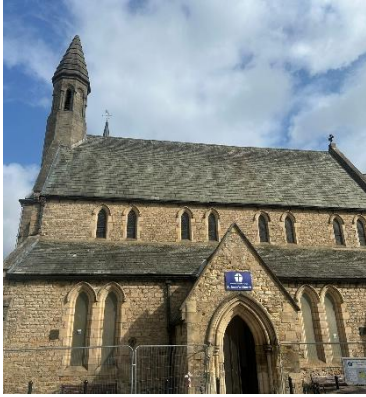
*Figure 4- South Nave and Aisle*

- 6.5.2 The condition is very poor, there are many areas of slipped slates, patches of historic replacement and is in desperate need of wholesale re-roofing<sup>3</sup>. There is water ingress internally and light is visible near the bell turret.
- 6.5.3 The junction with the bell turret has lead flashings and looks to be holding-up from ground level, however given the roof's condition this will need to be re-instated alongside the urgent re-roofing scheme.
- 6.5.4 The copings to the east have large gaps, particularly towards the top and at the finial, this should be checked for stability<sup>4</sup>. The flashing to the west is in lead and appears ok, to the east there appears to be some cracks in the flaunching.

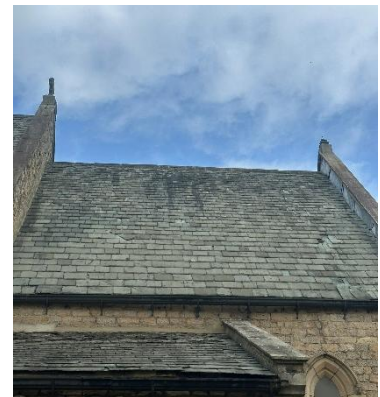
*Figure 7- Chancel South*

- 6.6.1 As per the South Nave and in very poor condition. Many slipped slates, leaving the sarking boards below exposed in several locations. The urgency of this replacement cannot be stressed enough as no action has been taken since the last inspection report which reported a poor and deteriorating condition, serious irreparable damage to the timbers internally could be caused if the roof continues to be left in this condition.
- 6.6.2 The finial to the east gable has an open joint to the rear, and this should be investigated at close proximity urgently<sup>5</sup>, access is good for a cherry-picker.

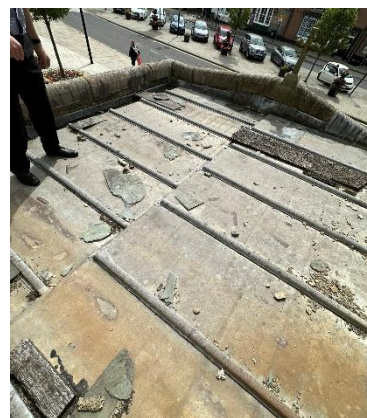
Figure 8 – SE lead roof (over WCs)

- 6.8.1 This roof is covered with lead in seven bays, with one drip, falling to the east. There are many patch repairs and a significant amount of debris on this roof, including large fallen slates. These have punctured the lead in a few locations, causing some dents and one split<sup>7</sup>. This will need to be properly repaired but only once the main roofs have been replaced.

- 6.8.2 It was reported previously that there was a crack in the lead to the southwest corner, it does not appear to have been repaired. There is also a crack to the north east corner, near the outlet. There is also some large vegetation growing in this location, this was partially removed at the time of the visit. The lead in this area will need repairs as another section has come loose completely.

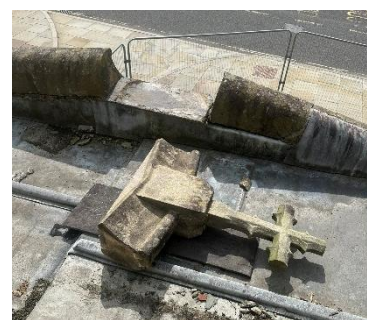
Figure 9 – as item 6.8.4.

- 6.8.3 The flashings to the wall of the South aisle and the chancel are in fair condition, the mortar above is beginning to break away.
- 6.8.4 The middle stone to the south parapet was visibly loose and laid down at the time of inspection to prevent it from falling. This full parapet section requires urgent attention<sup>8</sup>.

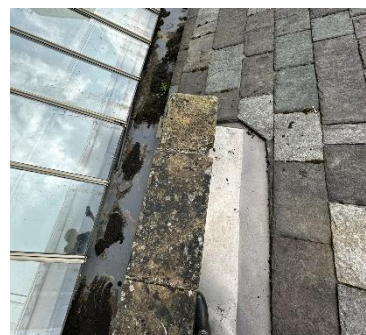
Figure 10 – N valley

- 7.3.1 The valley gutter which abuts the town hall has been re-formed and covered with stainless steel, generally in good condition but there is a build-up of vegetation to the west and some debris in the gutter<sup>11</sup>. The small parapet upstand was also re-covered with ‘Nicholson’s Masterform’.
- 7.3.2 The lower box valley over the town hall section is in a single-ply fleece backed membrane and in good condition, although there is a lot of moss build up which would be best cleared (this may be the

responsibility of the town hall – who have an access door to this section). Further to the east over the organ this changes to what appears to be a GRP type product. This is not finished well at the outlet to the east.

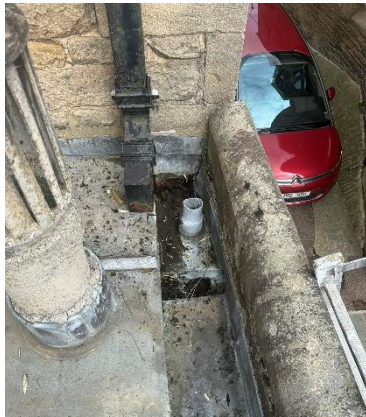
Figure 11 – SE Vestry & chancel

7.5 **SE Vestry (WC's)** – The rainwater hopper and outlet to the east side is completely blocked by vegetation. Some cleared but a thorough clear will be necessary. The downpipe from the chancel has a base section which is completely loose and simply sitting on the lead roof<sup>13</sup>.

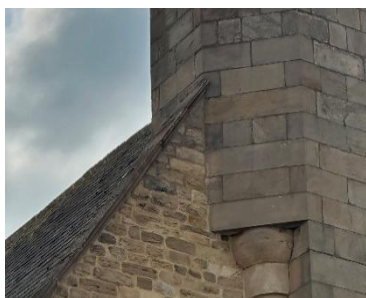
Figure 12 – N Aisle – W end

8.1.1 The coursed rubble masonry is generally in fair condition, although in some areas hard cement pointing has remained intact while the adjacent stone has weathered. Open joints are evident at low level on the north buttress and beneath the window, and these require repointing. See note regarding the coping in section 6.1, pictured here.

8.1.2 There is staining to the stone that indicates water may overflow onto this elevation from the parapet, though evident, it doesn't have appeared to deteriorate the condition of the stone or pointing.

8.1.3 The low-level iron ventilation grille is broken and needs to be replaced<sup>15</sup>.

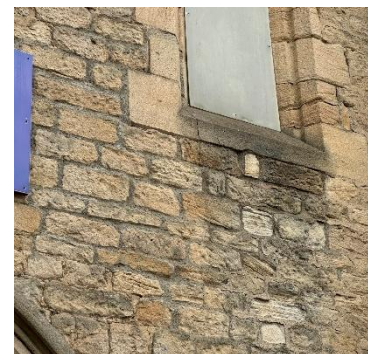
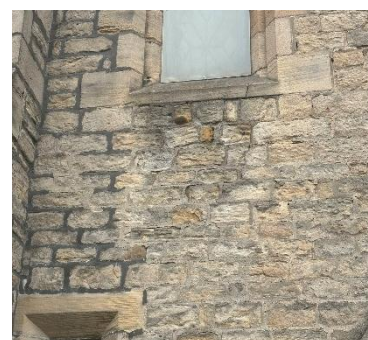
- 8.2.4 There are signs of former fractures around the large lancet windows, notably from the bottom right-hand corner of the north lancet extending towards the small rectangular window below, and at the lower left-hand corner of the south lancet. These should be monitored, as they may reflect similar structural movement<sup>17</sup>.

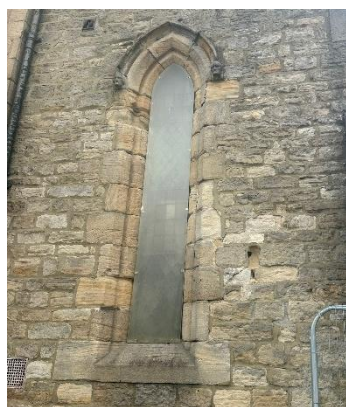
Figure 15 – S side of lancet & cill

8.3.6 On the south side of the lancet window there is an area of eroded stonework, with pointing that is unsightly and inconsistent. One stone in this location now requires replacement.<sup>19</sup>

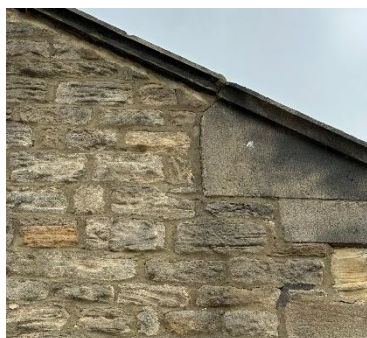
Figure 16 – SW Kneeler

8.3.7 There is a crack that runs up from the kneeler where it looks as if this stone may have moved, causing a gap in the coping, this should be pointed or re-set as required<sup>20</sup>.

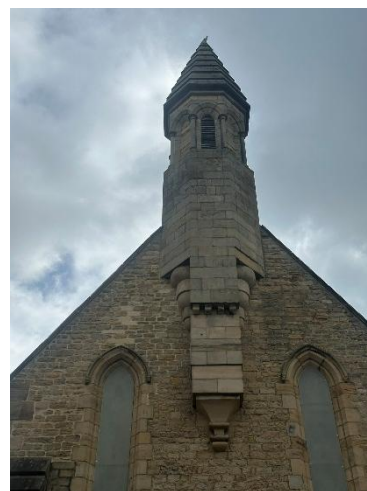
Figure 17 – Bell turret

- 8.4.2 The stonework is generally in good condition; however, one or two stones have lost their face (possibly due to incorrect bedding), and a past repair is evident where a stone face has previously failed. On the bottom right-hand side, above a corbel, a corner repair is visible which appears vulnerable and may break loose. Several of the larger stones above the corbels appear similarly bedded, and their condition warrants closer inspection<sup>21</sup>.

- 8.4.3 Two timber louvre blades are missing and require replacement in the south and east openings, a number of others have slipped which need fixing<sup>22</sup>.

- 8.4.4 A close inspection of the turret masonry was recommended at the last inspection but has not yet been undertaken; this is now overdue and should be arranged to inform future repair needs.

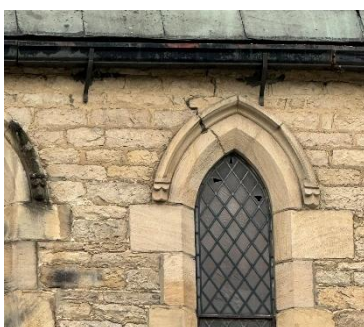
Figure 18 – Crack above lancet

8.5.2 As previously noted, there is a crack above the sixth lancet from the west which needs to be re-pointed and monitored for any progression. It appears though there may be a similar crack to the far westerly lancet and this should also be pointed and monitored as it was not previously highlighted.

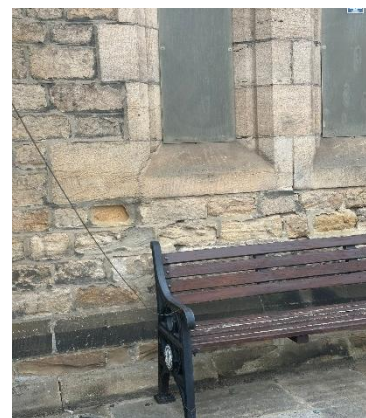
Figure 19 – second bay erosion

- 8.6.3 **Second Bay**: This bay shows similar deterioration, with extensive erosion below sill level. Approximately 3 m<sup>2</sup> of walling requires repointing, particularly beneath and around the window cills, where a large open joint is also present to the right-hand side of the sill and the buttress.

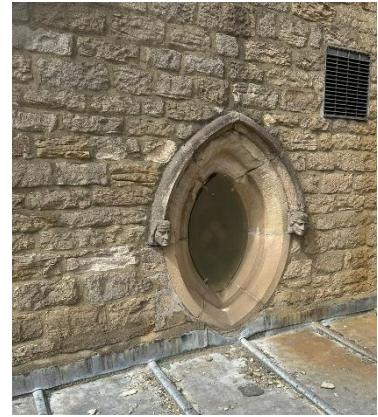
Figure 20 – East return window

- 8.6.6 **East Return Wall:** This contains a vesica piscis window. The wall is generally fair, but the moulded crown stone of the window arch is heavily eroded and has previously been mortared over. A few open joints at the head require re-pointing<sup>25</sup> as they are likely contributing to internal staining and water ingress. An open coping joint above this location also requires attention.

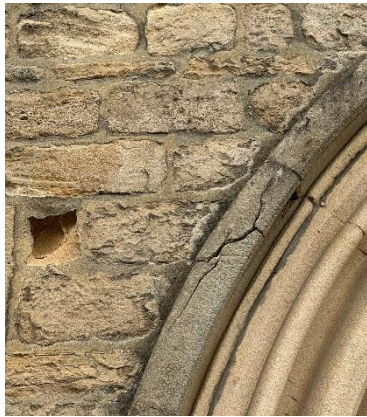
Figure 21 – Hoodmould and erosion

- 8.7.1 The fabric of the South Porch is of similar construction to the South Aisle. Large areas of the stonework are eroded, in places up to 25 mm deep, with deterioration accelerated by past repointing in hard cement mortar. In the long term, replacement of the most decayed stones will be required soon, as erosion is likely to continue. As a short-term measure, selective cutting out and repointing would improve condition. On the west elevation approximately 1.5 m<sup>2</sup> requires repointing<sup>26</sup>.

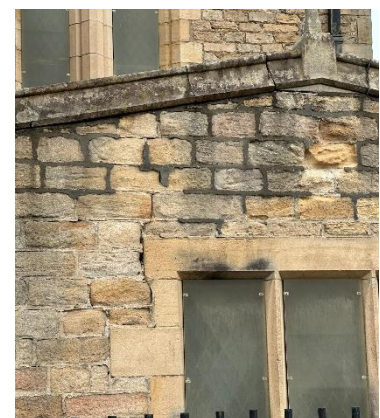
Figure 21 – WCs south elevation

- 8.8.1 The Vestry extension at the south-east corner is constructed in stonework similar to the main church, with a shallow gable facing south and the former boiler room located beneath. Some areas remain in poor condition.
- 8.8.2 **South Elevation:** The stonework shows widespread erosion, with some stones decayed up to 30 mm deep. The crown coping has shifted and requires re-setting (as per item 6.8.4). Much of the pointing is open or badly recessed, and earlier use of hard cement mortar has exacerbated decay. The majority of this elevation requires repointing in the near future<sup>29</sup>, and the overall condition is poor. The top left-hand corner of the window has very open joints, symptomatic of some movement, that need

to be filled with an appropriate lime mortar and monitored. There is a minor fracture to the stone below the corbel but not currently of concern.

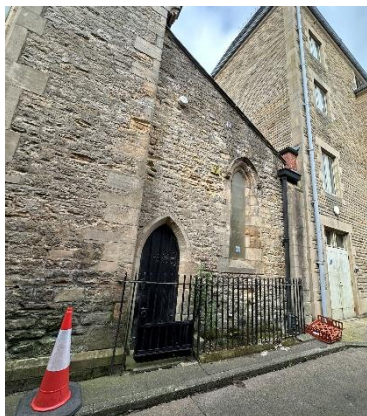
Figure 24 – E vestry

the stonework is damp and green, largely due to the previously blocked rainwater hopper. Past repairs in hard cement mortar have contributed to decay, and there are several open joints requiring sympathetic repointing. The stonework above the lancet is also eroding and there are open joints at the hoodmould which is causing deterioration of the plasterwork internally, which is damp – see section 17. The waste pipe serving the internal sink is missing and should be reinstated urgently<sup>34</sup>, even though this sink is reportedly not used. The surrounding area also needs vegetation clearing.

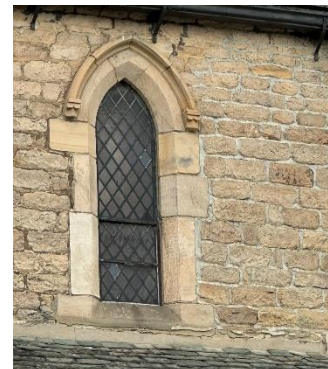
*Figure 28 – Clerestory window*

9.5 **South Clerestory** - The lancet windows are in reasonable condition there are several broken panes and replacement quarries, and the ferramenta requires painting. It is assumed that the metal hoppers do not open<sup>36</sup>.

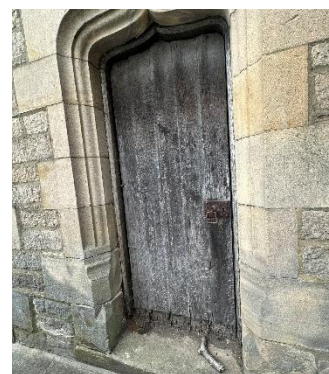
*Figure 29 – WCs door*

- The side doorway on the east elevation is set beneath an ogee-headed lintel and moulded stone surround, both in good condition. The timber door is oak boarded and in very poor repair. The threshold piece has come away (as noted at the last inspection), and the lower boards are now extensively decayed.<sup>39</sup>

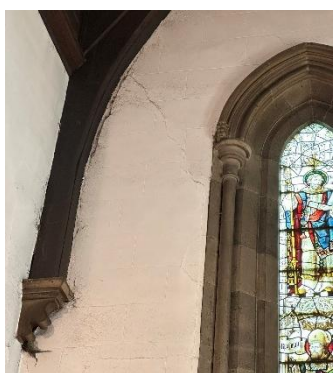
*Figure 48 – crack to LHS of E and rafter closest to E wall*

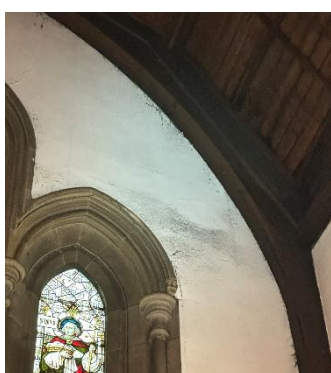
*Figure 49 – staining to SE*

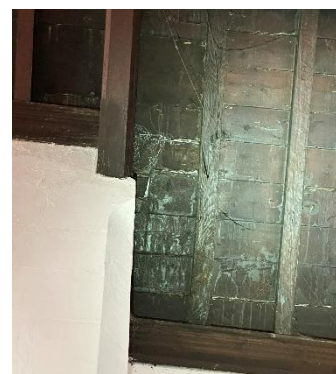
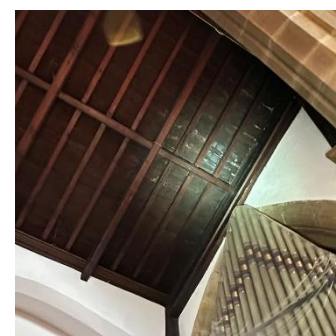
**14.1.1** There are further marks on the boarding at the extreme west end, a problem also noted at the last inspection. This was then attributed to defects in the west gable masonry and roof slating, which were repaired. However, staining remains evident, and similar marks are now also present at the east end. Both gables require areas of repointing, and once these works are undertaken, the condition should continue to be monitored. During future

*Figure 51 – Staining at mid N Aisle*

*Figure 52 – Staining at N Aisle E end*

roof works, a closer inspection of these areas would be prudent to establish both the cause of staining and the condition of the timbers.<sup>46</sup>

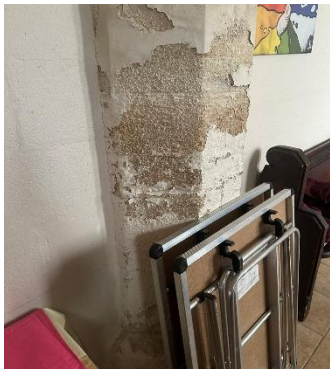
Figure 56 – Columns with damp issues

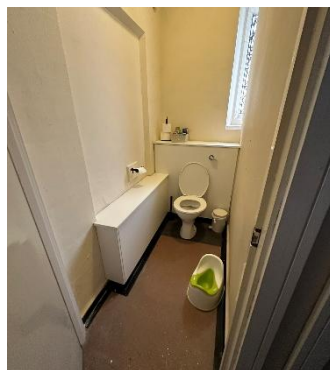
Figure 57 – WC area where floor had temp repairs

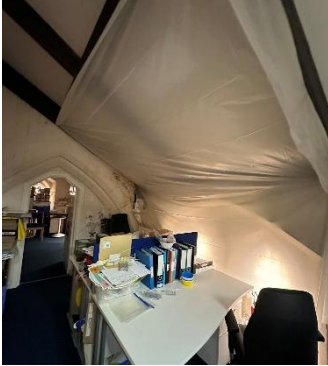
16.1.1 The South Aisle roof structure is closely visible at this level. It is currently covered in polythene sheeting to channel roof leaks into receptacles, but this is a temporary and unsatisfactory measure. The structure remains just intact but will soon deteriorate further as damp leads to rot. Daylight is visible through parts of the ceiling boarding. Urgent external roof repairs are required (see section 6).

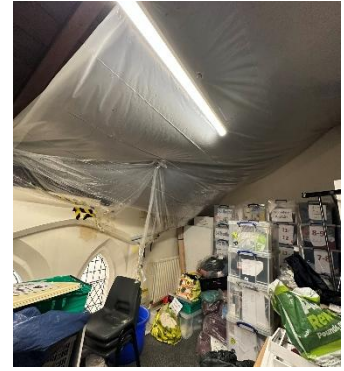
Figure 58 – ceiling S aisle W end

16.1.2 In the east room, the under-boarding to the ceiling is concealing damage from roof leaks. The rafter covering timber adjacent to the wall sounds hollow and may indicate rot within the structural timbers. This represents a serious risk, requiring urgent remedial action.

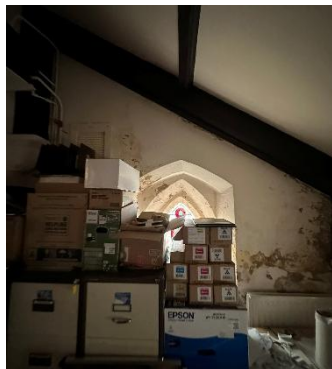
Figure 60 – damp to E wall

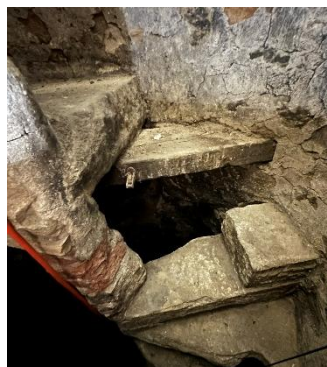
*Figure 67 – missing step*

20.2 Staircase Stonework - The walls of the staircase are of rough rubblestone and generally in fair condition. The steps are mostly ok except for the top five, which are broken, missing, or badly eroded. A timber board has been substituted for one step. Consolidation of the stonework below the access hatch is also required. The defective steps should be replaced and consolidated within the next couple of years.

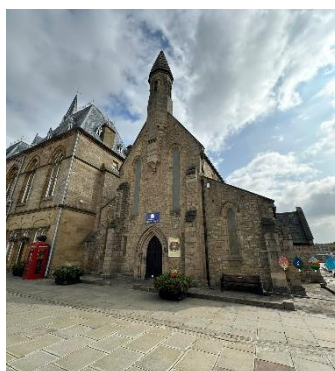
*Figure 37 – cracking to W wall*
