Stanley S Andrew

St ANDREW STANLEY

QUINQUENNIAL REPORT

19 October 2021

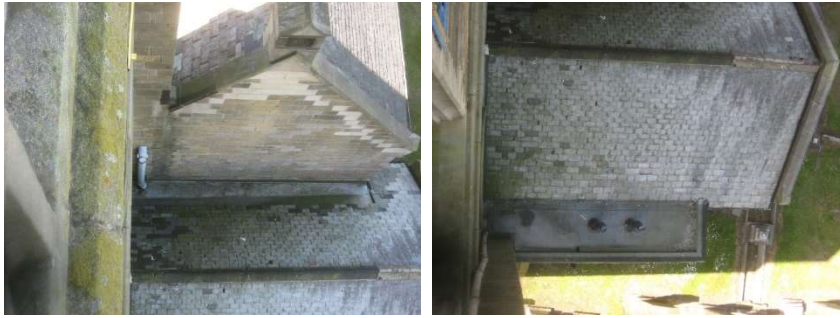
paras 16 - 18

16. The valley outlets were enlarged when it was relined 2001. A lead-lined W outlet chute goes straight through the turret masonry. The E bottom outlet has a very large cage and little silt. Its internal pipe goes round the Tower masonry and emerges over the Choir Vestry valley.

17. Choir Vestry good green westmorland. Substitute flashings against Tower carried over slates. Cover flashings at N upstand are painted. A few broken slates at E near ridge and one broken at W eave.

Repair broken slates both sides of Clergy Vestry, clear its gutter against Aisle end, renew its E plastic gutter	17, 18, 25
Check clock time, adjust if needed	41

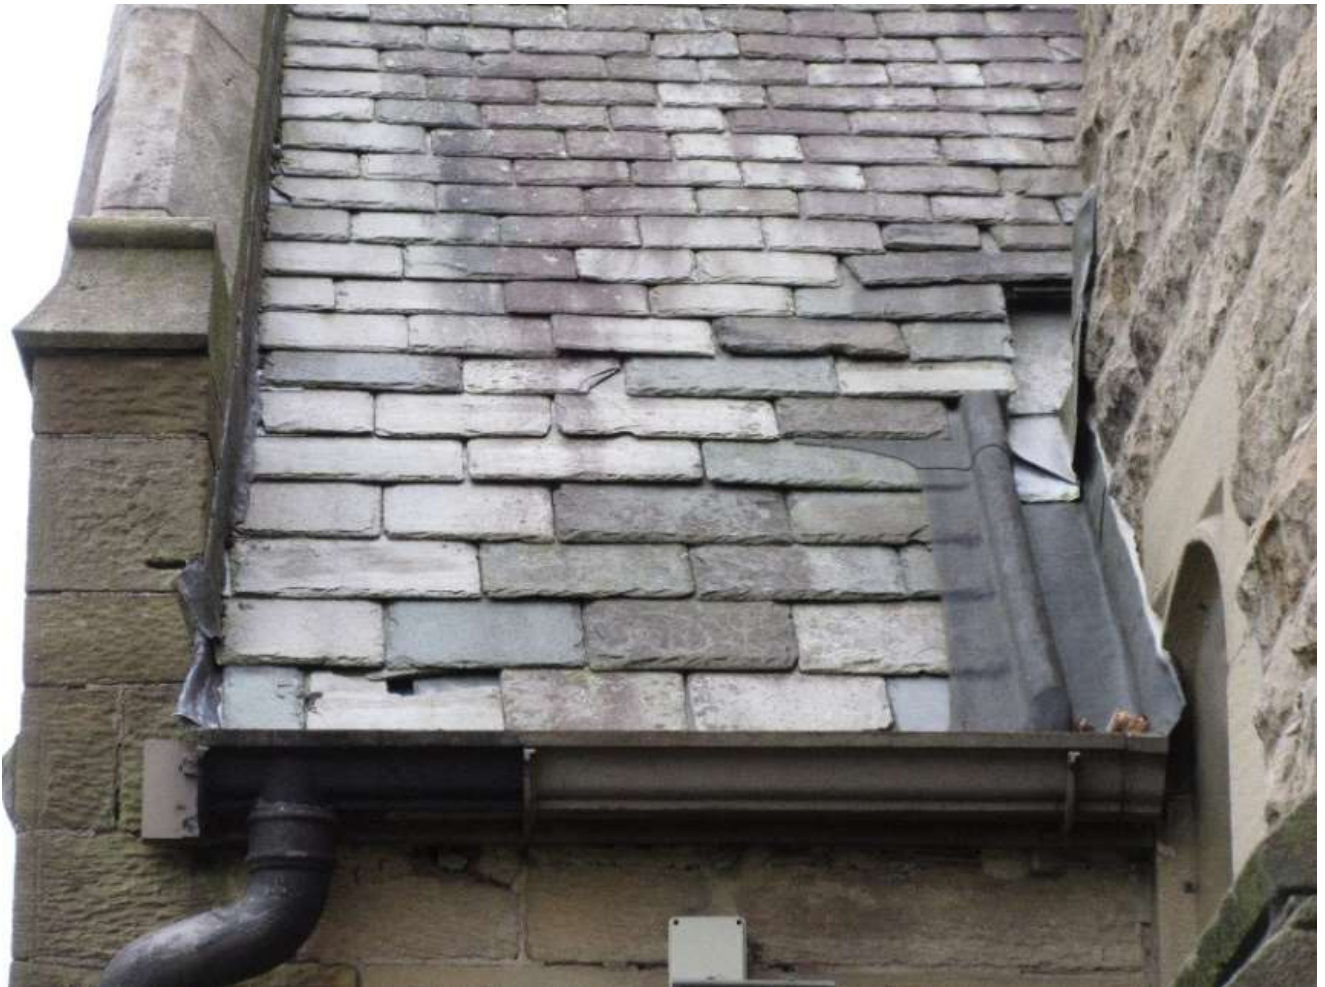
Choir vestry W side

18. The long one piece abutment gutter against the Aisle E end said to be relined in lead 2001. It appears too long but it is well shaded so may avoid some of normal summer expansion. It may be well washed by the piped flow from the main valley but should be kept clear. A water mark on the Vestry ceiling (para 59) should be kept under observation in case a leak remains.
The gutter outlet is a deep chute of mixed metals let into the Vestry W slope.
19. At E side two vertical flues pass through a narrow felt flat roof over the basement stair.
20. Clergy Vestry good green Westmorland. Substitute flashings against Tower and its buttresses, carried over slates. At S upstand lead cover flashings have disguise paint at E side only.
21. Small flat roofs E of both Vestries refelted 1991.

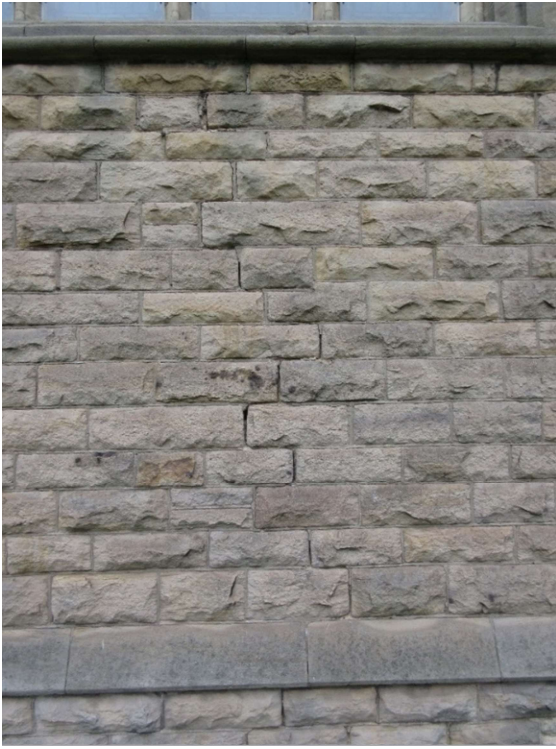
cracked joints at Nave W gable – para 32

32. W gables - have watertables on damp proof courses. Stone and modern lime pointing above string good. Below string stone and older narrow ribbon pointing good but very minor cracked joints below Nave cill due to spread.
Bell turret masonry good but moss high on the W side. Said to contain a disused single bell.

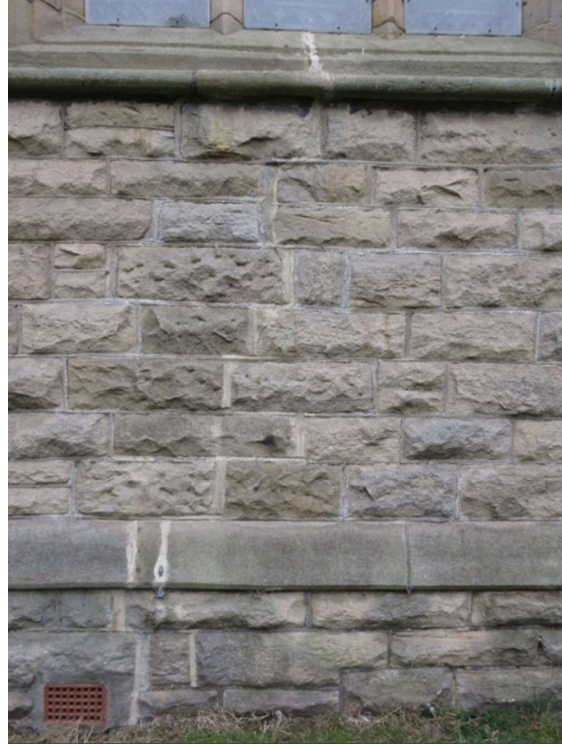
under Aisle NW window – para 33

33. Aisle N side – stone and pointing sound except:
 - Above and below W window roughly vertical cracks in stones and in wide vertical joints previously refilled have been cement pointed since the last report – very minor cracking again. Movement may be seasonal.
 - At 2nd window from W wide pointing at cill and joints below the cill, with very minor re-cracking of joints and cracking of stones.
 - Under 3rd window from W wide joints, not re-cracked.
34. Disused chimney on the Aisle E gable finishes as a simple square stone shaft with an open cap of stone slabs with side outlets.
Damp proof course under raised watertables with some visibly new masonry below.
35. Choir Vestry and Boiler stair – scattered very minor open joints.

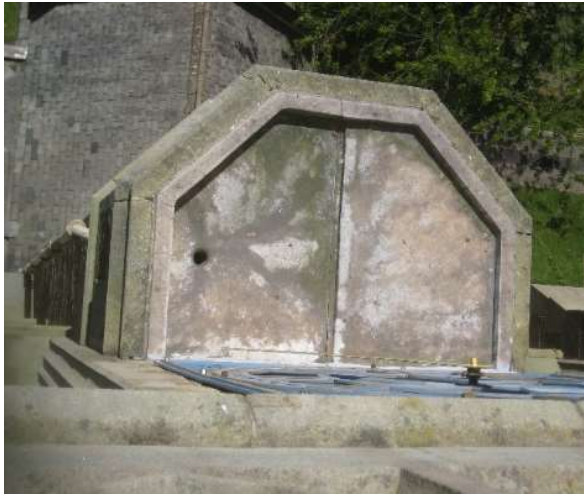
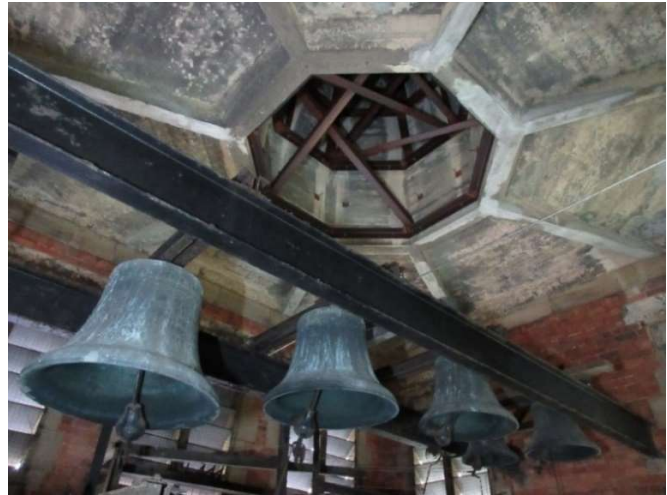
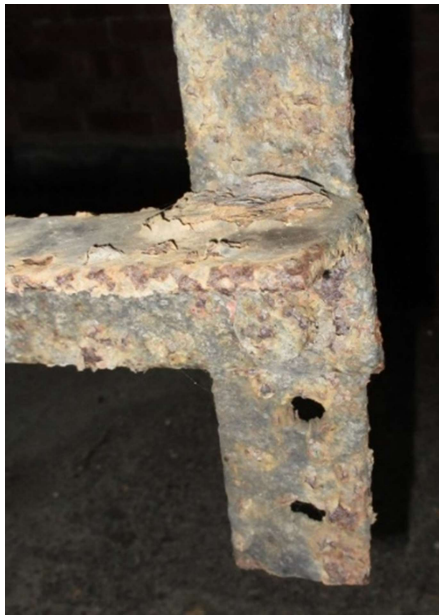
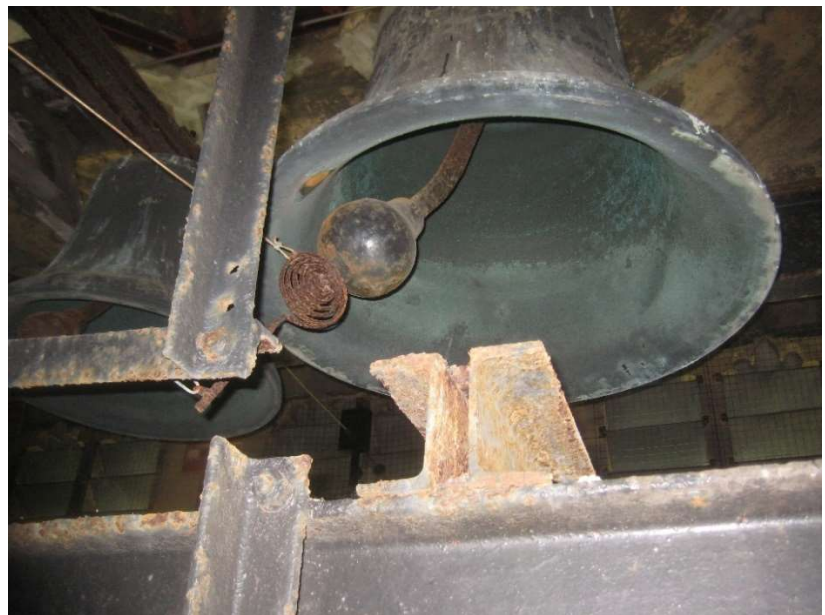
8. Clear signs of past spread and subsidence of the W end of the Nave and Aisle, but not of present movement.
9. The concrete needle spire has been covered in aluminium and Tower roof concrete repaired, braced and asphalted. In good condition when seen in 2016. Steelwork in the belfry (semi-exposed to the weather) now rusting more deeply and needs specialist stripping and repainting to preserve the bells and chimes.
10. The slate roofs are in good condition.

PART TWO

Rusting steels in Belfry

Strip, treat and specialist paint all steelwork in the belfry	9, 38, 39, 104
Repaint rainwater pipes N and S of Tower	22
Strip and paint handrails at Porch and steps at both Vestries	53 - 55

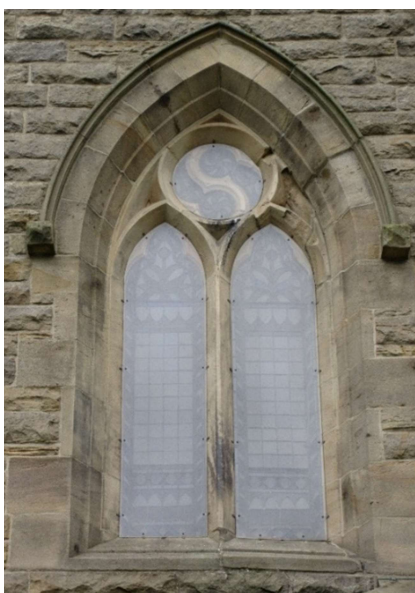
W end of Aisle – para 49

49. W end of Aisle – window fair but slight displacement of S tracery with loss of its outer face.
Door surround good but some hoodmould joints open.

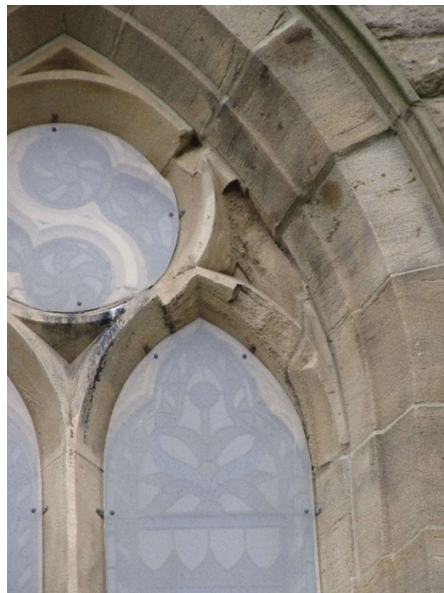
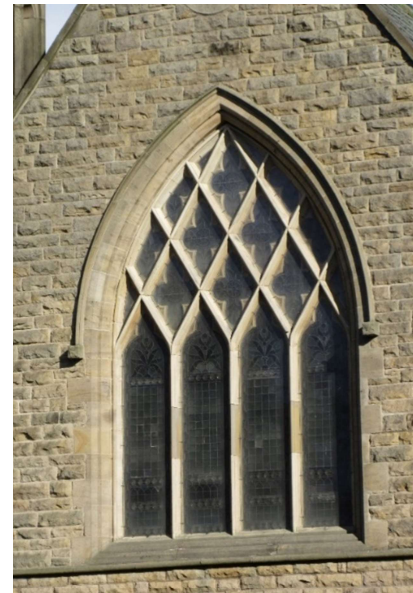
Nave W end – para 48

48. W end of Nave – lattice tracery, lime mortar pointed, good condition except open joints at cill and minor loss of one bead mould.

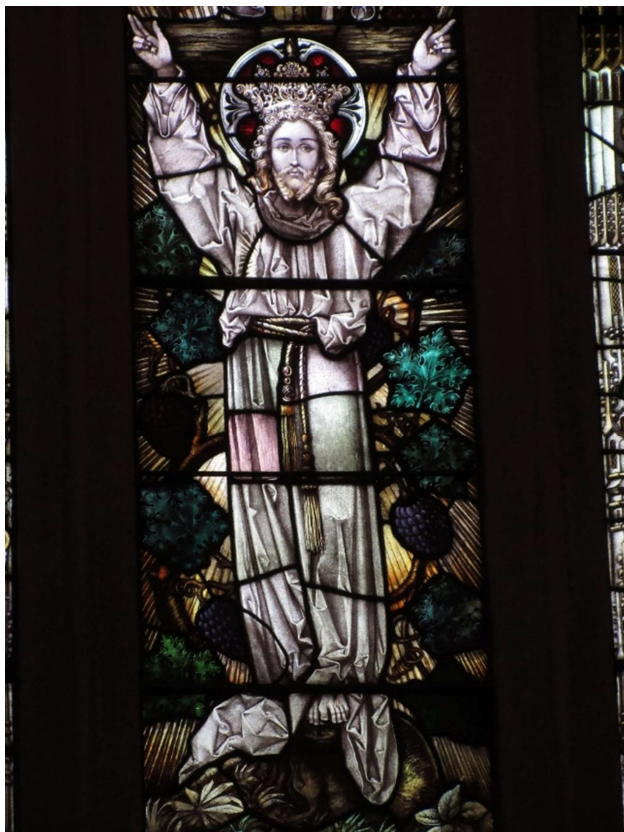
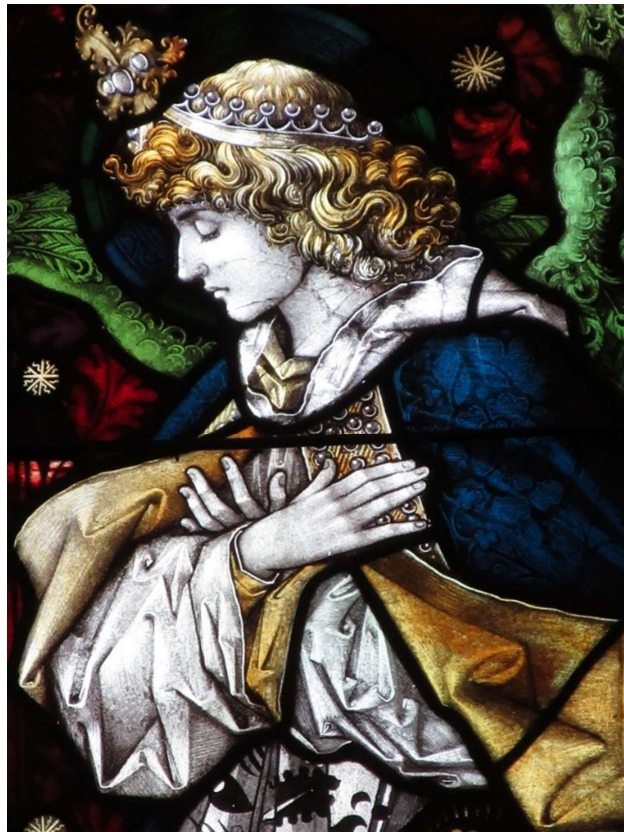
E lights

69. E – five light Bacon Bros cleaned and repaired 2016, small former repairs not all well coloured, sound.

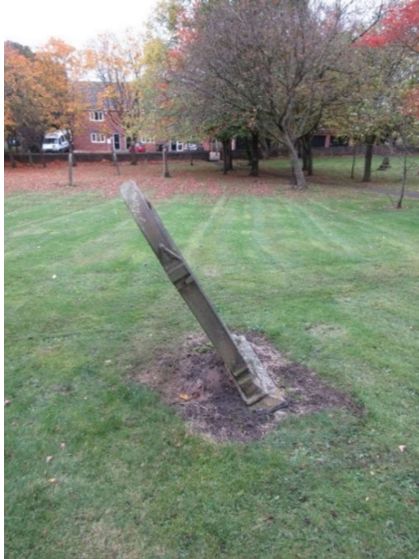
The Reed stone S of the Nave has a severe lean and appears unstable but was not tested.
