# **QUINQUENNIAL INSPECTION REPORT**

## **STOCKTON PARISH CHURCH**

**QUINQUENNIAL INSPECTION AND REPORT  
February 2022**

**David Beaumont BA (Hons) Grad Dip, RIBA, AABC**

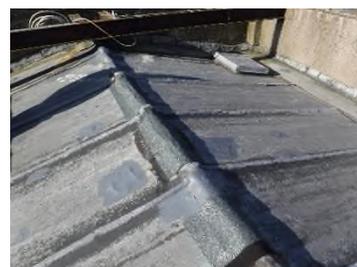
Lead roof is serviceable, old and patched, the mineral felt patches on the ridge look newish, all the flashings are all in place. The parapet lining in render is slight cracking but it

alright, the parapet capping is ok, some open joints. there are some weeds growing in it in the corner. The pinnacles look alright, the NE continues to lean out.

**Recommendation:** *paint beam (or remove if flagpole no longer retained, patch up wall top bitumen, repoint coping open joints. Plumb up the leaning finial.*

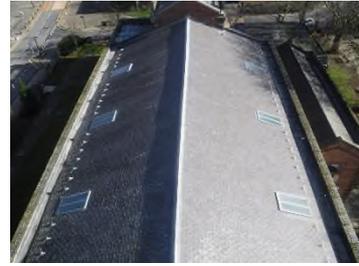
**B** **Nave roof:** Slating looks okay. This leads into lead box gutters. They seem fine although they do have cement pointing to the coping. The lead ridge looks okay, as do the copings.  
The roof has lead ventilators and access to gutters by roof lights.

There is a split at the W end in a patch which needs repair.

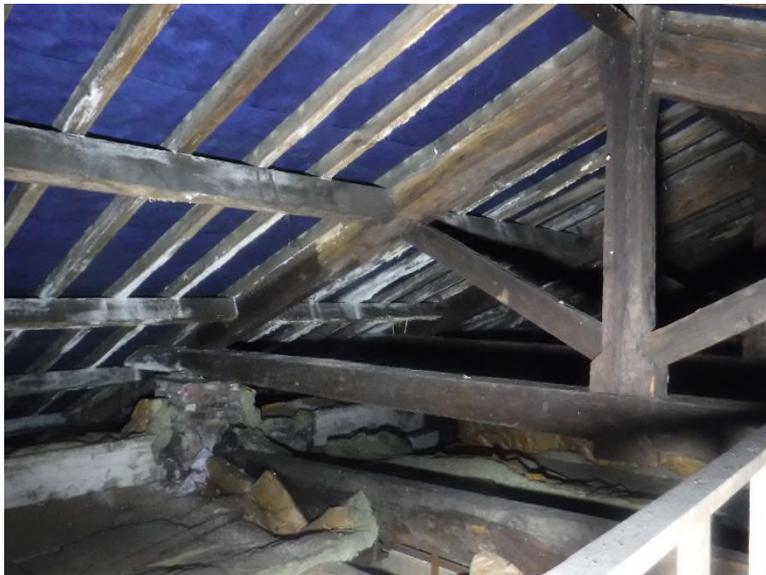
Salting showing on the rafters, particularly on the Northern side. Also, significantly at a collar across truss number 2 from the doorway, plus number 3 equally is salting and there looks to be some rot to the purlin as well. The condition of the rafters looks dramatic but is a cause of drying out? The third rafter in from the doorway has rot to its underside. This looks like it should be looked at in the future. An assessment is needed of all of the structure here. There is some woodworm to the base of the kingpost trusses, and it is not known whether that is still active (no mention of this in the 2010 QI). The aisles have had insulation placed over them, as have the nave, approximately 200mm thick. The West wall of the tower can be seen here and this has salting to it. The purlins do not go in very much and are bedded on timber in once instance

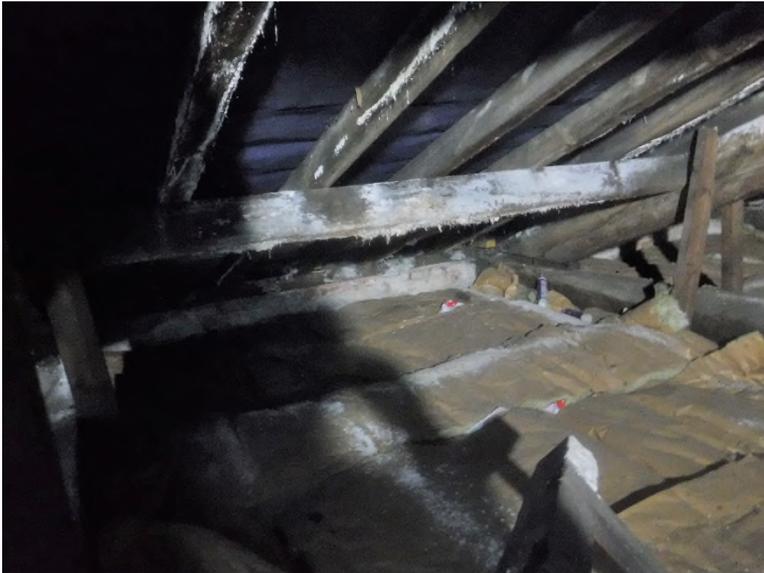
Salting seen at the last QI is still here. I do wonder if, because the roof covering has been renewed that we are seeing the wet in the structure from that time. The roof covering has ventilations up the slope and continuously at the ridge suggesting that ventilation has been introduced to assist drying out the roof?

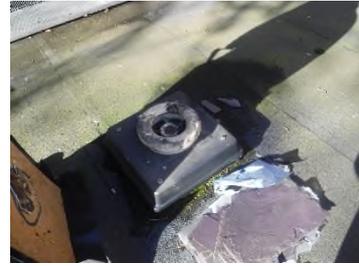
Boiler room: felt roof with blocked parapet gutter causing staining inside. blockage cleared at inspection.

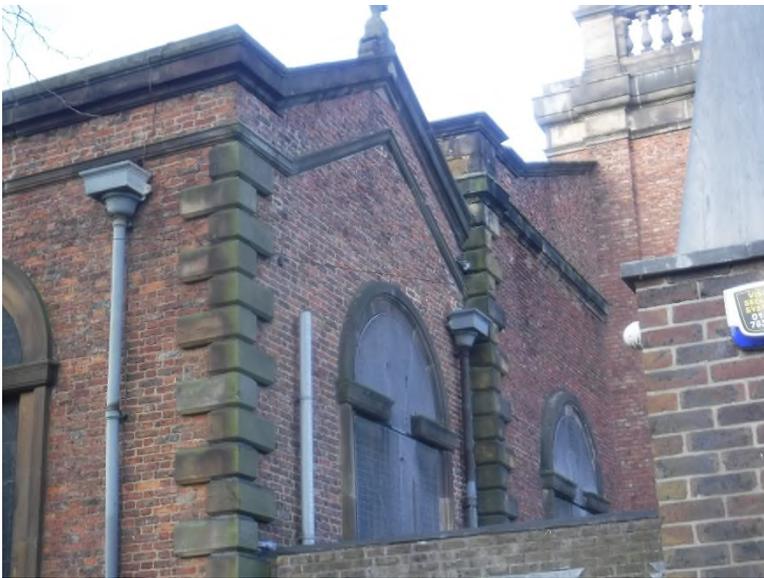
- C** ***South Aisle:** Rusting to collars at E end. There is a chute that seems too high from the hopper below it. This hopper goes down below and we know that there is a problem there with the cut out of the roof of the parish hall. The down pipe passes through the gap between the aisle and hall kitchen and the drainage at this point should be better understood. This was reviewed in 2017 and the pipe discharges to a below ground drainage system.*

***Recommendation:** check in rain that the chute discharges into the hopper, redecorate pipe.*

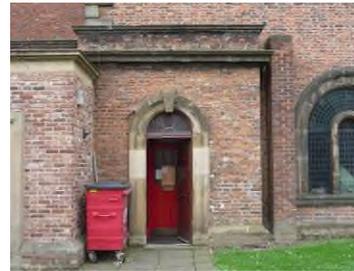
- **Outer Lobby:** Entrance doorway surround has had repairs in the past. The arch at the springing point is beginning to crumble. No action necessary now. Above that, the string course has open joints. There is a small flat roof above it. The walling has been botched but is generally sound. There is a small rusting metal pipe – establish if this is redundant. To the right of the porch is a brick stack former flue?

**Recommendation:** none

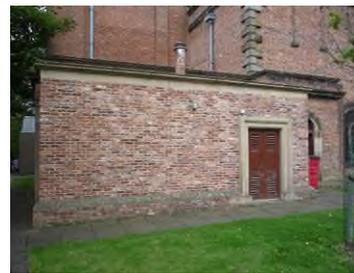
- C **Boiler Room:** A more recent addition. Flat roof – condition unknown – has a stone entablature with cornice. The brickwork does not match fully and it is all in cement but at least it is all clean. There was a lead flashing over the doorway that has been stolen. Also, on the Eastern elevation. The door itself has some broken ventilators and an open joint to the right-hand side of the doorway.

**Recommendation:** replace flashings, repair ventilators, repoint remove last of the lead over the boiler doorway and point up, provide tilt fillet on ashlar frame

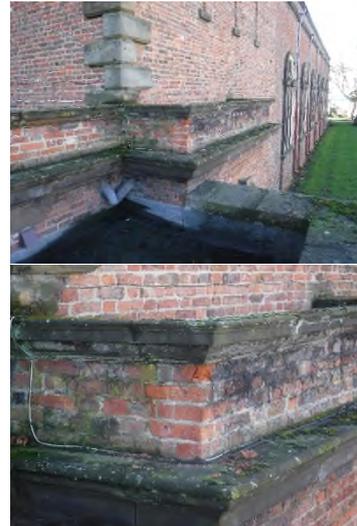
**C** **North aisle:** *The coping and string course has open joints. The brickwork below appears okay. The NE corner has a horizontal crack in the joint of the two frieze corner quoins suggesting slight structural movement- see cracked brick close by.*

**Recommendation:** *repoint and monitor crack*

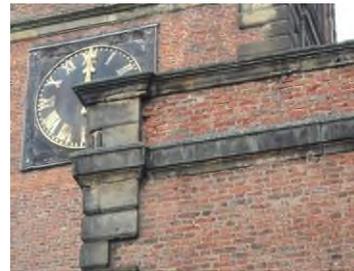
- C** **South Aisle:** Open joints to the cornice. The brick band below it has five or six broken bricks. The string course below that has open joints. The brickwork is generally the same as everywhere else, over pointed with cement. The middle window has a suggestion of a fracture on the left-hand side and that pointing needs doing. This area to the top of the window shows settlement, historically, although it is okay, just needs repointing. Downpipe areas have been repointed in lime like the N
- The Western corner at high level has open joints at the quoins. There is also some slight salting at the double doorway.

**Recommendation:** repoint open joints

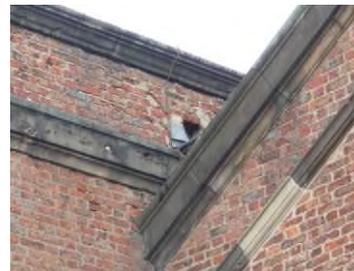
- C** **Lady Chapel (West elevation):** Raking cornice has open joints. The brick panel below it is okay. Slight crack between the two buildings. The door casing has been repaired in the past and it looks okay for the present.

Looks ok. Plant above the segmental head doorway.

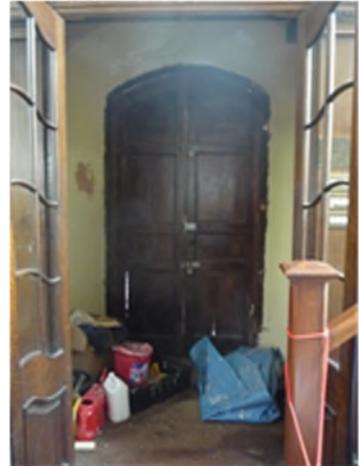
- B**
- **Nave west lobby:** The lobby is formed from a timber glazed partition- the doors are jammed. Within the space is various decorating lumber. It seems to be a disused secondary entrance and is not a means of escape. If it is, it needs clearing out.
  - Also the electric distribution board separated by a lightweight hardboard door. The exit doors are bolted, padlocked and the panels are shrinking in their frames.

**Recommendation:** repair doors, remove lumber

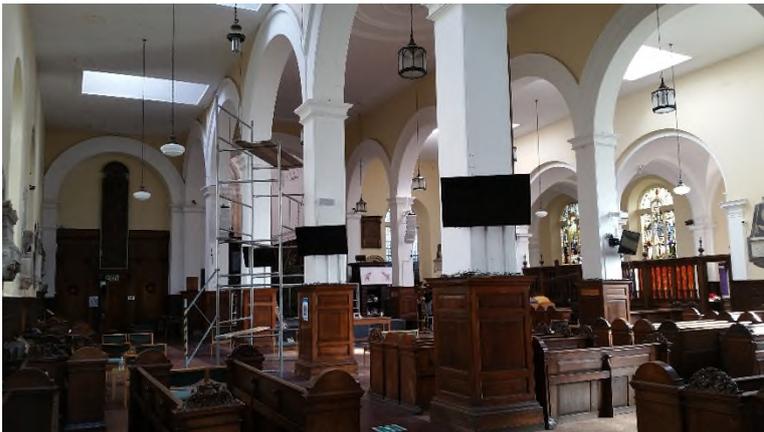
**East** - *There is an area of plaster breaking down at the nave junction of the Lady Chapel outer aisle, probably as a consequence of the roof junction on the outside.*
