St MICHAEL SULGRAVE

Washington

QUINQUENNIAL REPORT

14 March 2018

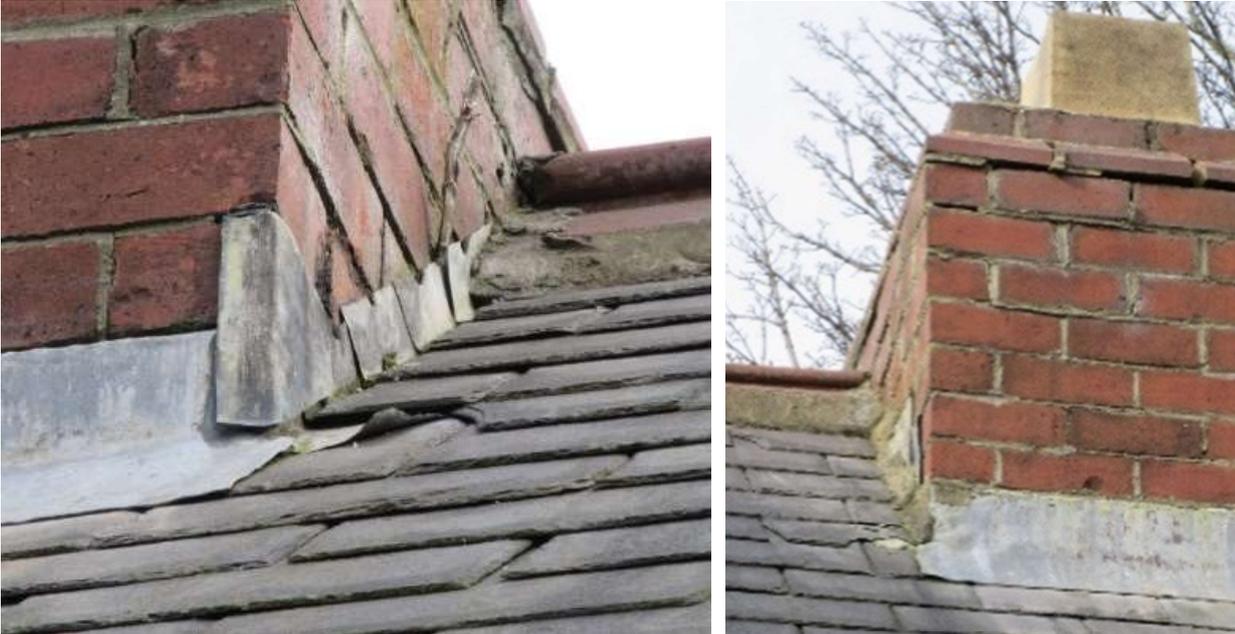
10. The **Chancel** and **Nave** roof is fair both sides. At S there is an uneven patch W of the Chancel arch at a former vent or turret, where one slate is slipping and one is on a lead clip. Any future repairs would be better with stiff copper clips not soft lead.
11. The lower **offshot** meets the Nave roof with fair lead valleys and stepped abutment flashings. Offshot slate good. Stepped lead flashings on soakers around the chimney. At the chimney SW and SE sides the cover flashings are all or part missing. At W a piece of flashing lies in the gutter and a stick is lodged in the remaining leadwork.

Lead cover flashings missing from both S sides of the chimney

Fit new lead cover flashings at SE and SW sides of chimney unless chimney to be demolished	11
Clear gutters and refix outlet and pipe at offshot W side and Nave NE pipe	12, 13, 14
Check any urgent electrical improvements (June 2017 report) have been completed	64

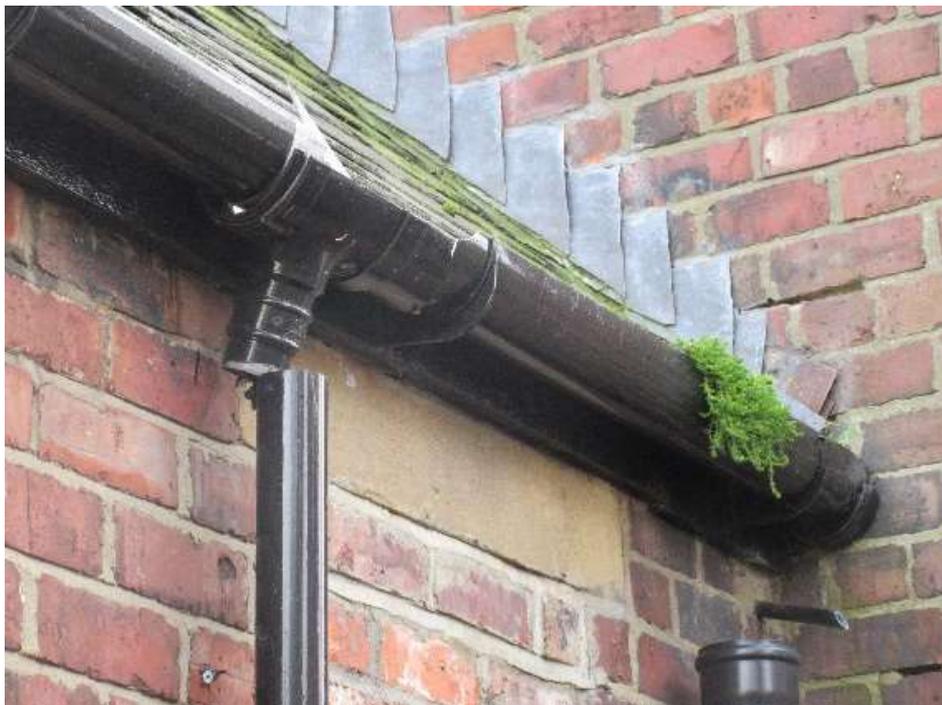
W side of offshot – outlet disconnected from gutter and pipe and gutter blocked

13. The offshot W outlet is loose from the gutter and pipe, spilling water into the brickwork.

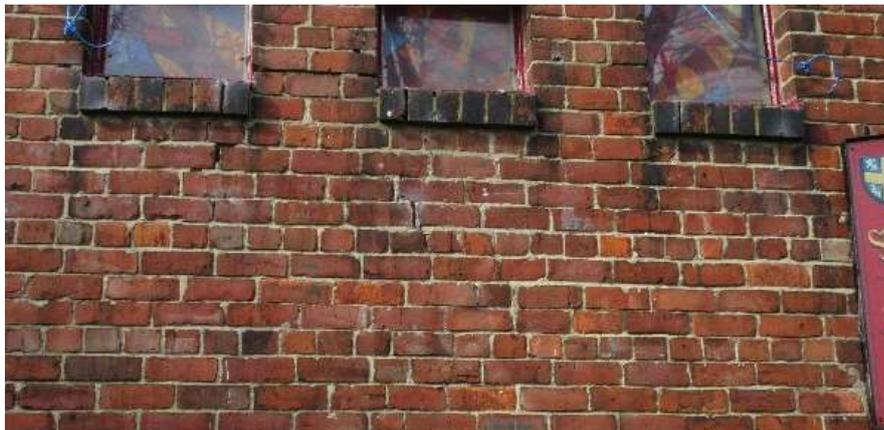
19. The E gable brickwork is good but slightly bellied out from vertical at cill level where some cracking of joints in and below the brick-on-edge cills and of two bricks below the cills. A cherry tree by the boundary wall is about the recommended 6m away so only in severe drought might also influence the wall's foundation. Two other trees formerly near the gable have been removed.

20. A difficulty is that once a wall is bellied the outer edge of the foundation becomes more highly stressed so movement could continue even after trees are removed. Deep raking and pointing the cracked joints could help trace whether the wall is stable or bellying continues.

Replace slipping slate at N verge of chancel	10
Rake and point tops of four buttresses, the window cills at E and N Chancel and E of offshot, around Nave NE pipe and under the E gable windows	14, 18, 19, 20, 27
If the chimney is to be kept rebed loose bricks at top of S side	23
Paint window cills at S and W Nave and cut out and repair rot at one W cill	31

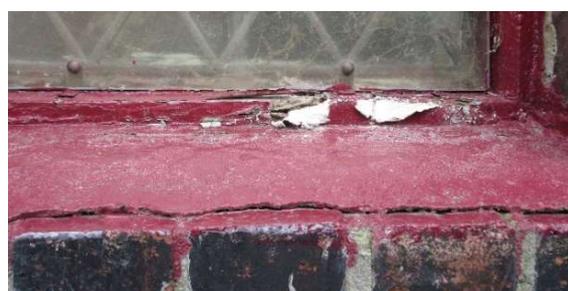
decay in a Nave W cill

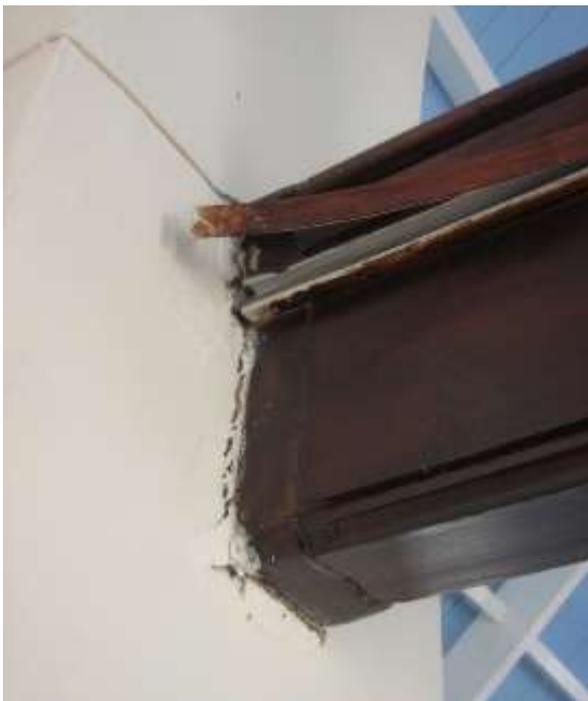
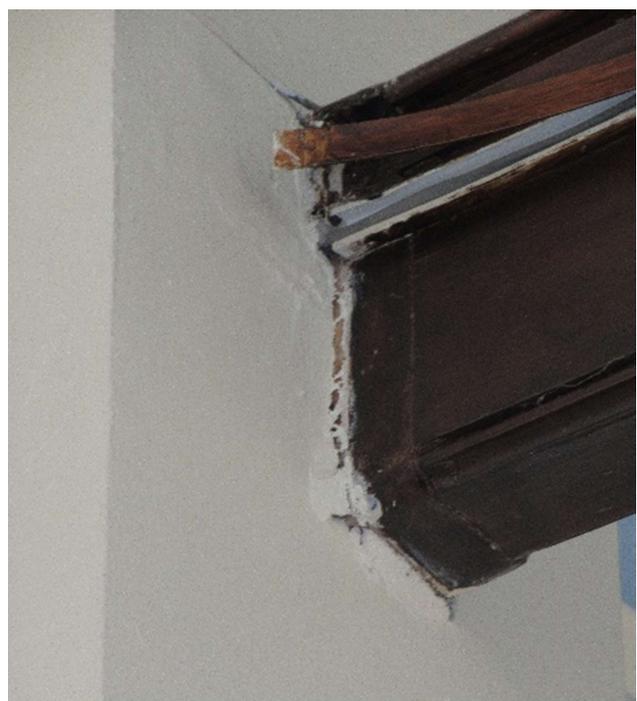
37. A plain round Chancel arch in the plastered brick without embellishment. Below the springs a timber rood beam with dressed mouldings and cross is built into the opening. In the past its S end pulled out of the plaster and a 43mm long infill of the moulding was inserted. In 1997 the infill was found further pulled 4mm out of the plaster. No further movement visible since 1997 or at present.

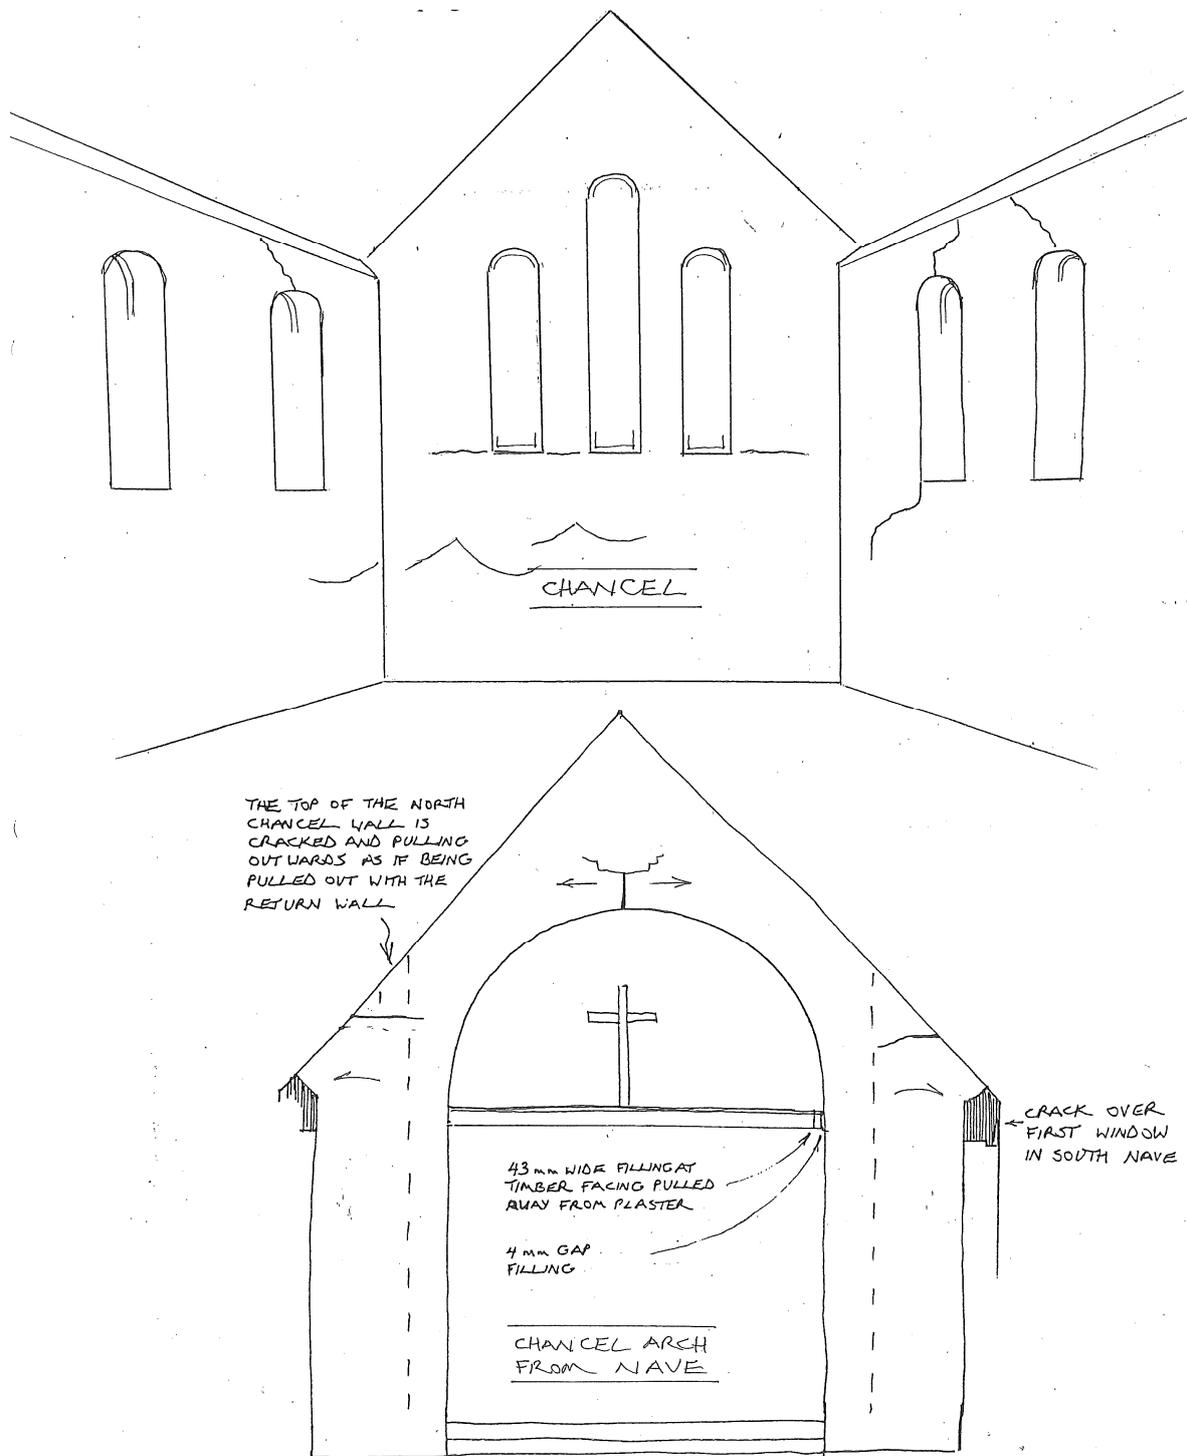
CHANCEL MOVEMENT CRACKS 2018 (very similar to 2007)

- under the Chancel SE window
 - horizontally E of the Chancel NE window cill
 - under the soffit of the crown of the Chancel arch and a short way up both facesOverall it appears the building is not moving further but seasonal movement continues to open and close the cracks. See paragraphs 37 - 39.

38. Plaster cracks at the Chancel arch and Chancel windows and walls have been recorded in past reports and have appeared stable since at least 1992. The whole interior was filled and decorated in 2011. Most cracks previously visible have reappeared, suggesting the building is essentially stable but that some parts flex slightly with the seasons.
39. As an aid to future inspections a 2007 record sketch is repeated below with minor additions. A crack over the Chancel SE window has appeared. One further hairline crack between two Chancel cills is added.

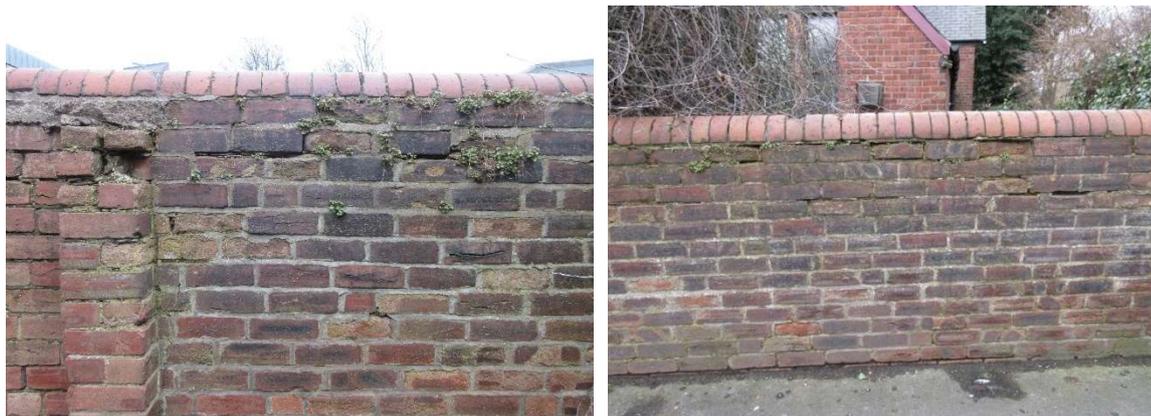
79. Enclosed all sides by brick walls with piers. The higher W and N walls with half round copings are of fair quality except patches of decayed bricks and joints with some plants both sides. Raking and pointing soon would prolong the life of the bricks.

part of the N wall – inside and outside

Repaint bargeboards and bell timbers	24, 29
Rake and point open joints in garden walls, replace decayed bricks	79
Obtain a five yearly electrical test report in June 2022	64 and Addendum
