# Quinquennial Inspection Report

Holy Trinity Church  
Swalwell, Tyne and Wear  
Diocese – Durham  
Archdeaconry – Sunderland  
Deanery – Gateshead West

**Date of report:** 4 March 2022

**Ref:** 21027 A

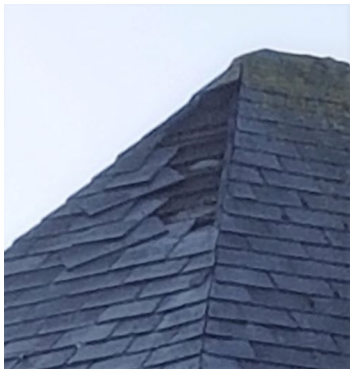
<p><u>Chancel</u> Ridge stones – solidly bedded and pointed Slating – missing slates at the apsidal end due to recent storms (see photo opposite).</p> <p><u>Nave</u> Ridge stones – solidly bedded and pointed Slating – some slipped, rotated and missing slates on the south slope.</p> <p><u>Porch</u> Ridge – solidly bedded and pointed Slating –all slates intact on north slope; south side and valley gutter not visible from ground level.</p>	
Repair needs	Replacement of missing slates; refixing of slipped and rotated slates.	B
<b>2.2 Rainwater goods and disposal systems</b>		
<p>Condition</p>

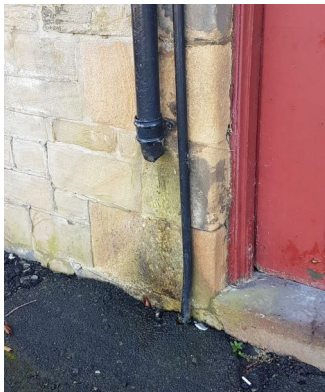
<p>Comprise cast iron half round gutters and circular downpipes.</p> <p><u>Porch</u> Downpipe terminates approx. 600mm above road surface resulting in splashing onto the stonework (see photo).</p> <p><u>Nave</u> There are leaking joints on the south side.</p> <p><u>Chancel</u> The gutters are leaking at the joint resulting in splashing of the walls at low level.</p> <p><u>Generally</u> The gutters have flaking paint and the gutter and downpipe joints are in need of re-caulking.</p>

Repair needs	Extending Porch downpipe to discharge at ground level	C
	Recaulking joints and redecoration of the rainwater goods.	C

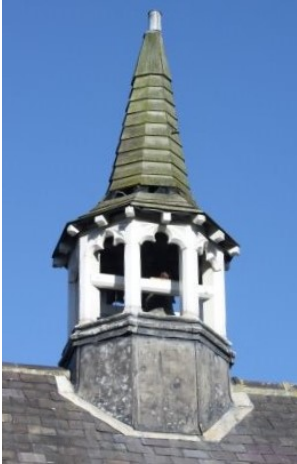
<p>The fleche has a slight lean towards the east. This should be monitored.</p> <p>Some cedar shingles are missing from fleche on the south and south-west sides. These should be replaced to prevent water ingress and timber decay.</p> <p>The painted timber framework and lead cladding to the base appear in fair condition.</p> <p>There are no louvres to the open bell structure to prevent water ingress and prevent birds nesting. It is recommended that louvres are fitted.</p> <p>The bell is understood to chime. NB The bell and mechanism could not be inspected due to the height.</p>	<p>F</p> <p>B</p> <p>B</p>
<p><b>2.4 Parapets and upstand walls, finials, crosses and chimneys</b></p>		
<p>Condition/ repair needs</p>	<p>There are no parapets, upstand walls, finials or crosses.</p> <p>The brick chimney which acts as a flue from a boiler appears in fair condition. The stainless-steel flue liner terminal appears intact at the head of the chimney.</p>

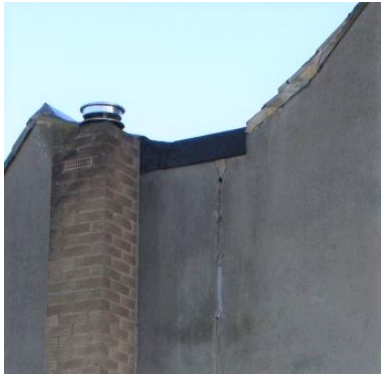
<p>Cracked render and verge pointing</p>

<p>Ribbon pointing in hard cement</p>	<p><u>West gable:</u> The render is generally sound, but the following defects were noted: - - vertical cracking to right hand of the centreline - vertical cracking to the right of the chimney - some cracking to the verge of the Nave north roof slope</p> <p><u>North wall:</u> The stonework and pointing are generally sound, but the following defects were noted: - - some decayed stone jambs to boiler house door - some loose ribbon pointing and open joints at low level of the boiler house - some loose ribbon pointing and open joints in the wall below the external steps - open bed and perpend joints to dwarf wall and coping</p> <p><u>East apsidal walls:</u> The stonework and pointing are generally sound.</p> <p><u>South wall:</u> The stonework and pointing are generally sound. However, defects were noted as follows: - - some stones with surface decay caused by hard ribbon pointing (see photo opposite). - surface decay to one of the door jamb stones</p>

Repair needs	<p><u>West gable:</u></p> <ul style="list-style-type: none"> <li>- rake out and repair render to crack to RH of brick chimney</li> <li>- fill cracks in verge</li> </ul> <p><u>North wall:</u></p> <ul style="list-style-type: none"> <li>- rake out and repoint open and loose pointing in lime mortar</li> </ul>	C
		C

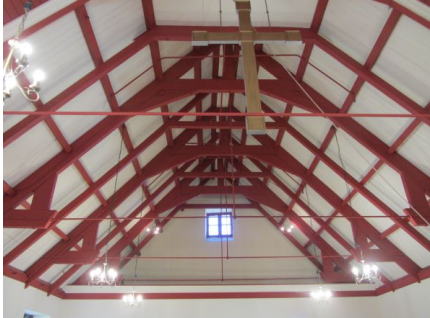
<p>Nave roof structure</p>	<p><u>Chancel and Nave:</u> Painted boarded ceilings, exposed purlins and exposed sections of trusses all appear in good structural and decorative condition.</p> <p><u>Kitchen, toilet and passage:</u> Painted plasterboard ceilings - in good structural and decorative condition.</p> <p><u>Porch:</u> Painted boarded ceiling and exposed rafters - in fair condition.</p>	
<b>3.2 Presence of bats etc.</b>		
<p>Comments</p>	<p>No evidence of bat droppings found internally. However, this does not necessarily mean that bats are not present. See Section 6.0 for sources of information should they be found.</p>	
<b>3.3 Internal wall finishes</b>	<p>See item 1.7 for window masonry.</p>

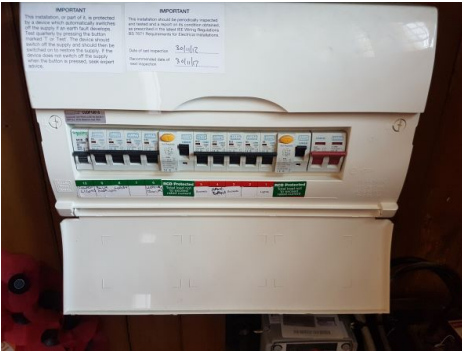
<p style="text-align: center;">Distribution board</p>

<p style="text-align: center;">Chandelier</p>	<p><u>Power supply</u> The meter and distribution board are located in the entrance porch. The distribution board is a modern type with plastic casing, MCB and RCCD protection (see photo).</p> <p><u>Light fittings</u> comprise: -</p> <ul style="list-style-type: none"> <li>• Chancel             <ul style="list-style-type: none"> <li>• 2No chandeliers with 3No light bulbs each</li> <li>• LED spotlights</li> </ul> </li> <li>• Nave             <ul style="list-style-type: none"> <li>• 4No chandeliers with 5No light bulbs each</li> <li>• LED spotlights</li> </ul> </li> <li>• Gallery             <ul style="list-style-type: none"> <li>• 2No chandeliers with 3No light bulbs each</li> </ul> </li> <li>• Kitchen, toilet and passage             <ul style="list-style-type: none"> <li>• Ceiling mounted circular fluorescent lights in glass diffusers</li> </ul> </li> <li>• Emergency lighting             <ul style="list-style-type: none"> <li>• Comprises 'maintained' escape light bulkhead fittings above escape doors.</li> </ul> </li> </ul> <p><u>Socket outlets</u> are located in the Nave and Kitchen.</p> <p><u>Extract ventilation</u> is provided in the kitchen and toilet. The extract fan to the toilet does not appear to be working and should be repaired or replaced. The kitchen extract fan does not seem very powerful. Consideration should be given to its replacement.</p> <p><u>Testing</u> The electrical system was last tested in 2012. The system should be tested within the next six months and thereafter every five years.</p>	<p style="text-align: right;">B</p> <p style="text-align: right;">E</p> <p style="text-align: right;">B</p>
