Church of St James, Thorp Thewles

Quinquennial Report

On the architect's inspection of

1st February 2024

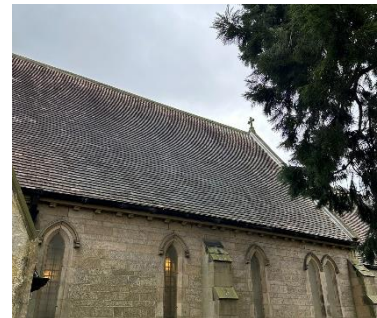
Figure 2- South Nave roof

- 6.2.1 Ridge – stone ridge which appears sound.
- 6.2.2 East abutment – reportedly masonry pointed to the water table. Water table jointing looks okay but lead flashing has been replaced with flashband, which is not a permanent alternative.
- 6.2.3 West Abutment- some slight open joints to water table, good lead flashing to the belfry.
- 6.2.4 General – clay tiling, several patched tiles, none match some are the wrong type and appear to not be well fixed. There are a number of areas where tiles are slipping, suggesting possible nail fatigue which will only worsen with time.

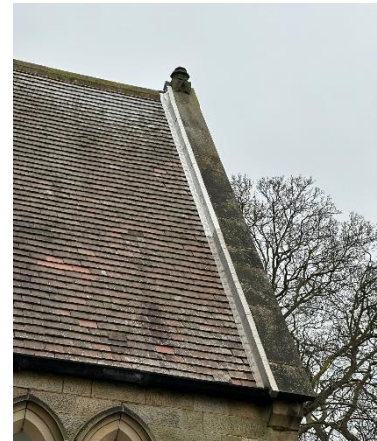
Figure 3- Chancel SE abutment

- 6.5.1 Ridge – mortar bedded stone ridge, mossy but sound.
- 6.5.2 West abutment – lead flashing is ok.
- 6.5.3 East abutment – lead theft resulting in ‘flashband’ replacement like the nave, this is taken over the top of the watertable.
- 6.5.4 Water table – has open joints and the apex stone appears to be slightly displaced.
- 6.5.5 General – tiles have several replacements in matching colour. One tile missing and will be liable to leaks. More than 10 other tiles slipping, mostly towards the lower part, the condition has worsened since last inspection.

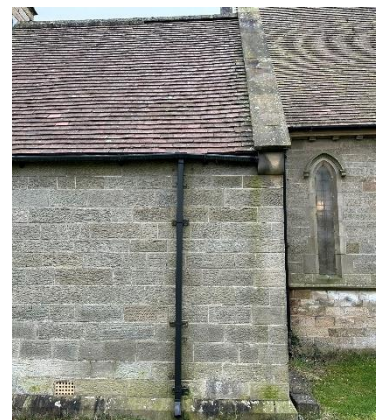
Figure 4 – Gutter joint to Vestry

7.3 **Vestry** – plastic gutters and downpipes. The gutter falls do not look correct, as the downpipe is at one of the highest points, to the west the gutter falls away significantly. A loose extension has been added to the base of the downpipe to try to make it discharge into the gully more efficiently, this is now loose.

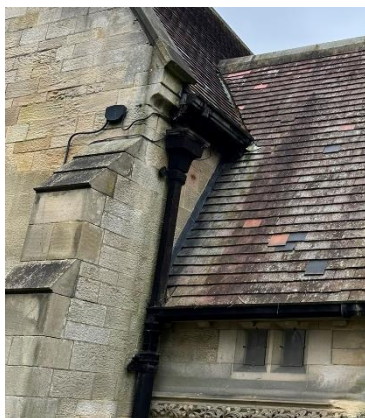
Figure 5 – Nave West section

- **West** (small section pictured at fig.5) - there is no pipe connecting the gutter outlet to the hopper head. The timber behind the gutter appears to be beginning to rot and requires maintenance. The downpipe has a foot but it looks too high, it may not discharge into the gully adequately. The gully was also covered with vegetation.
- **East** – gutter appears okay though there are cobwebs and moss growth at the brackets, indicating there could be some leaks.

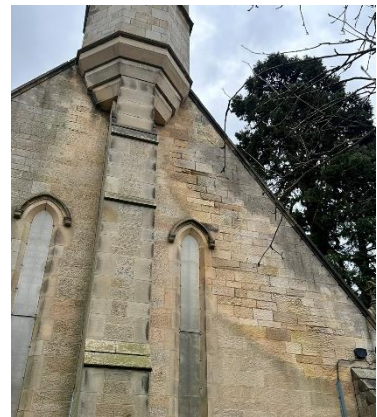
Figure 6 – W Gable S side

- 8.2.1 As per the north, there are open joints underneath the water table and still some previous cable fixings. Two stones heavily eroded above the lancet and some pitting to neighbours. It was recommended at the last inspection that this could be left 5 years if pointed around, this pointing is vital if you wish to avoid stone replacements, then the stone may be ok for another few years before replacement is needed.
- 8.2.2 Moss build-up to the string course is a result of no formal rainwater collection from bellcote. Stonework below the string course is eroding, but it is generally fair. There are some open joints at the bottom stage.
- 8.2.3 The incoming electrical supply is here and shrouded for the most part. Next to it is an unshrouded and ragged cable, function unknown.

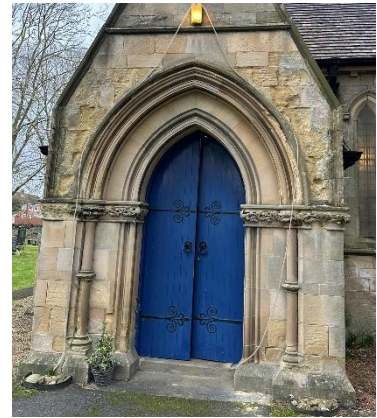
Figure 7 – S Porch

- 8.3.1 **West elevation:** Erosion to the top of the decorative string course causing a loss of carving (this is evidently caused by the poor gutter jointing above). Some open joints, particularly in the aforementioned area. Erosion, some salting and a couple of open joints at low level and to the plinth.

- Upper part of apex ashlar stonework is ok, though two stones have a delaminated face. There are also two holes from previous fixings above the light.
- The stonework above the springing point is heavily eroded on both sides of the arch and has lost its outer face. Some of the stones more eroded than the others but are okay for the moment. The inner arch moulding is also eroded to both sides. The ornamental string course has almost fully lost its decoration to the west.
- Below the string course, the shafts are beginning to erode. On the left-hand side at the bottom, the jamb moulding is also eroding significantly, though only marginally worse than reported in the last QI report.
- The bulkhead light is rather elementary and cable needs clipping back or routing properly.

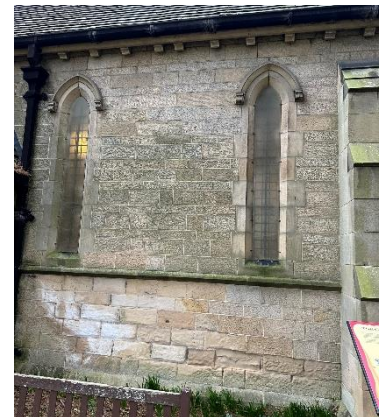
Figure 8 – S Nave erosion and lancets with cracks above

- 8.4.1 The stone above the string course is generally sound, below the string course there is erosion to the face of the stone. The previous report discusses some drainage repairs but it is unknown what these involved or if this has improved the condition. There is still efflorescence showing, but the condition doesn't appear to have significantly worsened from the last report. There are some open joints at the plinth course.
- 8.4.2 Some open joints to the buttresses, mostly on the south face.
- 8.4.3 The lancet windows have slight cracking at the apex and has been repaired in the past and should be monitored for any progression as it was indicated only one lancet had this issue in previous years. Both westernmost lancets have minor cracks above currently.

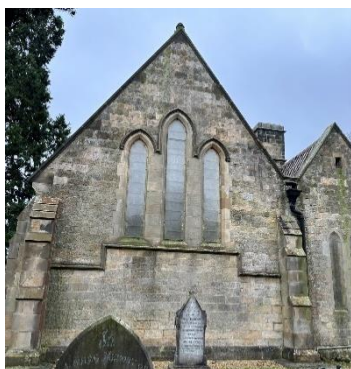
Figure 9 – E gable

8.7 **Chancel:** Some open joints to the bedding of the water table and bonding stones. Stonework above the string course is good, if a little stained with a few open perp joints but not currently justifying a re-pointing scheme at this gable. Below the string course some erosion and evidence of former ivy. A couple of minor open joints in the plinth. The left-hand buttress has some slight hairline open joints and has a stone at the mid stage which is delaminating. The right hand similarly has open joints but less erosion.

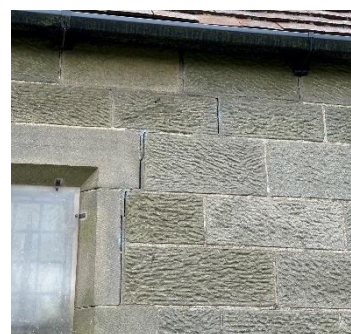
Figure 10 – RHS top window

- 8.10.1 The stonework is generally ok with some minor staining and erosion below window and some open joints at the plinth. Large open joints at the step which require attention.
- 8.10.2 The crack reported in the last QI was 3mm but didn't state where at the window. There is a crack of approx. 3mm to the RHS of the head, but also a 1mm crack to the LHS of the cill. This needs to be monitored to ensure this is historic movement, again possibly in connection with the boiler basement below.
- 8.10.3 There is also a 1mm crack to the LHS of the door head, this was not reported in the last QI report, suggesting some movement may be progressive.

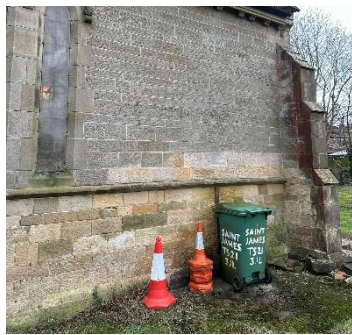
Figure 12 – NW Corner

8.11.1 Cracking to the top of two central lancets, exactly as reported in the last QI report, suggesting this is historic. It doesn't translate into the windowsills suggesting this might have been settlement in the west corner, there is a historic crack below the single lancet which has been cement pointed but has not re-opened since. The walling above the string course is good, as is the pointing. The string course has a couple of open joints in it.

8.11.2 Quite damp below the string course, particularly at either end, which is also reflected inside. The plinth has some open joints. Lots of lumber around the green refuse bin, which could be cleared as it is not useful. The damp also corresponds with a concrete slab which could be pushing the water up the external wall adjacent to it. This is the only area where damp is apparent above the string course. The damp to the E corresponds with the downpipe which may have leaks.

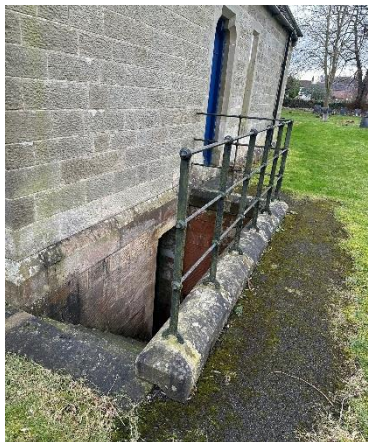
Figure 14- Boiler Rm Guarding

10.1 The paint is beginning to break down on the metal balustrading to the boiler room guarding.

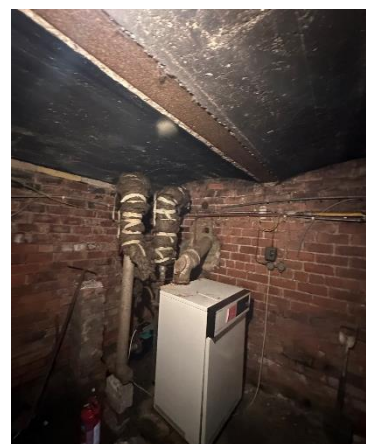
Figure 15- Boiler room – rusted beam

11.1.1 Ceiling – barrel vault concrete supported by very rusted beam running east to west.

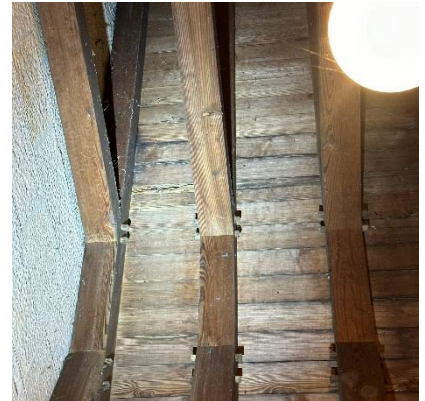
Figure 16 – Porch ceiling – rotten board

12.1 **Porch entrance:** open joisted ceiling, exposed timber boarding. Some slight staining from water penetration at the abutment to the nave and half way up each side, one board appears to be rotten just above the lowest tie.

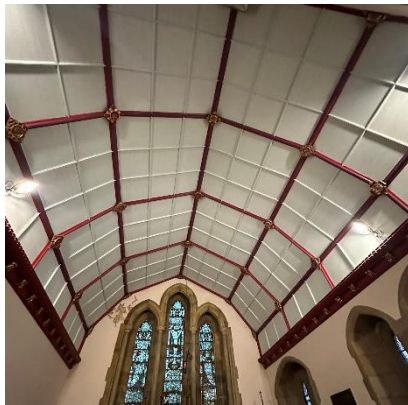
Figure 17 – Chancel ceiling

12.3 The **Chancel** is boarded in six segments, painted with contrast colour exposed ribs, and roof voids behind (not possible to inspect). Some slight shrinkage back from both the east and west chancel arch wall causing some roof dust to come down. A timber cornice at eaves level.

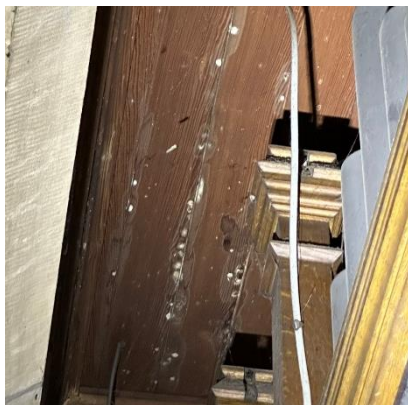
Figure 18 – organ chamber staining

12.6 **Organ Chamber** - flat with a T-fall, timber boarding with exposed ribs. Some white spots which appear to also have water stains surrounding them but not able to inspect void above. I would advise this area is inspected soon given the roof condition externally.

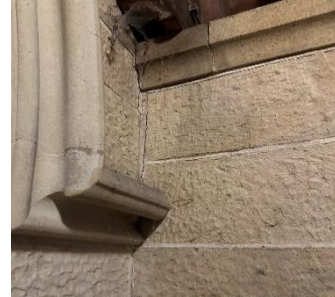
Figure 19 – Porch to Nave abutment

13.1 **Porch** – the abutment of the porch to the nave has a crack of approximately 2mm, unchanged from last report. Above the main entrance door a crack remains of approx. 2mm. To the arch above the nave entrance, the stone appears to have dropped slightly and there are some open joints now. The low level stonework has some erosion, though not currently problematic.

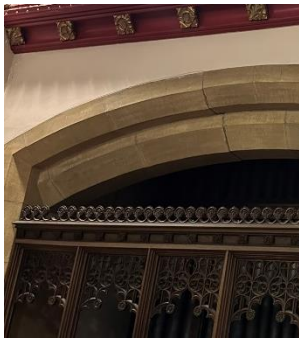
Figure 20- organ arch

13.3 The **North Chancel** contains the organ arch which has a 2mm drop on the western side that has been repaired in the past. It would be worthwhile raking out and re-pointing to monitor any further movement. The lintel to the vestry on the left-hand side also has a horizontal crack of approx. 2mm to the lintel. This also looks to have been repaired in the past.

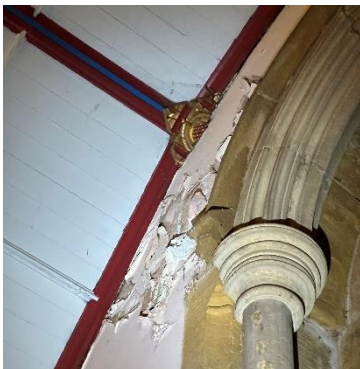
Figure 21- Chancel Arch

13.2 **Chancel Arch** – No current movement evident. One of the upper stones on the north side has been repaired in the past and requires decoration above it to both sides. There is a severe breakdown of decoration and plaster to the Nave side, appears historic but unknown if this area has now dried out, redecoration would assist the assessment. More minor to the chancel side but still sees some staining.

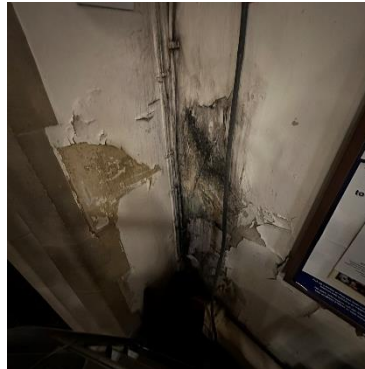
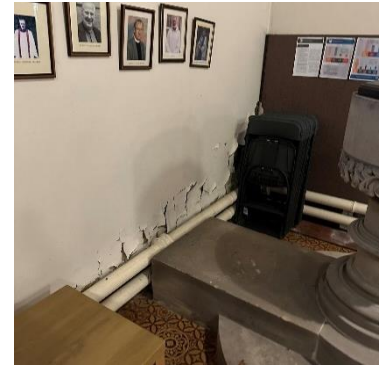
14.1 To the Nave all **walls** are plastered. Decoration breaking down at the SW & NW corners, very blackened behind boxes to the west. Also, at low level behind radiator pipes on the north wall and more significantly towards the font (though mostly covered with furniture) as mirrored on the outside (item 8.11.2).

14.4 Upper-level deterioration was deemed to be historical from water ingress due to flashing theft, now replaced with flashband. The low level is due to rising damp. Continue to ventilate the building and assess decoration needs in the future. Upper-level damp may return with failures in flashband over time as it is not a permanent solution.

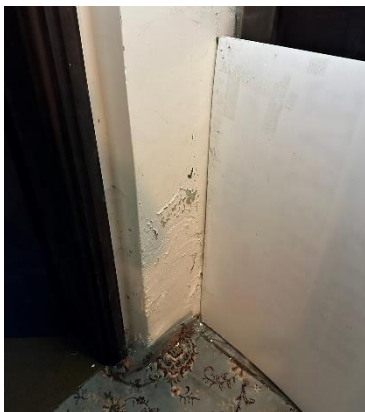
Figure 24- Damp near lobby door

14.6 **Vestry Lobby** has painted plaster finish, with some decoration breaking. There is damp at low level to either side of the external door, this will be made worse by the pointing around the external step noted at item 8.10.1.

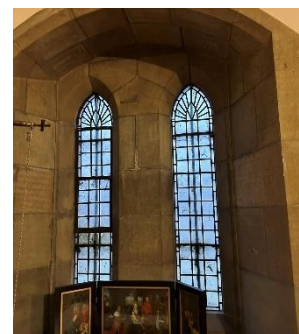
Figure 25- Chancel S window

17.4 All other glass to the chancel, Vestry and chancel has a few scattered hairline cracks to the glass but is otherwise ok, if a little dirty.

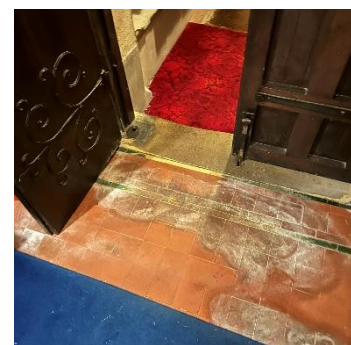
Figure 26 – Nave floor at entrance

18.1 **Nave** – pews have been removed and replaced by chairs. The floor finish is softwood block parquet which has reportedly been sanded and sealed and there is a carpet over the circulation areas, though the carpet doesn't look like it has a breathable underlay, it would be worth taking up the carpet to inspect and be sure there is no damp evident at the margins of the carpet. The porch has a Step up into nave. Towards the pulpit and under the carpet some of the tiles are loose.

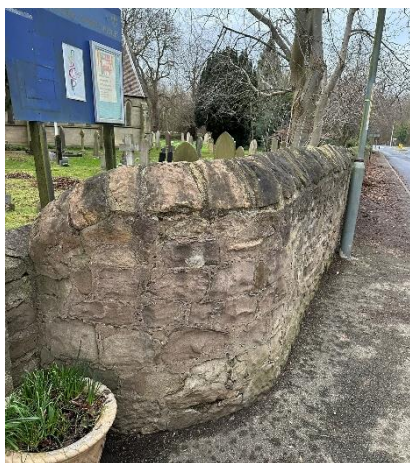
Figure 28 – S Churchyard from footpath

27.3 Trees: a very large number of mature trees. Inspected in 2013 and some pruned. The close proximity of a giant redwood (*Wellingtonia*) continues to threaten the nave. The tree surgeon reported that should branches fall, they would miss the nave, however if the entire tree was to fall it would be likely to cause significant damage, therefore the condition of the tree should be monitored closely.

27.4 **Southern Boundary:** Forms the primary entrance to the church. A stone wall which has been patched several times. Generally, it is in good condition though there are some breakdowns in the pointing, particularly at the corner by the streetlamp. The corner to the lych gate also sees moderate stone erosion. There are mature trees close to this wall.
