**QUINQUENNIAL INSPECTION REPORT
OF
FISHBURN, ST. CATHERINE**

**DIOCESE OF DURHAM
ARCHDEACONRY OF DURHAM
DEANERY OF SEDGEFIELD**

**QUINQUENNIAL INSPECTION AND REPORT
SEPTEMBER 2017**

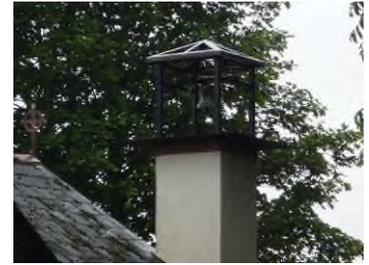
- C **Bells:** Single bell within a new steel frame containing an old bell installed circa 2007. The steel frame is rusty and the clapper appears not to strike well.

Recommendation: Redecorate steel frame, provide roof to the tower and repair bell operation.

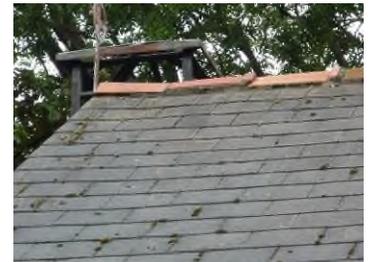
Red socketed clay dropping at the east end with the bedding generally sound, fibre board eternity type slates in fair condition with some moss to it, significant amount on the north side.

Church Recommendation: reset nave ridge, point up ridges where bedding missing, clear off moss, repair fascias, bargeboards and cover mouldings,

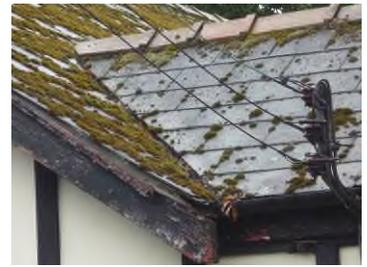
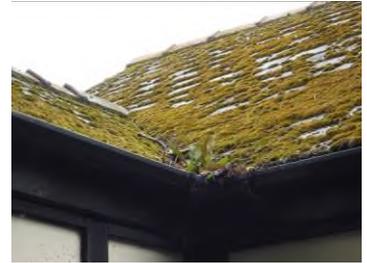
Same construction as the church, some bedding missing from the ridge tile socket joint, a lot of leaf build-up in the valley so unable to really see what is there.

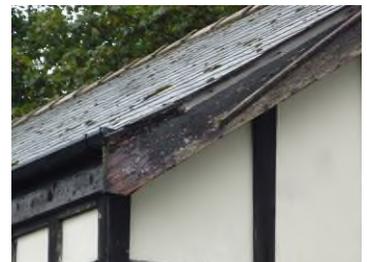
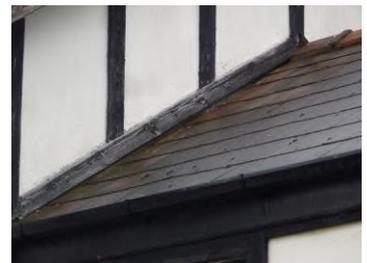
Same construction as the church roof, some of the bedding to the ridge is loose and the sockets are slightly open. The slating appears ok.

All the roofs have timber bargeboards and timber verges, these are in poor decorative condition and some of the verge timbers are coming away. The junction of the chancel to the nave has a timber covered board and this is coming away. Mostly effected at the west end.

The barge board feet of the south west corner is broken.

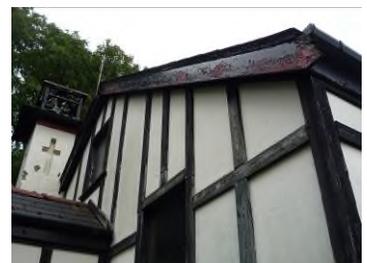
Same details as church but has more bedding missing at the ridge. Slating looks ok. The timber board abutting the church is rotten and coming away. The verge board is also rotting and coming away. The bargeboard is similarly rotten.

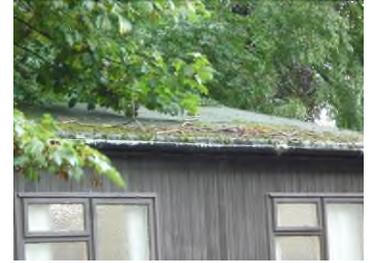
Mineral felt pitched roof which is covered in moss though appears there is no leaking to it, only the south side is easily inspected, there is a lot of tree debris on its surface.

B Hall Recommendation: remove moss from roofs

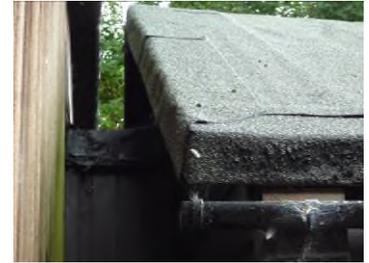
This is a mono-pitch roof with mineral felt which appears to be ok, though it is heavily mossy on the north elevation.

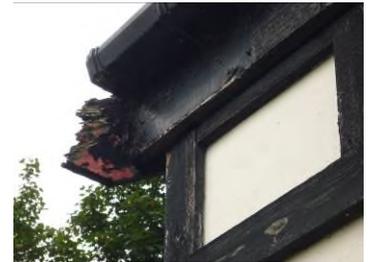
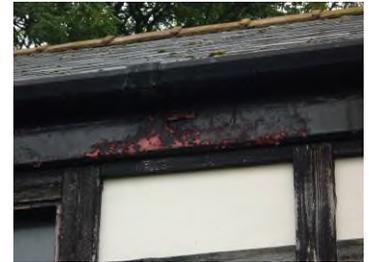
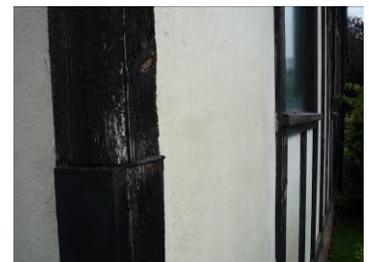
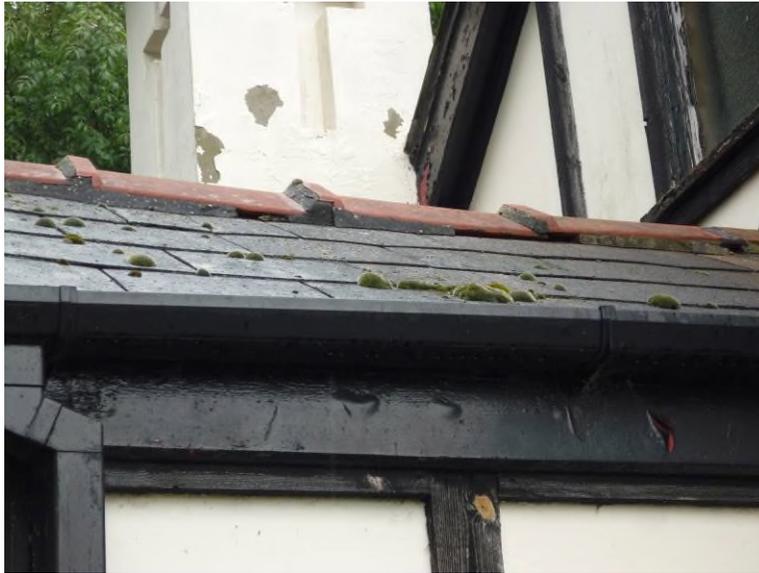
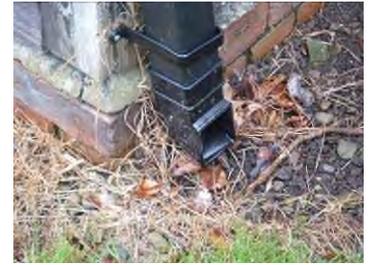
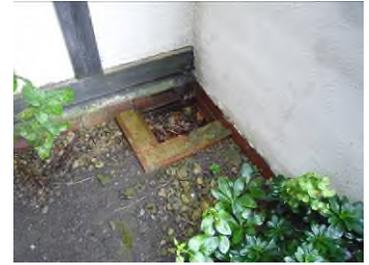
The church building has plastic rainwater gutters and downpipes, some gutters on the north side are leaking. The downpipes have been decorated over and this is coming away, they discharge to the ground, there doesn't appear to be any evidence of gulleys. Though there is one on the west face of the vestry but no downpipe associated with it.

All these downpipes do go down to the ground there appears to be no underground drainage system.

Recommendation: check records for an underground system, replace warped gutter on nave, repair gutter joints, repair downpipe joints, redecorate down pipes

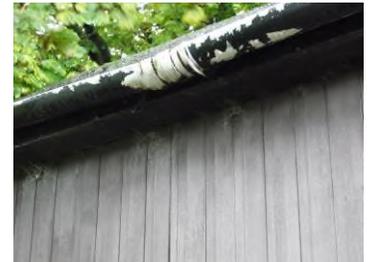
Downpipes discharge direct to the ground.

Recommendation: clear gutters and redecorate

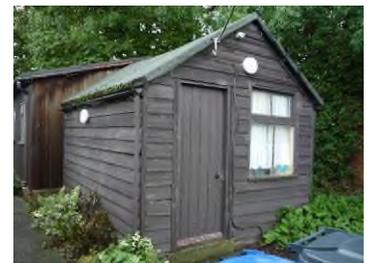
These are choked with leaves and soil, they are in cast iron, the downpipe on the north side is loose. Plastic to the south side.

Recommendation: clear gutters, refix loose downpipe

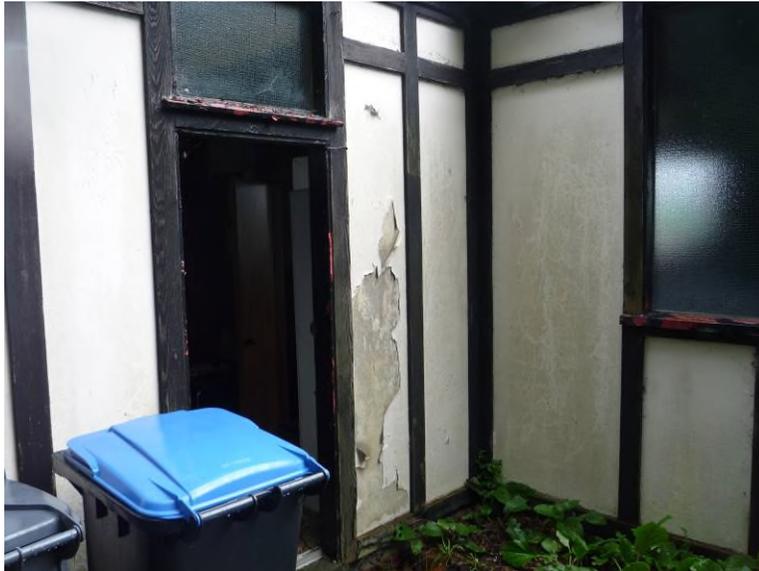
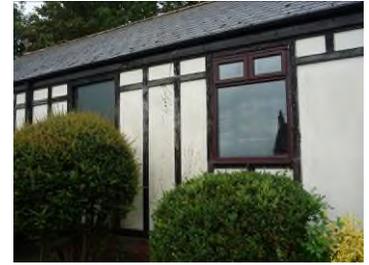
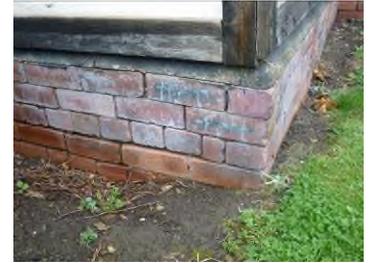
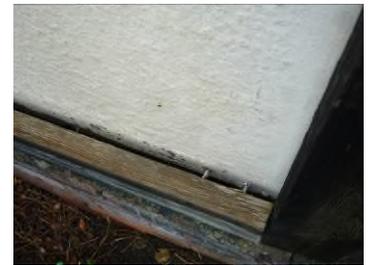
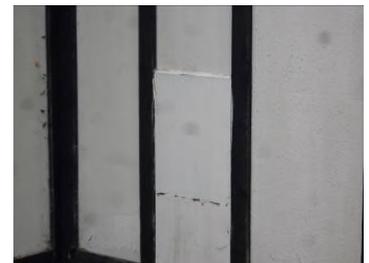
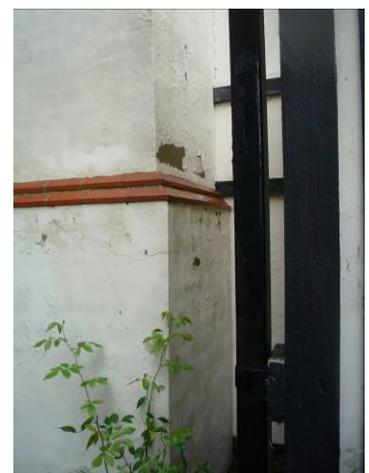
Timber stud walls with fibre board covered with timber cover beads. They are in various stages of repair, they have been cut at the windows and sealed up rather badly, and they are also shy of the bottom horizontal, which is coming away badly on the south elevation. There are various small holes to the boarding. The major problem is the coming away of the sole member at the bottom and water is just going down the back of it. It is also rotting away.

It has been patched in some places but that patching is failing now. There has been some patch repairs to the boarding in ply wood it doesn't look very good.

The vestry paintwork is particularly poor at the west elevation. The panelling on the north side is bubbling rather this is no doubt the paint.

There's a large rendered tower structure at the west end and the decoration is coming away from the render. On top is a steel structure providing a roof for the bell and the roof has blown away, the steel structure is rusting and the bell looks stuck as well.

Recommendation: the panels and boarding need repair and decoration, redecorate bell tower render, redecorate bell frame and replace its roof, ease bell

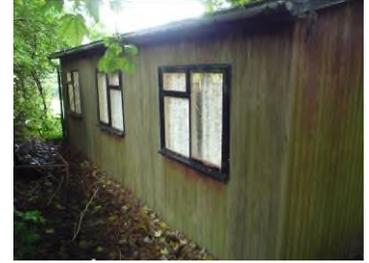
The walls to the hall are cedar boarding and these are in good condition, though have lost their decoration on the north and west side because of algae build-up. There is also a significant amount of cobweb to the soffit on the north side and there the bargeboard members etc. need decoration.

Recommendation: sweep down the walls, remove algae, redecorate, repoint plinth

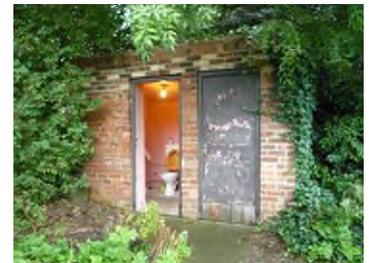
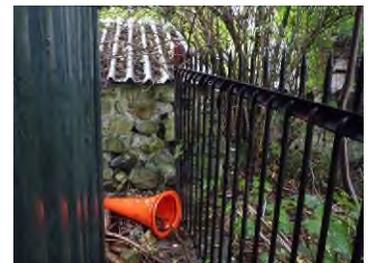
Inside the walls are plastered and painted and in fair condition, the floors are concrete.

A rather basic W.C. but serviceable with pan and wash basin. Wash basin is slightly loose on the wall. The electric don't appear to be working for the heater, perhaps the fused spur has gone.

The doors to both rooms are flush doors and in terrible decorative condition, and easily kicked in because their bottom panels have been patched over.

Recommendation: remove ivy, decorate exposed timber, repoint open joints, fix heater, clear store and inspect inside, replace doors

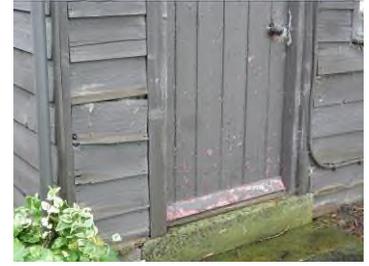
Shiplap boarding and breaking apart particularly on the eastern side by side of doorway, the panels are splitting, the bottom boards are also rotting as they get close to the ground, it sits on a brick plinth though there is not much evidence of it as the soil has built-up around it. The link to the church is a small flat roof mineral felt, roof not possible to inspect. The building is at the end of its life and while it can continue to be patched up now is the time- if funds allow to plan to improve these facilities.

Recommendation: plan to improve these facilities

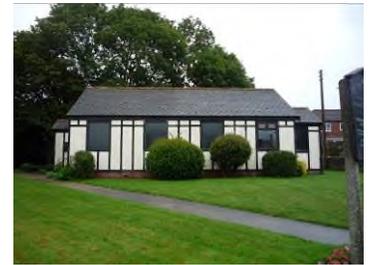
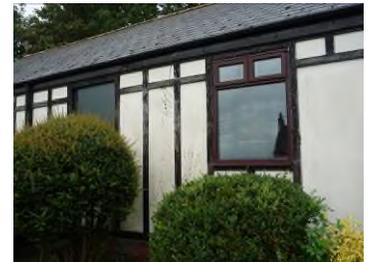
C Windows: The building has been remodelled with Georgian wired glass to all of the elevations which creates a very imposing impression inside and out. There is a domestic style brown UPVC window towards the south west end of the nave which is out of keeping with its neighbours. A possible window to the porch has been boarded in rather roughly.

Pair of double doors slightly catching at the lock, decoration failing.

Flush door locked at time of inspection, door handle loose and decoration coming away.

Recommendation: ease, repair and decorate doors, consider window replacement

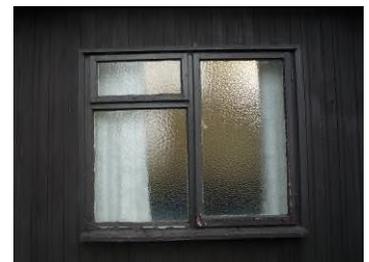
Modern 20th century side hung casement windows with opening casements, one has been re-puttied recently on the north side suggesting a former break-in, and the decoration is coming away from them. They are clear glazed to the north but obscured to the south, one is cracked towards the west end and the decoration is coming away very badly on the south side.

The wall sits on a brick plinth which has some slight washout of the joints.

Recommendation: decorate windows, repair cracked glass, repoint brick plinth

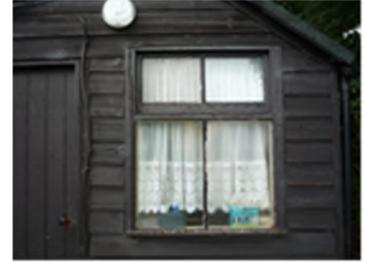
It has a single window in clear and obscure glass the putty is missing and the decoration is poor, the cill is rotten.

Boarded door eroded at the lock case. Door handle is loose and decoration break down.

Recommendation: plan to improve these facilities

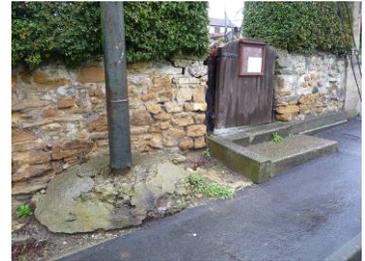
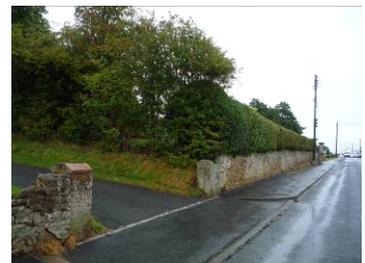
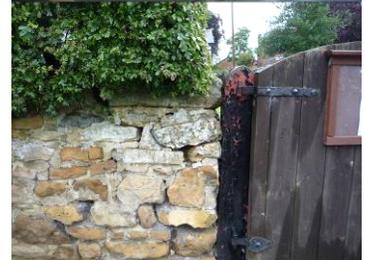
Random rubble sandstone wall topped with hedge, open joints to the walling at low level. Entrance gate where there are two steps in concrete slightly broken up but they will do. Decoration coming away from the fence posts.

Recommendation: repoint open joints, consolidate the gate post fixing

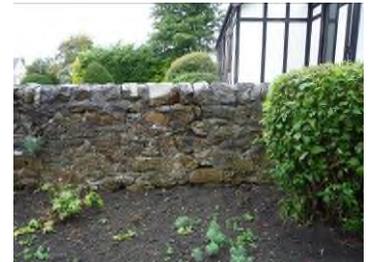
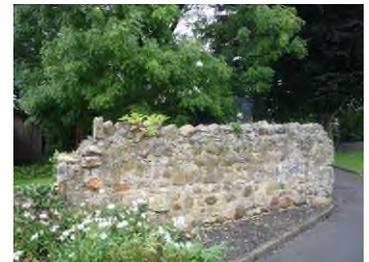
Poor quality random stonework wall, heavily restored in cement a lot of open joints to the cemetery path side, slight cracking at the northern end.

Recommendation: repoint open joints, redecorate and ease gate

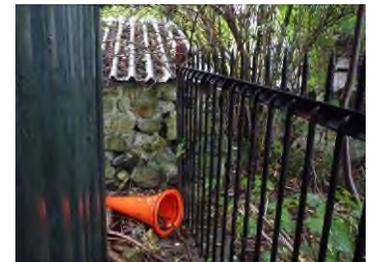
Mostly enclosed by a neighbour land which is overgrown, so not possible to inspect the neighbour side of the wall well, though it is obvious that there are open joints. Can see the W.C. doesn't have any drainage to it just drips on the back and there's an area of stonework which looks very poor adjoining the railings. There's a large sea container looking like a very permanent installation, close to the north wall and this is covered in ivy it's unable to be inspected.

Recommendation: point up accessible open joints to rear of wall

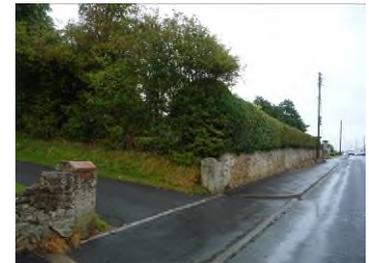
This looks onto private land, the churchyard is higher than the adjoining drive, and there is no fencing to it just shrubs. In the north west corner is a very large Sycamore tree which rather dominates the hall building, there's also an Ash tree but that is on the adjoining land both of those are dropping small twigs. Ash is known to be a brittle tree and it may be that a limb might come down onto the hall and kitchen.

There's also a Sycamore tree beyond the larger one which is in poor condition probably just a windblown sapling but now leaning towards the neighbour land and I suspect that this could be a problem in the future.

Recommendation: carry out a tree report with the aim of cutting back or down the trees.

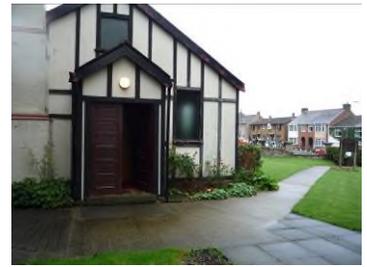
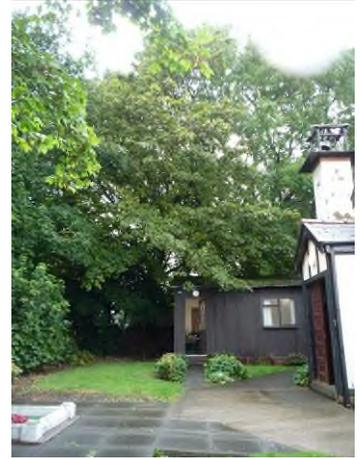
At the rear of the church the concrete paving is slightly slippery and there are some cracks and open parts to it by the disabled entrance gate.

Recommendation: remove algae and point up cracks in paving

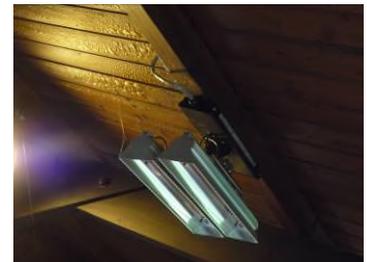
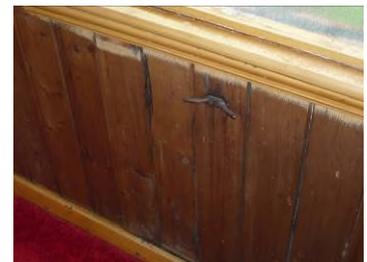
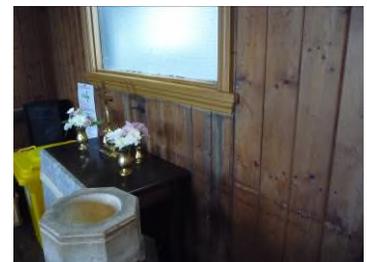
Ceiling – T&g boarded roof with three timber trusses with steel tie rods, no water marking, and good condition. Bubbling to the varnish is not caused by the heaters, it is actually over the whole of the ceiling surface.

Walls - Walls are t&g boarded and in fair condition though on the south side, some of the boards are loose and there is penetration of water at the window cills.

Recommendation: consider renewing ceiling decoration

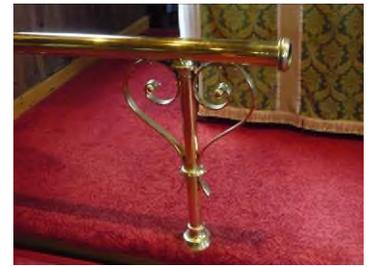
Ceiling – Open boarded ceiling, some paint blistering at a spot light.

Walls – Boarded fair condition, paint coming away from the skirting board, some boards are slightly loose on the north side. Curtaining covers the east end boarding causing slight mould on the surface due to lack of air circulation.

Floor – Is a raised platform in timber with carpet in good condition and loose altar rail.

Recommendation: consider renewing ceiling decoration, redecorate skirting board, fix wall boards, fix loose altar rail

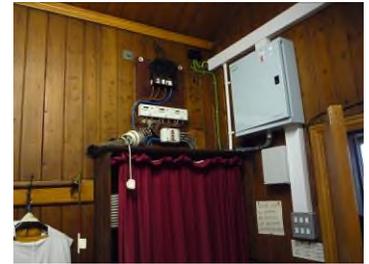
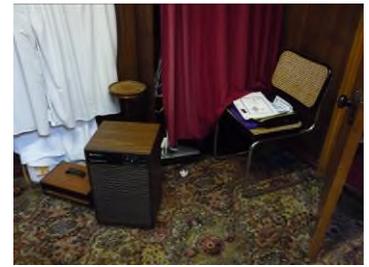
Room contains a small cupboard which is ok, the large metal cupboard is rusting on the surface.

Door to the outside and the west elevation- bolt is slightly loose and there is a build-up of woodlice and dust at the foot of the door, the Yale lock needs adjusting slightly into the catch. The Georgian wired glass panel above it has a crack in it.

Recommendation: consider renewing decoration, fix wall boards, repair west door and glass

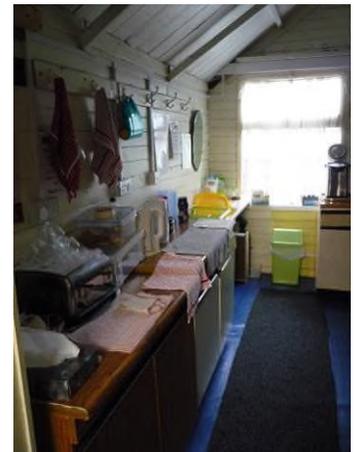
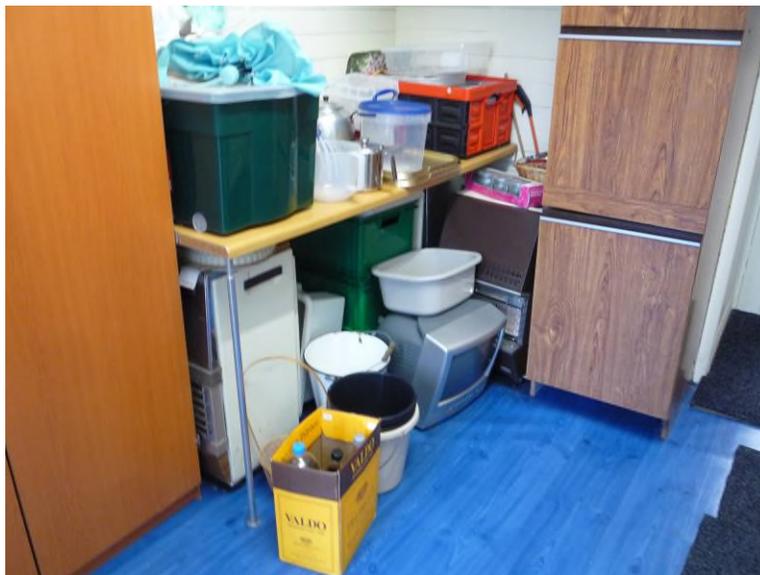
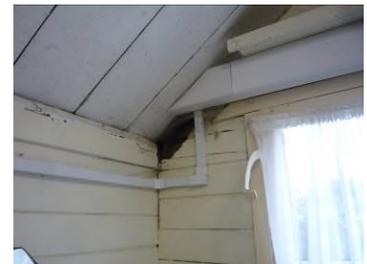
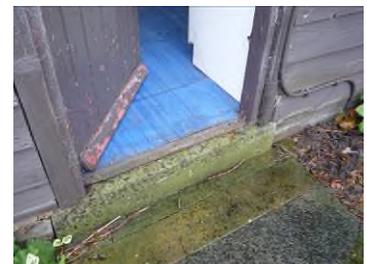
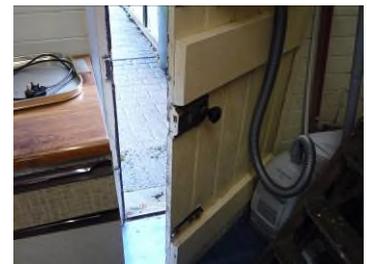
The room contains rudimentary sink and a cold water supply which often freezes, the sink is loose, out of date kitchen fittings alongside it, kitchen store cupboard for cups which is leaning into the room, and there is also three Calor gas heaters probably redundant.

The space is not fit for purpose

Recommendation: consider reordering
