West Pelton Parish Church  
Church of St. Paul with Columba

Diocese of Durham  
Archdeaconry of Sunderland  
Deanery of Chester-le-Street

Quinquennial Inspection Report  
September 2019

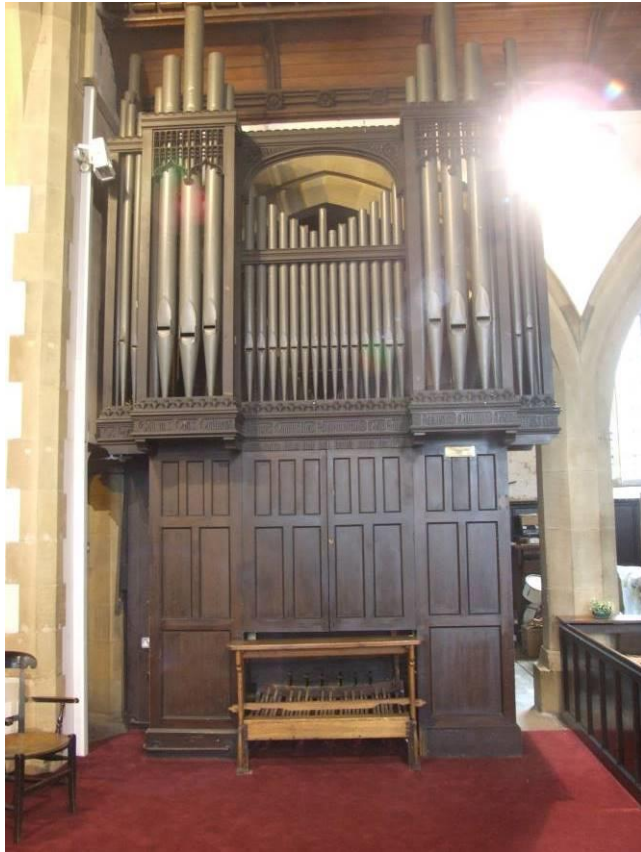
| 12.4 | In the south transept is the pipe organ by Harrison and Harrison is no longer affordably/economically repairable (£150,000.00). The instrument has two manuals and 21 stops. |

P1 (8669):  
Organ, now non-functioning

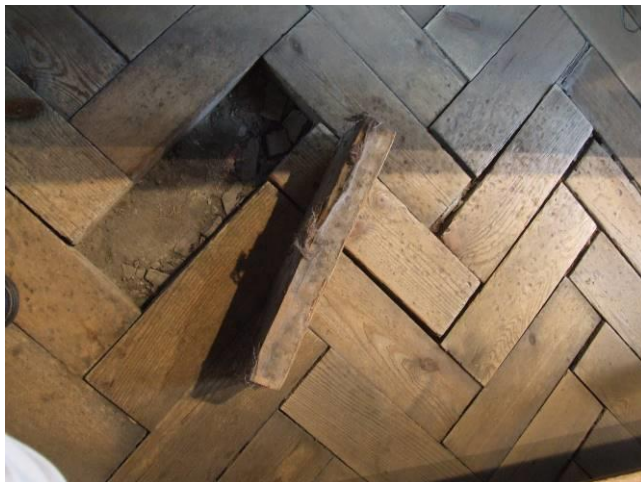
| 11.1 | There is woodblock flooring (softwood) under the pews in the nave and transepts; in some places these are loose and uneven. Where there is likely to be a hazard the area should be repaired as directed by the architect. |

P2 (8670):  
Pine woodblock flooring,  
sprung from substrate

| Lift loose woodblock flooring, clean out debris, adjust blocks to fit and bed on adhesive with make-up pieces of timber to fit | 11.1 | £1,000.00 |

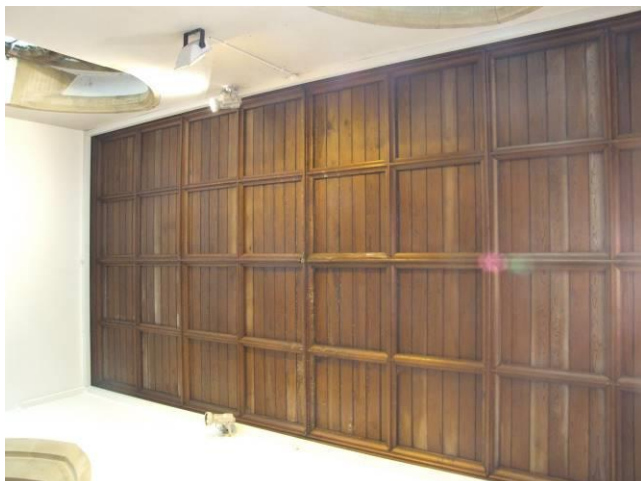
P3 (8672):  
Chancel roof; signs of water penetration salts

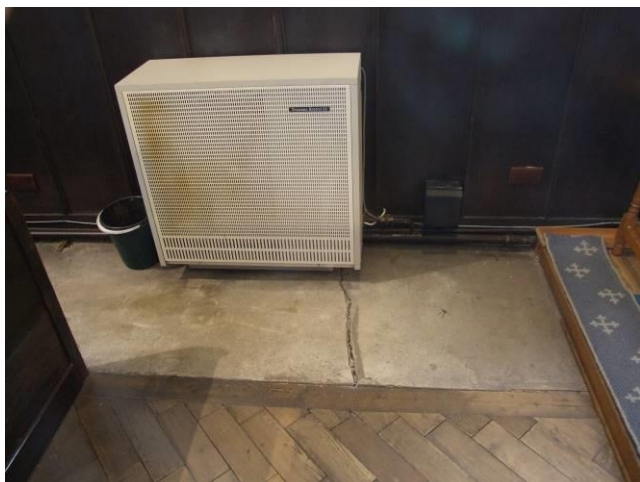
P6 (8675):  
Concrete slab movement in Lady Chapel

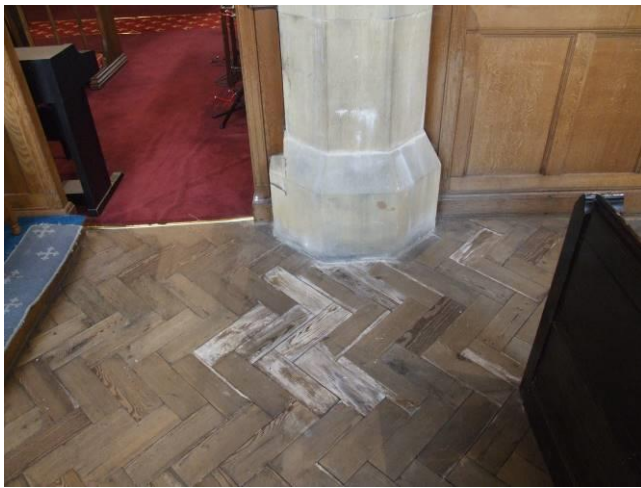
| 2.1 | <p>Issues with the south transept valley gutter has caused water ingress, staining ceiling and woodblock flooring in the Lady Chapel. Windows were fully repaired and protected previously, however proximity of protective glazing contains cobwebs/debris. The heating installation continues to be efficient and responsive. Re-decoration of walls mentioned in the previous Quinquennial report remains to be undertaken.</p> |

P7 (8677):  
Evidence of water ingress to Lady Chapel

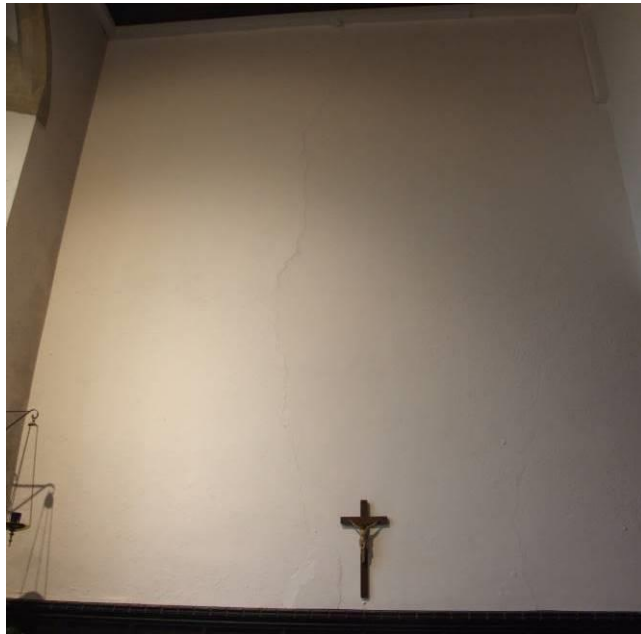
P8 (8679):  
Vertical cracking to Lady Chapel, east wall

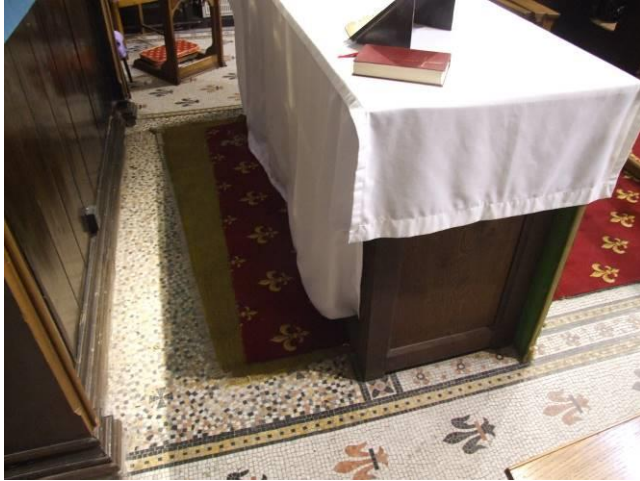
| 11.4 | The chancel floor is in good quality mosaic with "fleur-de-lys" pattern, reflected in the main graveyard entrance fencing, and is intact and in good condition. |

P10 (8684):  
Fleur-de-lys mosaic floor to chancel

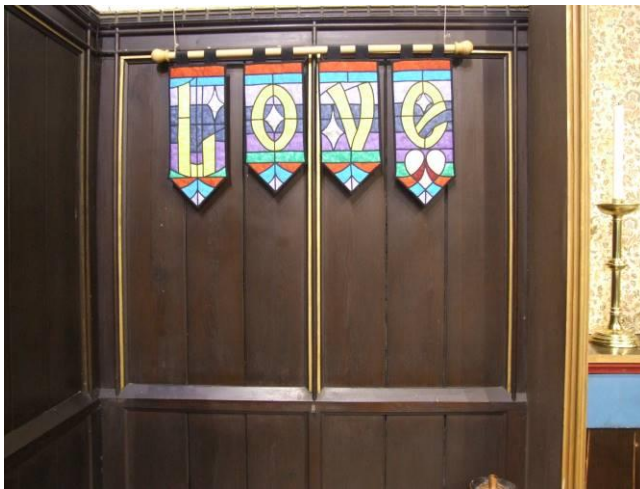
P11 (8685):  
Shrinkage to wainscoting to  
eastern chancel wall

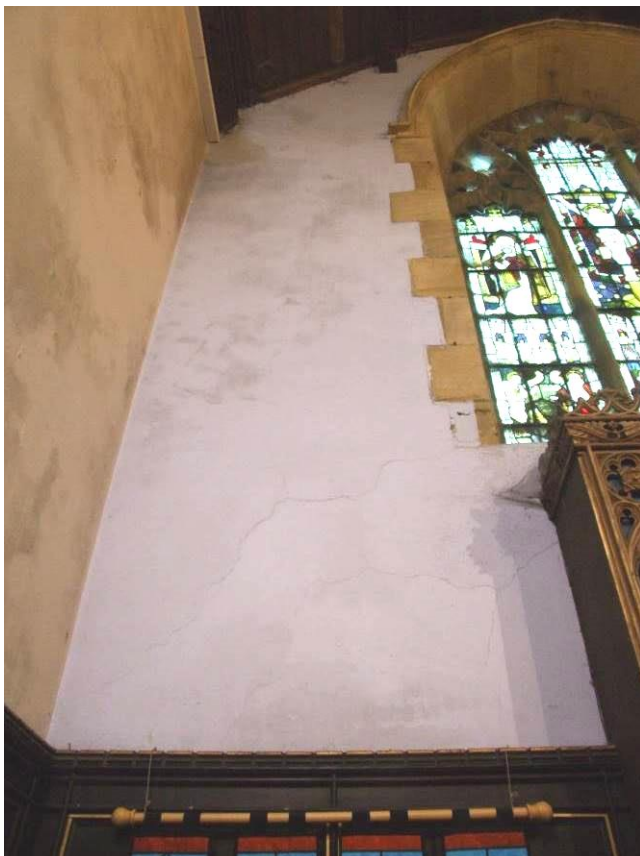
P12 (8686):  
Efflorescence to wall to eastern/  
northern chancel walls

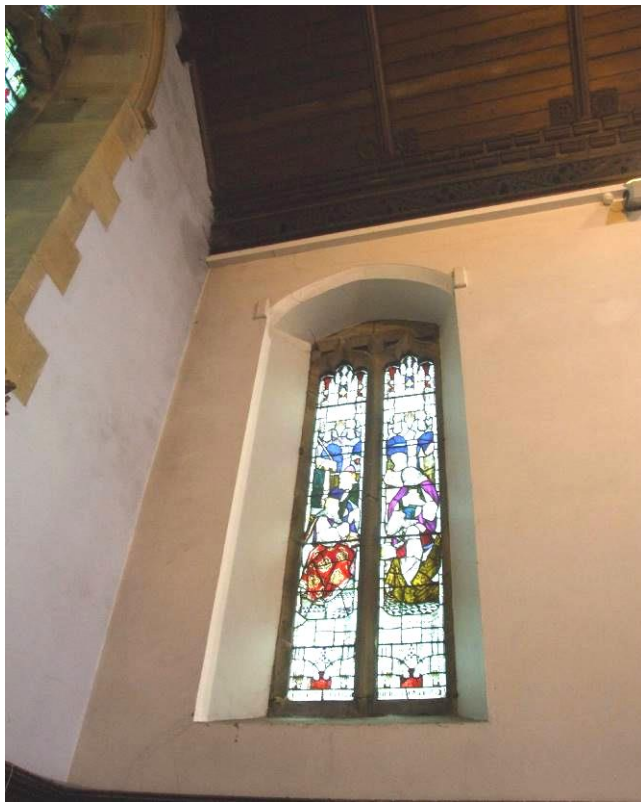
P13 (8687):  
Efflorescence to eastern chancel wall and  
cracking above south wall window arch

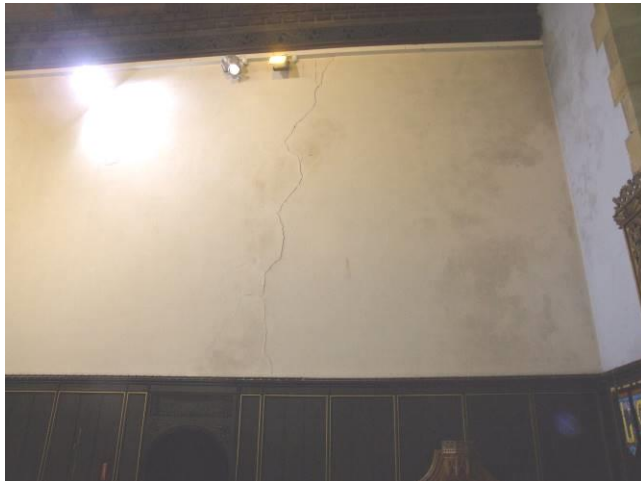
| 10.3 | <p>Internal cracks associated with the structural settlement referred to in the engineer's report should be filled and monitored for any ongoing movement.</p> <p>The north chancel wall previously reported to have staining and efflorescence should be checked externally at the downpipe position for any defect or leakages.</p> |

P14 (8689):  
Cracking to north chancel wall

| Check downpipe to north side of chancel wall in rainfall for signs of leakage onto wall face; repair as appropriate | 10.3 | DIY |

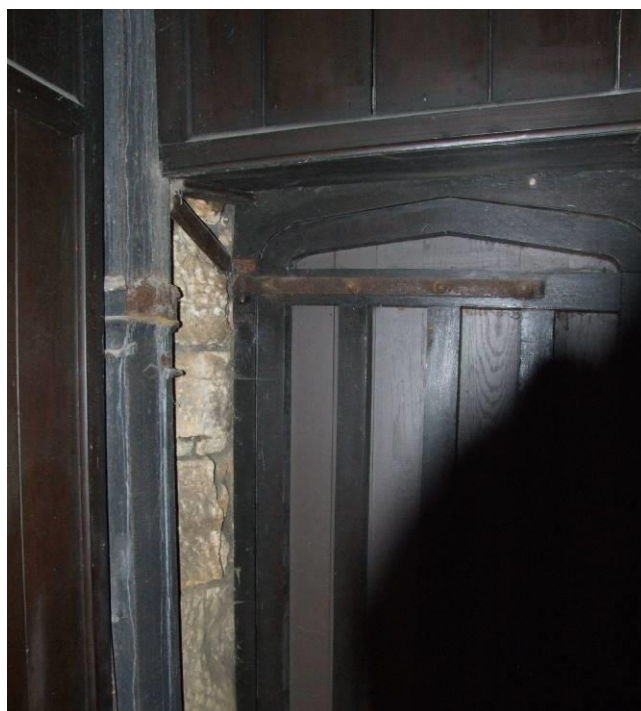
P15 (8690):  
Internal downpipe adjacent to vestry door

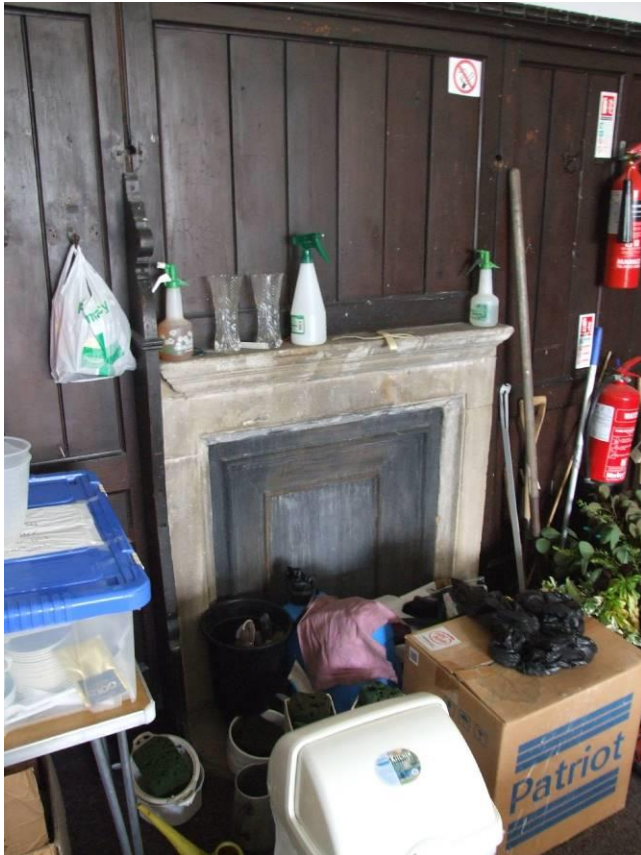
P16 (8695):  
Vestry fireplace, unventilated flue

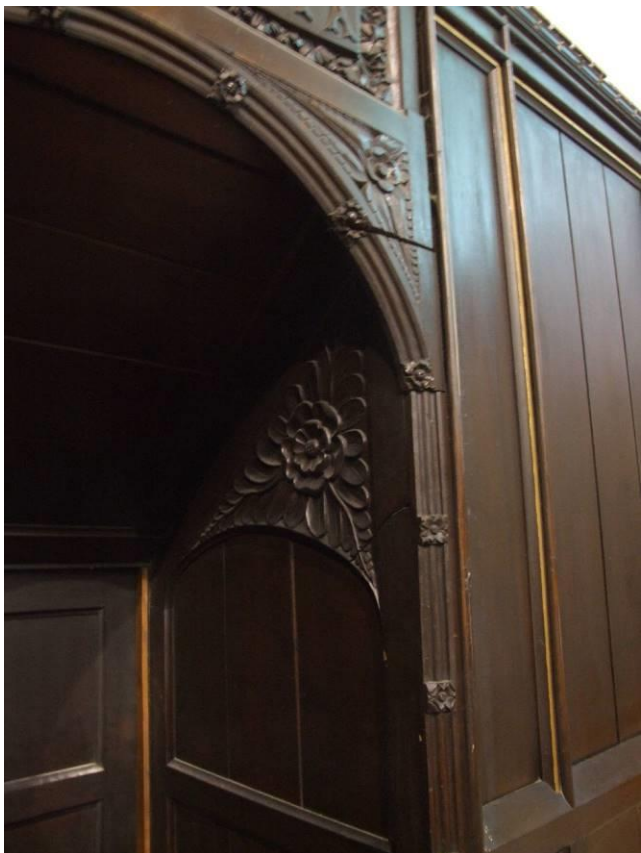
P17 (8702):  
Vestry door, cracked carving to  
right hand side

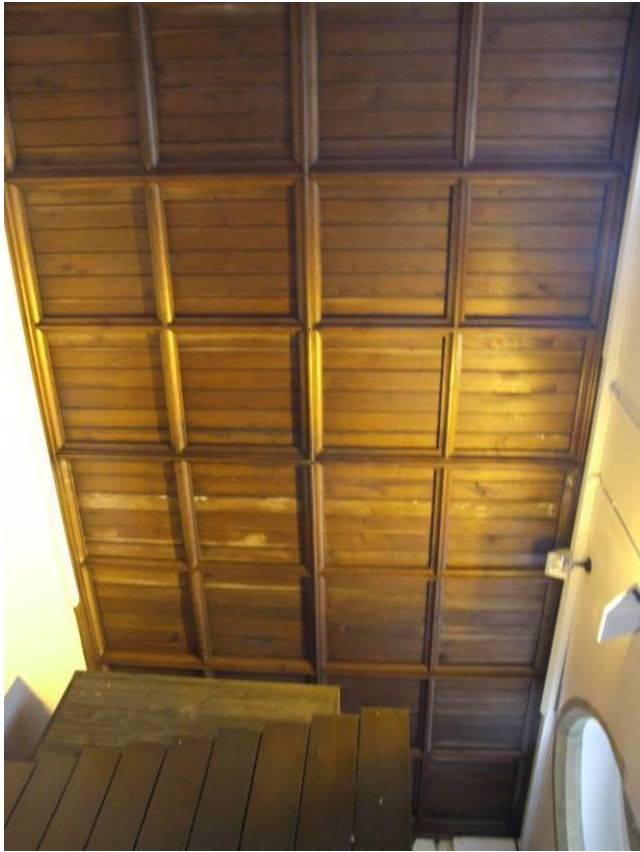
P18 (8704):  
South transept roof; evidence of  
water ingress

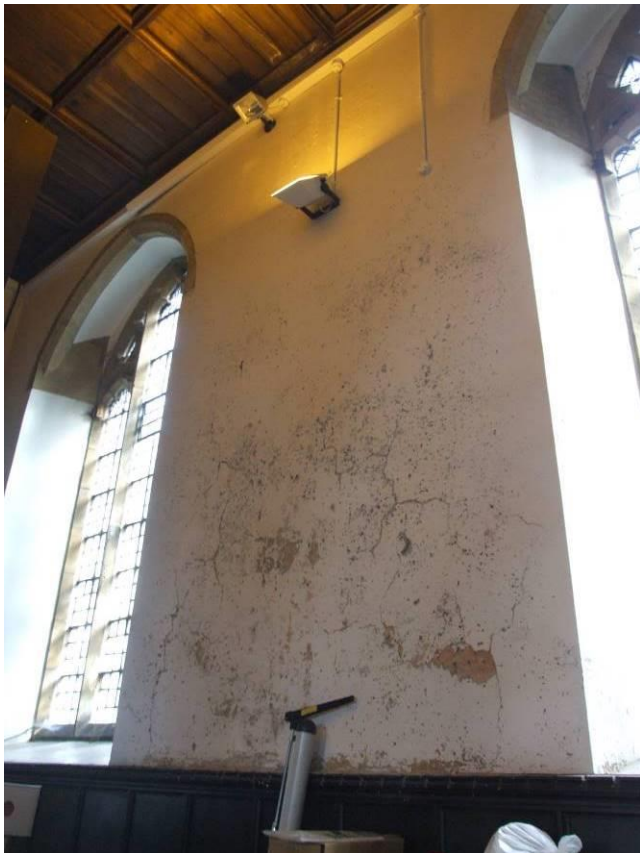
P19 (8705):  
South transept wall; historic  
water penetration

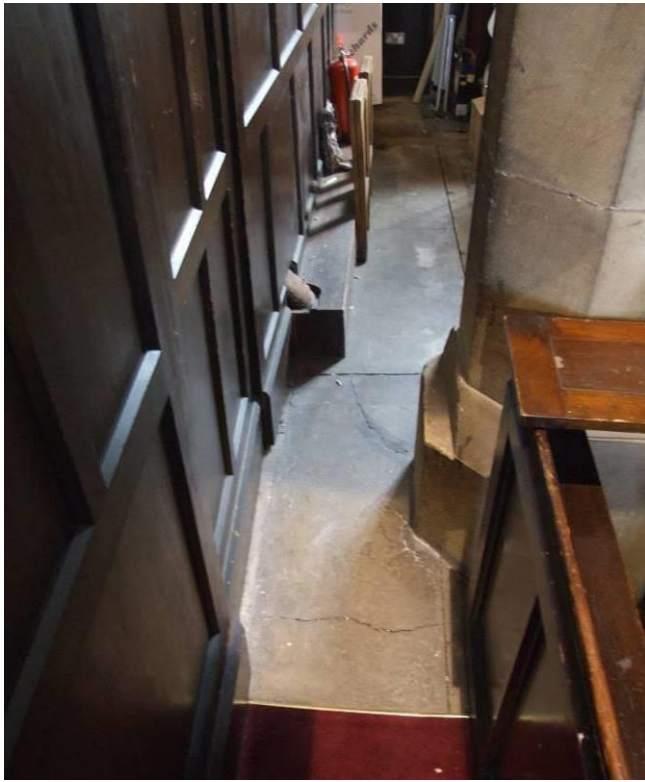
P20 (8709):  
Concrete slab movement in  
south transept

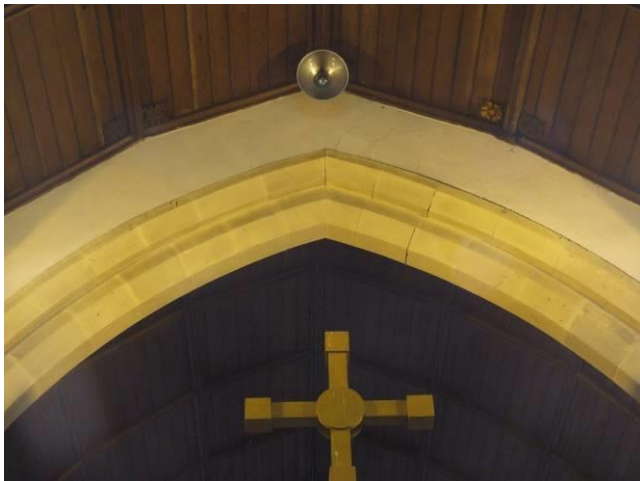
P24 (8719):  
Minor cracking to chancel arch

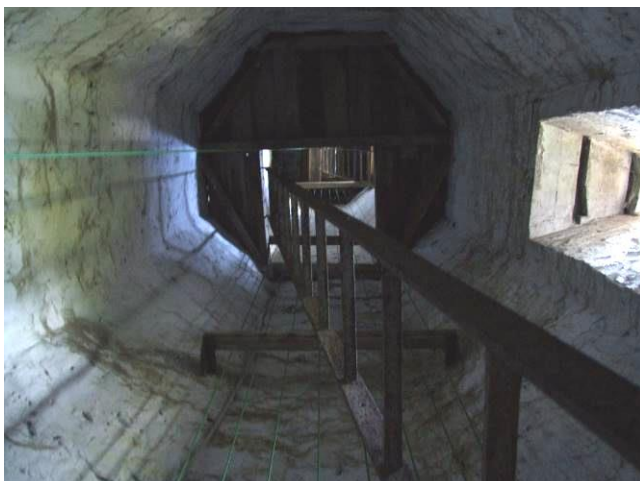
P25 (8723):  
Bell tower ladder with carillon wiring

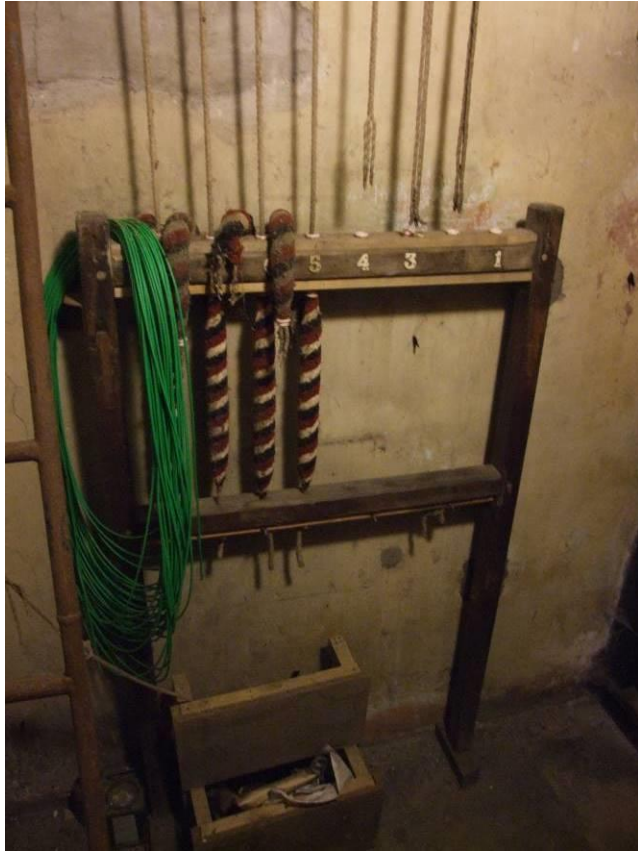
| 8.5 | <p>The eight tubular bells by Harringtons of Coventry were dedicated on 19th November 1898 and were restored in memory of Molly Witty in 1992. Bells No 1, 2 and 3 ropes have broken above the "Sally" and cannot be rung. There is a separate chimney bell which was tested and rings satisfactorily. The moving parts of the bell should be lubricated within the next 2-3 years.</p> <p>The ringing chamber is in untidy condition. The ringing arrangements are in neglected condition. Access ladders are corroded and insecure and there is evidence of current bird occupation, all of which prevented full inspection. The ladders require refurbishment/replacement, securing and appropriate handrails fitted for safe inspection and maintenance. Wire mesh in openings is too large gauge.</p> |

P26 (8725):  
Disused carillon

| <b>URGENT WORKS REQUIRING IMMEDIATE ATTENTION - Category 1</b> | Ref | Price |
|---|---|---|
| Clean out bell tower areas, check and replace bird mesh to all openings; clean, decorate and fix existing ladder access. Re-commission/restore bell ringing apparatus | 8.5 | £2,250.00 |

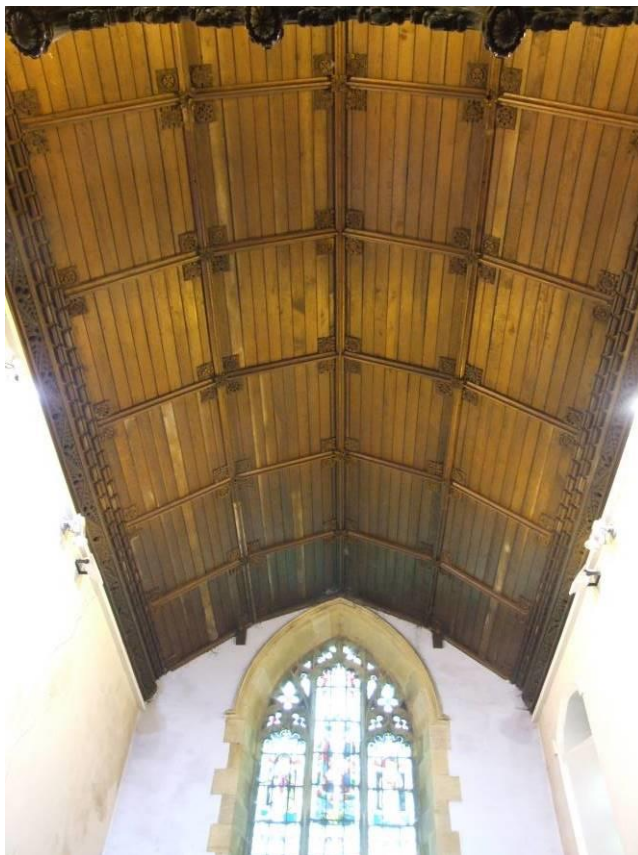
| 9.2 | The chancel ceiling is of similar construction, but narrower and with a decorative carved cornice, and no tie bars. All appears to be sound and in good condition, with no visible signs of water ingress. It was not possible to make a close inspection or access the roof voids. |

P27 (8728):  
Chancel ceiling; some water staining

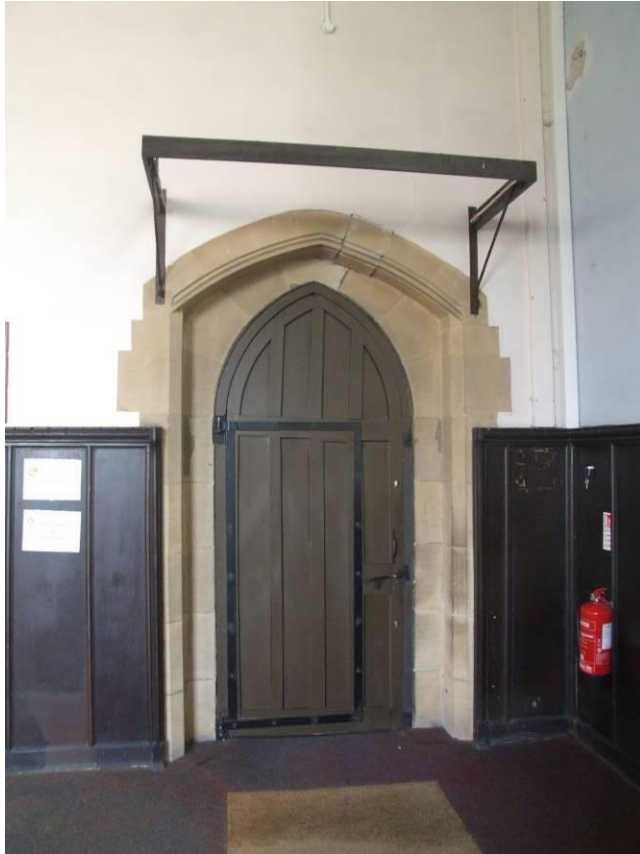
| 6.2 | The main entrance has a framed, arched door which has dropped but still fits the opening. The arched opening has also settled and there is a loose voussoir stone which requires re-fixing. The door was damaged by vandalism but is now repaired. |

P28 (8729):  
South entrance door; displaced stone arch

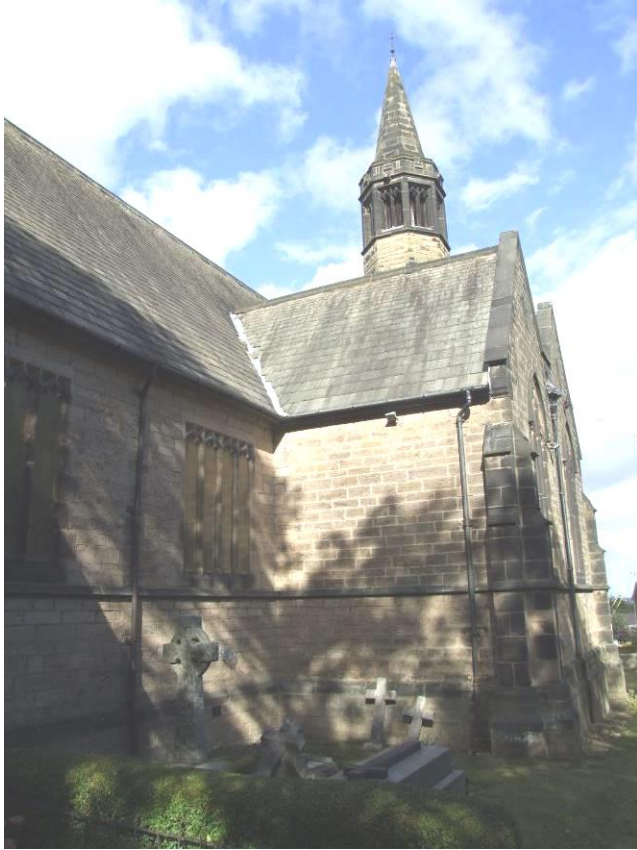
| <b>EXTERNAL INSPECTION</b> | |
|---|--|
| 3.3 | <p><b>South Transept:</b><br/>The rainwater hopper from the valley roof still has signs of rust spillage from a joint and this requires investigation to ensure there are no blockages and the discharge is watertight.</p> <p>The west side downpipe has a broken collar that needs repair.</p> <p>There are three loose slates at the tower base adjacent to the flashing and these need attention.</p> <p>Slating is generally satisfactory.</p> <p>Other rainwater goods are in good condition but need decorating.</p> <p>Annual cleaning out and testing is required.</p> |

P30 (8732):  
South transept, west end:  
damaged monuments, plastic guttering,  
displaced valley slates, small areas of high  
level pointing missing

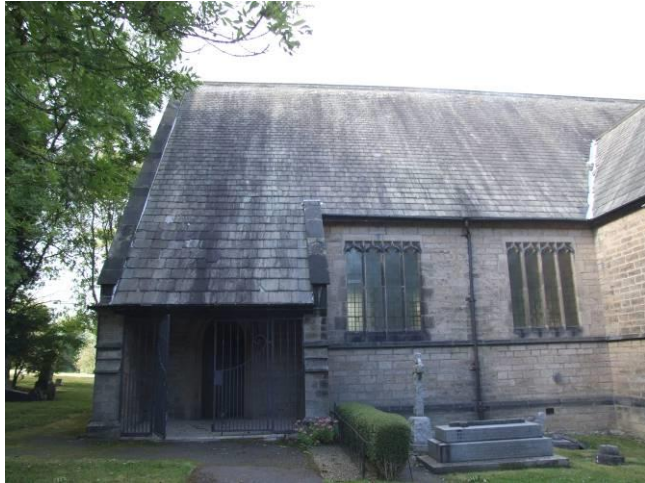
P32 (8734):  
West porch, displaced slates

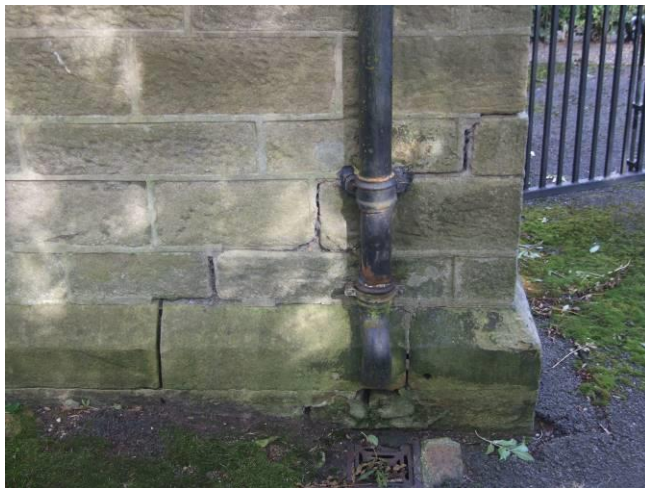
P33 (8737):  
Porch, southwest corner; joints  
opening from settlement

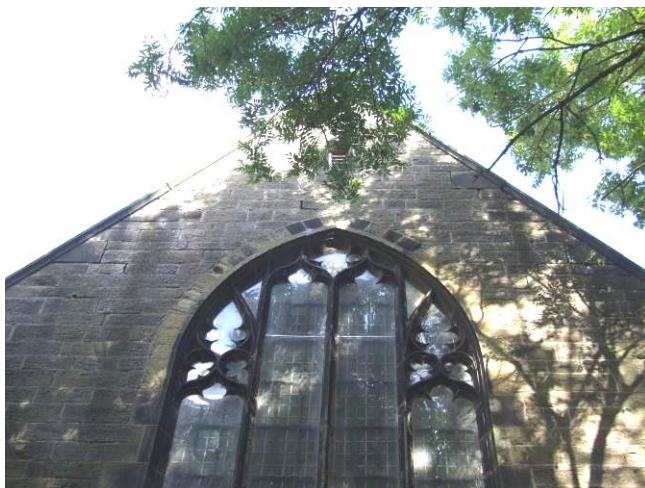
P34 (8738):  
West end; high level pointing missing,  
open joints to water tabling

| <b>URGENT WORKS REQUIRING IMMEDIATE ATTENTION - Category 1</b> | Ref | Price |
|---|---|---|
| West gable tablestones joints to be repointed and missing lead flashings to be replaced and others repointed | 3.1 | £500.00 |

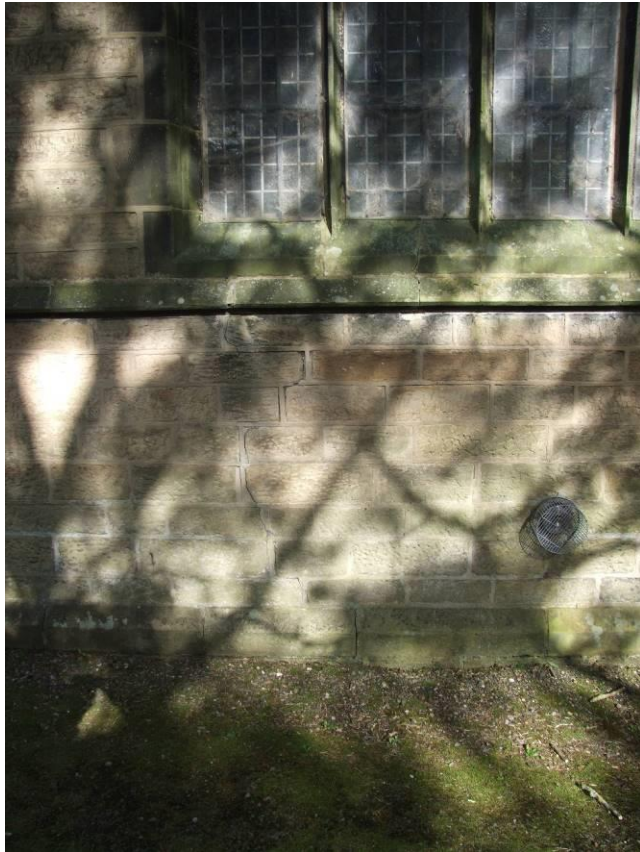
P35 (8740):  
West end; low level joint opening  
from settlement

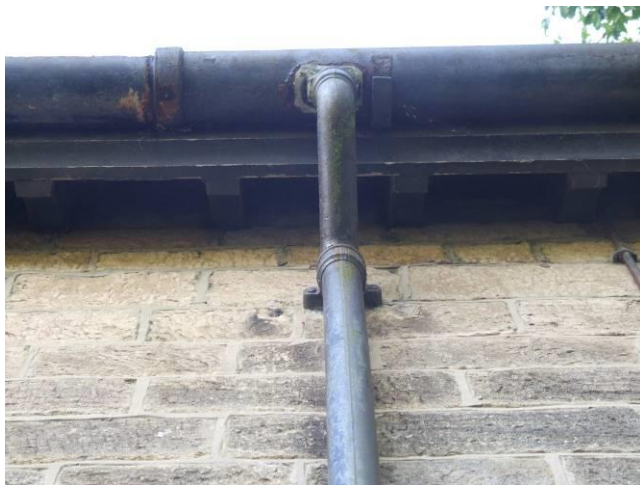
P36 (8741):  
Failing gutter/downpipe connection

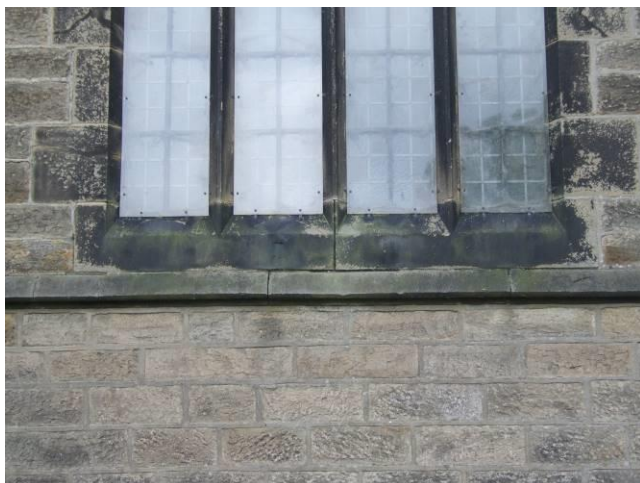
P37 (8743):  
Open joints, north side window/  
drip course

| 5.4 | Generally, all window sills and joints to be checked and repointed as required. |

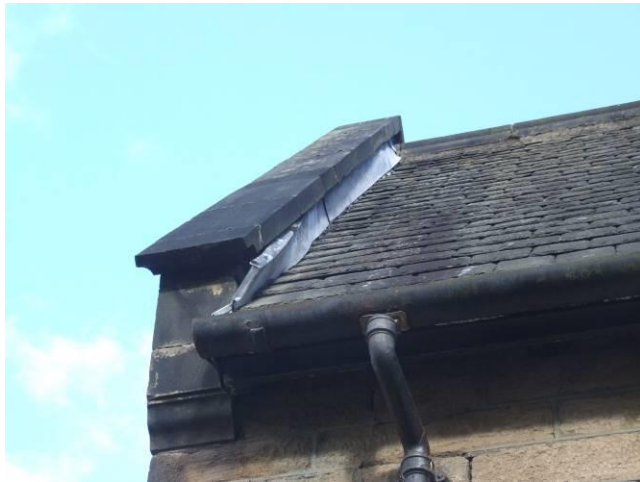
| <b>EXTERNAL INSPECTION</b> | |
|---|--|
| 3.2 | <p><b>North Transept Roof, West side:</b><br/>Lead flashing to gable and table stones needs re-fixing and repointing. A slate is missing at the valley with the Nave and a further one has slipped.</p> <p><b>East side:</b><br/>The lead soakers to the north gable are slightly wider at the top of the wall but they appear to give cover.</p> <p>An internal roof inspection during February 1999 with the structural engineer did not reveal any water ingress from this roof area. The leaded valley with the main roof was replaced in 1999 and it is due to be re-inspected from ladders by a roofer.</p> <p>There is a chimney rising from the north roof slope over the transept and this was in sound condition in 2001 but should be re-inspected by a roofer when next on site.</p> |

P38 (8744):  
North transept, west side;  
displaced lead flashing

| <b>URGENT WORKS REQUIRING IMMEDIATE ATTENTION - Category 1</b> | Ref | Price |
|---|---|---|
| North transept roof; west gable lead flashings need repointing and a missing slate at the valley replacing | 3.2 | £500.00 |

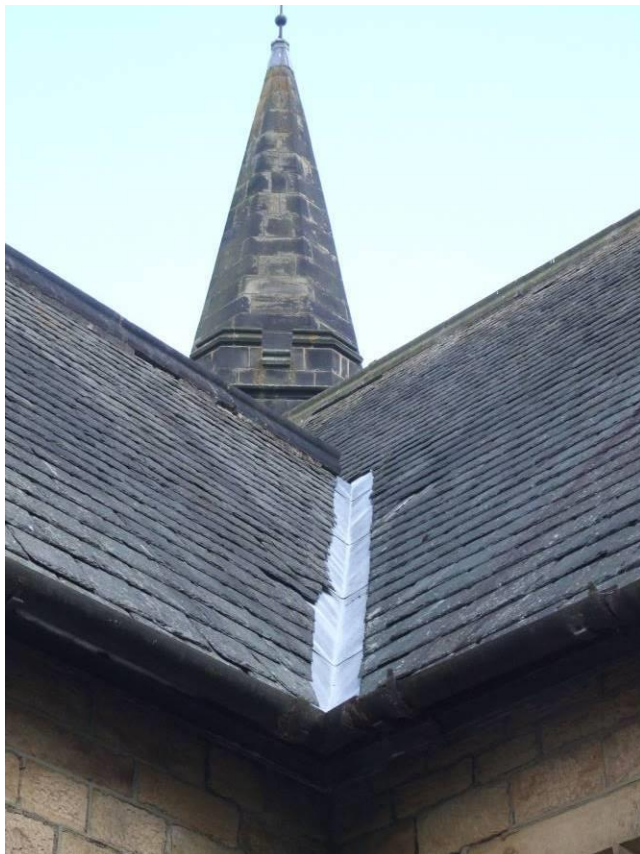
P39 (8746):  
North transept, west side;  
displaced slate in valley

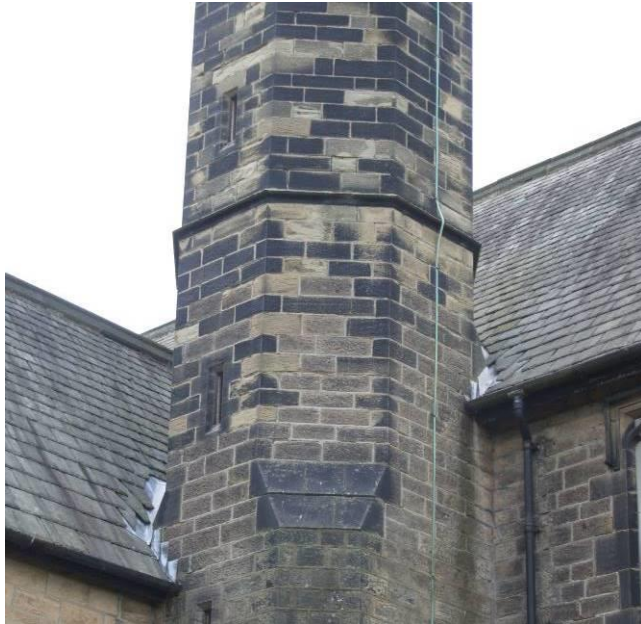
P44 (8759):  
Valleys to tower; displaced slates

| <b>URGENT WORKS REQUIRING IMMEDIATE ATTENTION - Category 1</b> | Ref | Price |
|---|---|---|
| Repair loose slates at tower base | 3.2 | £100.00 |

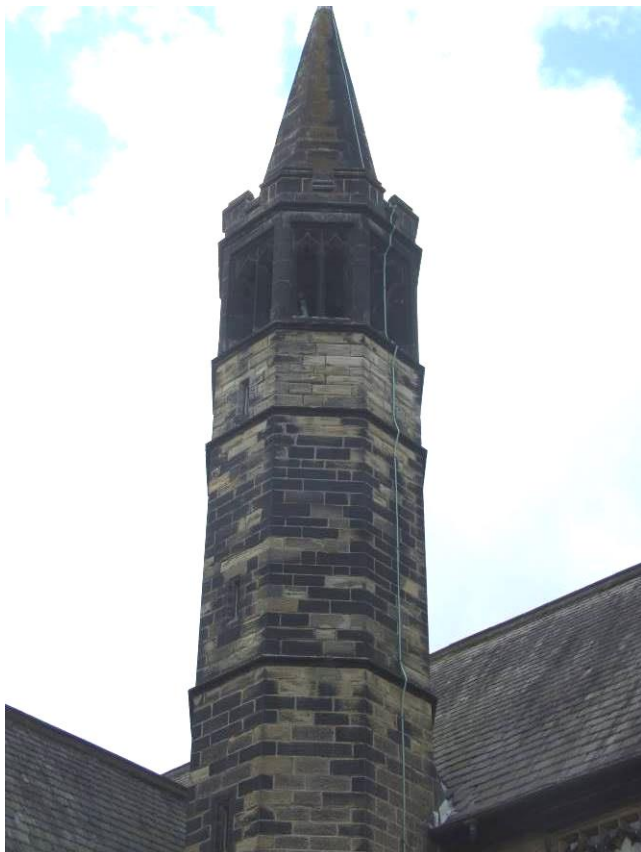
| 8.2 | The tower masonry has been deeply weathered in a band below the belfry openings on this exposed site. Other lower parts of the tower are weathered in isolated areas and parts will require repointing in due course. The timing for this masonry repair should be considered in the next 5 years. |

P45 (8760):  
Weathered stone below bell tower tracery

| Consider masonry repair/repointing to Tower | 8.2 | £5,000.00 |

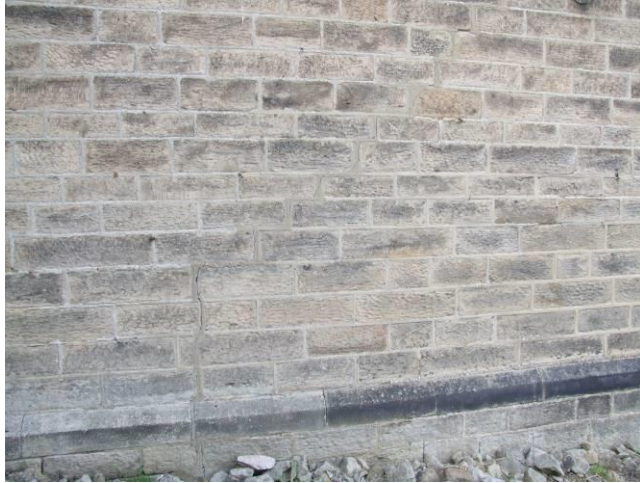
P46 (8764):  
South chancel wall; minor  
settlement cracking

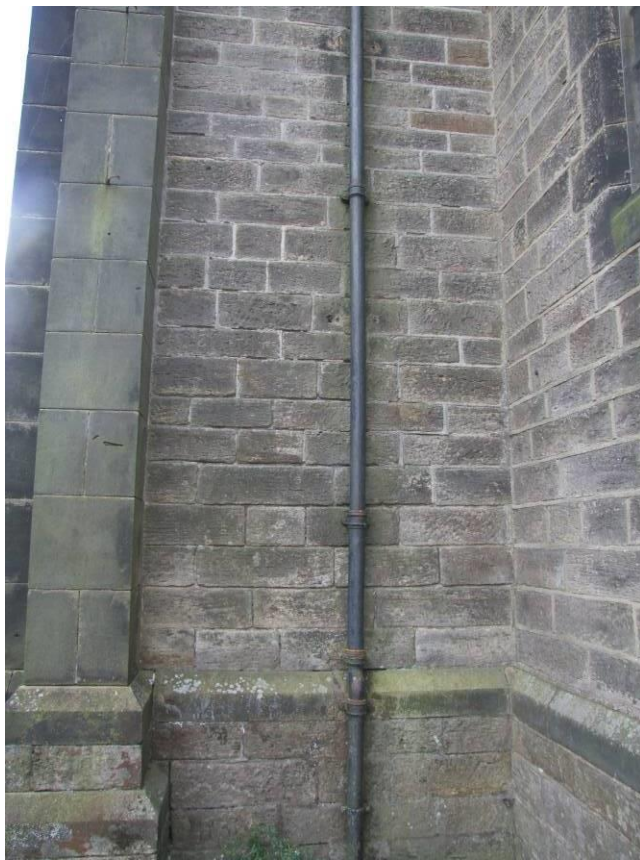
P47 (8765):  
South transept, east wall; missing pointing
