**Quinquennial Inspection Report  
St Alban's Church, Windy Nook, Gateshead  
Deanery of Gateshead  
Archdeaconry of Sunderland  
Diocese of Durham**

Report prepared by

David Jowett - Architect, BA, DipArch, RIBA  
25 Roseworth Avenue  
Gosforth  
Newcastle upon Tyne  
NE3 1NB  
Tel: 07788 710 204  
email: [david@davidjowett-architect.co.uk](mailto:david@davidjowett-architect.co.uk)

11 March 2021

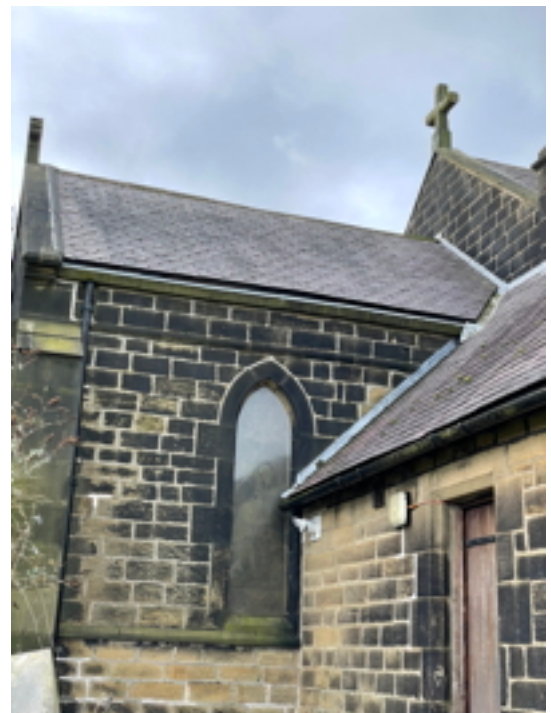
**North Transept West Roof**

Several chipped slates 3no to South Nave Roof, 1no to North Transept West Roof, 2no to North Aisle. One section of synthetic lead-free flashing has come loose to the nave roof north west gable and needs to be secured immediately.

Replace all chipped slates. £150.00.

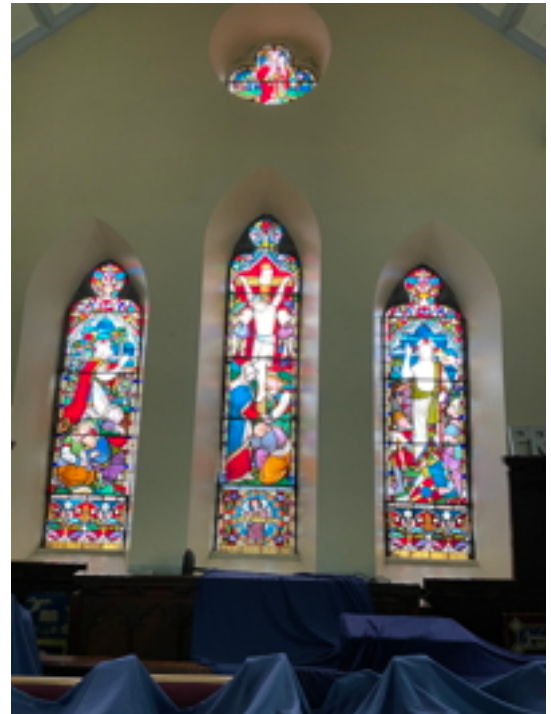
**Windows 7, 8, 9 and 10.** W7-9 Three stained glass lancets. W10 Quatrefoil window above. Rather garish stained glass, possibly reused as the fit to stonework openings is poor. Saddle bars are rusting. Some distortion, repairs may be required soon.

Windows 7 to 10 saddle bars are rusting. Some distortion, repairs may be required soon.

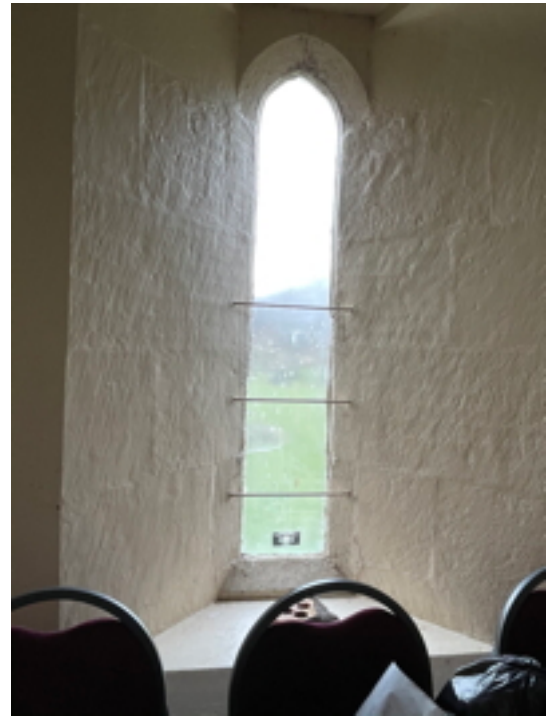
**Window 20 North Aisle, west wall temporary glazed in polycarbonate**

Windows 15 and 20 should ideally be replaced

Replace cracked queries and replace 3no windows. £6000.00

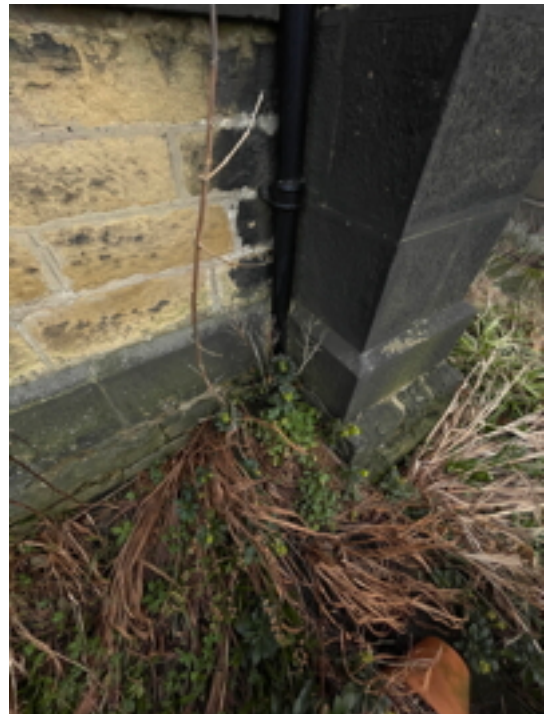
Bottom of pipe blocked by vegetation

Some run offs obstructed. One gully missing.

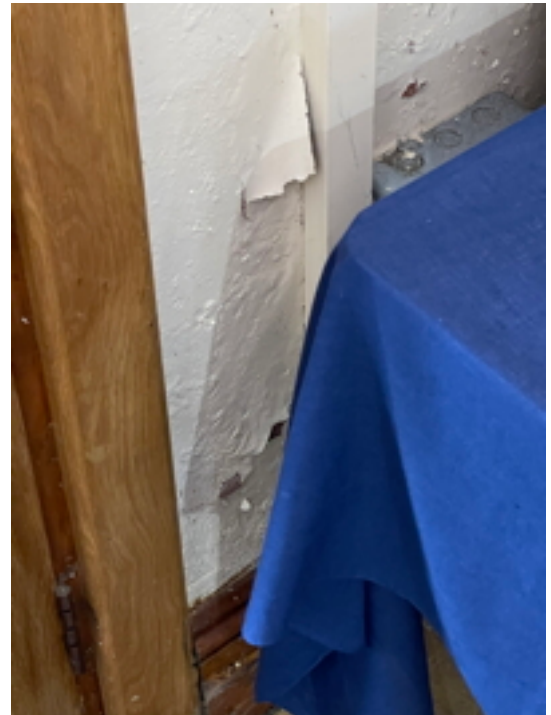
**Peeling Paint to RHS of Door to Entrance Lobby**

All is in satisfactory condition except peeling paint to RHS of door to Entrance Lobby.

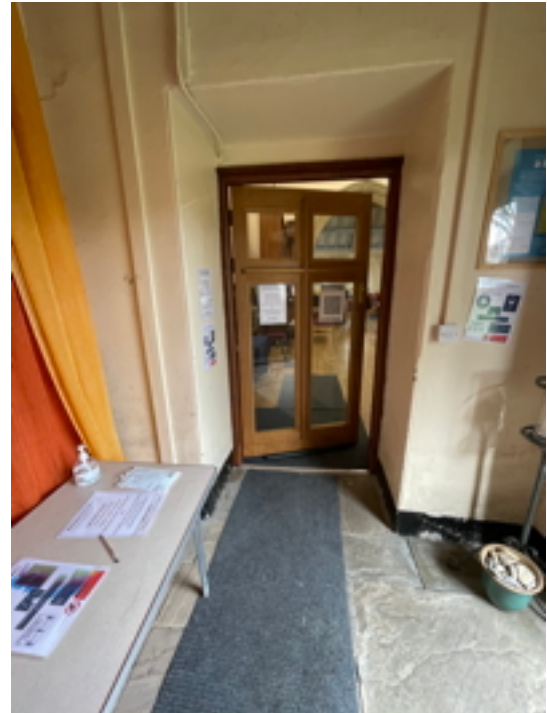
**Porch Looking North**

Decoration deteriorating and efflorescence at low level on walls and mould around door. Wheelie bin and stored material could compromise emergency escape route. The porch floor requires some pointing of joints.

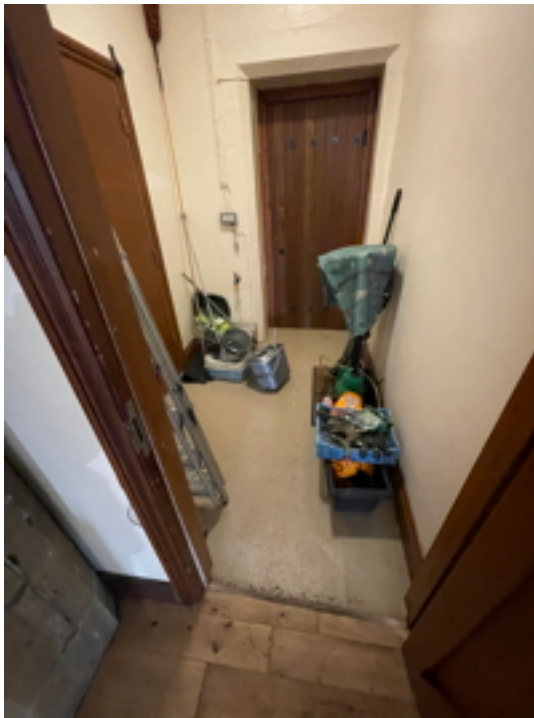
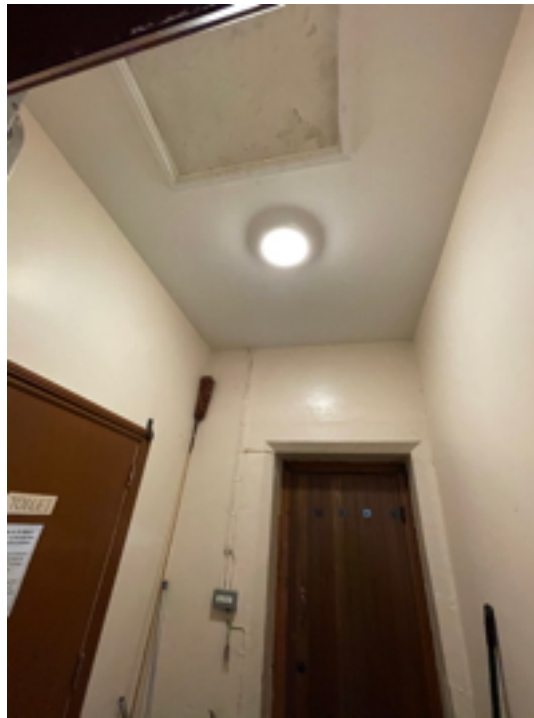
**East End Lobby**

The East End Lobby is generally in satisfactory condition. Stored material could compromise emergency escape route. Edge seals to flooring should be replaced to avoid washing water ingress.

Replace edge seals to vinyl flooring in East End Lobby with Dow 785+ clear silicone sealant. £50.00

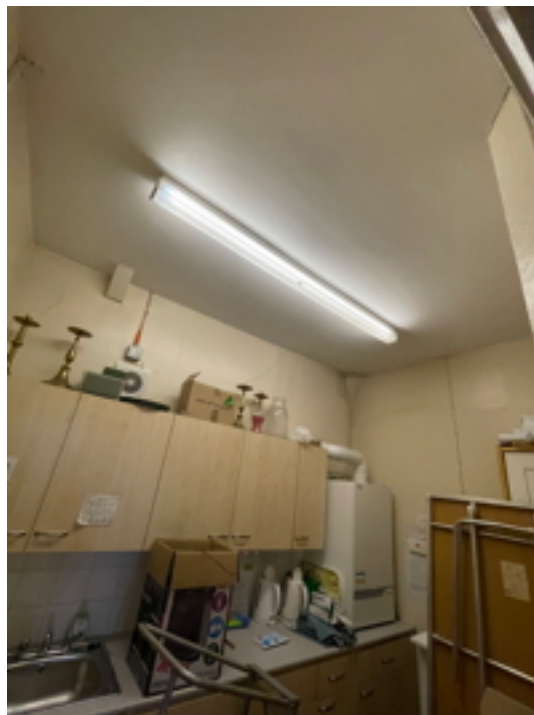
**Kitchen**

The Kitchen is all is in satisfactory condition but needs decoration. Stored material compromise the use of the space. Edge seals to flooring should be replaced to avoid washing water ingress.

Replace edge seals to vinyl flooring in Kitchen with Dow 785+ clear silicone sealant. £50.00

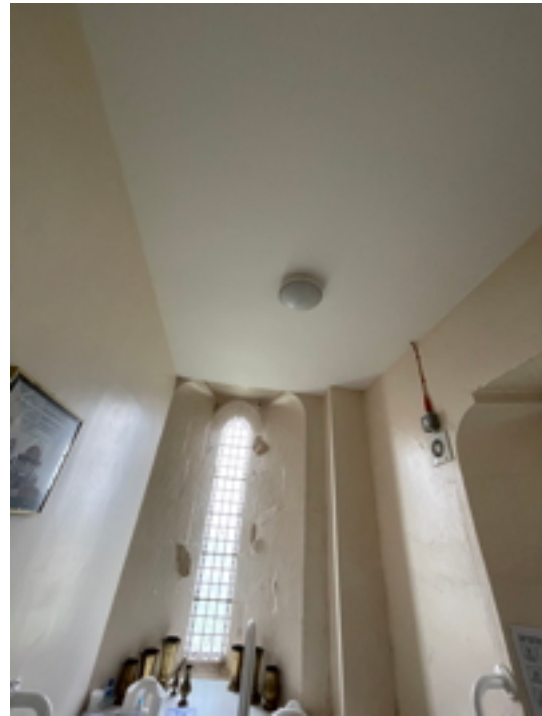
The Ground Floor Accessible WC in generally satisfactory condition but needs decoration. Edge seals to flooring should be replaced to avoid washing water ingress.

Replace edge seals to vinyl flooring in WC with Dow 785+ clear silicone sealant. £50.00

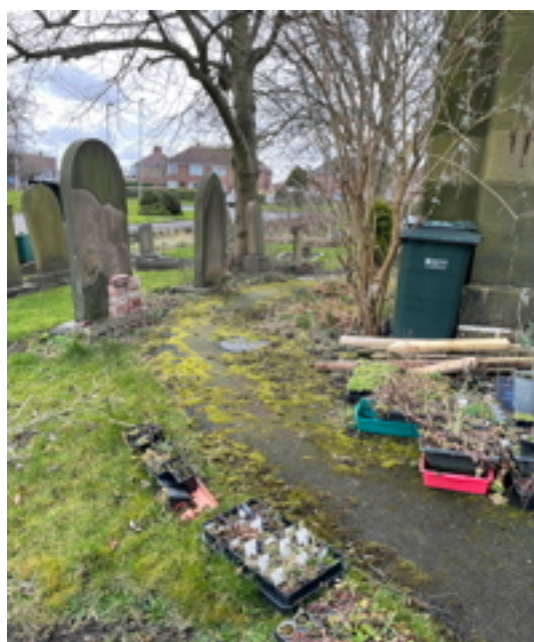
**Buddleia growing at the North East Corner of the Chancel**

The trees generally all appear is satisfactory condition. However the buddleia and other seedlings seeding should be fully removed before they cause damage to the church structure which could be significant if left. The trees should all be inspected by a qualified tree surgeon every five years and pruned in accordance with their recommendations.
