**DIOCESE OF DURHAM**  
**CHURCH OF ST PHILIP AND ST JAMES**  
**WITTON LE WEAR**  
**ARCHDEACONRY OF AUCKLAND**  
**DEANERY OF AUCKLAND**

**ECCLESIASTICAL JURISDICTION AND CARE OF CHURCHES MEASURE 2019**  
**QUINQUENNIAL REPORT NOVEMBER 2021**

JOHN TAYLOR ARCHITECTS LTD  
THE STUDIO  
64 HIGH WEST ROAD  
CROOK  
CO DURHAM  
TEL. 01388 767124

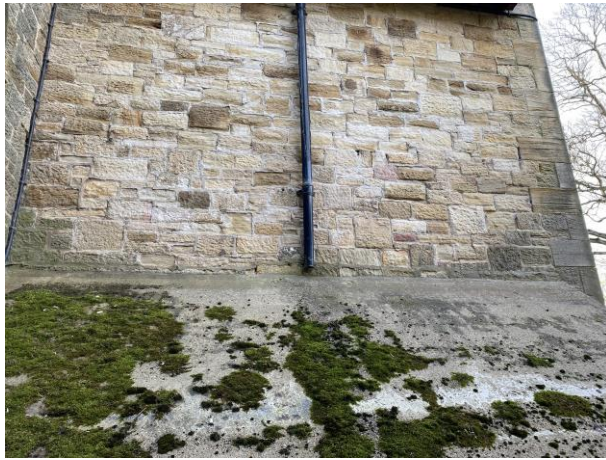
The boiler house roof is formed with in-situ concrete which receives direct rainwater discharge from the nave roof which is aggravating the erosion of this roof exposing the coarse aggregate.

Image A: In situ concrete roof to Boiler house.

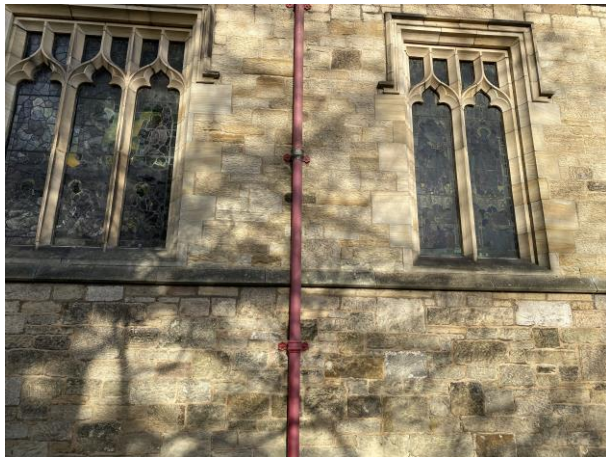
Temporary repair to downcomer requires permanent solution.

Image B: temporary repair to South elevation downpipe

- a) Clean out all rainwater goods. **Band 1**
- b) Clean out all blocked, trapped gullies. **Band 1**
- c) Form concrete step to boiler house. **Band 1**
- d) Permanent repair to downcomer, south elevation. **Band 1**
- e) Reposition slipped/missing roof tiles. **Band 1**
- f) Employ specialist to inspect and remedy areas affected by woodworm. **Band 1**
- g) Remove vegetation, rear of organ chamber roof. **Band 1**

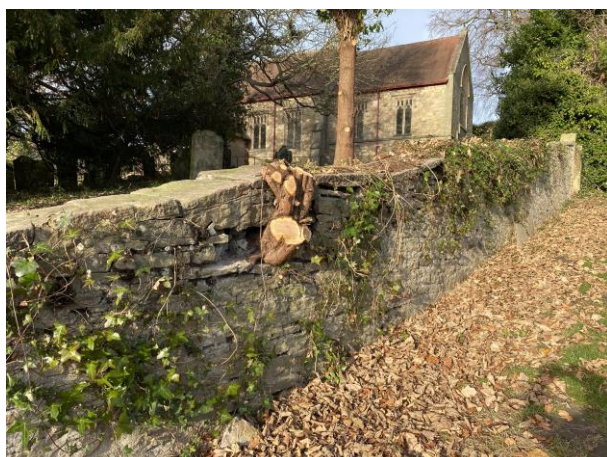
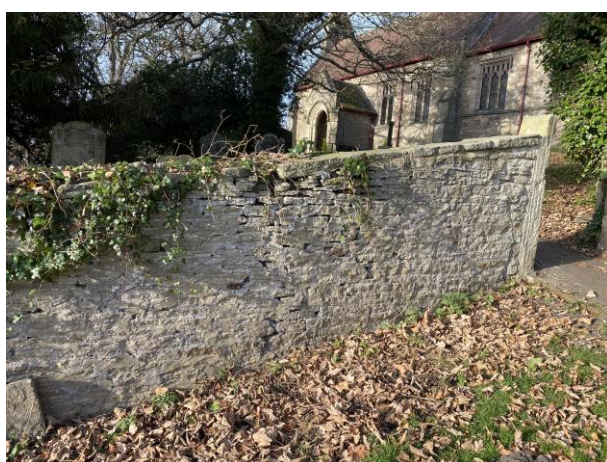
The boundaries to site are formed with random stone walling which is generally sound and in good order. The wall forming the East and North boundary in particular appears to have been rebuilt in the more recent past. South boundary, some coping stones are misplaced, wall requires pointing in isolated areas.

Image C & D: Boundary walls requiring attention

- a) Boundary walls reposition/bed coping stones and repoint areas of walling. **Band 2**
- b) Seal and secure woodblock flooring. **Band 1**
- c) Clean off moss growth to North facing roof areas. **Band 1**
- d) Decoration to external woodwork. **Band 1**

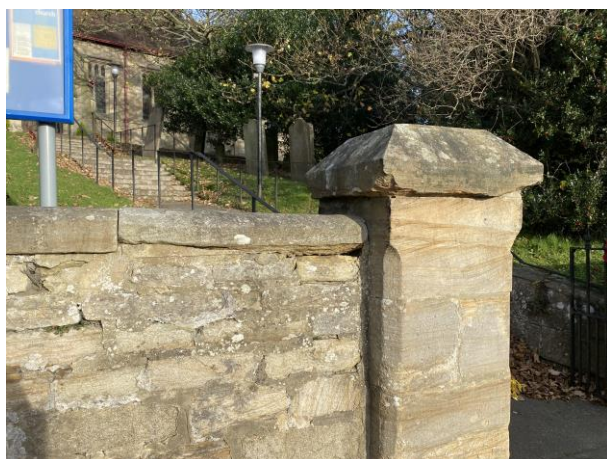
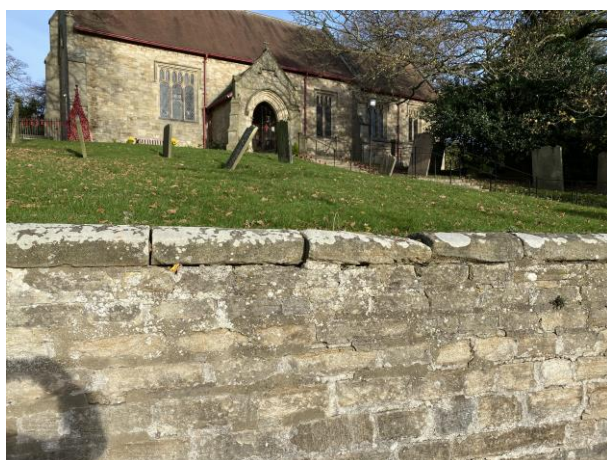
Image E & F: Lifting coping stones to Southern boundary wall

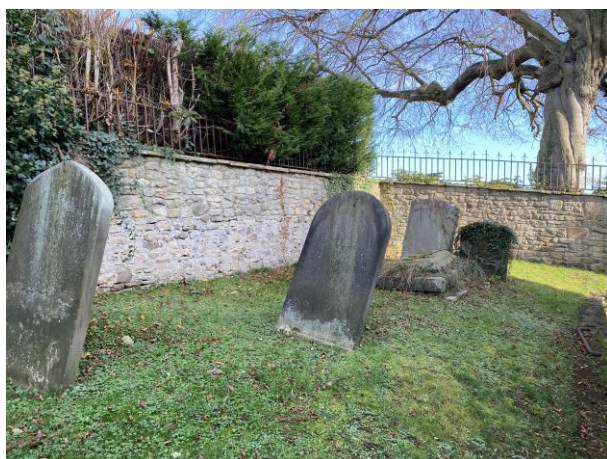
Isolated headstones leaning quite heavily require monitoring for stability.

Image G: Leaning headstones

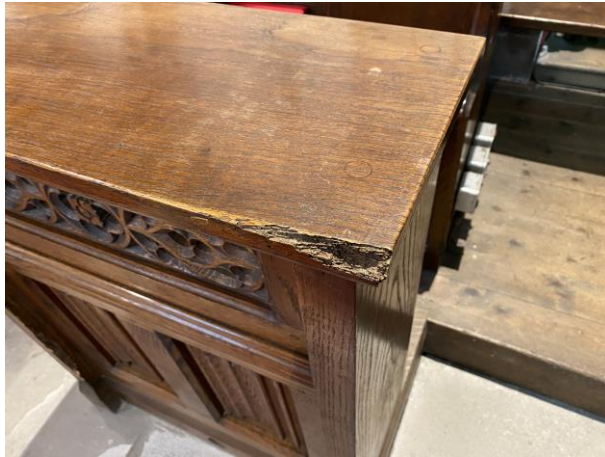
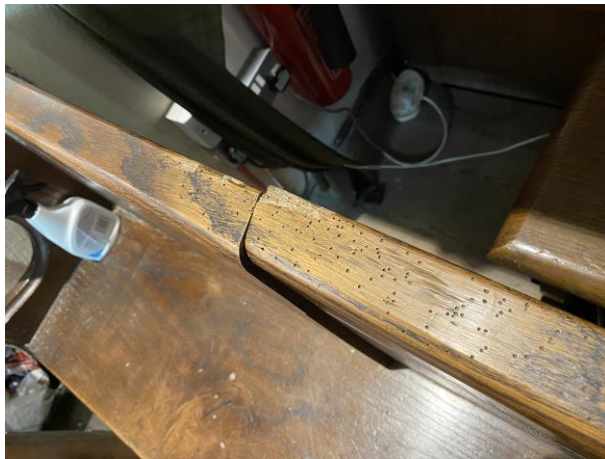
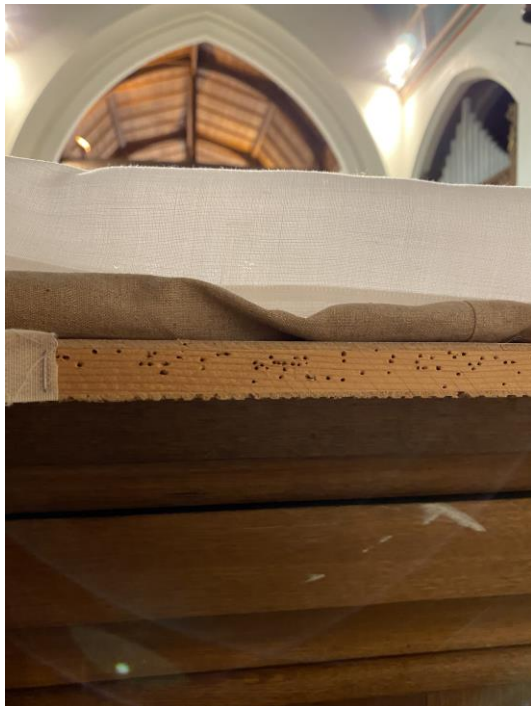
There is evidence of woodworm infestation in the choir stalls, lectern and alter table. These areas should be inspected by a specialist as soon as possible and any recommendations immediately implemented.

Image H, I & J: Evidence of woodworm

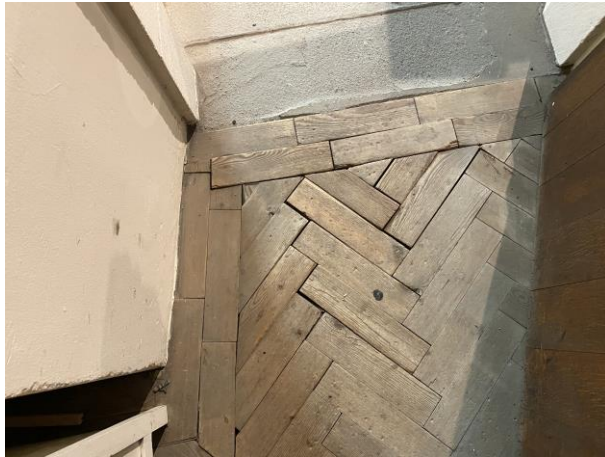
The floor to the nave is a combination of concrete to the entrance point and walkways and woodblock to the pew areas. Some areas of woodblock flooring are loose laid and any surface sealant has long since been worn off.

Image K: Loose woodblock flooring

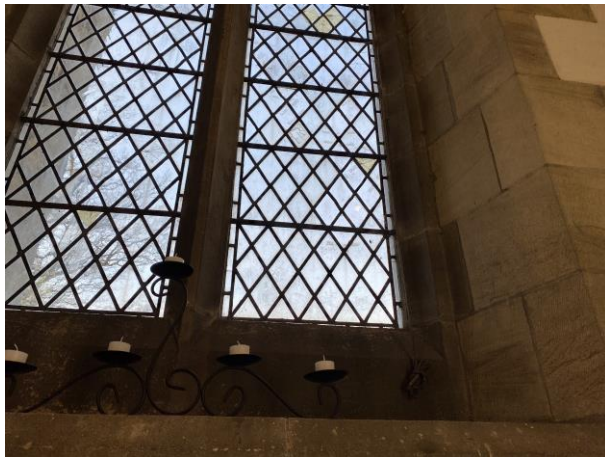
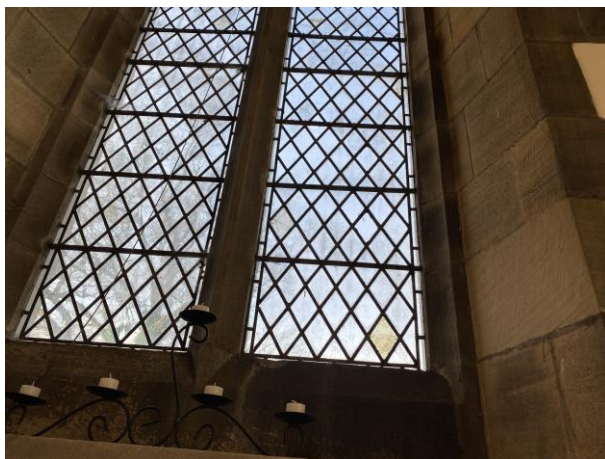
Window to West end of this elevation clear leaded light. Isolated lead panes are holed/cracked, require replacing.

Image L & M: Broken / cracked leded lights

- a) Repair broken/cracked leaded lights. **Band1**
- b) Decorate all rainwater goods. **Band 2**
- c) Isolated repointing. **Band1**
