Quinquennial Inspection

**St Mary St Stephen,
Wolsingham**

**For
St Mary St Stephen Parish Council
August 2018
Revised April 2019**

Church: St Mary St Stephen, Wolsingham.
Archdeaconry: Auckland
Diocese: Durham.
Date of inspection: Dec 2017
Weather: Dry and sunny

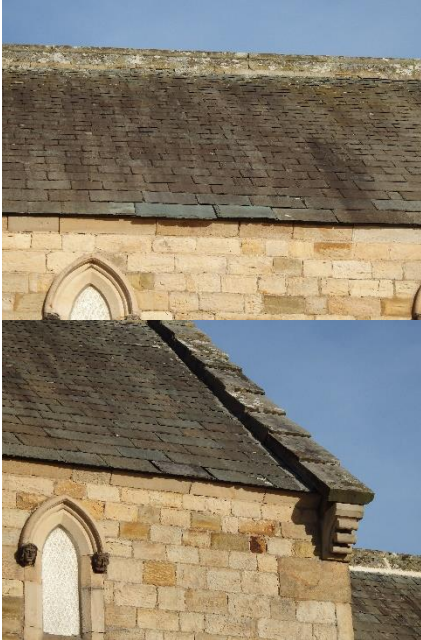
No.	Description	Recommended Action	Cat. /Cost	Photograph
EXTERIOR				
1.0 Roof coverings.				
Green Westmoreland slates in diminishing courses				
1.1	<p>South elevation – nave. Minor loss of pointing to ridge tiles. Evidence of recently repaired slating (associated with water damage noted internally). 1 no undersized slate at east end. No gutter.</p>	<p>Point up the ridge tiles. Monitor for possible continuing water penetration, which may be due to lack of a gutter to the nave roof.</p>	<p>B D</p>

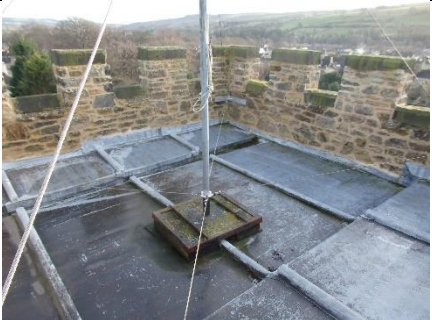
1.9	Tower roof Lead finish to roof appears to be sound. The flag pole is fixed in position with tensions cables (ingeniously without the need to penetrate the roof finish). The pole sits in a steel cradle which in turn is bedded on timber blocks on rubber matting. The timber blocks are showing inevitable signs of decay.	The state of the timber blocks should be monitored. These should be monitored and may need to be replaced, possibly during the quinquennium.	D

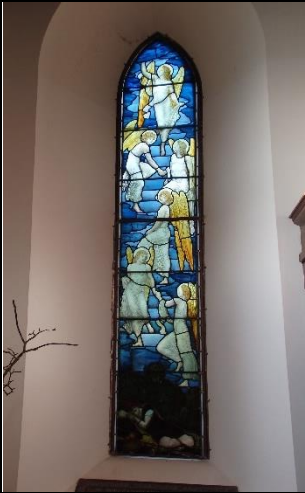
3.6	West elevation. Ground level appears to be approx. 200mm above internal floor level.	Monitor for potential damp within the church	M	
3.7	Tower has recently been repaired under a Heritage Lottery grant. Stonework generally in a good state of repair.			
4.0	Windows			
4.1	The stained glass to all windows apart from 3 in the chancel. The stained glass is Victorian and sound. Of particular note is The Jacob's Ladder by Holiday. This was recently conserved and protected with isothermal glazing.

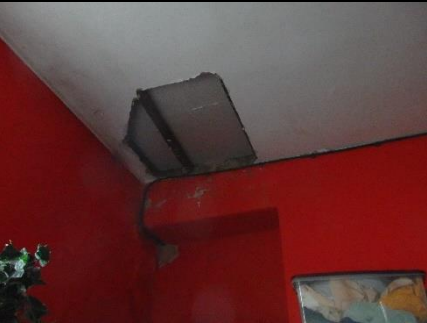
6.5	Storm damage to trees has been noted since the last QI.	The parish advise the trees are checked periodically by the local authority.		
	INTERIOR			
7.0	Ceilings			
7.1	Scissor roof trusses with corbelled wall posts form the roof structure to the nave, all appears sound The timber boarded sarking to the roof provides the internal ceiling finish. All seems sound.			
7.2	Exposed trusses to the north and south aisles. As with the nave, the timber boarded sarking to the roof provides the internal ceiling finish. All seems sound.			
7.3	The ceiling to the rear vestry is damaged. It is understood this will be repaired as part of the imminent refurbishment of the heating system and the relocation of the boiler	Make good ceiling following heating system up grade.	C

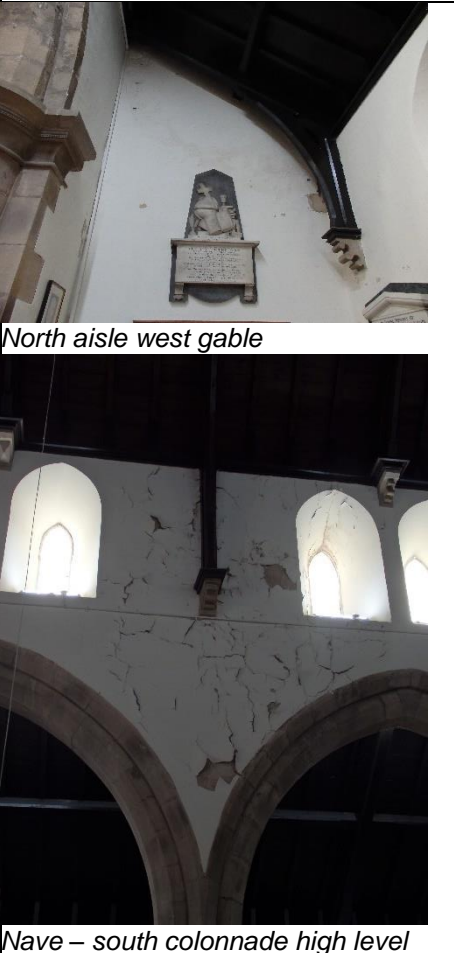
<p>8.0</p>	<p>Walls</p>			
<p>8.1</p>	<p>There are signs of drying out from previous water penetration incidents:</p> <ol style="list-style-type: none"> 1. West gable north aisle 2. High level to south colonnade in south aisle East gable south aisle 3. South colonnade/nave west end 4. Organ chamber. <p>The problem is possibly exacerbated with the use of an incompatible emulsion on lime plaster.</p>	<p>Monitor for drying out and redecorate when the plaster is ready to do so.</p>	<p>C</p>

<p><i>North aisle west gable</i></p> <p><i>Nave – south colonnade high level</i></p>

<p><i>South aisle colonnade high level</i></p> <p><i>South aisle east gable</i></p> <p><i>Nave south clerestorey, west</i></p>
--	--	--	---

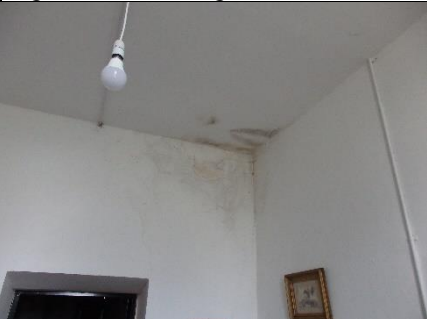
<i>Organ chamber high level</i>
8.2	Mould on ceiling and wall in vestry, possibly from older water penetration prior to recent reslating.	Monitor for drying out. Treat with fungicide and redecorate when plaster ready to do so. If persistent, investigate further.	C
