# St Mary's, Woodland

Quinquennial Inspection

## CONDITION SURVEY 2021

Ian Wells B Arch RIBA AABC

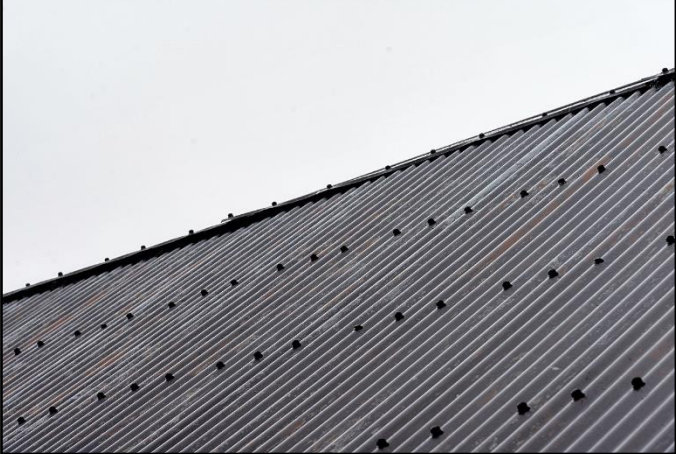
<p style="text-align: center;">The ridge is lifting in places and needs to be carefully re-fixed.</p>
		<p><b>Chancel and Vestry</b></p> <p>As nave but with a greater need for redecoration. Less black paint appears to have been applied and is in greater need of redecoration.</p>

<b>Priority Rating</b>	<b>Work Required</b>	<b>Budget Costs</b>
2.01	Urgent Works requiring immediate action	1.13 Update logbook. 3.01 Fix down lifted roof ridges. 3.02 Clean out all rainwater goods and repair a broken joint. 3.03 Clean out rainwater gullies and establish if they are running effectively. 4.06 Change the vestry door lock to thumb turn operation. 5.04 Ensure PAT testing is up to date. 5.09 Service fire extinguishers.	£0 £200 £0 £0 £50 £100 £100

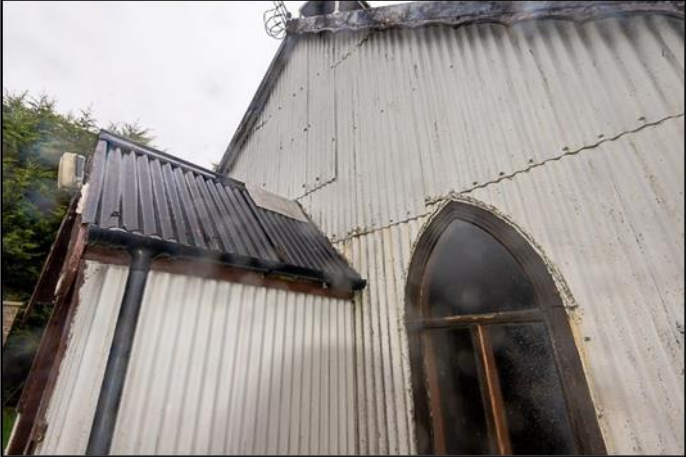
<p style="text-align: center;">The porch roof appears to be older and less satisfactory. Consider new roof sheeting.</p> <p><b>Porch</b></p> <p>The roof appears to be older and has a saddle type patch repair.</p>

2.03	Works recommended to be carried out during the next two years	6.04 Patch repair boundary walls.	Unknown
2.04	Works needing consideration within the next five years	3.06 Re-clad porch roof and upper section of the west gable directly over the porch. Establish a more formal routine for regular maintenance	£1,000 £0

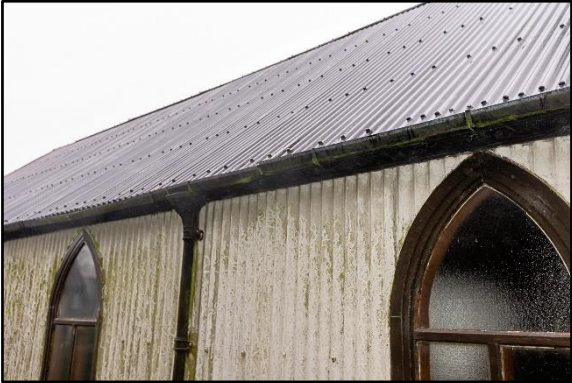
<p style="text-align: center;">A gutter joint on the north elevation has sprung apart.</p>
3.03	Drainage below ground	<p><b>Surface Water Drainage</b> UPVC gullies with plastic grates to most rainwater pipes.</p>

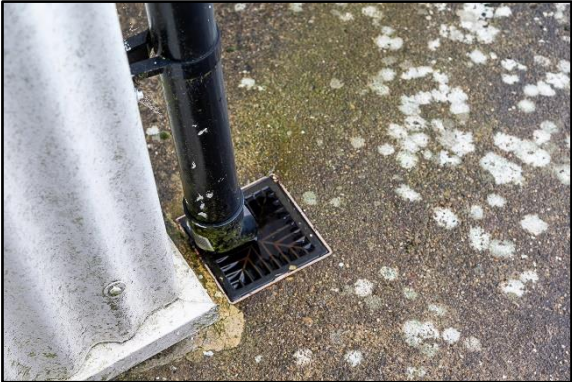
<p>There are no inspection chambers associated with the surface water drainage, so it is likely that the below ground drainage runs to soakaways. Several of the gullies were full and not draining away when I visited. All gullies need jet cleaning.</p> <p><b>Foul Water Drainage</b> Serves the kitchen and the disabled WC and connects to the sewer in the road. There are modern UPVC inspection chambers at changes in direction and connections. The foul drainage route is marked on the plan in appendix A.</p>

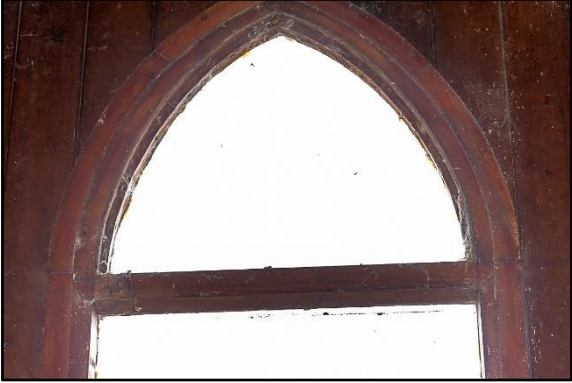
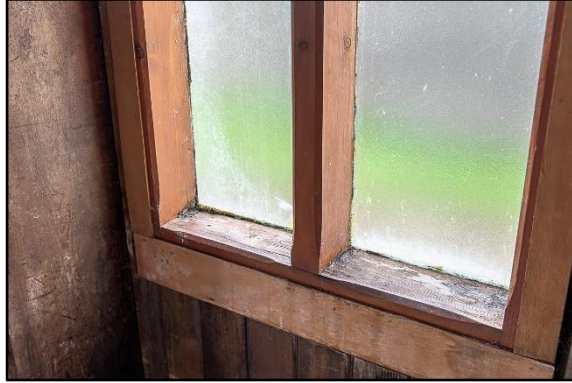
<p>W5 Main glass panel appears to have slipped down</p> <p>A typical internal sill showing some moisture ingress. Fresh putty is required.</p>

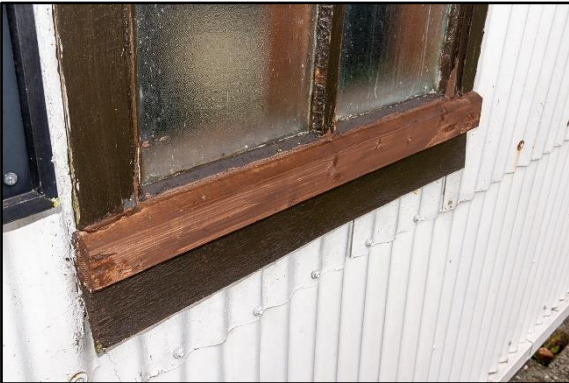
<p style="text-align: center;">A recent windowsill repairs. It would benefit from a further coat of stain. The whole window requires redecoration.</p>		
		<p>W1 – W11 all similar wood framed, single glazed and lancet headed fixed lights. The frames have a mixture of timber and putty beading. W5 has a slipped sheet of glass. W6 has an air rifle pellet hole in it. Several of the frames have rotten sections usually sills. All require patch repair and redecoration.</p>
		<p><b>Window External Protection</b> None. This does not appear to be a problem.</p>

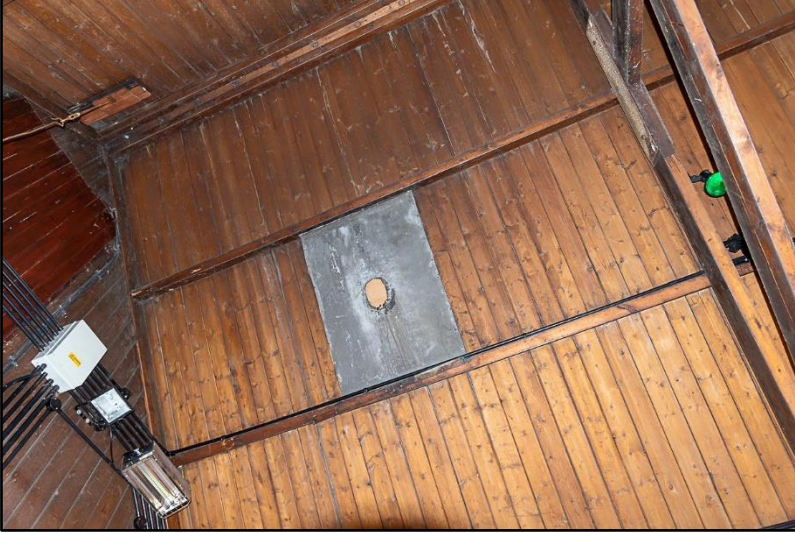
<p>The boarded soffit is stained below the ridge. This staining suggests water leakage from the roof weathering in the past and possibly currently.</p> <p>The scissor trusses have several repair plates. These are the result of damage which occurred when the roof was supporting very heavy snowfalls.</p>

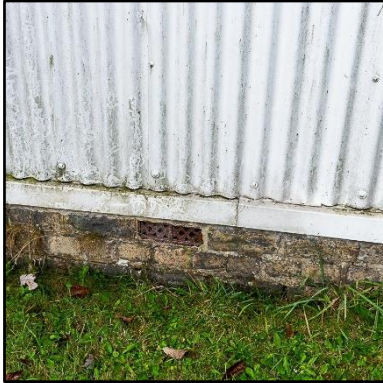
<p style="text-align: center;">South side air brick</p> <p>It is essential that airbricks are cleaned out so that they work and are protected by mesh to keep vermin and insects out.</p>

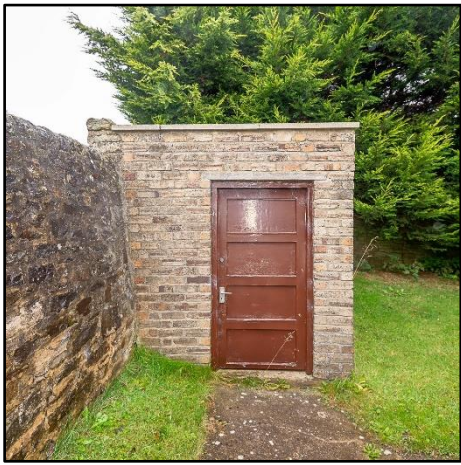
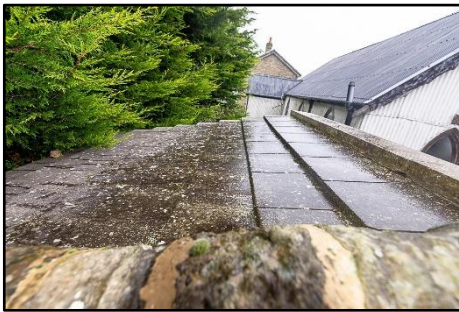
The door would benefit from an overhaul and redecoration.
		The roof appears to be sound.
