CHURCH OF SAINT BRANDON

BRANCEPETH

REPORT ON QUINQUENNIAL INSPECTION May 2018

Knox McConnell Architects Ltd
24 Victoria Road, Saltaire
Bradford BD18 3JR

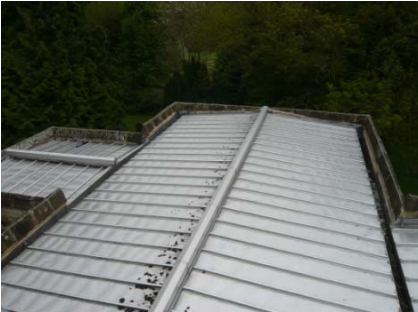
<p>2.1.6.</p>	<p>Chancel Roof This is stainless steel however the lead flashings were stolen. As set out earlier the roof was renewed in 2004 and the flashings poorly replaced. The parapets are well set and in reasonable order.</p>

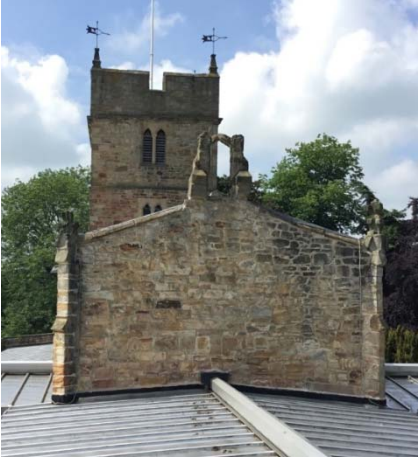
<p>2.2.7.</p>	<p>East Elevation of the Nave</p> <p>The East elevation of the Nave has been re-pointed. Some of the stones however are very friable and debris has been falling off onto the roof with the potential of causing blockages in the rainwater disposal. A number of the more friable stones should be brushed back and the debris removed on a regular basis.</p> <p>The parapet to the Nave gable had a lead capping to it. Now replaced with mesh reinforcement flashing. The pinnacles and bellcote above appear to be well pointed and secure.</p>

<p>2.2.8.</p>	<p>Recommendations:</p> <ul style="list-style-type: none"> B • To the east elevation of the nave at roof level: Repair friable stones and regularly check for blockages and damage caused by falling stone debris. B • North Nave Clerestory Bay Three – Second window from the West: Replace the cill pointing below the cill which has failed B • North Nave Clerestory Bay Four Third window from the West Carry out conservation repair to head and reveal. B • To Bay 5 north clerestory, fourth window from west: repair failed pointing.

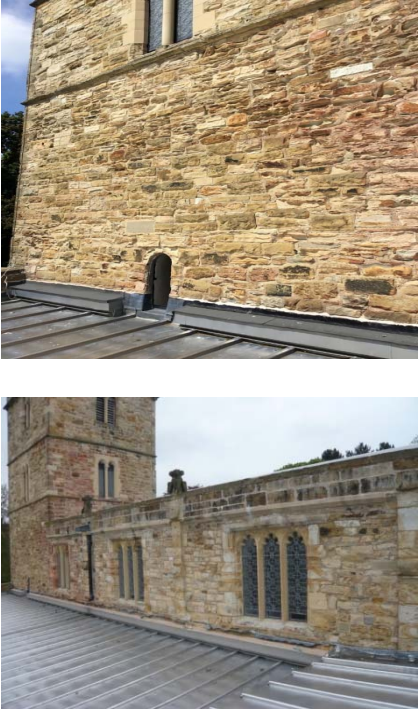
2.3.	<p>SOUTH NAVE CLERESTORY STONEMWORK AND WINDOWS From west to east</p>	
2.4.	<p>Bay one is the tower. Access is gained via a casement window. See tower stonework section.</p>

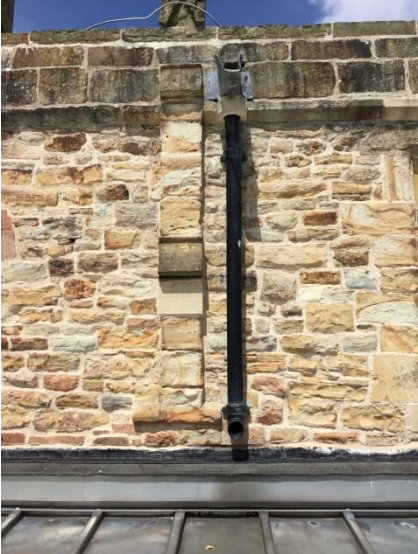
<p>The top photograph shows a close-up of a stone wall with a small, dark, arched opening. The bottom photograph shows a wider view of the stone wall with several windows and a tower structure in the background.</p>
2.5.	<p>Between Bay One and Bay Two is a small buttress and the moulded section is severely eroded and a new carved section should be inserted. This needs to be repointed due to theft damage.</p>

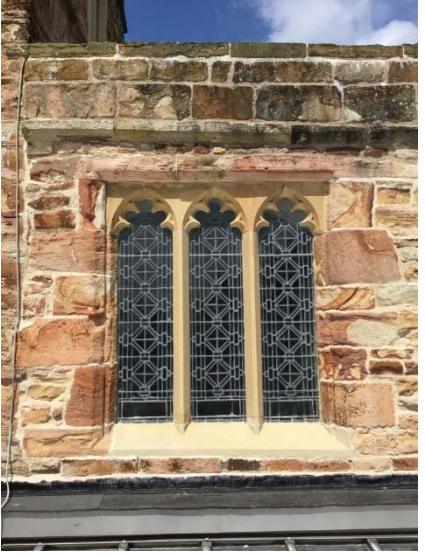
<p>2.5.1.</p>	<p>Bay Two 1st window from West This tripartite window has a new tracery head, cill and mullions with new glazing and lead comes all as before.</p>

2.5.5.	<p>Recommendations:</p> <ul style="list-style-type: none"> B • Bay two, 1st window to south clerestory: Replace failed mortar to glass line B • Bay three, 2nd window to south clerestory: <ul style="list-style-type: none"> ○ Renew failed mortar ○ Replace stone to East of reveal B • Bay four, 3rd window to south clerestory: Replace failed mortar B • Bay five, 4th window to south clerestory: Replace failed repair

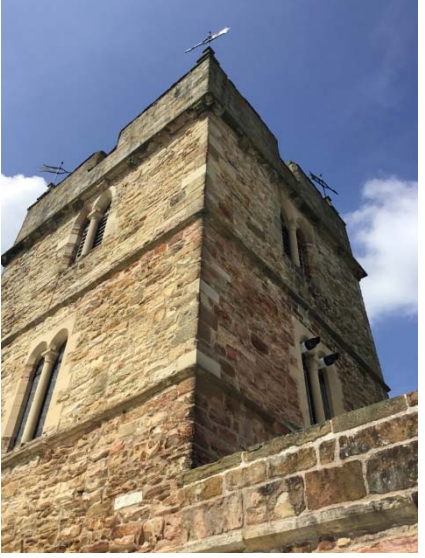
2.6.4.	<p>Upper Tower East Side</p> <p>The Stonework appeared to be in satisfactory condition, though it was not entirely visible. This should be checked when access is next available.</p>

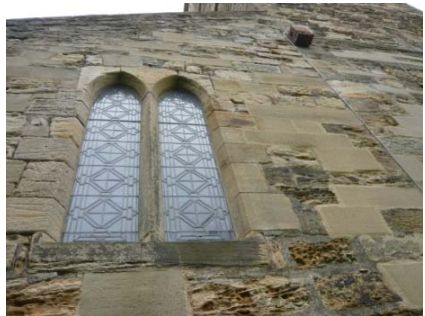
2.6.7.	<p>Base of Tower (From Ground Level) West Side</p> <p>The stonework of the lower section has been repaired in the last twenty years with the same tooled ashlar as on the previous section of wall. This isn't wholly successful visually. As before the window has been replaced and the window surround appears to be in good order. The older stonework is suffering severely from erosion and areas of hard pointing at lower levels are causing the stones to erode more quickly than may otherwise have been the case. Some</p>

stonework will need to be replaced within the quinquennium.	
2.6.8.		<p>Middle Section of Tower West Side This section has been re-pointed within the last 15 years. There has been some replacement of stones and this is much more successful than in the lower section. This stone has been pitched and is laid to random coursing.</p> <p>Below the string course there is a rather rusty box fixed to the wall. This should be removed.</p>

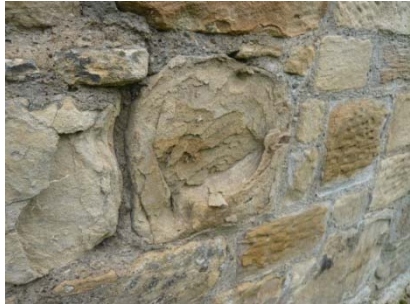
2.7.2.	<p>West End Gable of South Aisle</p> <p>This has a two lancet window which has been replaced as elsewhere. The stonework around the window appears to be in reasonable order. There are various very eroded stones in this elevation some of which will need replacement in the not too distant future. The pointing however seems to be reasonable. At the base of the plinth there are two cast iron access points to services beneath.</p>

B	<ul style="list-style-type: none"> Generally, severely eroded stone to have a programme of replacement/
	E	<ul style="list-style-type: none"> Ground levels around the west end should be improved if damp becomes a problem internally.
	B	<ul style="list-style-type: none"> West end generally: Stone work replacement needed (except upper tower)

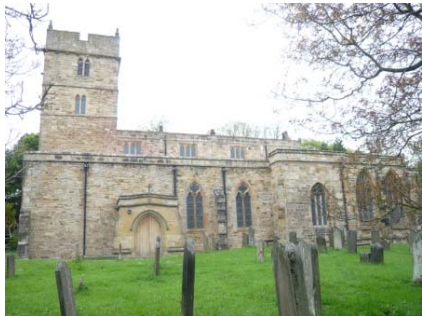
2.8.1.		<p>South Elevation: Bay One To the West of the South Porch</p> <p>A couple of the coping stones in this section require re-pointing. Some stones are shaling fairly badly though the erosion isn't quite as bad as the West elevation. There is some hard pointing at lower level which is affecting the stone to a certain degree, however, removing it would probably cause more damage. There are two ventilation holes which have been constructed in stone and are very neat. At the base of the wall there is no plinth but there is a stone path. The grassed area slopes down towards it. The gully was blocked with vegetation. Note that there is an overflow outlet at low level from the WCs beyond.</p>

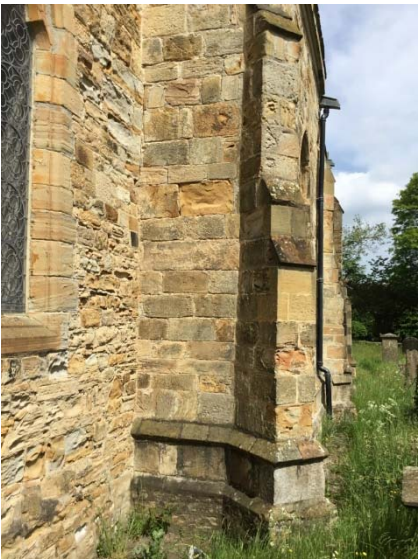
<p>2.8.6.</p>	<p>South Transept: West Elevation The Western buttress to the transept is in reasonable order as is the West elevation.</p>

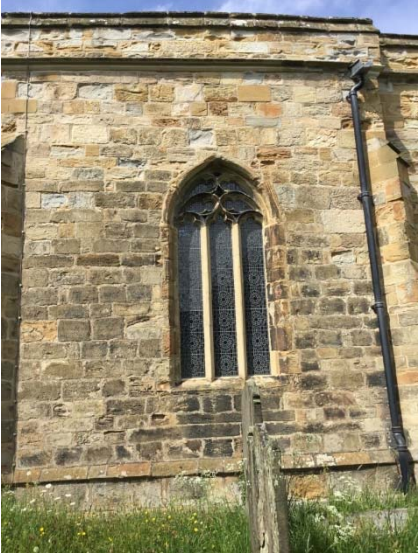
<p>2.8.7.</p>	<p>South Transept: South Elevation There is a three lancet window with lozenge shaped tracery above. The window glazing is post fire as elsewhere. The mullions and some of the reveal appear to be post fire. The head of the window appears to be well weathered although sound. Generally, the stonework and the pointing on this elevation is slightly better than some other areas.</p>

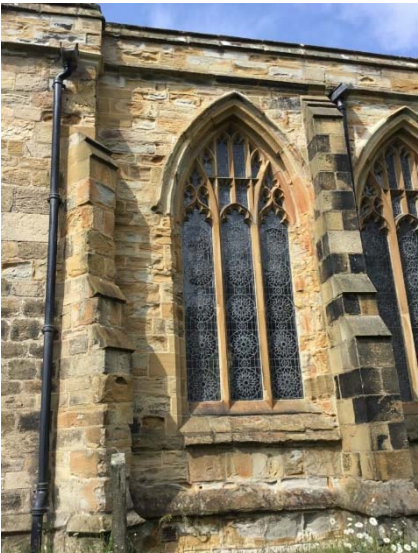
<p>2.8.8.</p>	<p>Lady Chapel: South Elevation Bay One from the West This has a three lancet window with decorated tracery above. The Eastern reveal is well weathered and little of the moulding remains. Some of the stones are well eroded but it is well pointed at other levels. At plinth level the pointing is harder and appears to be affecting the stone.</p> <p>There is a metal air vent grate which is fixed rather haphazardly and could be neatened up significantly. At the base of this wall is a flagged pathway.</p>

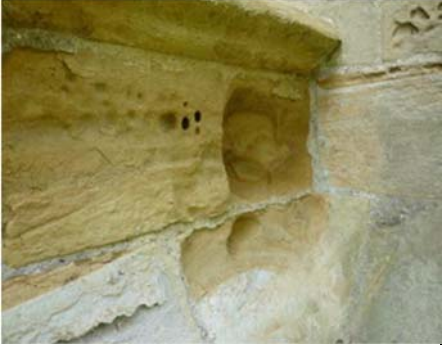
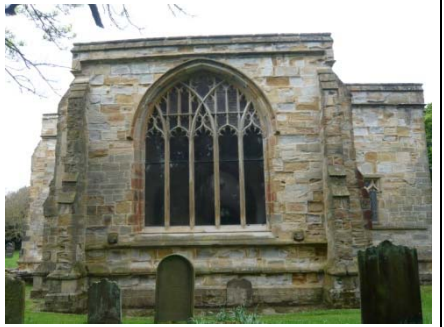
2.9.4.	<p>Chancel: East Elevation</p> <p>This has a five bayed window with decorated tracery above.</p> <p>The string course above the window in a couple of areas requires re-pointing.</p>

<p>The stone generally is eroding as elsewhere and becoming very powdery and friable. This is particularly evident below the plinth course moulding in this area. Note that there are a couple of interesting corbel type stones projecting from this elevation and also a well weathered carved stone in the South buttress. The origins of these are unknown to me. At the base of here there is a flagged path. The buttresses to the North are well pointed if a little eroded.</p>

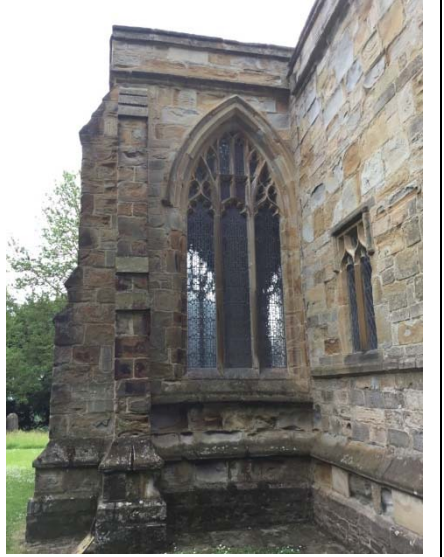
<p>2.9.5.</p>	<p>Chancel: North Elevation East End This small bay has a three lancet window with tracery above. The moulded string and plinth course at lower level surmounts severely eroded stonework below. The pointing overall is good.</p>

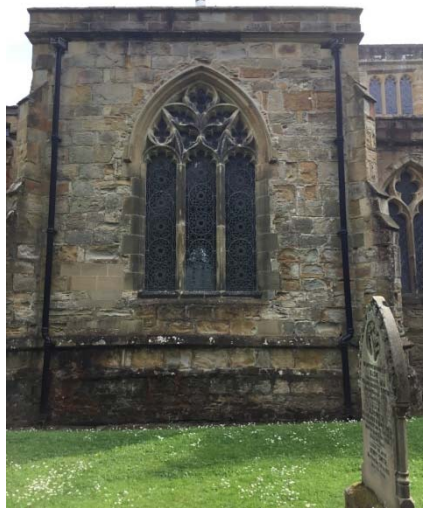
2.10.2.	<p>North Transept: North Elevation</p> <p>This has a three light window with tracery above. There are small fixings around the window stonework which require removal. However, the stonework around the window appears to be in reasonable order. The wall stones are suffering from erosion as elsewhere. Some areas of pointing below the lower string course is required. Some other areas of pointing at higher level also need to be carried out. The downpipes and overflows appear to be working well and are free flowing.</p>

2.10.4.	B B	<p>Recommendations:</p> <ul style="list-style-type: none"> • North transept: East elevation, repair stone at the base of the Southern reveal. • North transept: North elevation, repoint lower string course. Small fixings around the window stonework require removal.

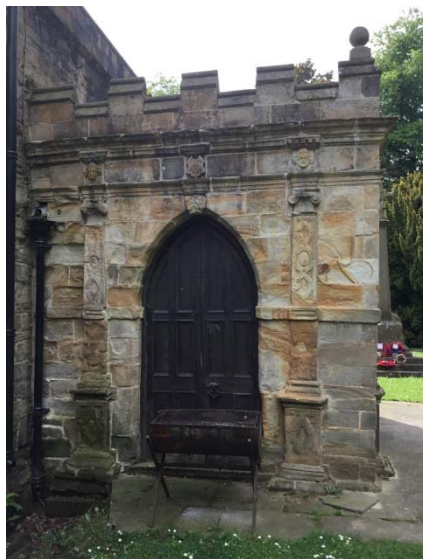
2.12.		NORTH PORCH	
2.12.1.		<p>North Porch</p> <p>This is a lovely example of late 17th Century early Classicism.</p> <p>North Porch: East Elevation</p> <p>There is a timber door in this opening which is not normally used. Originally this porch had three openings one of which has been blocked up with stone. The Northern elevation door is normally used.</p> <p>The stonework has undergone a programme of stone conservation since the last QI.</p> <p>Above the door there is a keystone with a shield above and flanking the doors are two pilasters with carved decoration depicting ionic columns with rusticated stonework and carved stonework. The</p>

<p>details of these pieces of stone are being at risk of being lost by erosion. Above the pilasters are faces carved in stone and above those small set forwards with dental moulding. There is a downpipe in the corner.</p>

2.12.4.	<p>Recommendations:</p> <p>M</p> <p>C</p>	<ul style="list-style-type: none"> • Vigilant maintenance is required to ensure the good order of the porch. • Carry out 3D recording of the carved details for archive purposes.

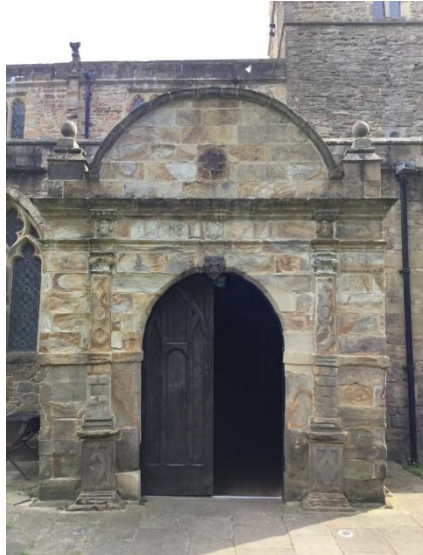
2.12.2.		<p>North Porch: North Elevation The North elevation of the porch has a carving of a boar at the keystone and also has two pilasters flanking the doorway. These are constantly at risk of losing their detail through erosion.</p>

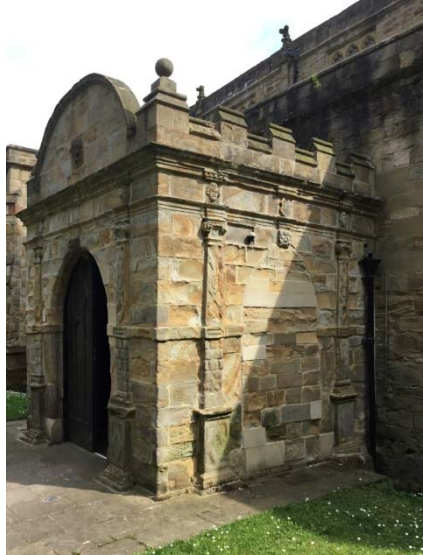
2.12.3.		<p>North Porch: West Elevation This elevation has an opening which has been blocked up with stone. One is severely eroded. There is a carved keystone as before and two flanking pilasters. At higher level there is a daylight sensor for the lights.</p>

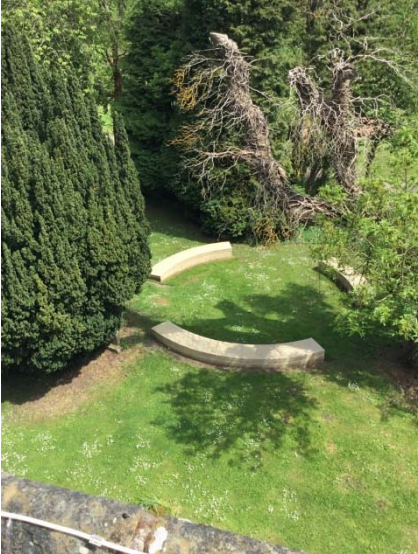
2.13.	CHURCHYARD	
2.13.1.	<p>The Churchyard is still open and is maintained by the Parochial Church Council. Some of the great number of headstones are listed Grade II in their own right. These are slabs to Jane Foster 1721 and Henry Mills 1807 (four metres South of the Church); monument to Robert Thompson 1729 (three metres South); headstones to John Wilson 1782, Hannah Stockburn 1777 and Thomas Johnson 1799 (ten metres South). In addition the main entrance gate piers gates overthrow an adjacent style and are all listed Grade II. These features were not examined in detail.</p>

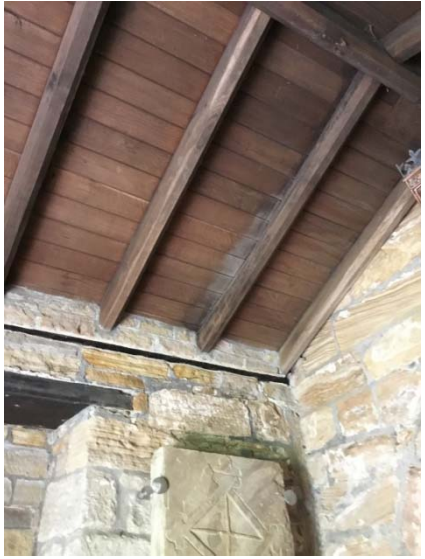
<p>3.1.5.</p>	<p>North Porch: Ceiling At the top of both of the walls to the West and the East there is some steelwork which may be in connection with some structural work that was carried out about 30 years ago to the roof. This should be brushed back and repainted. The stone floor is flagged and is in good condition.</p> <p>The ceiling is timber boarded and with exposed rafters and ridge in good condition. All of the doors are in oak. Two of which are older with dark stain. The ferrementa should be redecorated. The new oak door has hand forged nails and handmade ring latch.</p>

3.1.6.	<p>D</p> <p>B</p> <p>C</p> <p>C</p>	<p>Recommendations:</p> <ul style="list-style-type: none"> • North Porch: West wall, improve unsightly wiring. • North Porch: internal stonework repairs are generally required. • North Porch: East wall, replace lost strap hinge to door. • North Porch: Ceiling, rub down and repaint rusty bar.

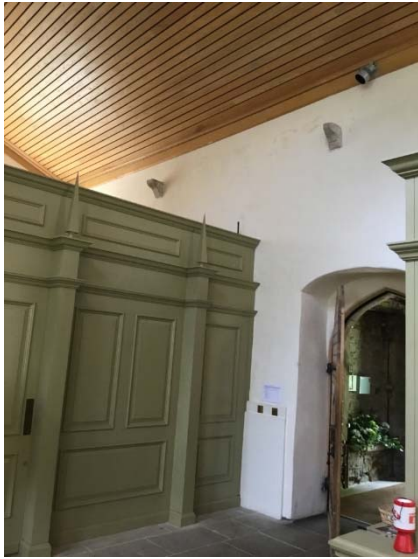
3.2.		<p>NORTH AISLE</p>	
3.2.1.		<p>North Aisle: West End School Room: Not accessible during the 2018 QI.</p> <p>To the West is a small room sectioned off with a painted timber screen. The floor in the room is vinyl. There are two radiators and a small sink. There is a lay light in the ceiling which allows light in from the window at the West elevation. There are fitted cupboards for storage and also for the electrical installation and lighting. This has all been renewed within the last 15 years. The lights are inset into the ceiling and there is a smoke/heat alarm. This room is used for Sunday School. All in reasonable condition</p>

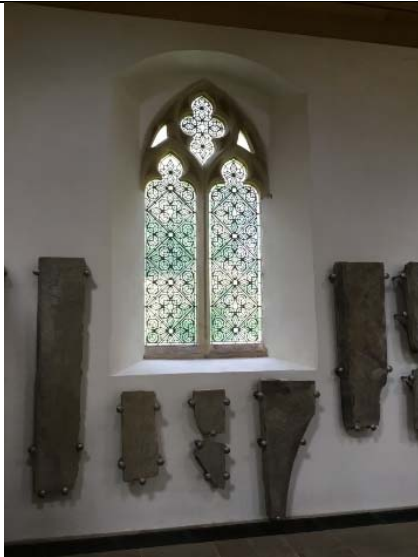
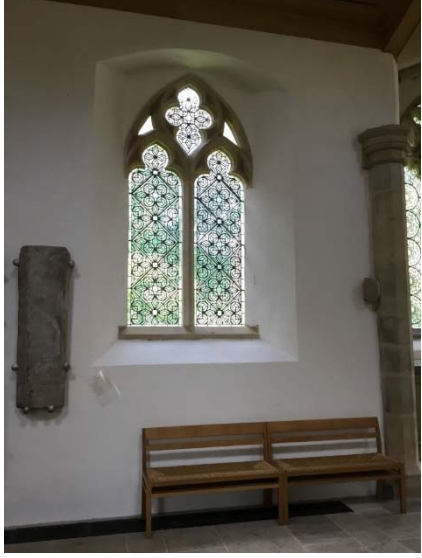
3.2.2.		<p>North Aisle: Split into three bays</p> <p>Bay One: At high level evidence of water ingress.</p> <p>Bay Two: The second bay has a two light window. To the East side of the cill is a hairline crack which runs vertically. This should be monitored and filled.</p> <p>Along the north aisle wall there are 11no cross slabs displayed vertically – off the wall.</p> <p>Bay Three: also has a two light window. There are some fine hairline cracks to the rendering and some filling and redecoration may be required. There is also some mottling of the paintwork in between the bays although this isn't too visually intrusive. There is a crack from the East side of the cill of the window running vertically as it is on the West side of the cill. A crack to the west side of the head. Some dampness evident at high level due to leaks caused by recent lead theft.</p>

3.2.4.	<p>B</p> <p>B</p> <p>C</p>	<p>Recommendations:</p> <ul style="list-style-type: none"> • North Aisle: Bay Two, fill and monitor hairline crack. • North Aisle: Bay Three, fill and monitor hairline crack from the East side of the cill of the window running vertically as it is on the West side of the cill. • North Transept: Repair joinery to cupboard.

3.1.6	<ul style="list-style-type: none"> North Porch: internal stonework repairs are generally required. 	£500
		3.2.4	<ul style="list-style-type: none"> North Aisle: Bay Two, fill and monitor hairline crack. North Aisle: Bay Three, fill and monitor hairline crack from the East side of the cill of the window running vertically as it is on the West side of the cill. 	£500

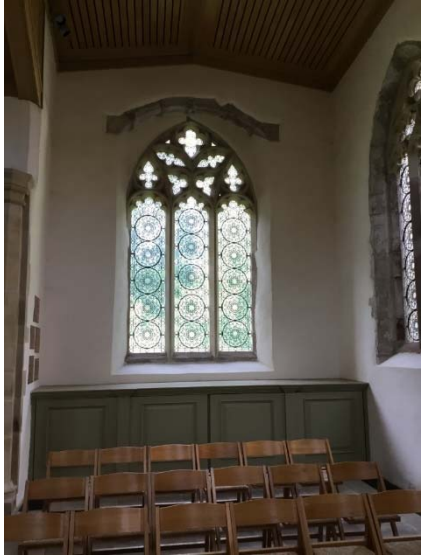
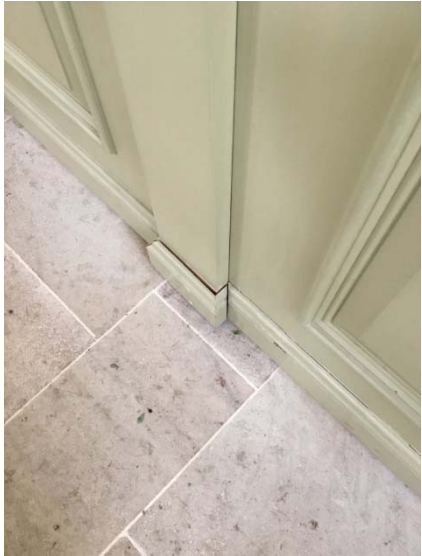
<p>3.2.3.</p>	<p>East End of North Aisle/North Transept. This Transept projects only a couple of metres North. On the North side are large cupboards for temporary seating storage. Some minor joinery repairs needed at the base. There is a three light window with tracery above and there are a couple of small cracks in the render at the edges of the cill. To the East wall of the North Transept is another three light window. No defects are noted.</p>

3.2.4	<ul style="list-style-type: none"> • East End of North Aisle / North Transept - Repair joinery to cupboard 	£200
		3.4.4	<ul style="list-style-type: none"> • South transept: repair cracks around openings. 	£200

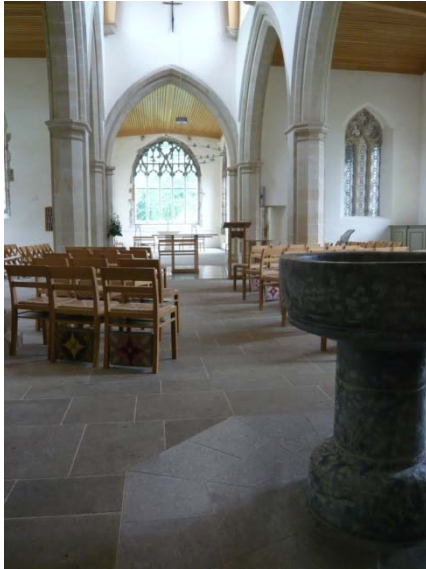
3.3.		<p>NAVE</p>	
3.3.1.		<p>This is an arcaded nave with three bays and an archway into the base of the tower. At the West end is the refurbished organ as mentioned earlier. On the first octagon stands a Frosterly Marble font. There is no liner within the font.</p> <p>The arcading has been completely rebuilt following the fire and the roof above is of steel construction with ash timber boxing around the structure. Bases of the trusses are covered with new carved stone corbels.</p> <p>The lighting is fixed to the East side of all of the trusses and has been renewed within the last 15 years. There are no obvious defects.</p> <p>The floor is stone flagged and in good order generally, although some grouting between is beginning to break up.</p>

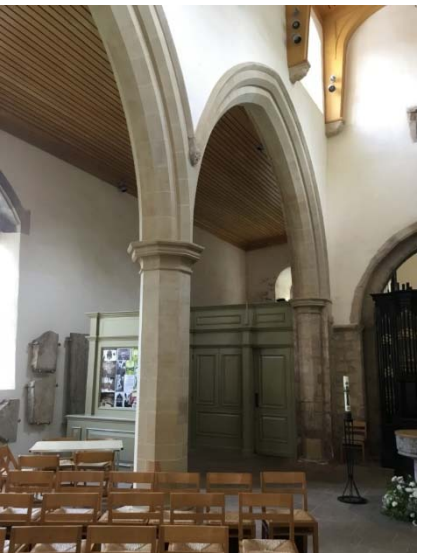
3.4.		<p>SOUTH AISLE</p>	
3.4.1.		<p>South Aisle: West End</p> <p>This is partitioned off with a softwood painted screen behind which is a kitchen and two WCs. The kitchen is fairly new and in good order with a radiator, a hot water boiler and controls for the heating. Only the ceiling hatch is showing wear. Following that there is a lobby with two WCs. One wheelchair accessible - this one also has the baby changing unit. The disabled WC has a large radiator and the entire compliant grab rails etc.</p> <p>It was noted around this kitchen and WC area that in the junctions of the ceiling and the wall small cracks have appeared and these should be filled and redecorated in due course.</p>

<p>3.4.4.</p>	<p>Recommendations:</p> <ul style="list-style-type: none"> D • South Aisle: kitchen, fill cracks in plasterwork. A • South Aisle: Bay Two and Bay Three, brush down and vacuum powdery stonework. Monitor cracks in render. C • South transept: repair cracks around openings. D • South Aisle: Above kitchen ceiling, high level damage noted due to water ingress – decoration may be necessary. 	
<p>3.5.</p>	<p>CHANCEL</p>	
<p>3.5.1.</p>	<p>Chancel: North Wall Split into four bays Bay one: has a window with three lights. No defects.</p> <p>Bay two: has a window of three lights. This has a small crack running through the render from the cill which should be filled and repainted. Also at the apex.</p> <p>Bay three: has a doorway into the vestry and above that is a patch where it is understood some wall painting was discovered, subsequently covered with lime wash. Within this bay is a small squint view hole through from the vestry towards the East altar.</p> <p>Bay four: has a three lancet window. There are some ferrous fixings in the reveal which should be removed if possible. Other than that no other defects were</p>

3.4.4	<ul style="list-style-type: none"> • South Aisle: kitchen, fill cracks in plasterwork. 	£100
			<ul style="list-style-type: none"> • South Aisle: Above kitchen ceiling, high level damage noted due to water ingress – decoration may be necessary. 	£1,000

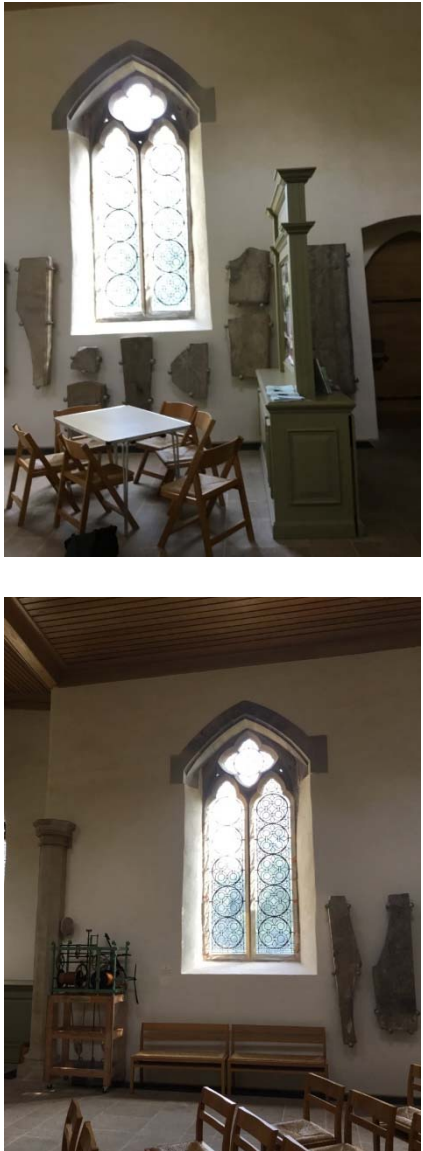
<p>3.4.2.</p>	<p>South Aisle Split into three bays. Bay one: has the doorway into the South Porch which has storage fitted in. The structure within the Porch appears to be sound although a slight damp smell was noted. There is a push bar release mechanism to the South Porch for easy escape. The door to the Porch has been renewed and matches the door to the North Porch. At this end of the aisle there is a foam extinguisher. The render and paintwork has a slightly mottled effect but it is not too visually intrusive.</p> <p>Above the kitchen and WCs, there is visible evidence of damp to the west wall. Pointing and flashing to be improved externally.</p> <p>Bay two: has a two light window. The cill of the window is very powdery and the whole of the window reveal and cill should be brushed down and the dust vacuumed up. Here there are 10no cross slabs displayed vertically. It was noted that there are some cracks in the render to be monitored.</p> <p>Bay three: also has a window with powdery stonework.</p>

3.4.4	<ul style="list-style-type: none"> South Aisle: Bay Two and Bay Three, brush down and vacuum powdery stonework. Monitor cracks in render.
			-
			-

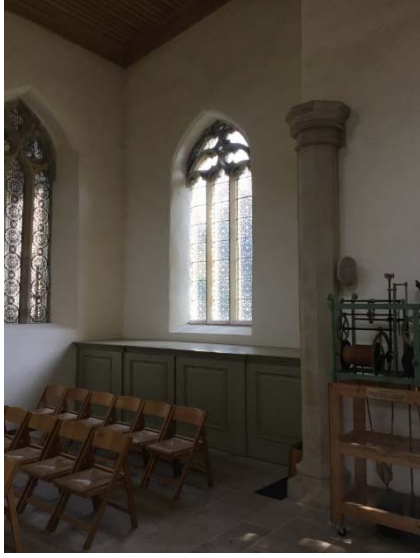
<p>3.4.3.</p>	<p>South Transept At the end of the Aisle stands the South Transept which extends only a couple of metres to the South. This has a three light window and storage cupboards as in the North Transept and appears to be in good order. Within this space there is an internal window into the Lady Chapel. At the cill of the window is a small crack which should be repainted and filled and also to the apex. Also to the left of the window cill to the South window, there is a small crack.</p> <p>To the East of the South Transept is a small passageway which has a stone lintel above. There is a crack through that stone lintel but it is understood</p>

<p>that structural work was undertaken to ensure the structural stability of this during the rebuilding.</p>

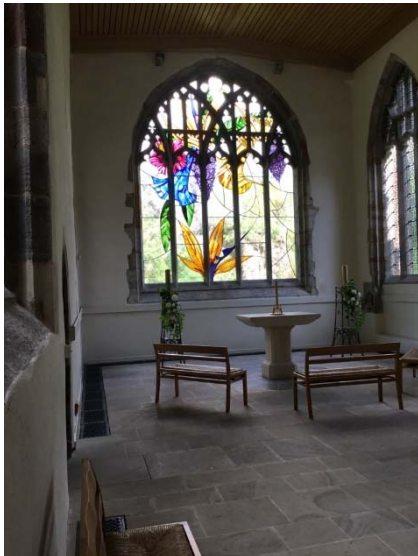
noted. Also a dado arrangement for venting the lower wall.	
3.5.2.		<p>Chancel: East Wall The East window has been recently re-glazed. No other defects noted.</p>

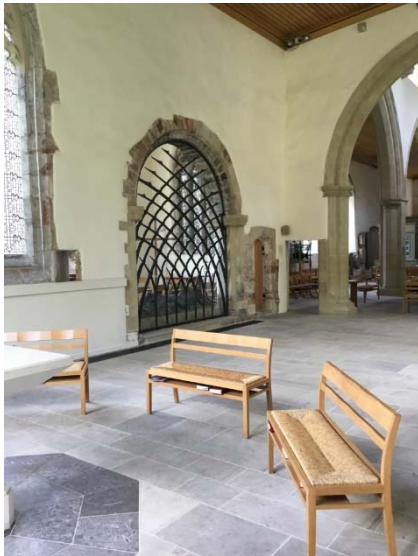
3.5.3.		<p>Chancel: South Wall This is split into three bays. Bay one: The first bay from the East contains a small aumbry which is rusty and is not used and a three light window. Crack at the apex. No further defects noted. Bay two: is a three light window with no obvious defects. Bay three: is an archway through to the Lady Chapel. This is glazed with a wrought steel frame and lattice work by Brian Russell. Also there is a squint hole through from the Lady Chapel towards the East end.</p>

3.5.4.		<p>Recommendations:</p> <ul style="list-style-type: none"> D • Chancel: North Wall, bay two, fill cracks and repaint. D • Chancel: North Wall, bay four, remove ferrous fixings.

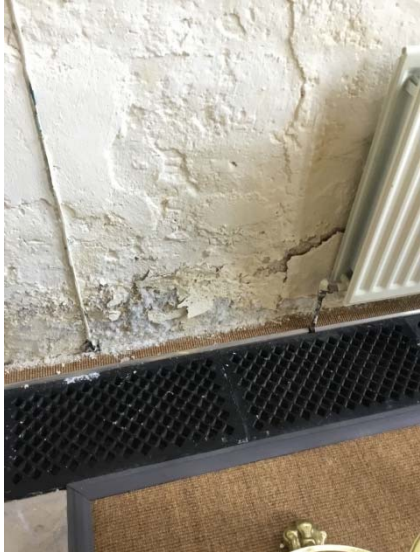
3.6.		THE LADY CHAPEL
3.6.1.	<p>To the Lady Chapel there is a doorway with an ogee lintel with new oak door. The Chapel has three large external windows and one internal window all in good order. South west window requires pointing at cill.</p> <p>The lower areas of external walls are showing signs of damp. The east wall especially. The external boiler house removal should help.</p> <p>There are five wall lights with exposed MICC cabling which could be improved upon. There is also in the wall below one of the windows a piscina in reasonable condition.</p> <p>To the North there is the effigy of Neville which was conserved following the fire. It is noted that there is a yellow residue on the arm and shield.</p> <p>Note that there is some wall painting adjacent to the doorway.</p>

3.6.2.	<p>Recommendations:</p> <p>D</p> <ul style="list-style-type: none"> • Lady Chapel: South west window requires pointing at cill. <p>B</p> <ul style="list-style-type: none"> • Remove external boiler house and repair plaster and redecorate.

3.6.2	<ul style="list-style-type: none"> The Lady Chapel – Following removal of external boiler house, repair plaster and redecorate. 	£2,000
		3.8.5	<ul style="list-style-type: none"> To the Tower: Fill gaps around window casements in chamber below the bells. Tower - Chamber below Bell Chamber: point up gaps around windows. 	£1,000

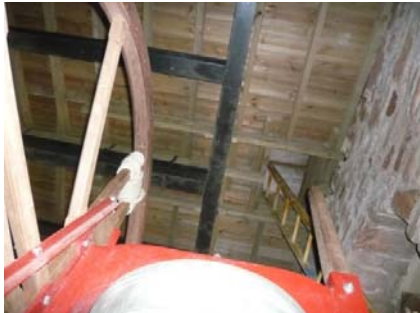
3.8.	TOWER	
3.8.1.	<p>Bell Chamber</p> <p>The access out of the Bell Chamber onto the roof is very difficult. The bell frame is new since 2004. There are eight bells and they are rung regularly. The roof to the Tower is also relatively new which has a steel framework on a concrete wall plate and timber rafters and boarding above. The hatch onto the roof was difficult to manoeuvre and could be improved.</p> <p>Inspection of the tower roof was not possible.</p>

<p>3.8.5.</p>	<p>Recommendations:</p> <p>C</p> <p>B</p> <p>B</p>	<ul style="list-style-type: none"> • Tower: maintain and review the boilers regularly and clean droppings. • Tower - Chamber below Bell Chamber: point up gaps around windows. • Bell Chamber: Improve access to the roof. Relocate the ladder.

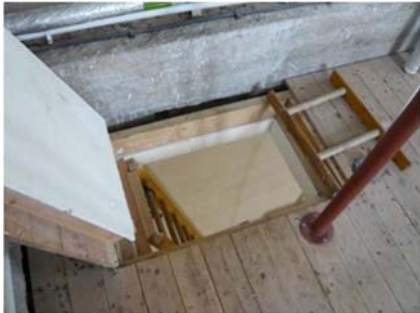
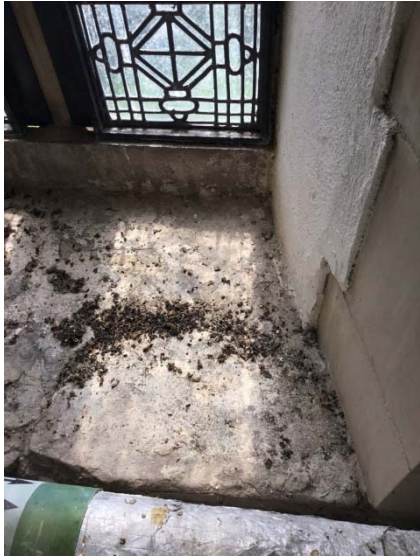
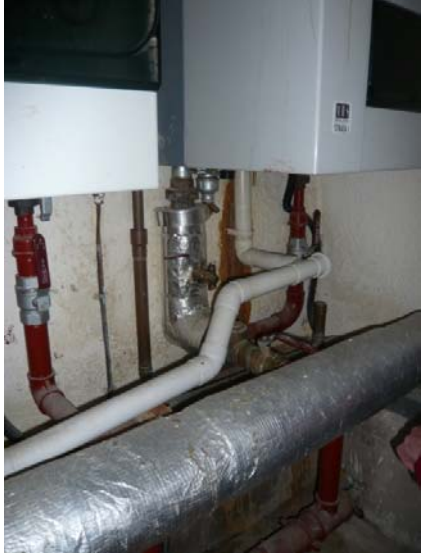
3.8.2.	<p>Chamber below the Bell Chamber</p> <p>This houses the plant room. Which includes two new gas fired boilers, a hot water system and manifolds for the under floor heating system etc. These were all new in 2014. Some evidence of leakage is old from previous boilers.</p> <p>There have been bats accessing this space. All of the windows have been renewed and are in good order. It was noted around the West window and the South window that there are gaps which are allowing the ingress of rain water and possibly insects and bats and should be filled/ pointed</p> <p>The interior is in good decorative order and access into this space from the Ringing Chamber has been improved. There is also access from this level onto the Nave roof. Visual inspection only.</p>

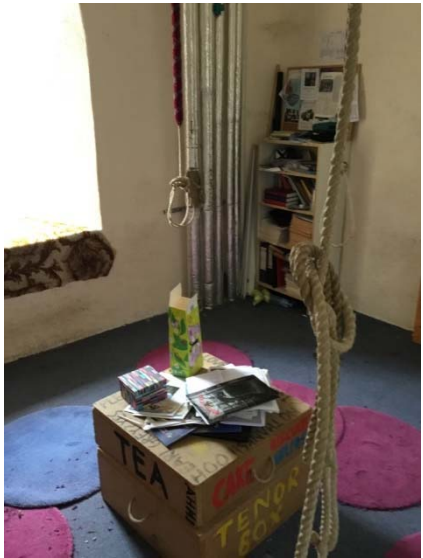
<p>3.8.3.</p>	<p>Ringling Chamber</p> <p>The bell ropes are terminated in this space. This has had a new floor and a new ceiling. The heating pipes which are lagged pass through this space. There are four fluorescent type lights on the walls. The windows are new and in good order one of which is openable to gain access onto the Aisle roof. The hatch from below has a counter balance which works well. There is also a moveable barrier so that it can be arranged around the hatchway in the floor whilst people are entering and leaving the Bell Ringing Chamber. There is a simple softwood timber bench arrangement to the East. There is a small shutter into the main body of the Church. The lighting cabling goes over the niche to the East side of the Bell Ringing Chamber within a galvanised metal conduit. This is rather intrusive.</p>
