## QUINQUENNIAL INSPECTION REPORT

**CHURCH OF ST. CUTHBERT**  
NORTH ROAD, DURHAM, DH1 4NQ

JUNE 2022

Diocese of Durham

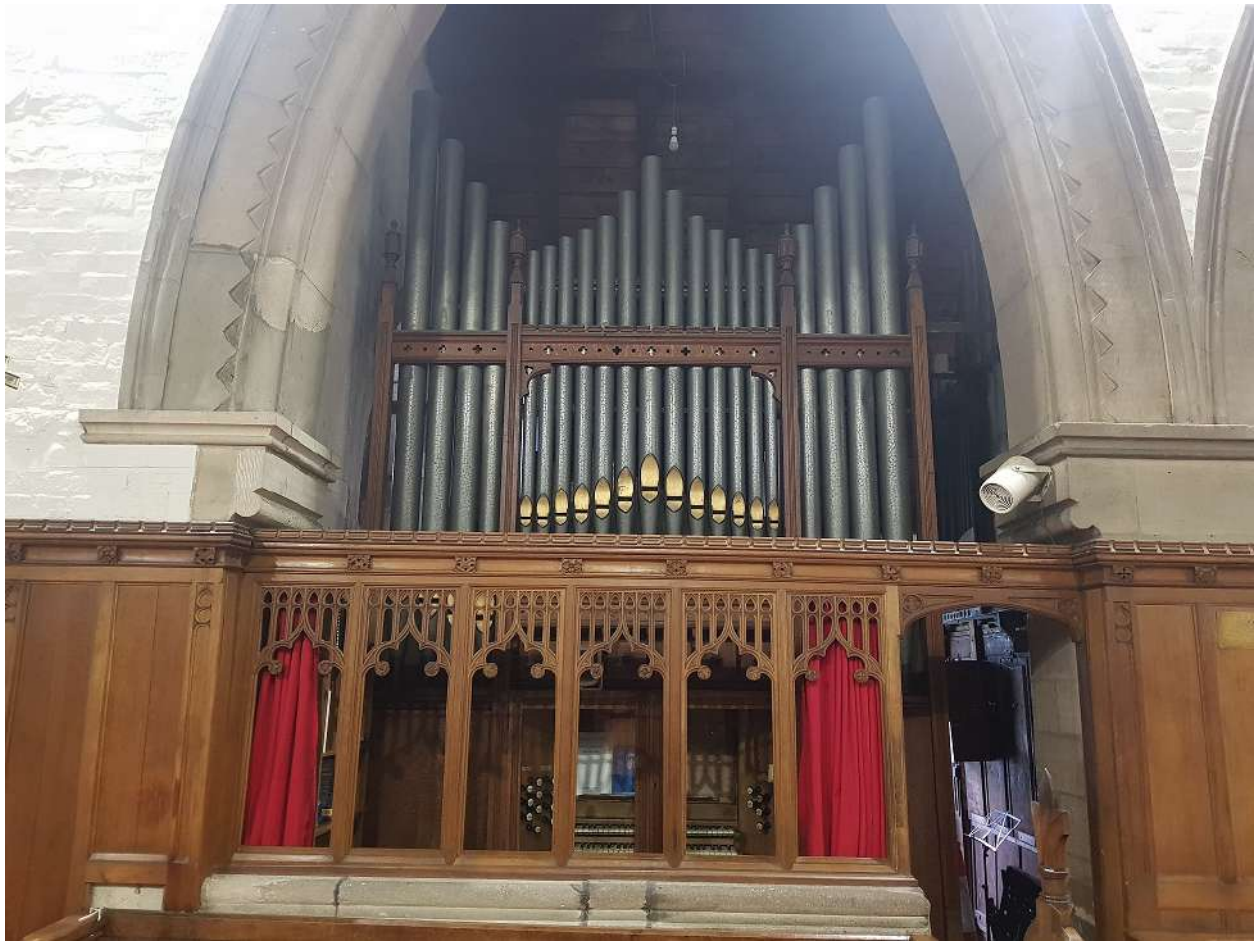
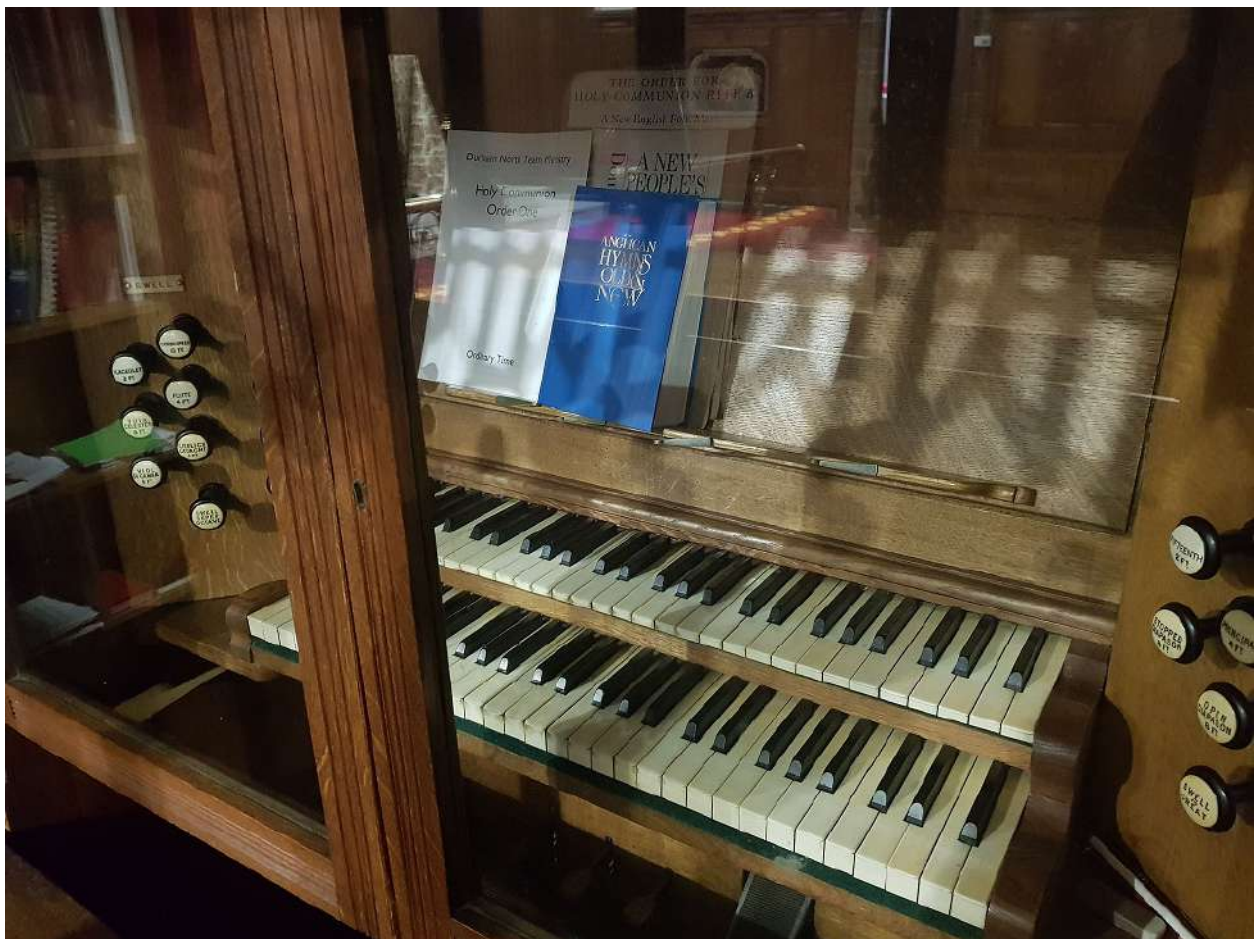
Although no testing of the musical instrument was made as part of the inspection it is recommended that it is checked and inspected regularly.

All maintenance and repair works associated with the organ to be undertaken by a competent and experienced organ tuner.
