**QUINQUENNIAL INSPECTION REPORT  
OF  
ELWICK HALL, ST. PETER**

**DIOCESE OF DURHAM  
ARCHDEACONRY OF HARTLEPOOL  
DEANERY OF HARTLEPOOL**

**QUINQUENNIAL INSPECTION AND REPORT**

**DATE DECEMBER 2022**

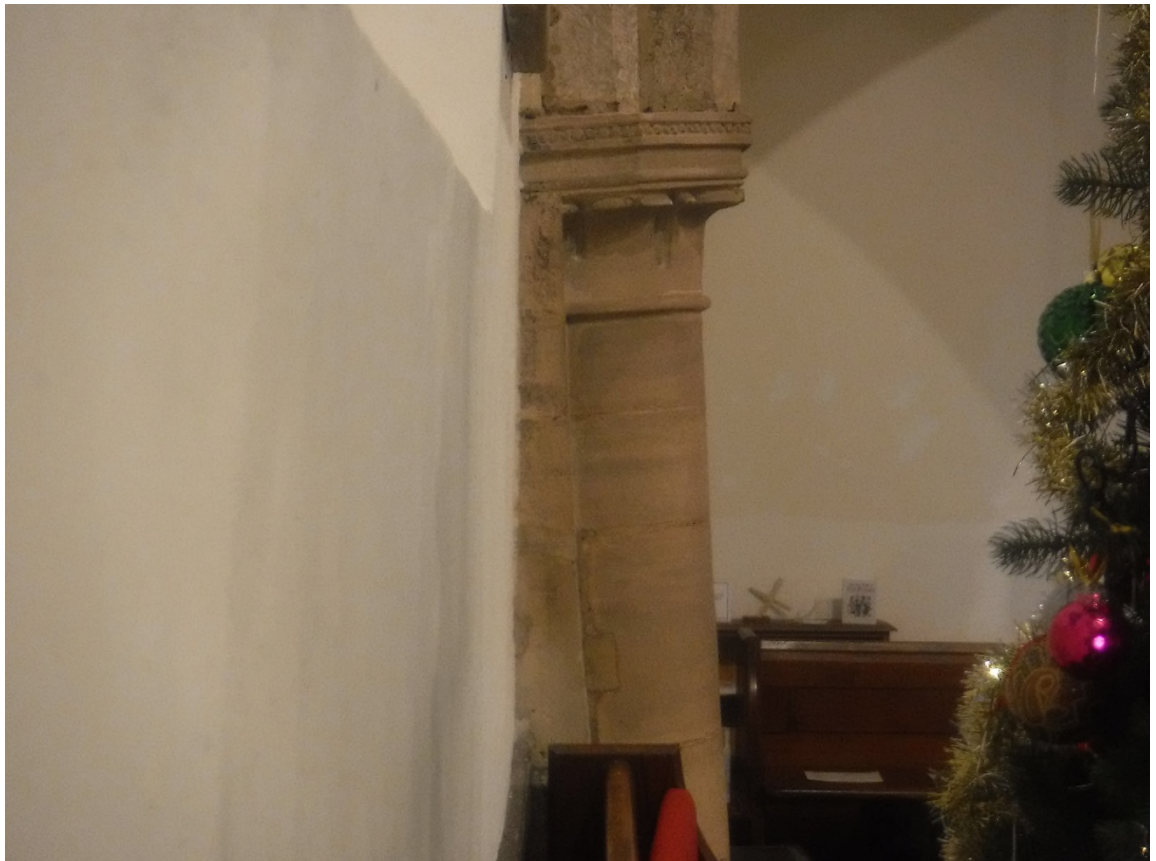
There is some distortion to the final arch at the W side on both arcades, however this is all historical. The plaster above the arcades at the W end on the N side shows that there is a shear crack up there but again this is just a minor problem probably superficial hairline crack. All of the arcades are sound as is the chancel arch, there is no cracking there. The tower is solid and in good condition.

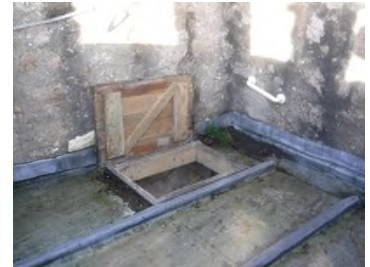
#### **Roof:**

Loose slab tops to the murlons. Pointing to the flashing out in places but it is firm, hatch could do with a hinge on it, better grabrailing, another two in fact as you exit is required. Lightning conductor has four terminals just made of the straps and one downtape. Render inside on the masonry is all sound, dirt in the top of the parapet gutter.

**Recommendation:** refix merlon slabs, sweep up parapet gutter, add grab rails, add hinge to hatch.

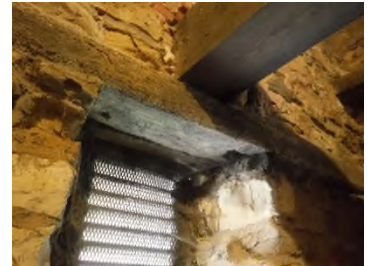
## Belfry:

- **Roof** - Is all dry ok. I might argue that the head of the parapet shows a touch of damp I'm not sure really but that is why that needs to be cleaned out a bit more regularly.
- **Walls** – Plastered over, fair faced walls a bit eroded but ok. Walls are not particularly thick, possibly 300-400mm and there are some erosion to the mixture of sandstone and limestone walling. Timber lintels over the openings support the bell beam, the window to the E is slightly eroded but it is sound.
- **Floors** – Boarded timber, bit dirty with dust and sand from stone they are slightly uneven but I think they are sound enough.
- **Miscellaneous** – Two bells old on headstocks, painted, reasonably sound, they are tolled, the sound bow to both of them are wearing rather and it might be wise to turn these sometime in the future and the striking hammer is making a bit of a dent on the E one.

**Recommendation:** see recommendations on bells above

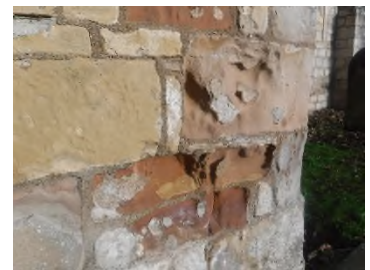
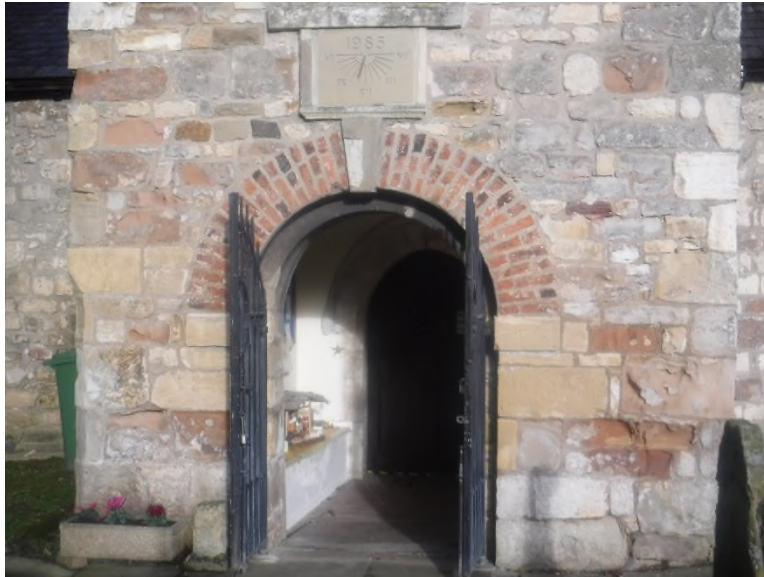
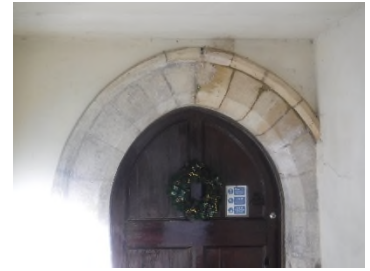
### Base of Tower:

- **Ceiling** – Boarded ceiling some nailing showing through and decoration breaking down a bit.
- **Walls** – Are plastered and they are ok.
- **Floor** – Is flagstone and has a temporary timber ramp and a carpet that rucks up a bit it is not fixed down.
- **Miscellaneous** - The archway to the church has got a little bit of damp to it or erosion but it has previously been painted and it has lost its paint now but it looks ok and the door within it is painted single door and that itself is ok.
- Door arches are ok

**Recommendation:** fix down carpet

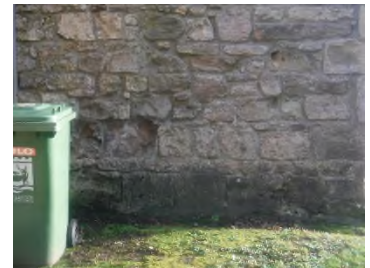
- **East Elevation:**

**Bottom stage –** OK, apart from some slight erosion just on the external corner and a bit of green showing on the junction to the nave and that is because of the overflow of the gutter.

**Recommendation:** none

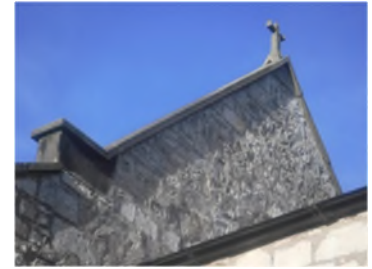
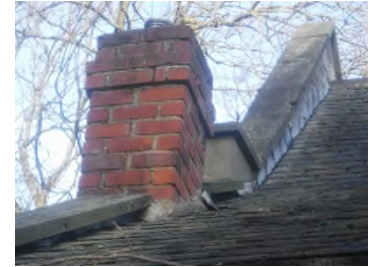
The watertable over the aisle at the W end is slightly undulating at the brick flue and this is now redundant, the brickwork itself is in pretty poor condition and I think frankly this should come down now and then reset the watertable, bits of bedding lying on the slating surface, actually looking at the watertable from the W that is also over the nave is wriggling a bit.

**Recommendation:** remove chimney

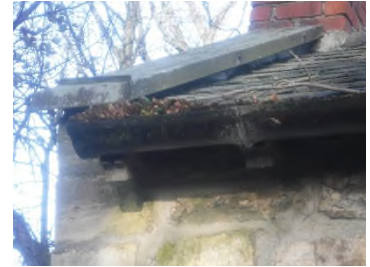
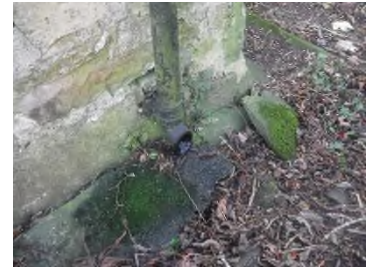
Rainwater goods are Ogee gutters and circular downpipes in cast-iron, look in fairly good condition, grass growing in N aisle gutter on right side of tower. Downpipes discharge to open gullies which are absolutely choked with leaves.

**Recommendation:** clean out gutters, pipes and gullies

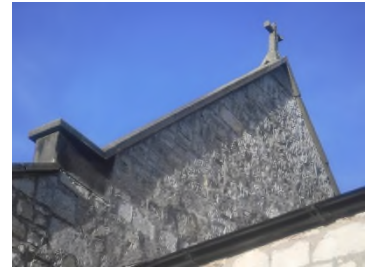
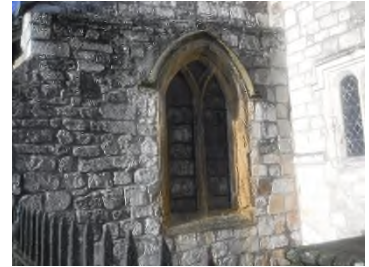
**East side** – Gable looks ok, east facing wall has horizontal ledge that could do with a water shedding slope, walling and buttress generally ok, window within it two light lancet eroded right hand jamb and the central mullion is going as well.

**Recommendation:** add mortar topping to ledge

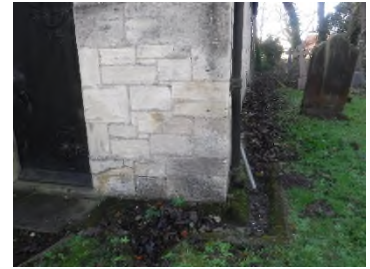
there is a crack running from the N kneeler down to the door head probably dropping in the corner, historical differential settlement, nothing too troublesome, a slight open joint at the bottom by the gulley and the arch has dropped fractionally in the past but is ok. Door within it is timber boarded locked shut not in use and the decoration is ok.

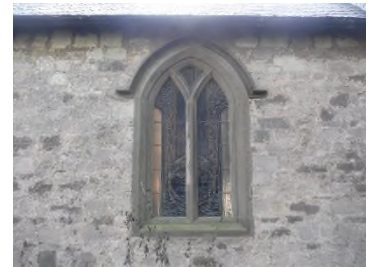
**North Aisle:**

Random rubble brought to course, it is all tight apart from two or three small areas but they just don't need doing at the moment. Wall has two windows in it, both the same pattern twin light lancets with pictorial glass in good condition. The W most mullion has been patched in cement in the past, this is the modern glasswork, and it has been done in lime so that is to its credit. There is damp at low level inside. Perhaps the external ground level should be lowered or perimeter drain be installed?

**Recommendation:** look at reducing external level/ improve ground drainage

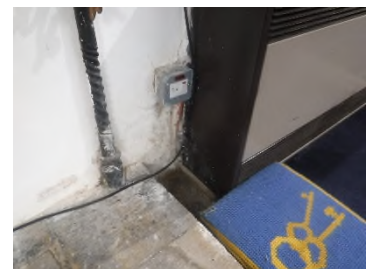
Except in the vestry the external walls are strapped (lath and plaster held off walls on battens). While this is may keep most of the plaster warmer and dryer than otherwise, debris must accumulate in the cavity over decades and become damp from below causing decay in the hidden timbers. Low level plaster damage is widespread.

There have been some remedial repairs to the plaster work that are successful. It is noticeable however just at the skirting board level of pipework there is efflorescence particularly on the N side.

**Recommendation:** none

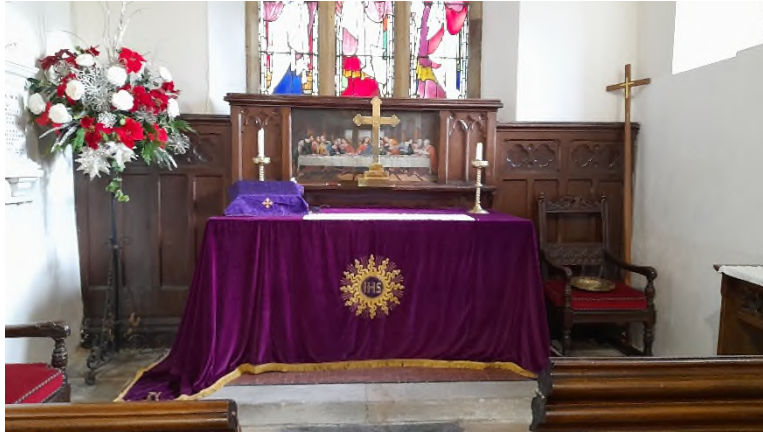
A reredos with inset 'Last Supper' painting is the only panelling.

Inner porch door painted arched framed timber, sound.  
Inner vestry door framed oak batten door without frame, fitted to face of stone surround. Sound but applied fabric draught stripping now decayed. Modern night latch adapted to stone frame.

**Recommendation:** update vestry draught stripping

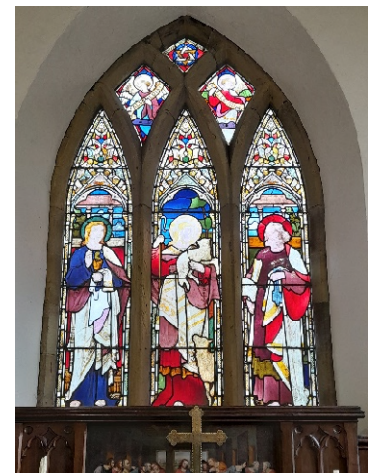
**East** - Triple light, intersecting tracery, angels over St John, Good Shepherd, St Peter. Highly coloured Victorian. Five faces and some other parts very faded. Minor cracks but otherwise fair. Dirty. Might be cleaned and the lost parts repainted by a very skilled painter or might be replaced with different glass.

**South Chancel** - Both triple lights clear leaded diapers, some dirt but sound. One mullion damaged by rusted end of a saddle bar (para 42).

**East of South Aisle** - Kempe & Co. Crucifixion good painting, minor damage bottom of S light, some dirt.

**South Aisle SE** – Clear leaded diapers with two inserted heraldic devices. Sound but some dirt.

**South Aisle SW lancet** – Clear leaded diapers with some yellows. Sound but some dirt.

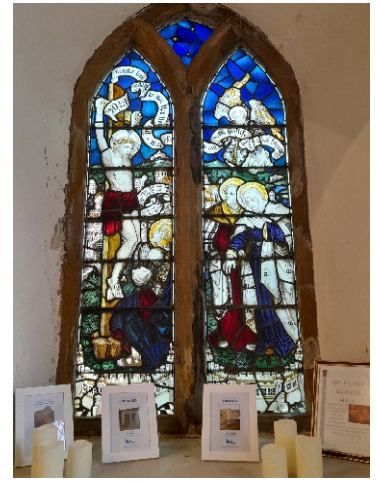
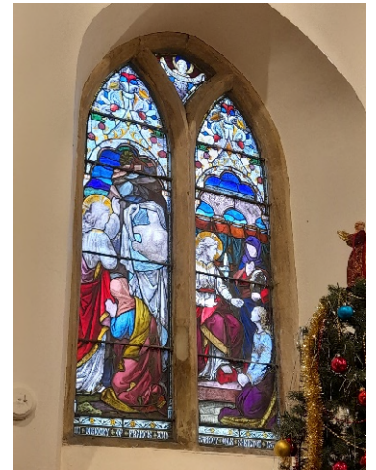
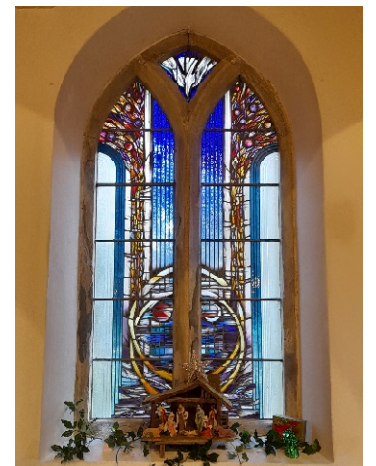
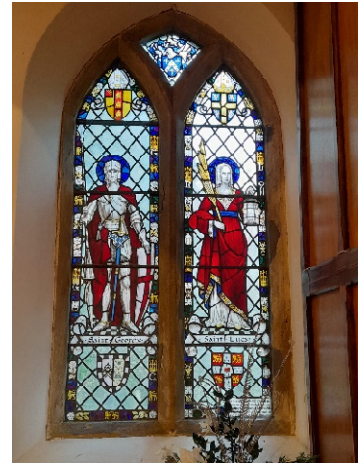
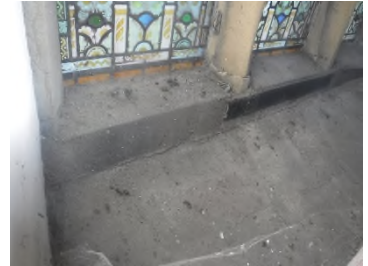
**West** – Cole Sheraton 1867 memorial two light with angel in Y tracery. Similar to E including paint loss and dirt.

*The saddle bars look rather rusty.*

**North Aisle NW** – ‘Marriage’ 2009 by Alan Davies. Very vivid design, good condition.

*Central mullion was patched in mortar at the time of the installation, slight cracking to it but not problematic.*

**North Aisle NE** – Reynolds memorial 1920’s SS George and Lucy by A K Nicholson, good condition, some dirt.

**Vestry** – Clear diapers, internal ferramenta, good condition but some dirt.  
No protection.

*Rather dusty and rusting saddle bars as well as the security vertical bars, a couple of cracked panes and quite dirty and because it is behind curtains it is rather musty.*

**Recommendation:** ventilate vestry window, carry out other noted repairs

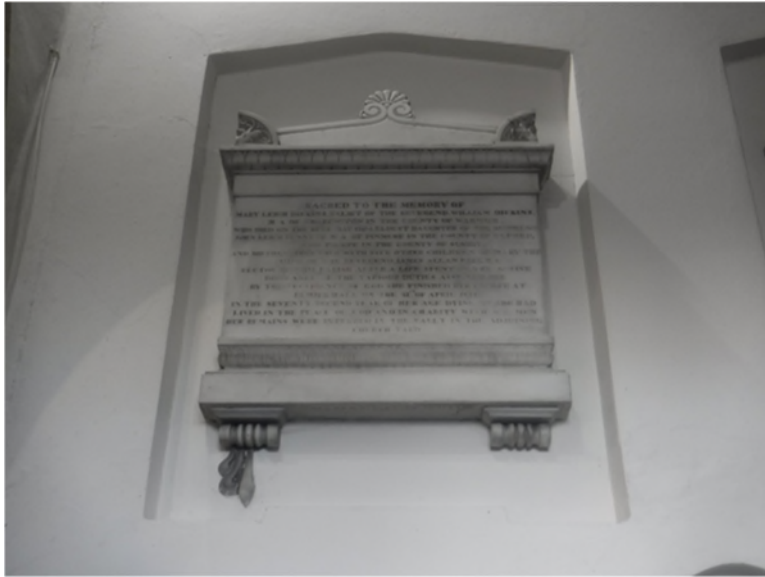
Six marbles on chancel N side, one on S, all but one recessed into the strapped plaster. Some dirt.

Three of the marbles have lost part of their consul bracket ornament.

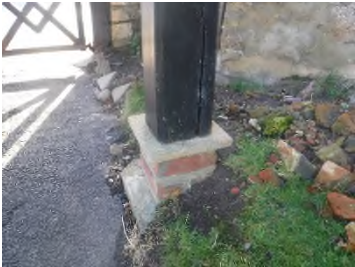
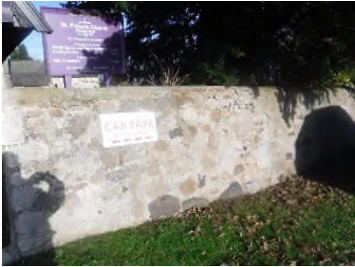
Timber lych gate which is in fairly good condition though there are some slipped slates.

Boundary wall formed of random stonework which has seen some recent repairs and hard capping.

Conifer and Yew trees on the boundary, the one on the bend looks as though it could potentially be pushing the wall.

**Recommendation:** replace slipped slates on lych gate, remove trees threatening boundary wall.

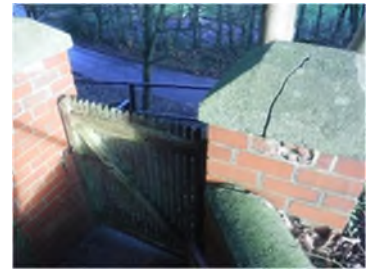
Not able to be seen on the outside it is all scrub. The timber gates to the top of the steps is a bit rotten on the top rail, the gate posts have been rebuilt in modern brickwork, recovered perhaps, cap concrete perhaps I can't tell but it has got a big crack in it.

**Recommendation:** clear undergrowth

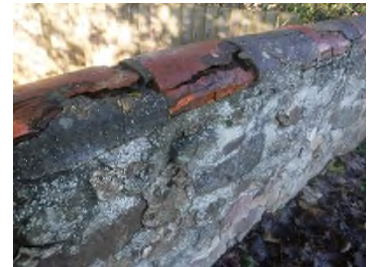
- **Northern end** – This looks down to the beck that curves around and runs along the W of the boundary, there is a brick retaining wall here that is holding back the bank but it is breaking up and is pretty poor condition, there are a lot of trees just outside of the church boundary that really are beginning to threaten the W end, they certainly could do damage to it, there is some trees particularly at the NW corner whos branches are over the roof and those that are on the W side are beginning to do the same.

**Recommendation:** seek specialist advice to reduce tree cover at west end, repair boundary fencing and stone wall, install light in wc.
