QUINQUENNIAL INSPECTION REPORT - APRIL 2021

THE PARISH CHURCH OF
SAINT MICHAEL AND ALL ANGELS

FRONT STREET, ESH, CO. DURHAM, DH7 9QY

Report prepared by

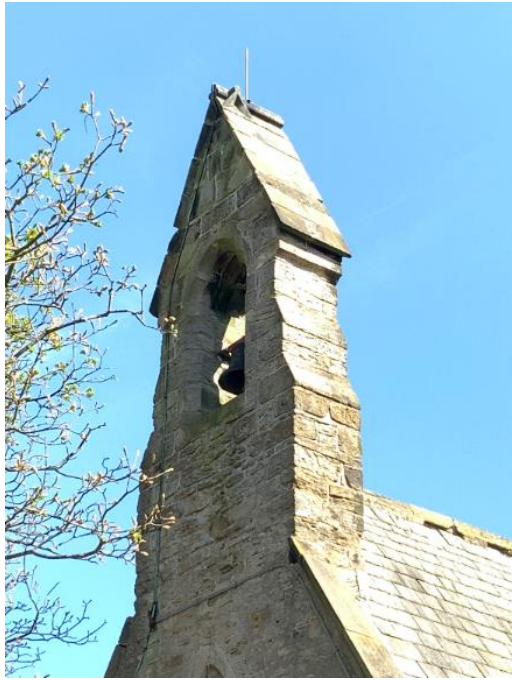
Bell-cote

<p>Condition</p> <ul style="list-style-type: none"> • The 2009 report notes that the bell-cote was completely repointed between the 1994 and 2000 inspections, and the bell being remounted with new fittings, bearings, etc. • Pointing remains in a sound condition. • There are some large chips of stone missing from the projecting edge of the water tabling. • Lightning conductor tape appears to be secure. • Two of the lower lead step cover flashings on the South East side of the bell-cote have come away, probably due to natural weathering opening up the stone joints they were bedded into. In fact one of these remains in the gutter below. Although the lead soakers remain in place, these cover flashings do need to be replaced as soon as possible. The work will require the repointing of the stone joints in this area. • There is a missing stepped cover flashing on the North East side of the bell-cote, but this has been replaced with a mortar fillet at some point in the past, and this remains stable.

<p>Repair Needs</p> <ul style="list-style-type: none"> • Re-fix lead cover flashings to prevent water ingress, and repoint stonework joints in the same location. 	<p>B</p>
---	---	-----------------

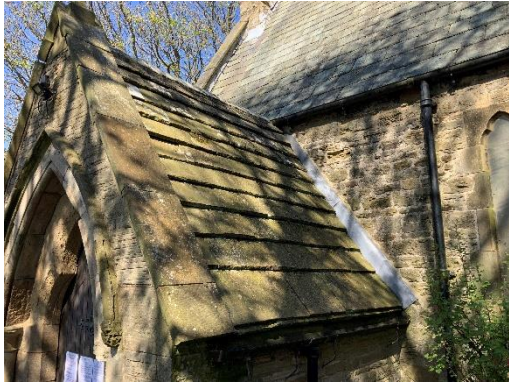
<p>Condition</p> <ul style="list-style-type: none"> • The previous report indicates this was stripped and recovered in 2005, and the roof remains in good condition. • As noted in the last report, the mortar fillet is pulling away from the South gable creating a route for water ingress. However, the fillet itself remains generally sound. 	
	<p>Repair Needs</p> <ul style="list-style-type: none"> • Seal the gap between the mortar fillet and the South gable to prevent water ingress. 	<p>C</p>

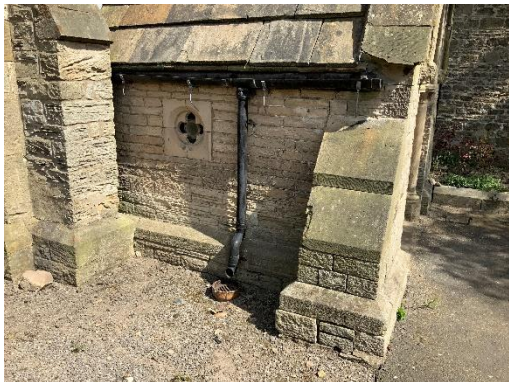
Porch Walls

<p>Condition</p> <ul style="list-style-type: none"> The pointing has weathered out of the stonework at low level in a number of locations, probably exacerbated by dampness in the stone. Repointing with a lime mortar will aid stone drying. The pronounced weathering of the front gable wall has continued since the last inspection. Further delamination has occurred, including the loss of edges and features. There is delamination of the ashlar stone which is integral with the lowest coping stone, on the left hand side. There is pronounced weathering of the roll-mould above the arch including chips and cracks, and also a loss of clarity in the features of the leaf-stops at each side, probably caused by excessive dampness in the wall. There is pronounced weathering to the right hand pilaster at its head and base.

<p>Repair Needs</p> <ul style="list-style-type: none"> There are some areas of stonework at low level which should be repointed using lime mortar. The gable will continue to weather slowly, and at some point some replacement stonework will be required. Weathering will certainly be reduced by dealing with water ingress from the copings noted in the previous section. 	<p>D</p> <p>E</p>

<ul style="list-style-type: none"> It would be worth taking some moulds of the leaf-stops at each side for replication at some point in the future. Photographs have been taken for record purposes. 	D
--	---	---

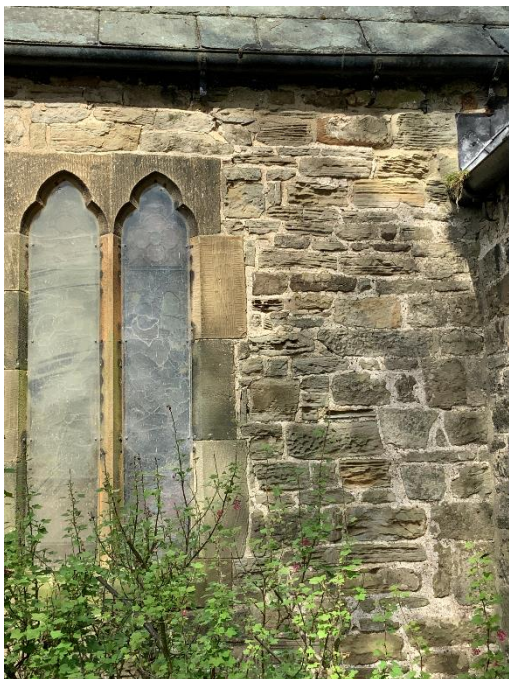
South Elevation of the Nave

<p>Description</p> <ul style="list-style-type: none"> Walls are of sandstone rubble with ashlar dressings. The wall a buttress adjacent to the West gable, and an ashlar plinth. 	
	<p>Condition</p> <ul style="list-style-type: none"> Pointing is in reasonable condition. There is pronounced weathering to one or two stones. There will be a need for isolated stone replacement at some point in the future. 	
	<p>Repair Needs</p> <ul style="list-style-type: none"> None at present.

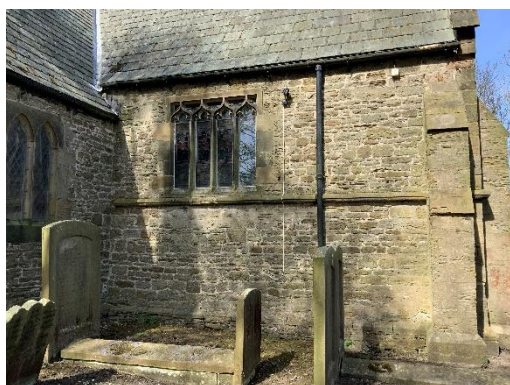
South Elevation of the Chancel

- Walling is generally sound, although with some pronounced weathering to isolated stones, as elsewhere.
- Some areas have been repointing poorly with cement-based mortar and this is exacerbating the stone degradation.

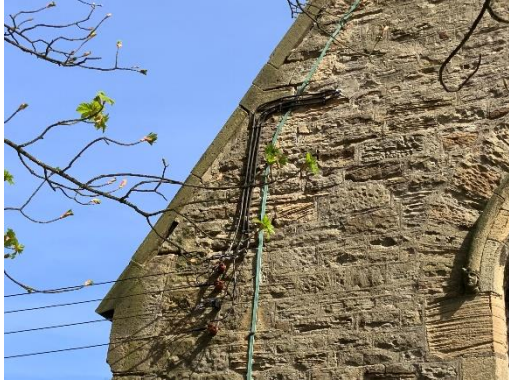
<p>There are a couple of stones at knee level which are also weathering poorly. See photo.</p> <ul style="list-style-type: none"> This is being exacerbated by the hard cement pointing which has been applied at some point in the past. Removal of the pointing will cause further damage to the stone face so it should be left to weather away. Isolated stone replacements will be required at some point in the future. There are some isolated areas of walling, particularly below the copings and on the buttresses that would benefit from repointing. The long crack in the walling running from the window head upwards for about six feet does not appear to have propagated further since the last report. However this should continue to be monitored. The cables and lightning cable attached the elevation appear soundly fixed.

<p>Repair Needs</p> <ul style="list-style-type: none"> Carry out isolated areas of repointing, using lime mortar. Monitor the cracking in the wall above the window head. 	<p>D</p> <p>M</p>

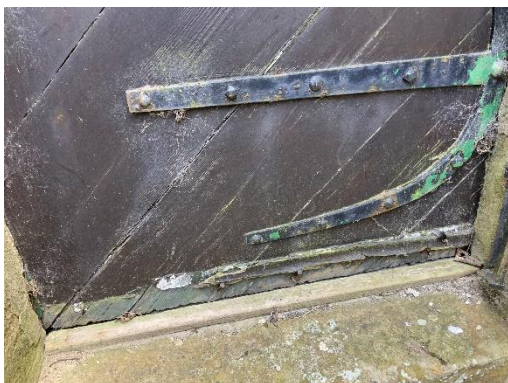
- The front door has a crack, noted in the last report, which seems to be getting bigger. This is manifesting itself as a large splinter which should be secured to expel water.
- The front door would benefit from a new coat of preservative woodstain, particularly in the splash zone at the base where it is degrading.
- The exterior door to the vestry (D2) is in sound condition. There is pronounced weathering to the stone arch, particularly around the keystone, although no remedial action is needed now. There is an outer iron security gate which doesn't latch to the stonework and so moves freely. The timber door has preservative woodstain which is failing at the base of the door and it would benefit from replacement. The weatherbar at the base of the door has completely come away and needs to be replaced.

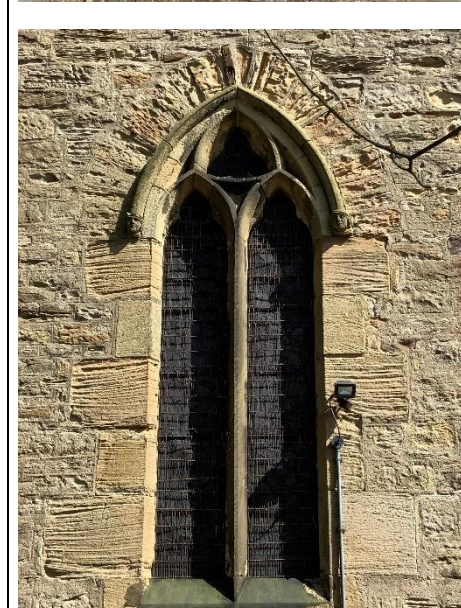
<p>W11</p>

<p>W8</p>	<p>with stained glass. The stone surround is in good condition. There is polycarbonate protection.</p> <ul style="list-style-type: none"> The west window (W11) in the Nave is a large bipartite window with trefoil above. The stone surround is weathering poorly at the head, particularly around the keystones, and the pointing has weathered out of the stone tracery. There has been some displacement in the stonework here, and there is a crack running through the wall vertically from the right hand side of the arch, suggesting historic movement. The metal mesh over the window is rusting and staining the sill and wall beneath. The guarding offers little protection to the stained glass. This should be replaced, preferably with polycarbonate. Internally, there is some minor damage to the stained glass of W11. A small piece of glass is missing from the right hand panel, and there is some distortion and minor cracking.

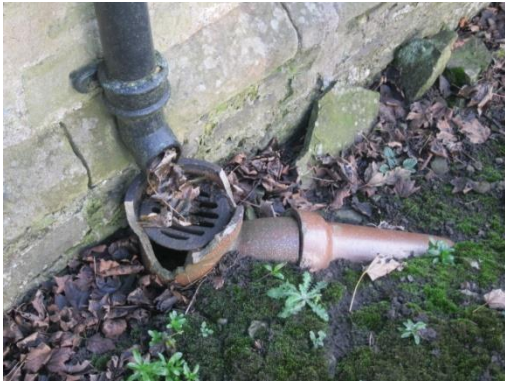
10.6. BELOW GROUND DRAINAGE

<p>Description</p> <ul style="list-style-type: none"> • There is no WC facility in the church, and therefore no foul water drainage system. • There are no manholes in the grounds of the church, so it is assumed that rainwater gullies discharge to local soak-pits. • There is a raised bed between the Porch and the Transept, and the three downpipes here discharge to the soil. It would be preferable to lower the level of this bed, and to ensure free draining soil or gravel. 	
	<p>Condition</p> <ul style="list-style-type: none"> • The state of the surface water drainage system can't be assessed, except to say that all gulleys appear to be emptying. 	
	<p>Repair Needs</p> <ul style="list-style-type: none"> • Gullies should be kept clear of leaves at all times. 	M

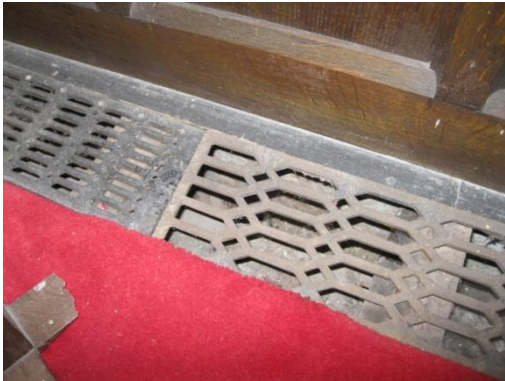
<ul style="list-style-type: none"> • There is a raised timber floor in the Vestry which is largely covered by carpet. 	
	<p>Condition</p> <ul style="list-style-type: none"> • The tiled floor in the Porch is sound. • The raised timber flooring appears to be solid. • The woodblock flooring in the Nave is very uneven, but not exceptionally so for a building of this age. The finish is wearing and it would benefit from being sanded back and re-varnished. The carpet runner is in good condition. • There is a noticeable squeaking floor board under the carpet at the West end of the aisle. This is possible linked to dampness in the chamber below. • In the last report it was noted that the hatch to the basement heating chamber was coming apart and needed to be fully rebuilt and/or reinforced and remounted on its hinges. This hatch has been covered with carpet now, and the carpet has heavy tables, ornaments and a small pew on it, so the author was not able to inspect the hatch or the chamber below. However, Rev. Peers advises that the hatch has been propped from below for safety, and this is also noted in the Log Book. Certainly, walking over the area of the hatch, there did not seem to be any bounce in the floor • The raised floor of the Chancel was covered by carpet and could not be inspected fully, but it appeared to be sound. • The grilles in the floor behind the altar are unstable although they are not in a high traffic area • The timber floor in the Vestry was covered by carpet and could not be inspected fully, but it appeared to be sound.

<p>Repair Needs</p> <ul style="list-style-type: none"> • Remove carpets from the Transept and investigate the 'soft' floors. 	<p>B</p>

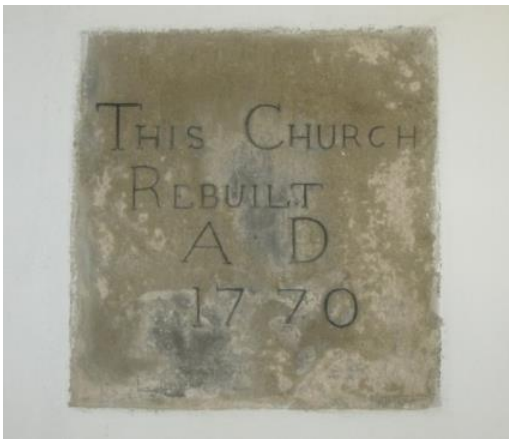
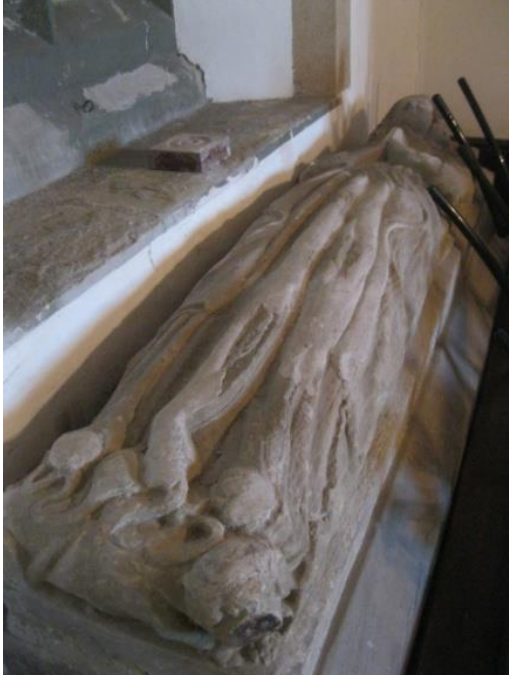
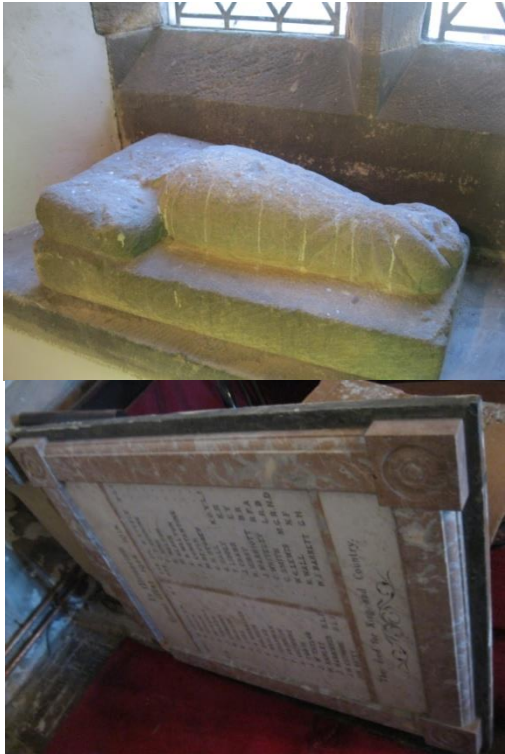
<p>Description</p> <ul style="list-style-type: none"> • There are a number of plaques and monuments in the church. • Facing a visitor on entering through the Lobby doors, is a plaque commemorating the rebuilding of the church in AD 1770. • In the Transept, against the South wall, is a sandstone effigy of a lady mounted on a raised plinth. On the sill of the East window is another sandstone effigy, this time of a baby. • There are a number of other wall mounted memorials in the Nave and Transept. • There is a large marble memorial to those killed in the Great War, and this is propped up in the Transept. It is believed to have been brought to St. Michaels from the Church of St. John the Baptist in Hamsteels following its closure. This was discussed with Rev. Peers who advises that a permanent home for the monument has still to be found. <p>Condition</p> <ul style="list-style-type: none"> • The sandstone effigy of a lady in the Transept has been patched with mortar in the past. Earlier reports indicated rising damp causing stone delamination in plinth. • The sandstone effigy of a baby in the Transept is missing its head. <p>Repair Needs</p> <ul style="list-style-type: none"> • The large marble memorial in the Transept needs to be mounted on a wall for safety reasons (or securely stored elsewhere) It should be mounted by 	<p>B</p>

<p>a professional tradesperson with the skills necessary to install the correct fixings to take the heavy weight.</p>	
---	---	--

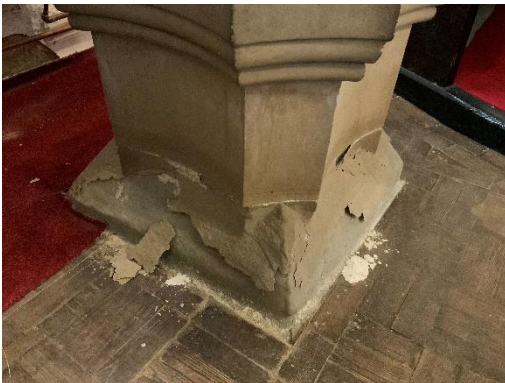
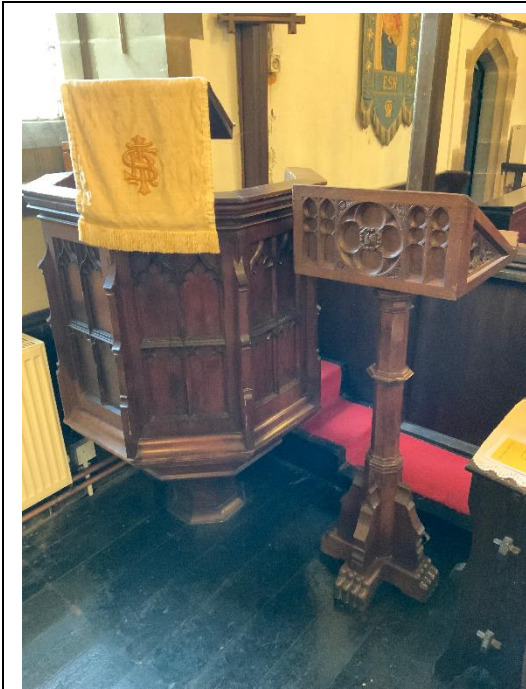
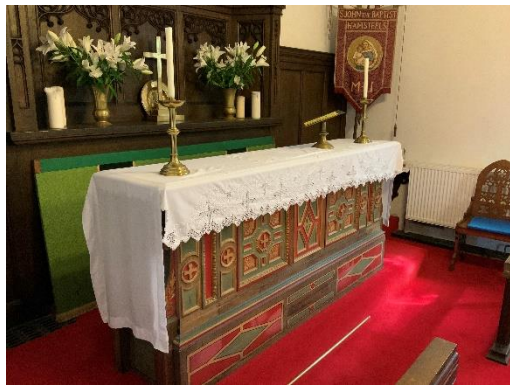
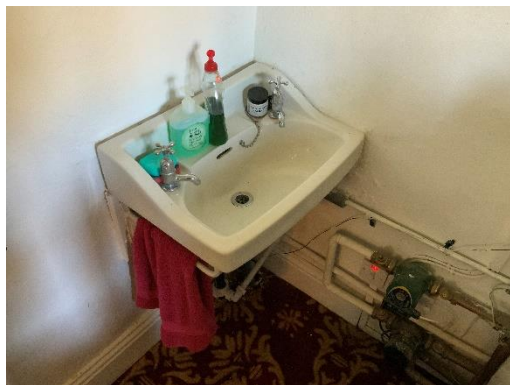
- The bell rope sash at the bottom end still needs to be replaced. It was damaged due to water ingress, as noted in the last report.
- Evidence of damp in the base of the font was reported in 2014, and this has progressed considerably. There are large areas of delamination. This is rising damp coming up from the heating chamber below, another reason to ensure there is adequate ventilation in the chamber.

- The pews are generally in sound condition and are stable.
- The pulpit is sound and secure, and in a reasonable state of decoration.
- The lectern is sound and secure.

- The choir stall pews are in reasonable condition.
- The altar is stable.
- The wash basin in the Vestry is secure, and in working order. It does not appear to be plumbed in to a foul water drainage system, so only soap should be used here. The condensate pipe from the boiler has been connected to the waste pipe. Rev. Peers notes that they've recently had a leak in the basin pipework, but that this has been repaired and a dehumidifier used to dry out the Vestry

- Replace the bell rope sash.
- Remove carpet to basement trapdoor and address ventilation.
- Monitor delamination of stonework to base of the font.

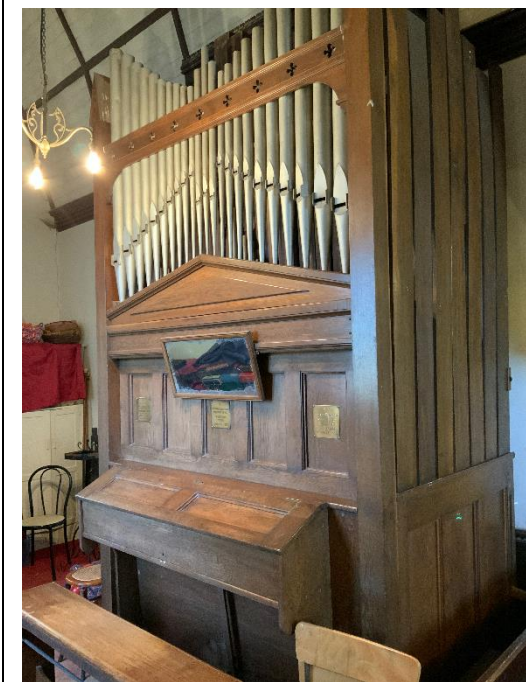
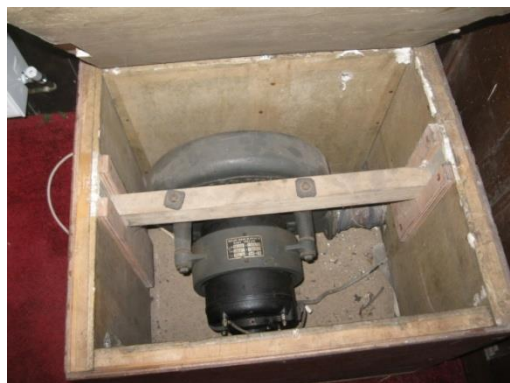
- Rev. Peers has advised that the organ has had several repairs in recent years and that it doesn't stay in tune for long.

- A specialist should be engaged to repair the organ.

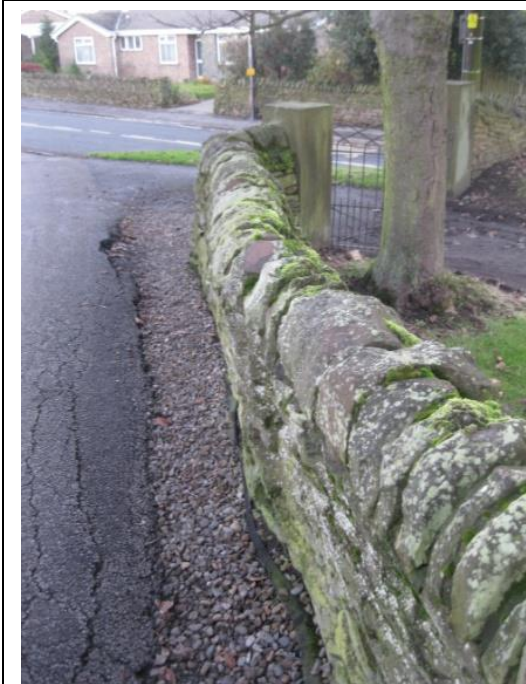
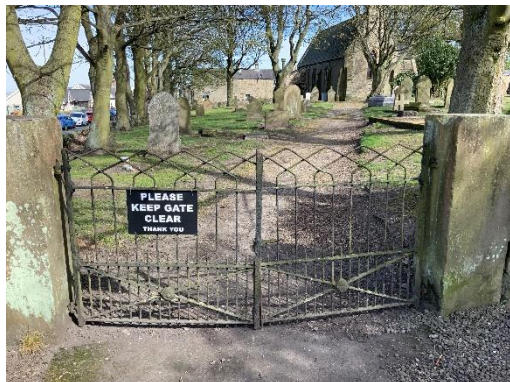
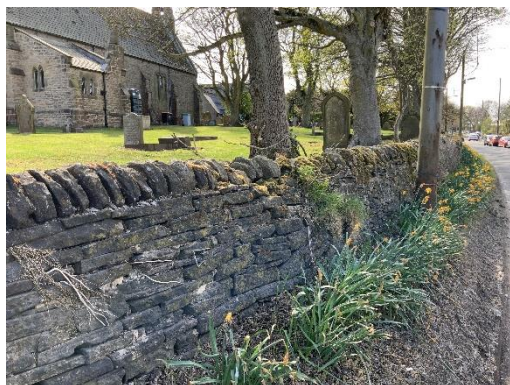
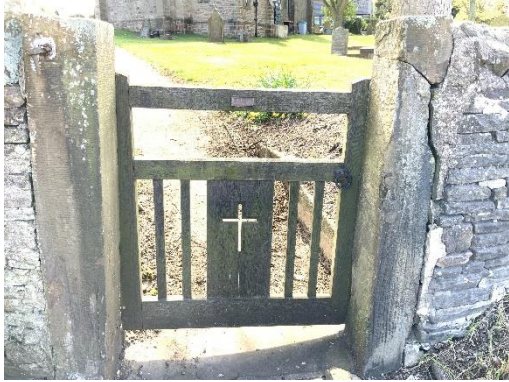
- The rubble stone retaining wall to the Northern boundary is bulging in a number of locations, perhaps as a result of the action of tree roots. The wall appears stable but should be monitored for any changes. In the longer term, it may be prudent to have some sections taken down and rebuilt.
- The rubble stone walling to the Eastern and Southern boundaries is sound, and the copings are stable.
- There is pronounced bulging in the rubble stone wall just to the South of the vehicular gates. This
- The iron gates to the vehicular entrance are in reasonable condition but would benefit from repainting.
- The timber pedestrian gate has been replaced and is in good condition, although the original posts remain. The stone pier to the right-hand side of the gate, looking from the outside, has fractured, although it appears to be stable.

<ul style="list-style-type: none"> The steel gate to the village green is in reasonable condition, although there is noticeable delamination of the stone gate posts. 	
	<p>Repair Needs</p> <ul style="list-style-type: none"> Monitor the rubble stone retaining wall to the Northern boundary and report any further movement. Repaint the vehicular iron gates. 	<p>M D</p>

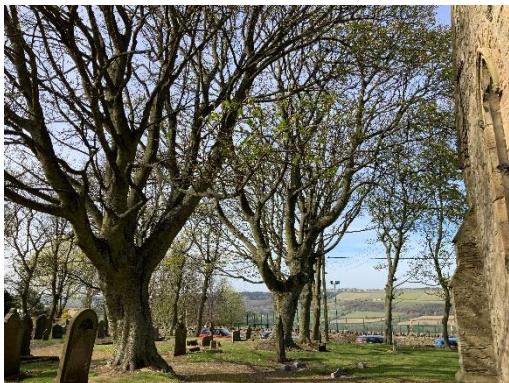
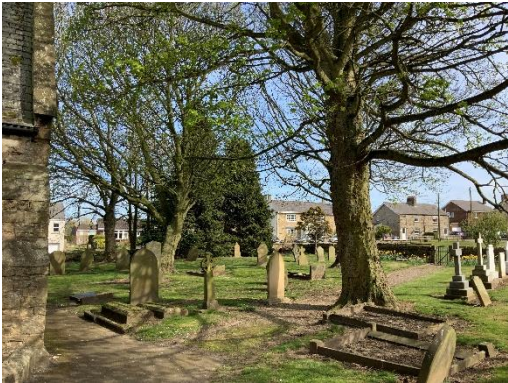
<p>Condition</p> <ul style="list-style-type: none"> The large trees to the South and West of the church are growing close to the Transept and the Nave, and in time may pose a risk. They may need to be pruned back in the future. They will be depositing leaves into the church gutters which must be kept clear at all times. 	
	<p>Repair Needs</p> <ul style="list-style-type: none"> None. Note that any works to trees in the churchyard must be done with the permission of the Local Authority, due to the Conservation Area status of this part of Esh.

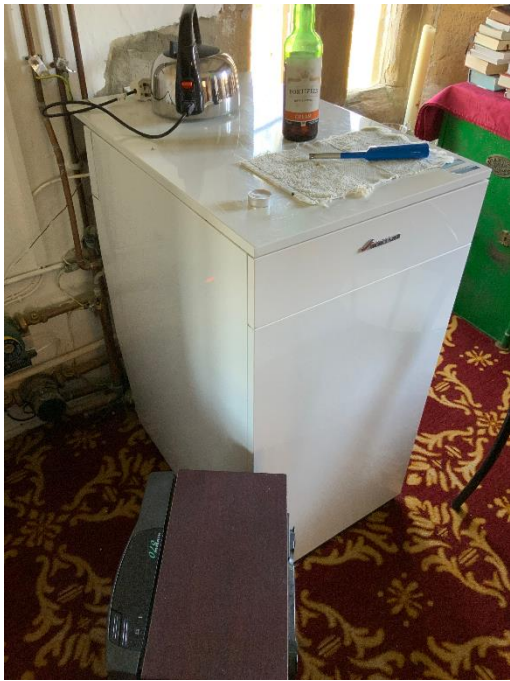
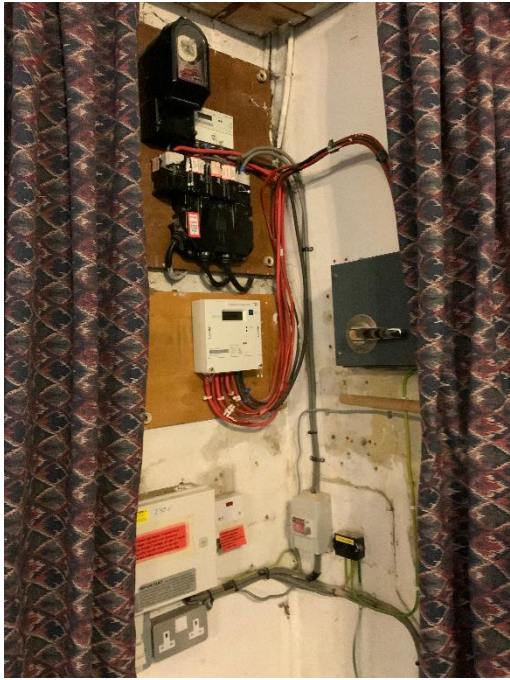
<p>Condition</p> <ul style="list-style-type: none"> • The boiler is being serviced regularly, although it's noted that a service is now overdue. • The log book indicates that the last inspection of the electric system was in 2007, so an inspection is long overdue. Rev. Peers tells me that arrangements are being made. • The log book indicates that the lighting protection system has been recently checked and improved.

<ul style="list-style-type: none"> • The fire extinguishers haven't been checked for some years now and would benefit from a service • Although PAT testing has been carried out in the past, a check is overdue and this should be carried out. 	
	<p>Repair Needs</p> <ul style="list-style-type: none"> • Arrange for boiler to be serviced. • Arrange for the electric system to be inspected by a qualified electrician. • Continue with regular maintenance inspections for all items. 	<p>B</p> <p>B</p> <p>B</p>

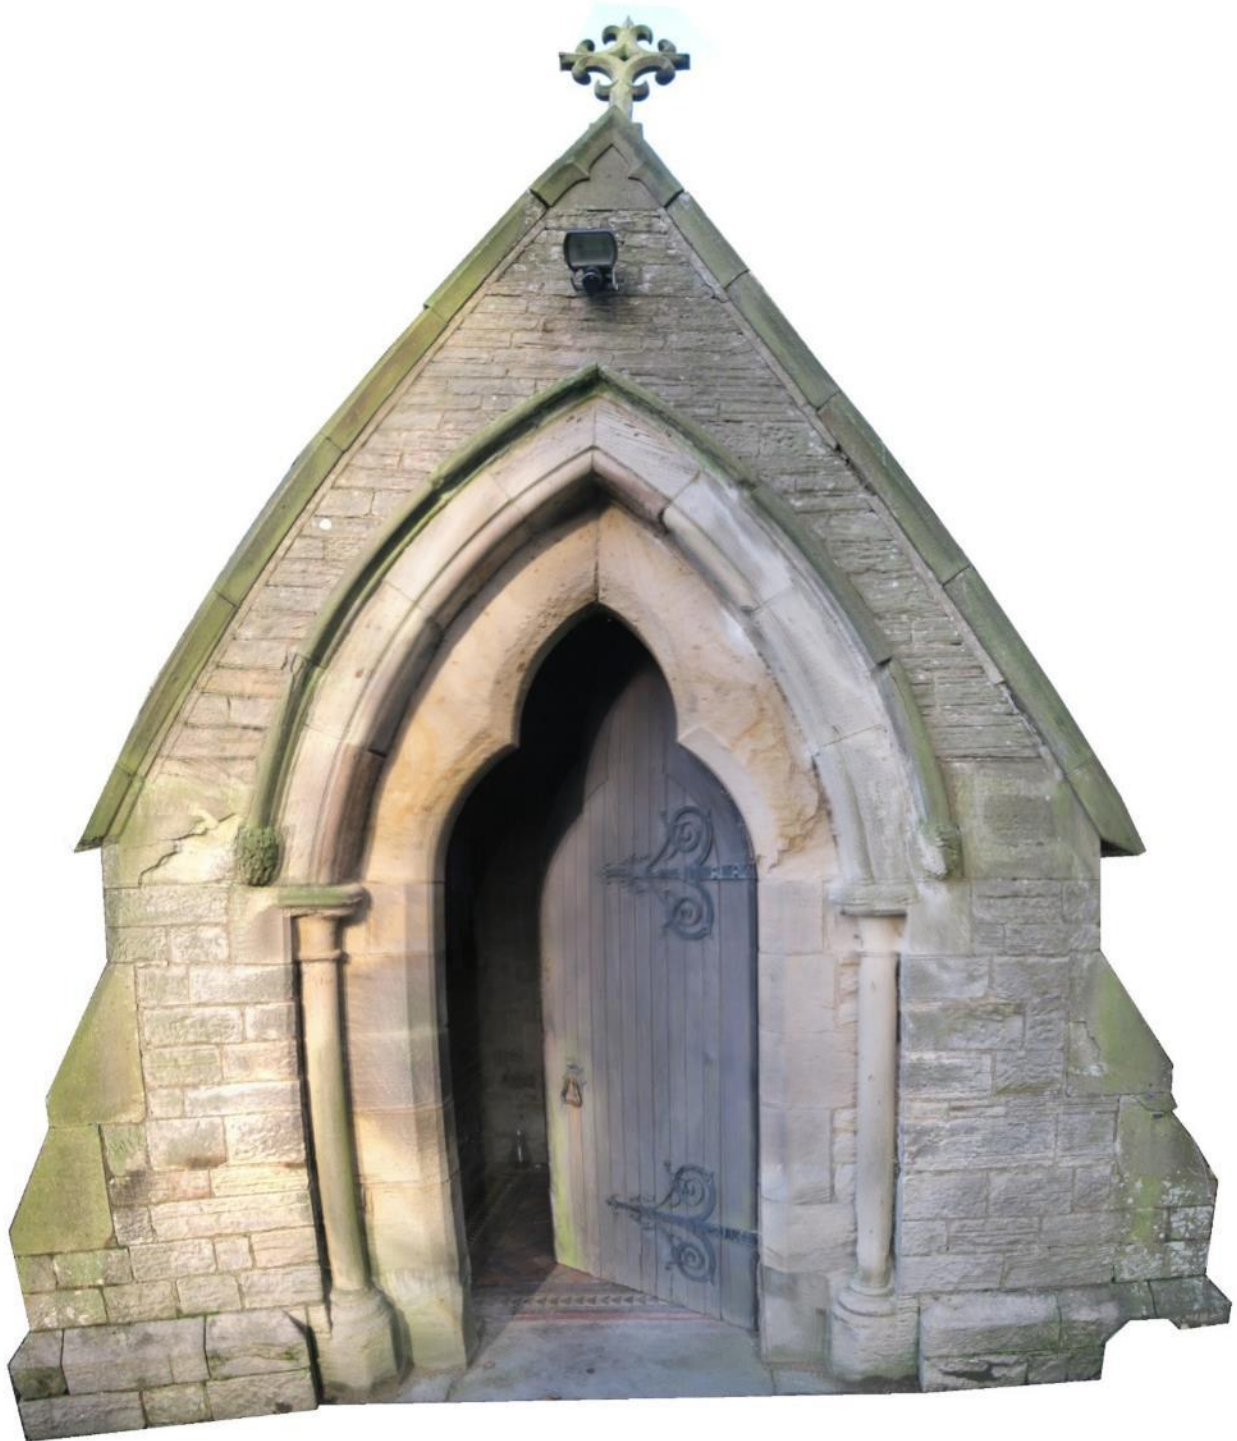
The photo below records the current state of the Porch Gable in December 2014. The photograph has not been rectified, so can't be scaled from.

This quote has been prepared to give an indication of the works required to the Porch gable and door surround. The quote is indicative and is to be used as a guide for the purposes of fundraising. There are additional costs associated with the work, such as the requirement for making a listed building application. The author can assist with the process if required.
