# St Paul's, Evenwood

DIOCESE OF DURHAM

Quinquennial Inspection

## CONDITION SURVEY 2021

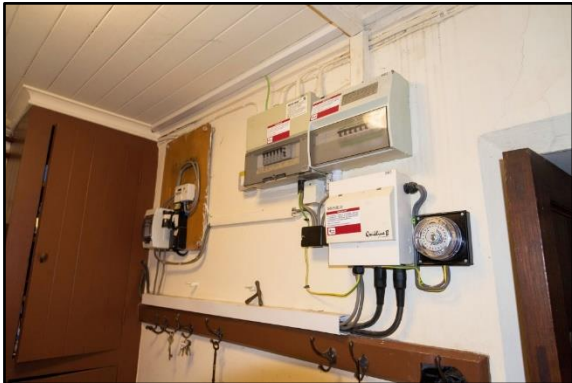
<p>The meters and distribution boards are located on the wall in the vestry corridor.</p>

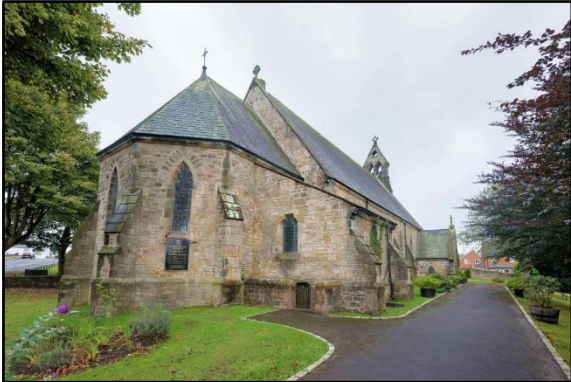
<p><i>North side</i></p>

<p>6.01</p>	<p><b>Churchyard</b> Comment on the general condition of the grassed and planted areas.</p>	<p>A very tidy walled churchyard without graves. Lawns with well controlled trees and planters with shrubs.</p> <div style="text-align: center;">
