# Quinquennial Inspection Report

Church of St Andrew  
Aycliffe Village, County Durham

Diocese – Durham  
Archdeaconry – Auckland  
Deanery – Auckland

**Date of report:** 2<sup>nd</sup> August 2023

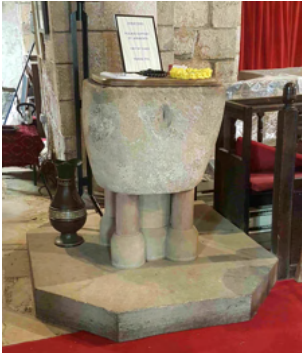
<p><u>Fittings and furniture comprise:</u> -</p> <ul style="list-style-type: none"> <li>• Font – Saxon or early Norman, plain sandstone basin on four columns on an octagonal base (see photo).</li> <li>• Sanctuary altar table – made from oak in the Jacobean Period</li> <li>• Reredos – finely carved oak with dark stain</li> <li>• Communion rails – oak rail on balusters</li> <li>• Bishop's Chair – in carved oak</li> <li>• Armchair – finely carved oak with dark stain, upholstered seat and back</li> <li>• Nave altar table in oak with medium coloured stain</li> <li>• Lectern – in finely carved oak</li> </ul>

<ul style="list-style-type: none"> <li>• Pulpit – in dark stained oak panelled on sandstone base with winding sandstone steps (see photo).</li> <li>• Frontal box or chest – in timber panelling</li> <li>• Organ screen – oak panelled with dark stain.</li> </ul> <p>All in good condition.</p>	
--	---	--

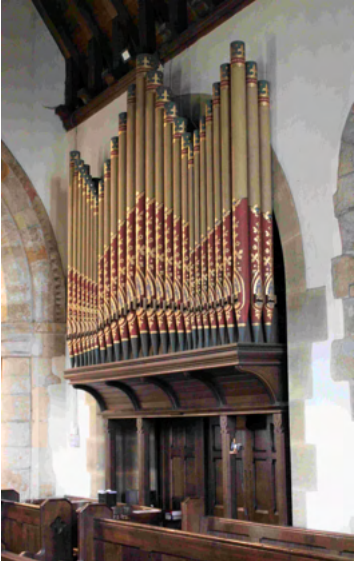
<b>3.10 Organ</b>		
Condition	Built by Foster and Andrews (London) in 1886. The organ is tuned and serviced regularly by Harrison and Harrison of Durham and is understood to be in good working order.

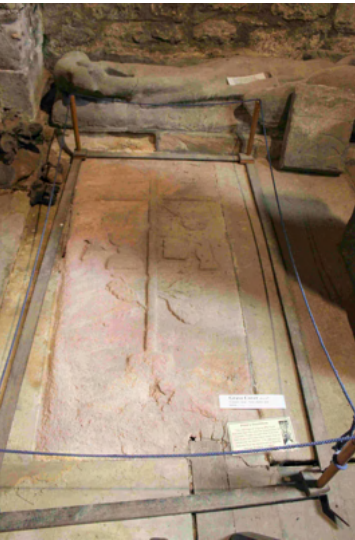
<b>3.11 Memorials, plaques and other features</b>		
Condition	<p><u>Wall memorials and plaques</u></p> <ul style="list-style-type: none"> <li>• Hardinge marble wall memorial</li> <li>• Rev C J A Eade brass memorial wall plaque</li> <li>• Chapman brass memorial wall plaque</li> <li>• Henry Pascoe Smith memorial window plaque</li> <li>• Rev J D Eade brass memorial window plaque</li> </ul> <p>All in good condition and secured firmly to their respective bases.</p> <p><u>Other features</u></p> <ul style="list-style-type: none"> <li>• Two Saxon crosses</li> <li>• 14C priest's grave cover at rear of North Aisle</li> <li>• Remnants of three grave covers are built into Chancel south wall</li> <li>• Stone effigy of a knight in the NW corner of the Nave.</li> <li>• Display of pre-Conquest stones at west end of South Aisle</li> </ul> <p>These are in stable condition apart from the grave cover which is deteriorating due to rising damp. The PCC have obtained quotations for its conservation but these were prohibitively expensive.</p>

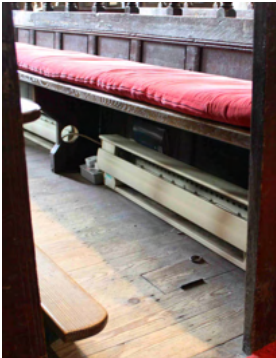
<p>The heating system comprises under-pew electric convector heaters (see photo), supplemented by electric storage heaters located in the Aisles. A large oil-fired convection heater (installed in 1982) is located on the west wall at the base of the Tower. (The oil tank is located in an enclosed structure abutting the west wall of the Tower constructed with stone walls a flat roof covered with roofing felt). The convection heater has not worked for 2 years and was noisy in operation. The PCC are considering removing the convection heater and oil storage tank together with its enclosure.</p>	
Comments/actions	The under-pew convectors and storage heaters do not provide adequate thermal comfort levels especially in winter. The PCC are currently considering alternative heating systems.	E
