**QUINQUENNIAL INSPECTION REPORT  
OF  
ST. IGNATIUS, HENDON, SUNDERLAND**

**QUINQUENNIAL INSPECTION AND REPORT**

**February 2020**

**David Beaumont BA (Hons) Grad Dip, RIBA, AABC**

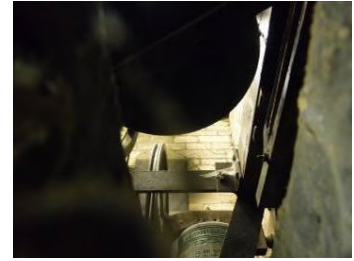
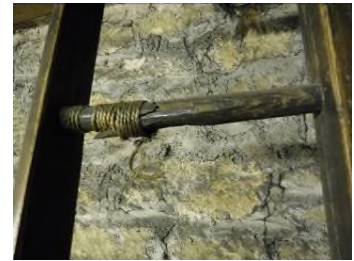
The ladder to the belfry is timber and has got a broken rung. It is not fixed properly and should be replaced with an aluminium raking ladder, fixed at the head and foot. The hatch is too heavy to lift and the bells are in the way and that is why I couldn't inspect any further. There is a secondary aluminium ladder leading to a secondary access. Two accesses into the belfry? Why?

**Recommendation:** replace ladder, lighten hatch, and provide grab rails. Reconnoitre the belfry and establish what is needed to access the spire. Beware of possible major biohazard when accessing the spire.

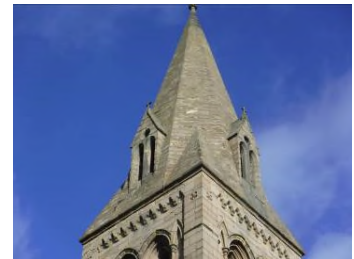
-      **Spire:** The lucarnes which are quite substantial are in fair condition, they have large louvres, and it looks like pigeons are getting in. May need netting externally or blocking internally.

**Recommendation:** see comments at tower interior section for inspection

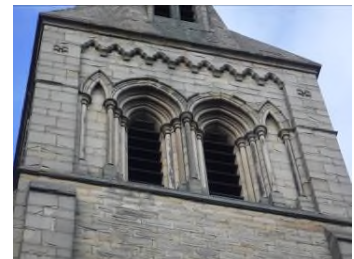
-      **Belfry:** Multiple order arched openings with nook shafts. The louvre boards (slate?) look good.

**Recommendation:** none

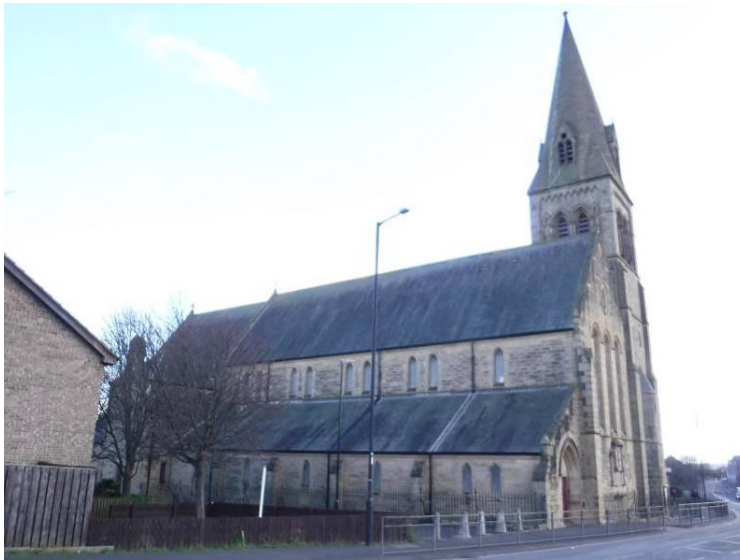
- **Nave:** Some open joints on the ridge, bedding is a bit suspect but it all looks sound. Abutment flashings look ok. General slating looks ok, one missing perhaps up at the ridge towards the tower end.

**Recommendation:** none

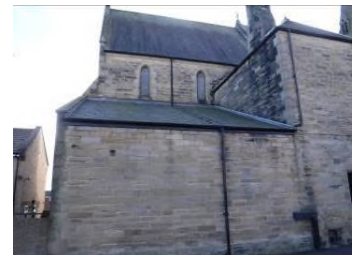
- **Lower Vestry:** All repaired recently and in good condition.

**Recommendation:** none

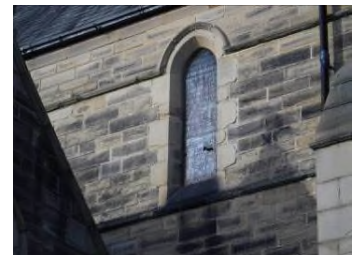
- D Chancel:** One of the clerestory window glazing is broken. This is the next area of planned window repairs

**Recommendation:** carry out window repairs

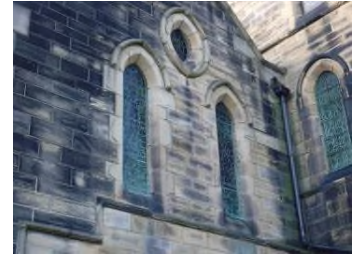
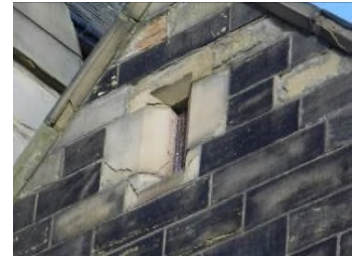
**West** – Some breaking up of the water table and some heavy pollution on the stonework, there is also a little windows right up by the apex that has a guarding that looks ok.

**Recommendation:** fix back grilles

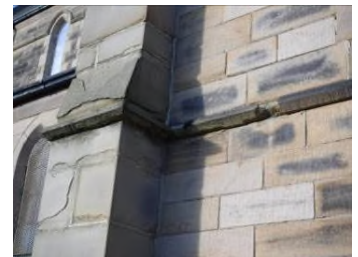
- **South Aisle:** Loss of moulding at the stringcourse below the bottom of the lancets and discolouration of the stonework. The buttresses are losing a bit of their stonework on the top angle. Some shaleing of the stonework of the plinth at the west end.

**Recommendation:** none

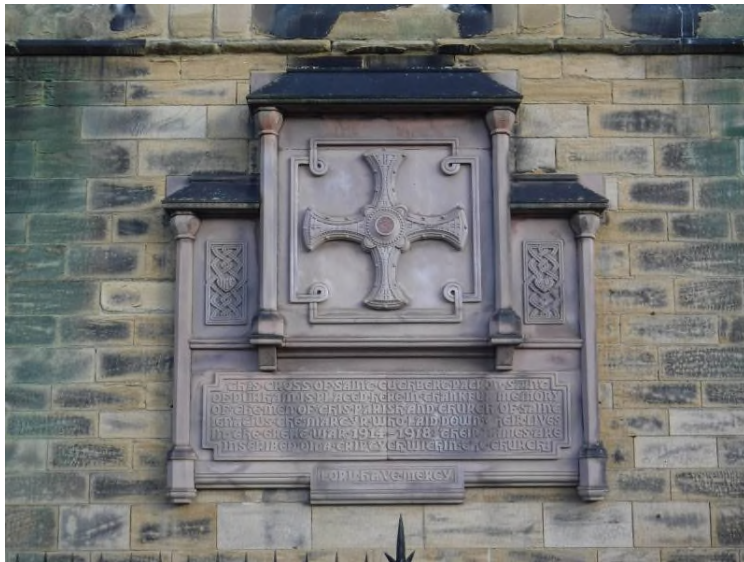
WWI memorial panel. Slight erosion to features but little change since the last inspection.

**Recommendation:** none

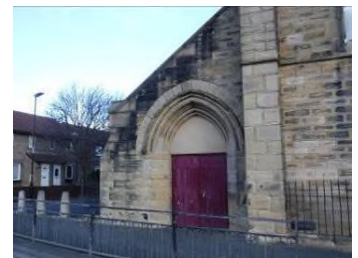
**D North Aisle:** This has a door entrance with a lancet archway with typical erosion, the door itself needs redecorating.

**Recommendation:** redecorate door

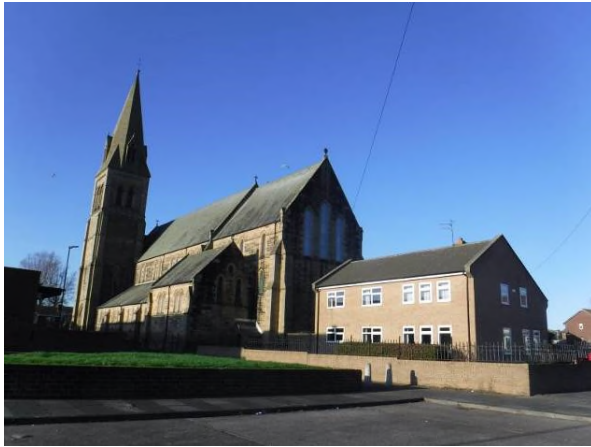
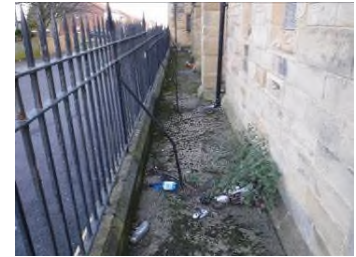
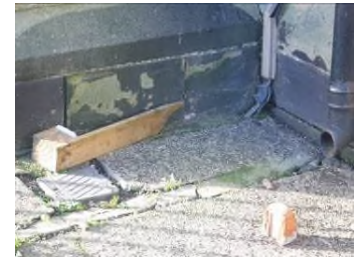
The church site is an island surrounded by footpaths and roads. The site boundary is low walls and railings with a compounded vicarage within brick walls at the east end. The railings themselves are in poor condition and the stone kerbs they sit on are often broken due to rust expansion of the buried fittings. Whilst this may seem a low priority for expenditure of funds, their restoration would indicate a commitment to the long term future of the church.

**Recommendation:** sweep up the margin, look to restore the railings and stonework kerbs

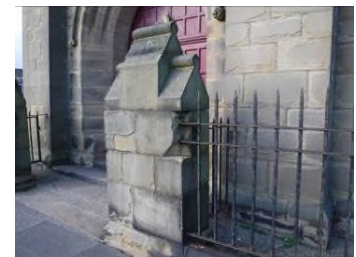
The area within the railings is a concrete margin and this is broken up in places and has various bits of masonry and rubbish within it some of which will be ammunition for vandals.

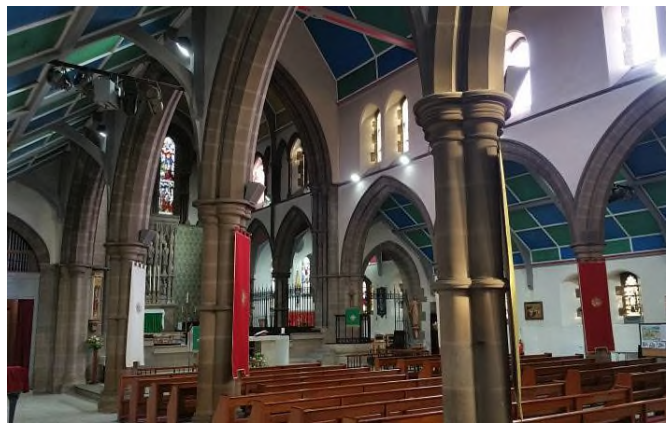
- **Ceiling** – Four kingpost trusses to the nave forming a barrel vault with panelled infill panels which are all sound. In the chancel open barrel vault again panelled but no tie rods. The aisles have simple lean-to trusses with exposed purlins, here the boarding shows a bit more water ingress than elsewhere. Within the Lady Chapel this also has a barrel vault ceiling, where there is a breakdown of the decoration at the box gutter.

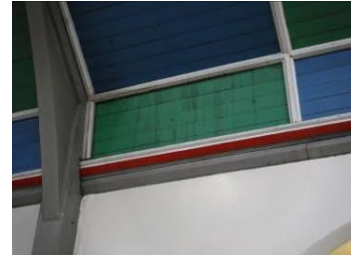
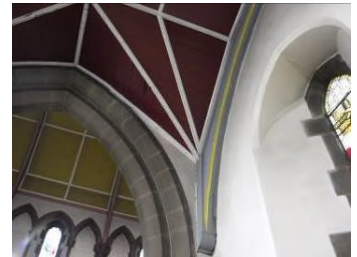
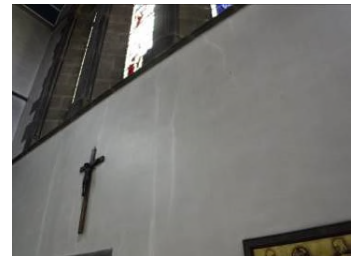
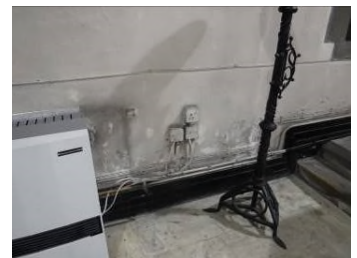
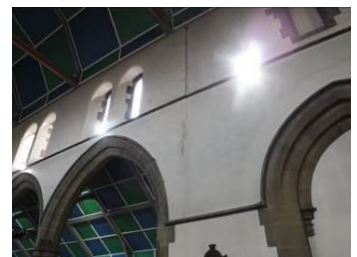
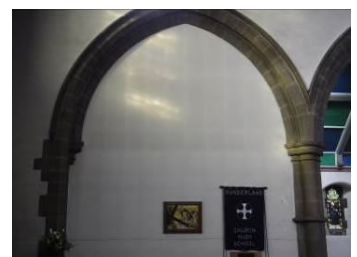
- **Walls** – These are painted plaster and showing their age now in that the decoration is breaking down a bit. The west wall of the nave has some vertical cracking but it is not evident on the outside and the lower parts are a bit

scruffy now, the infill arches at the west forming the entrance lobby and the sacristy have ghost marks on them for the stud work.

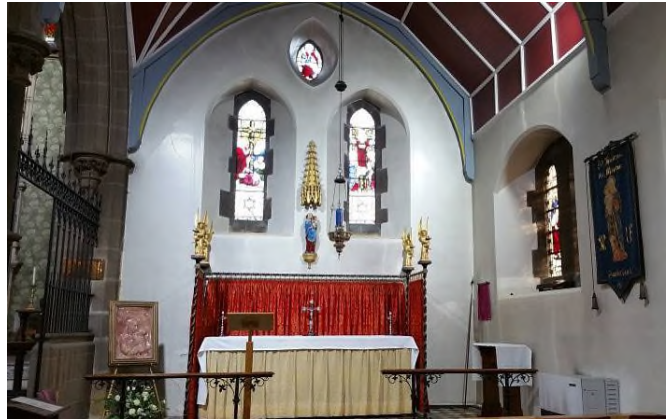
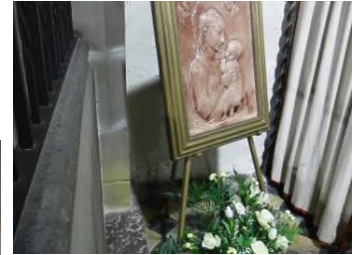
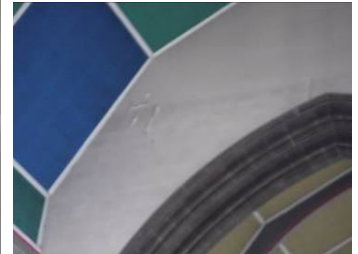
The Lady Chapel east end below the termination of the box gutter shows some broken plaster work, hopefully this is all historic now.

The William Morris wallpaper at the chancel east end is beginning to come away at the joints.

**Recommendation:** update decoration, perhaps start on the west wall first?

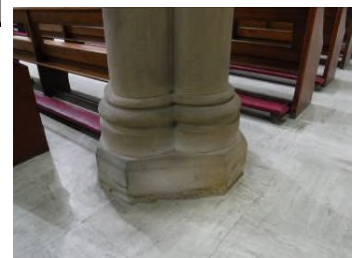
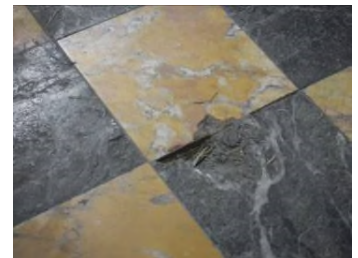
The east and west glazing has been renewed as well as one of the clerestories.

All the arcade stonework is fine there is no cracking to it, there is slight erosion to the bases of the columns nothing to be concerned about.

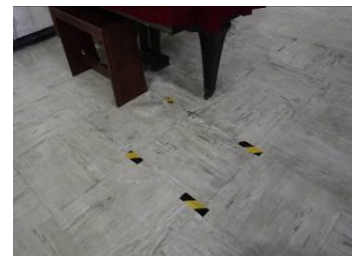
- **Floors** – Solid floors throughout comprising- Chancel; marble floor combination of different types both black and white and coloured all in good order. The choir pews are on large format timber herringbone laid onto solid below it. At the low altar within the nave one or two of the granolithic white floor tiles is lifting and will cause a trip.

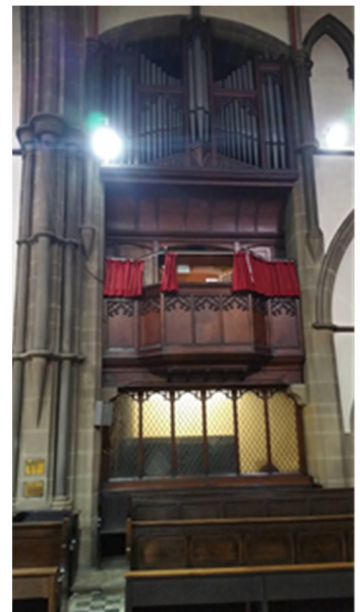
Below the organ is the blower room containing the incoming electric supply and metering, it has got choir robes in it, it is basic but serviceable.

**Recommendation:** none

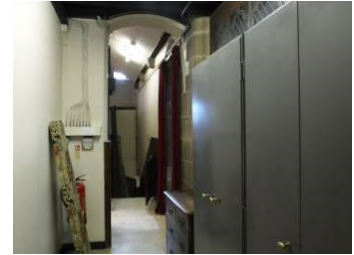
- **Corridor leading to Vestry Room:** Generally ok, perhaps a little down at heel but it will do. Stairs leading down are generally sound they have worn over time.

**Recommendation:** none

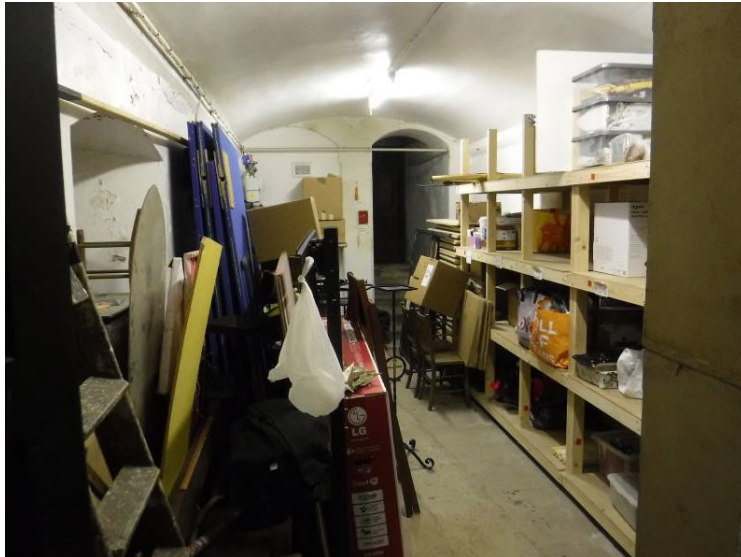
- **Basement:**

Barrel vaulted plastered out space with some damp showing on the walls, concrete floors quite recent, some old drainage in the floor by the look of it, racked out for various goods provides storage, there is a bolted and padlocked door no longer in use. The ceiling of this passageway -the paint is breaking down a bit and there is damp to the walls quite obviously as below ground. There isn't adequate ventilation, it is slightly musty, the policy is to keep the door open I think and try to get a bit of air through.

**Recommendation:** none

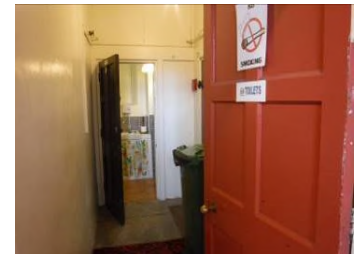
- **Vestry Lobby:** A little dated now, contains the wheelie bin, floor slightly uneven with carpet.

**Recommendation:** none

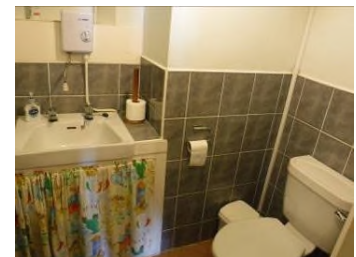
- **W.C.:** Basic but serviceable.

**Recommendation:** none
