QUINQUENNIAL INSPECTION REPORT

CHURCH OF St. PETER
YORK AVENUE, JARROW, NE32 5LP

NOVEMBER 2022

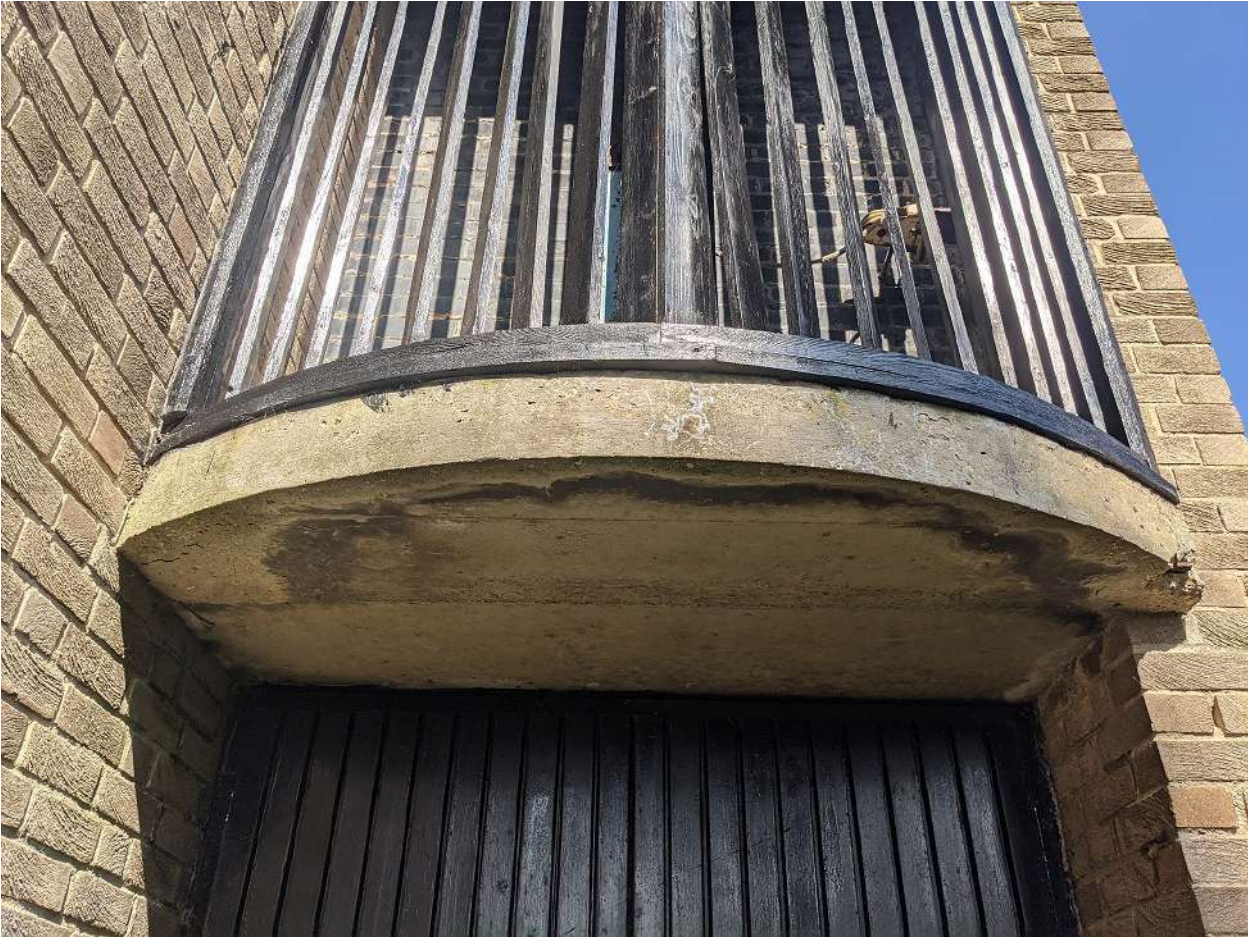
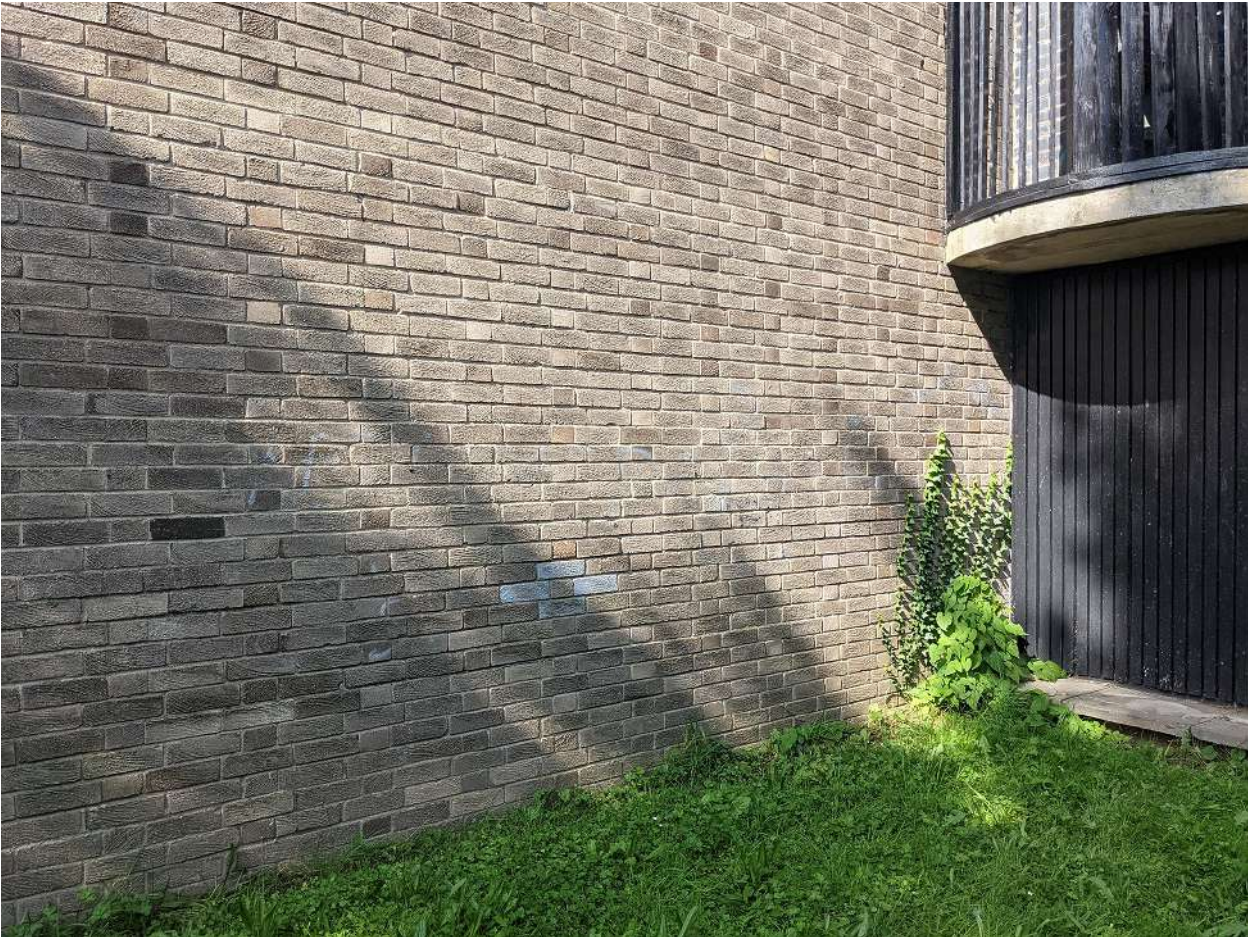
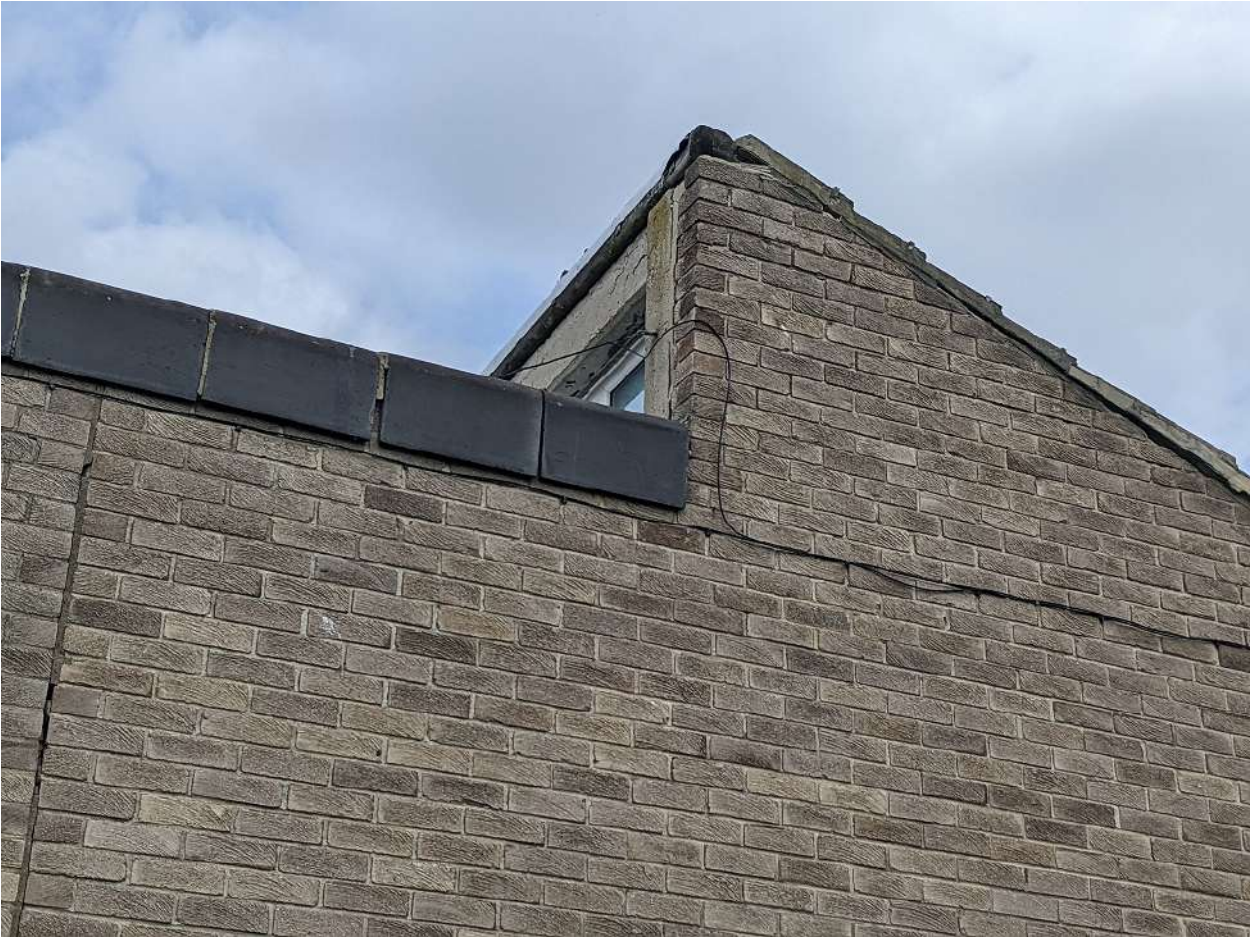
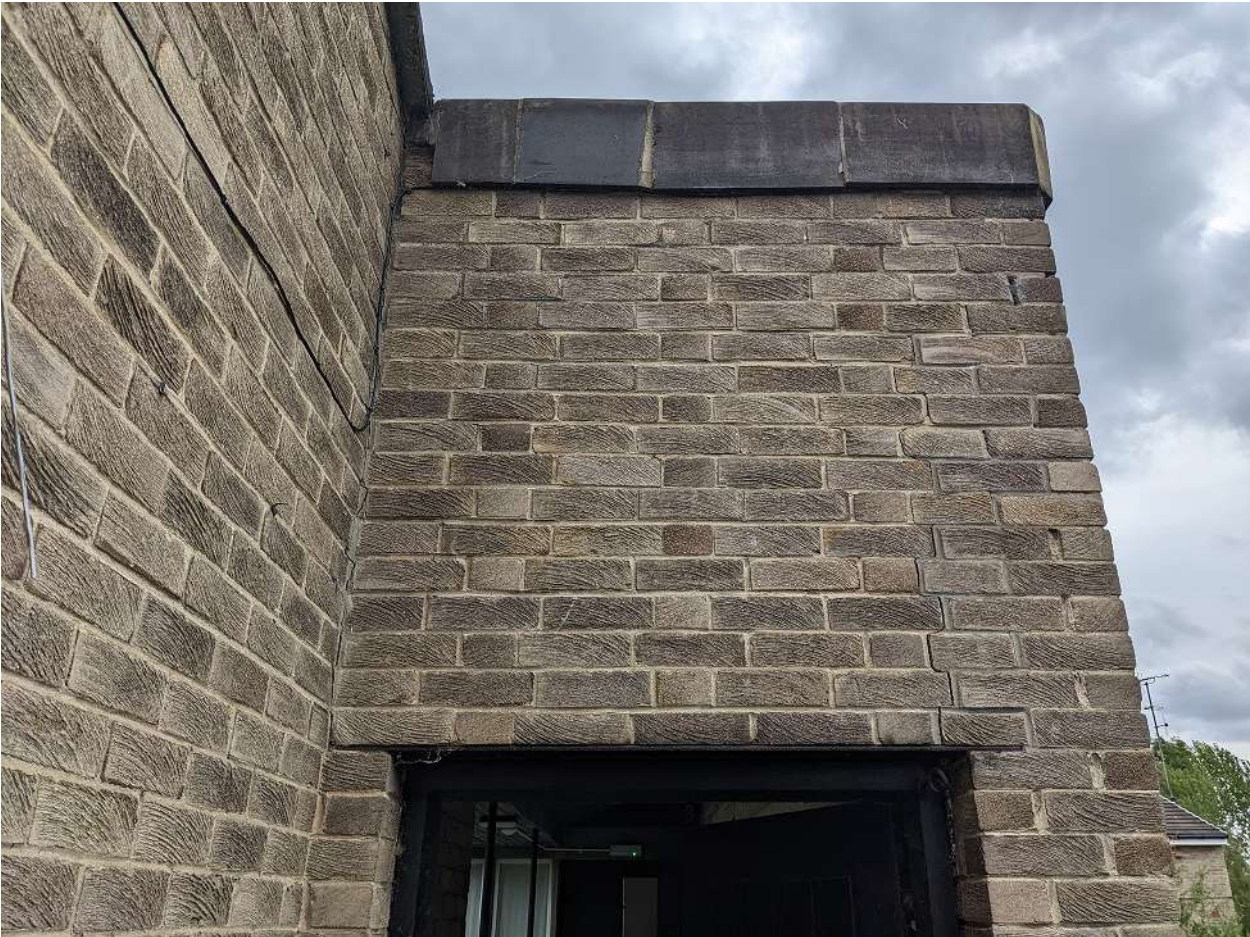
There are several areas of loose and/or missing mortar to the brickwork walling at plinth level which would benefit from repointing.

R1	It is highly recommended that a schedule of work and specification is drawn up to address the defects noted to the pointing of the walling brickwork.
R2	7.2.2 Action walling repairs by a competent and experienced building contractor.

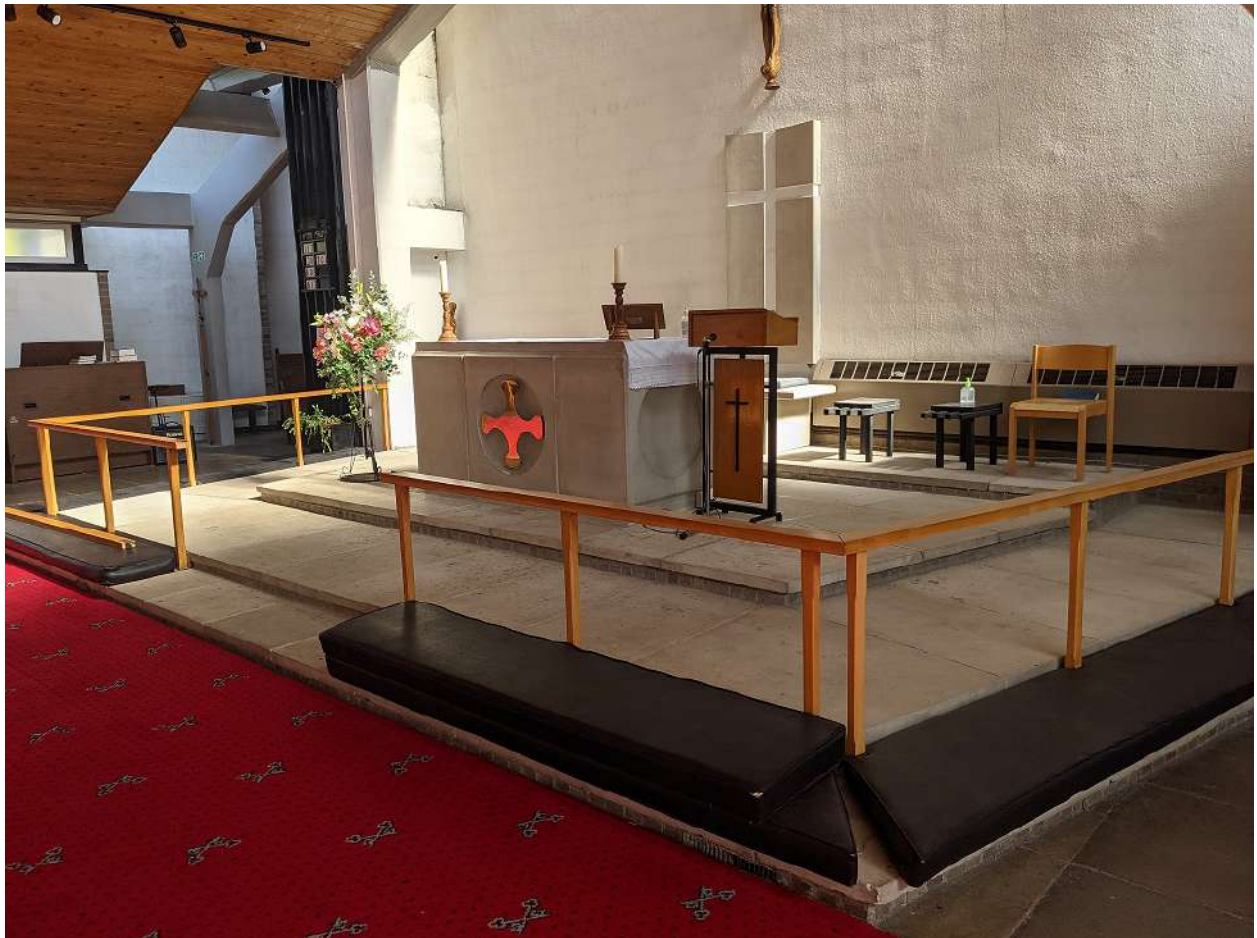
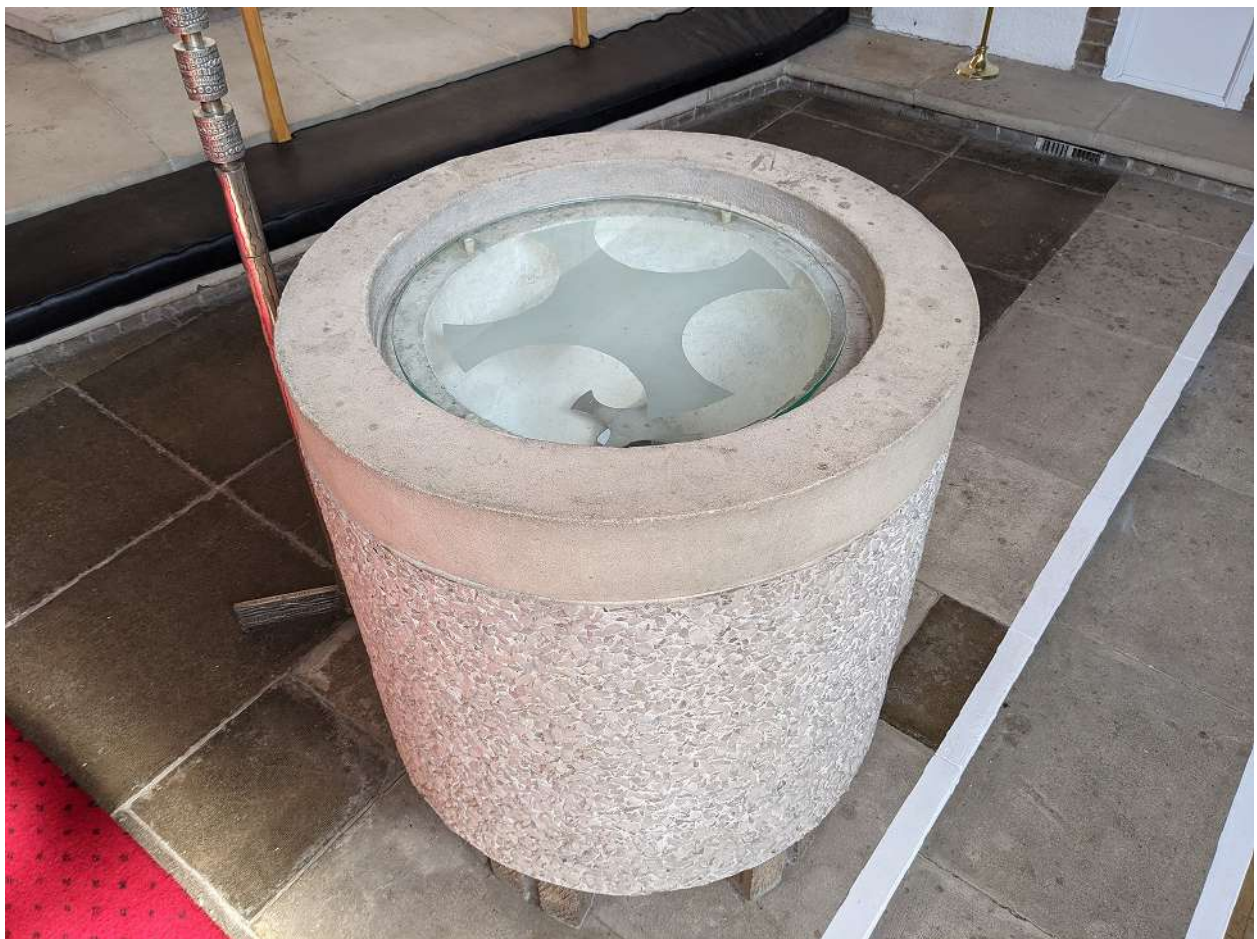
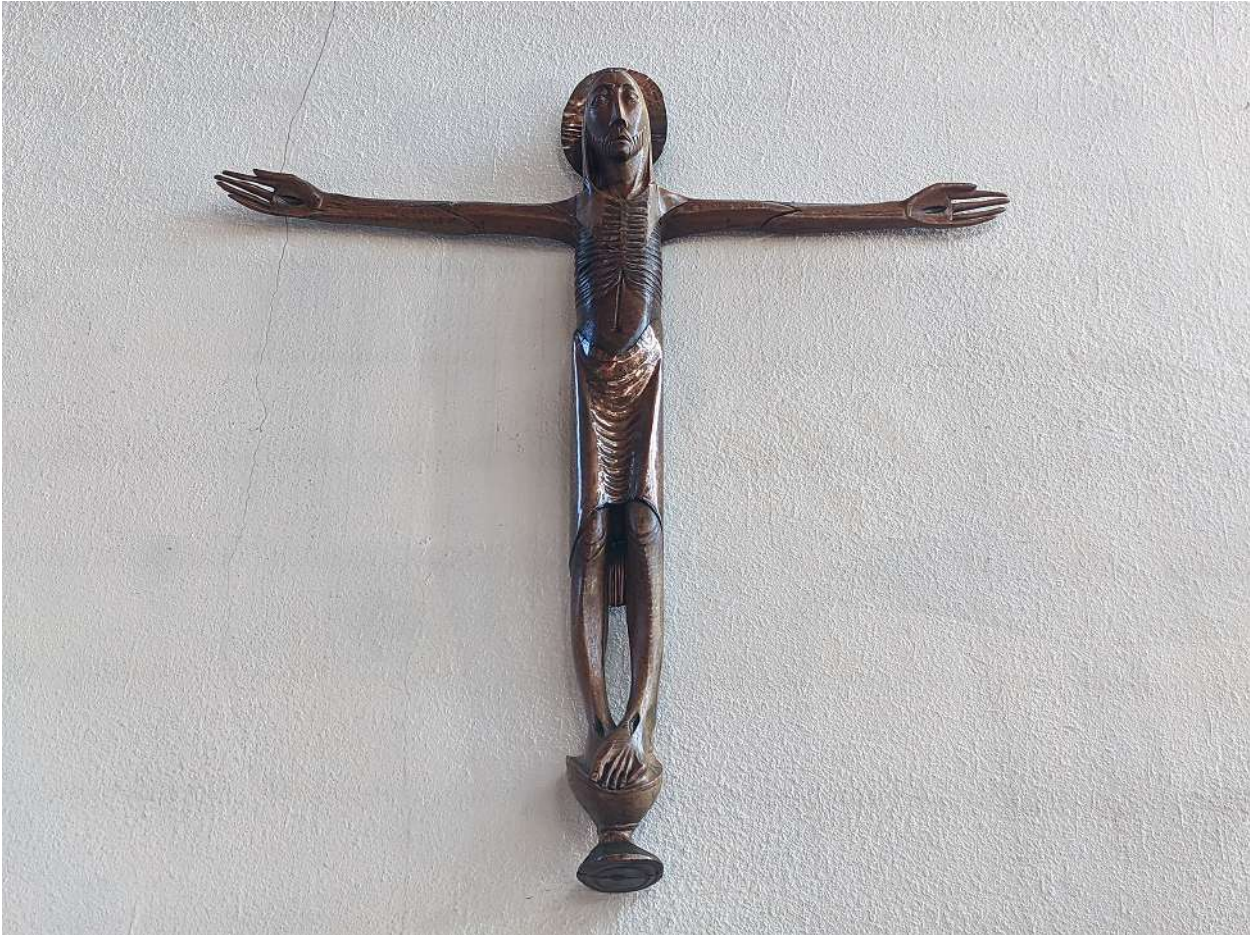
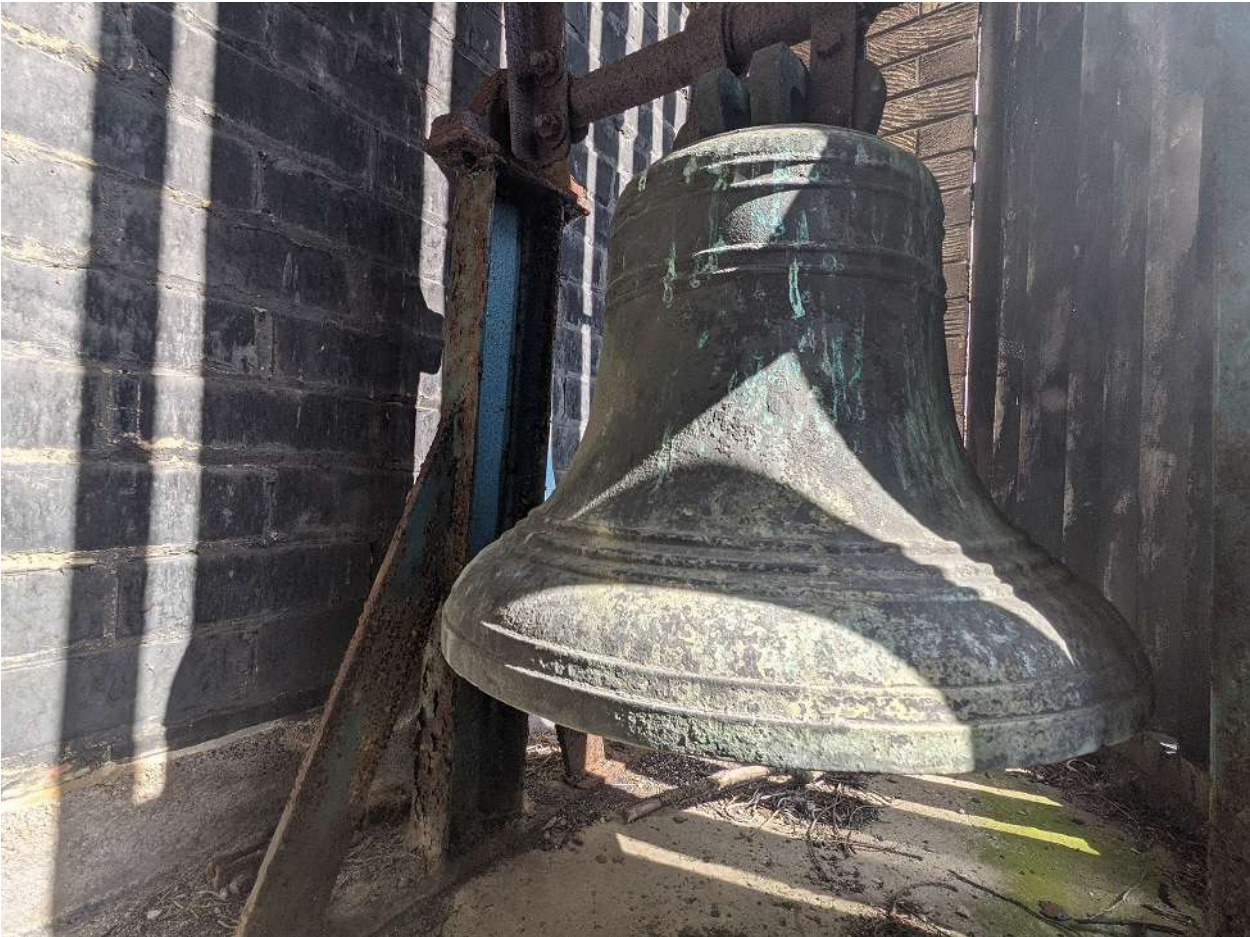
Located to the centre of the raised Sanctuary at the east end of the Worship Space the High Altar is contemporary to the design and build of the church centre. Altar top constructed from a single white art stone slab laid on 3 no. base blocks of smooth white artificial stone, circular indentations to each end and to front and back. A brass cross is integral to the front of the high altar sitting within the circular indentation, cross design matching that of the font.

All is in excellent condition.
