QUINQUENNIAL INSPECTION REPORT

CHURCH OF St. PHILIP & St. JAMES OAK CRESCENT, KIMBLESWORTH, COUNTY DURHAM

NOVEMBER 2021

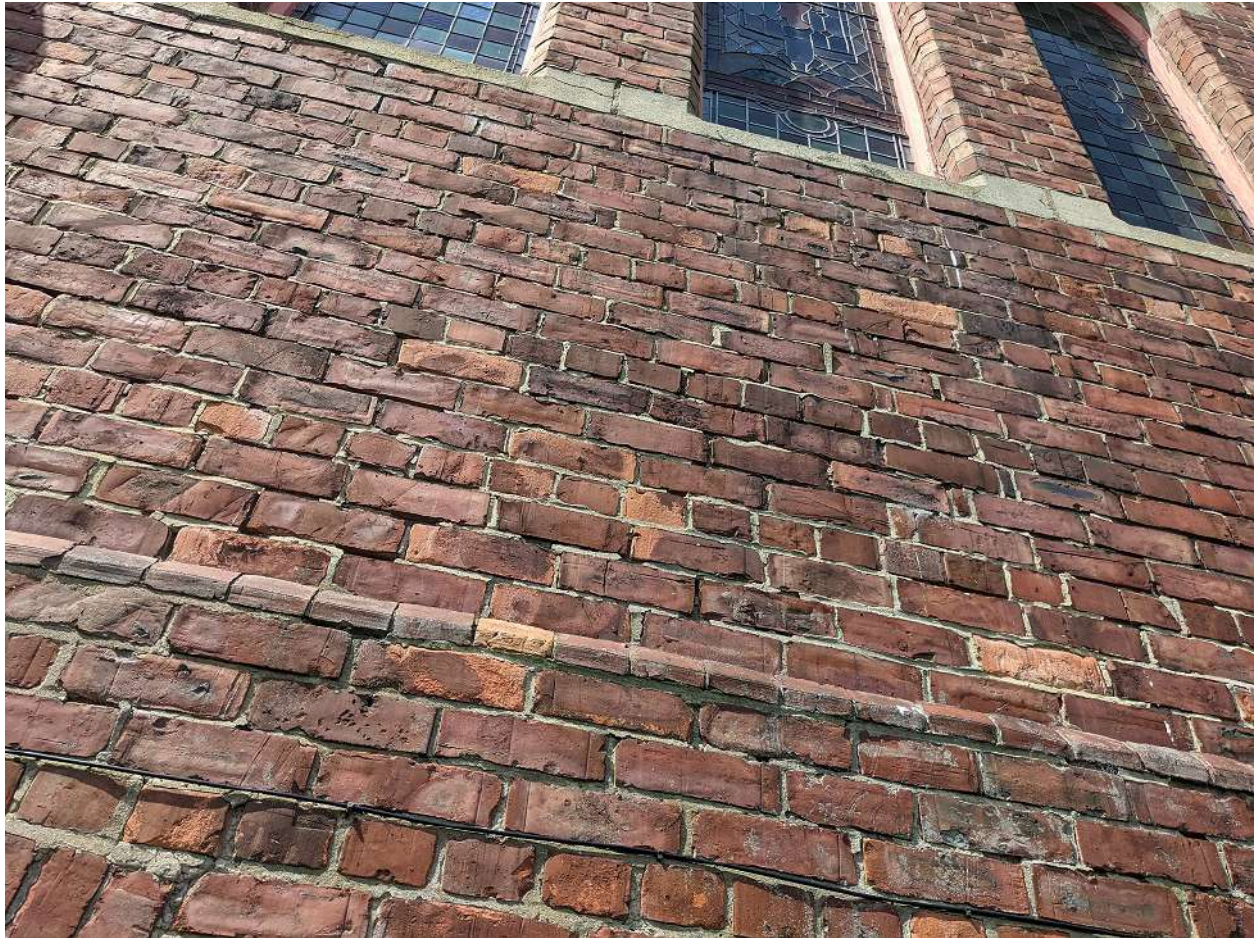
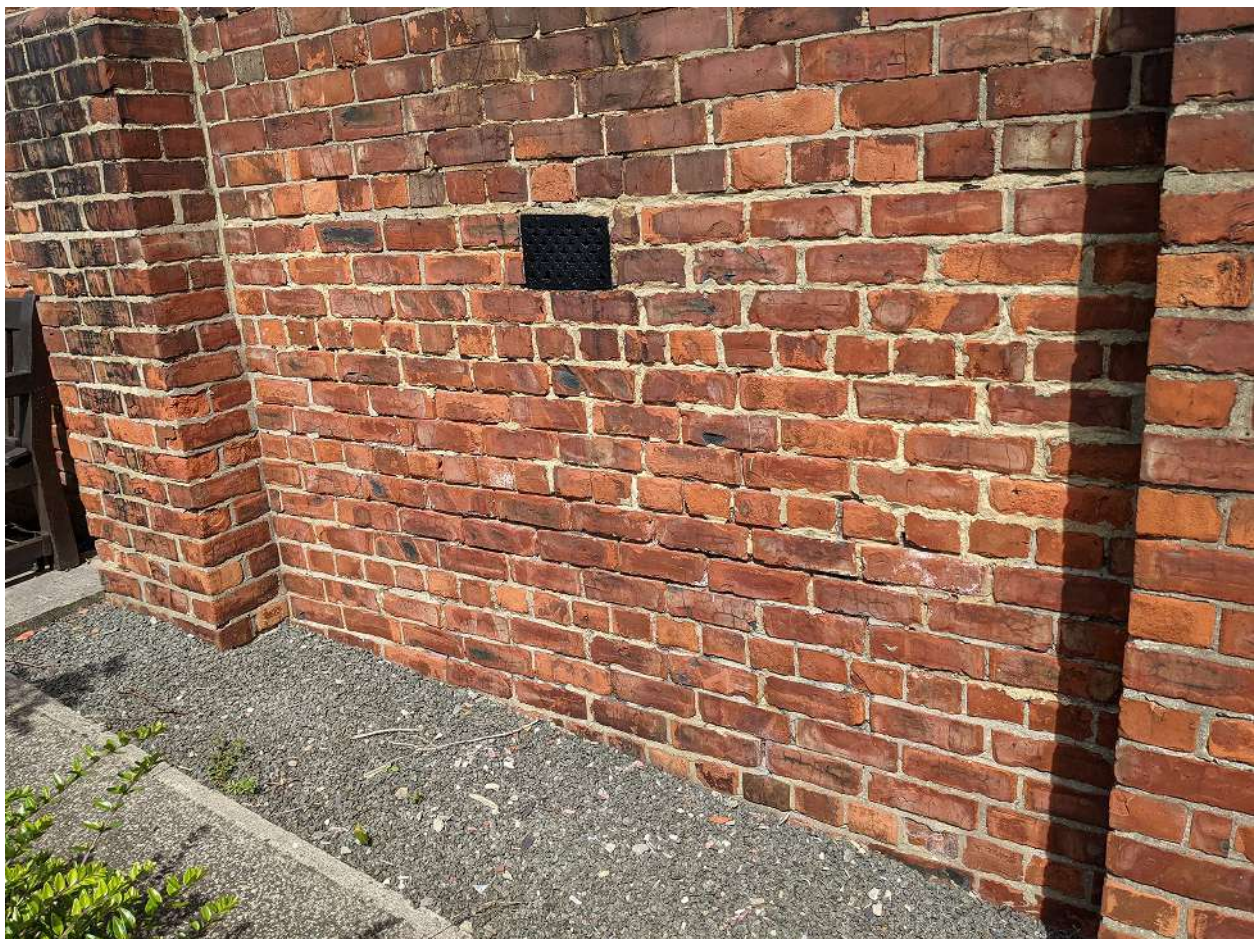
The church fabric repairs carried out in 2019 looked to start addressing the condition of the stone surrounds with the nave south clerestorey condition addressed.

R2 It is recommended that stone surround repairs are carried out on a phased approach across the quinquennial period, although a start early in this period is highly recommended at year 2.

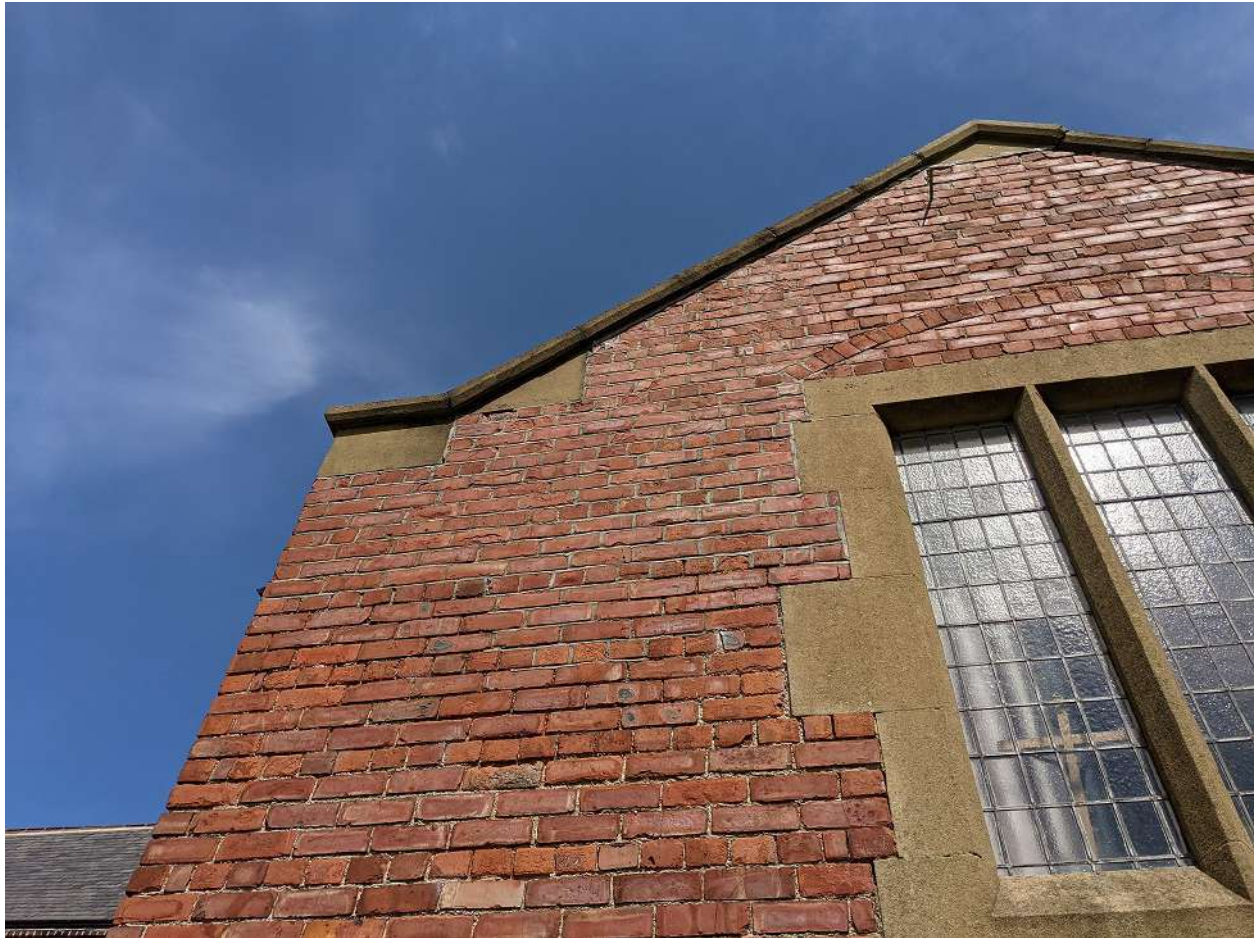
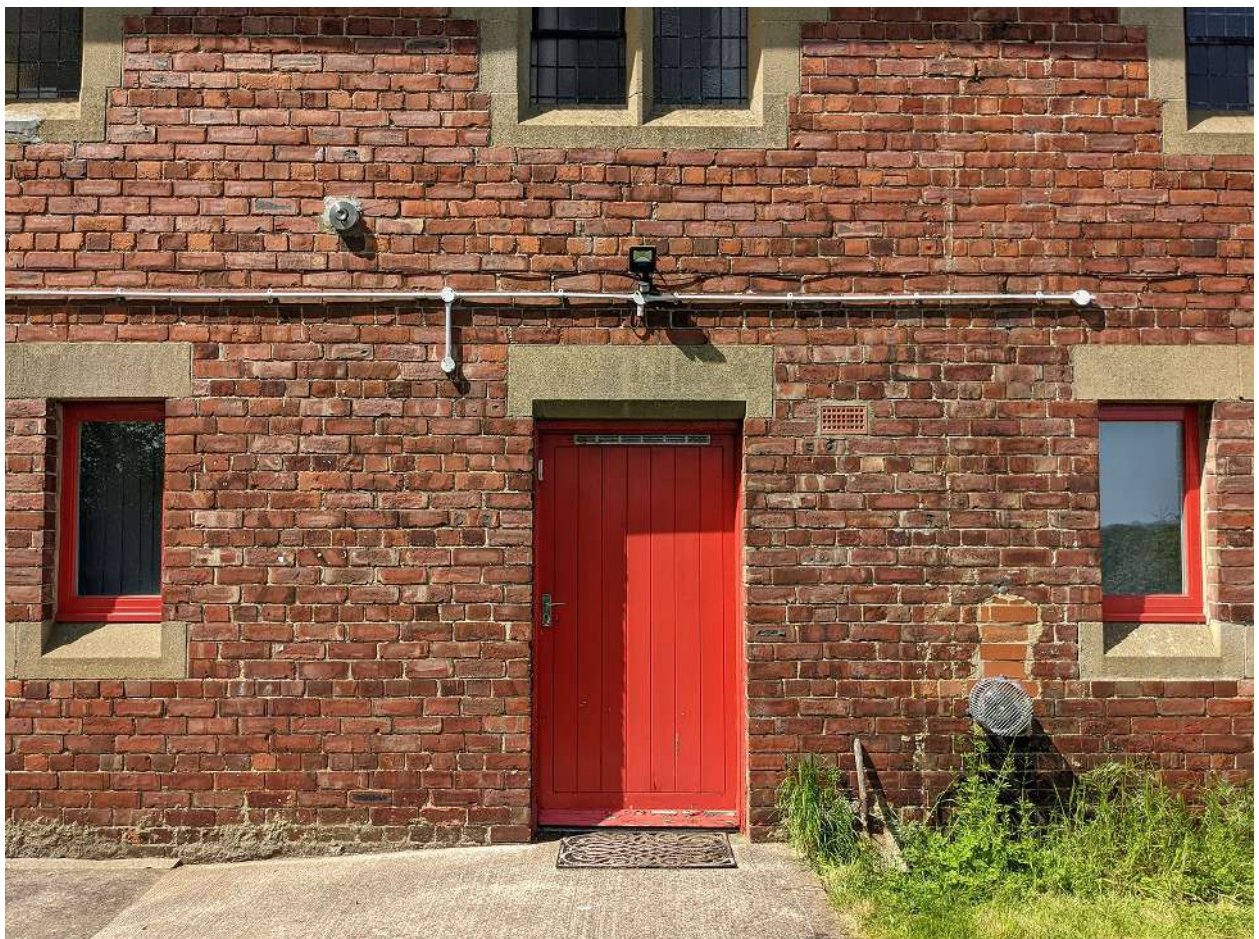
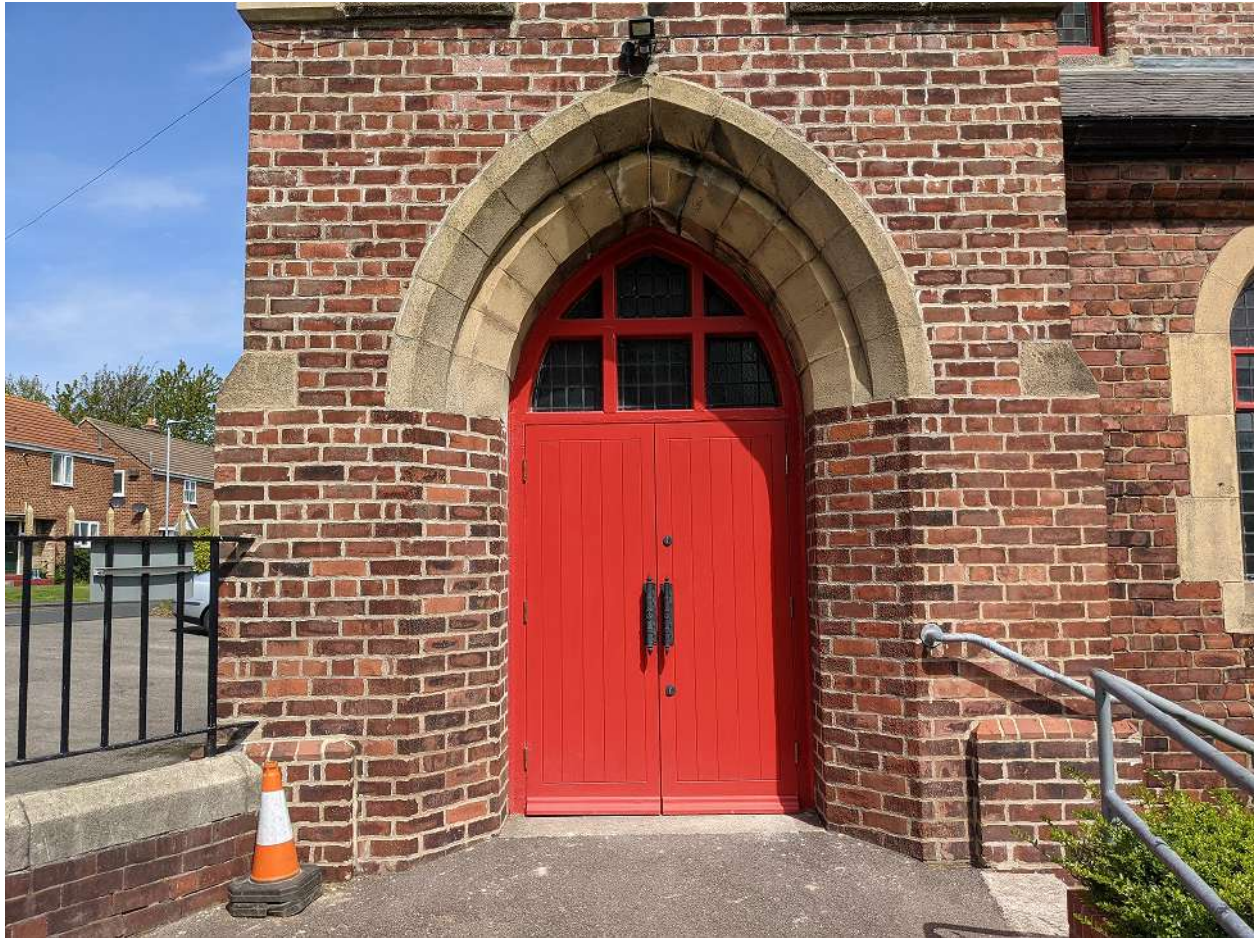
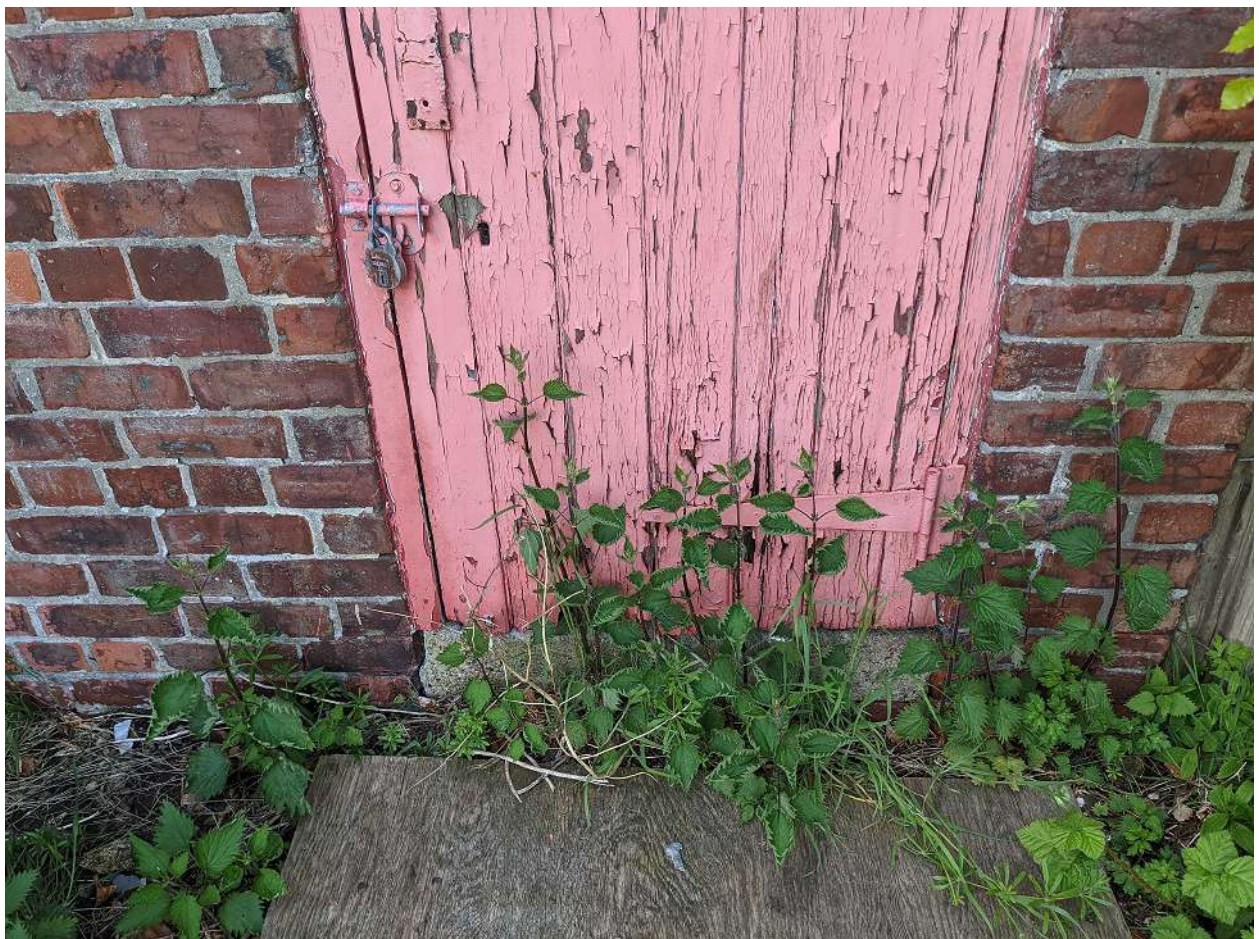
8.1.1 Replacement door installed as part of the 2019 church fabric repairs, as such is in a sound, good condition.

M	As a matter of ongoing maintenance, it is recommended that the door, door frame and ironmongery is refurbished and redecorated every 5 years.
----------	---

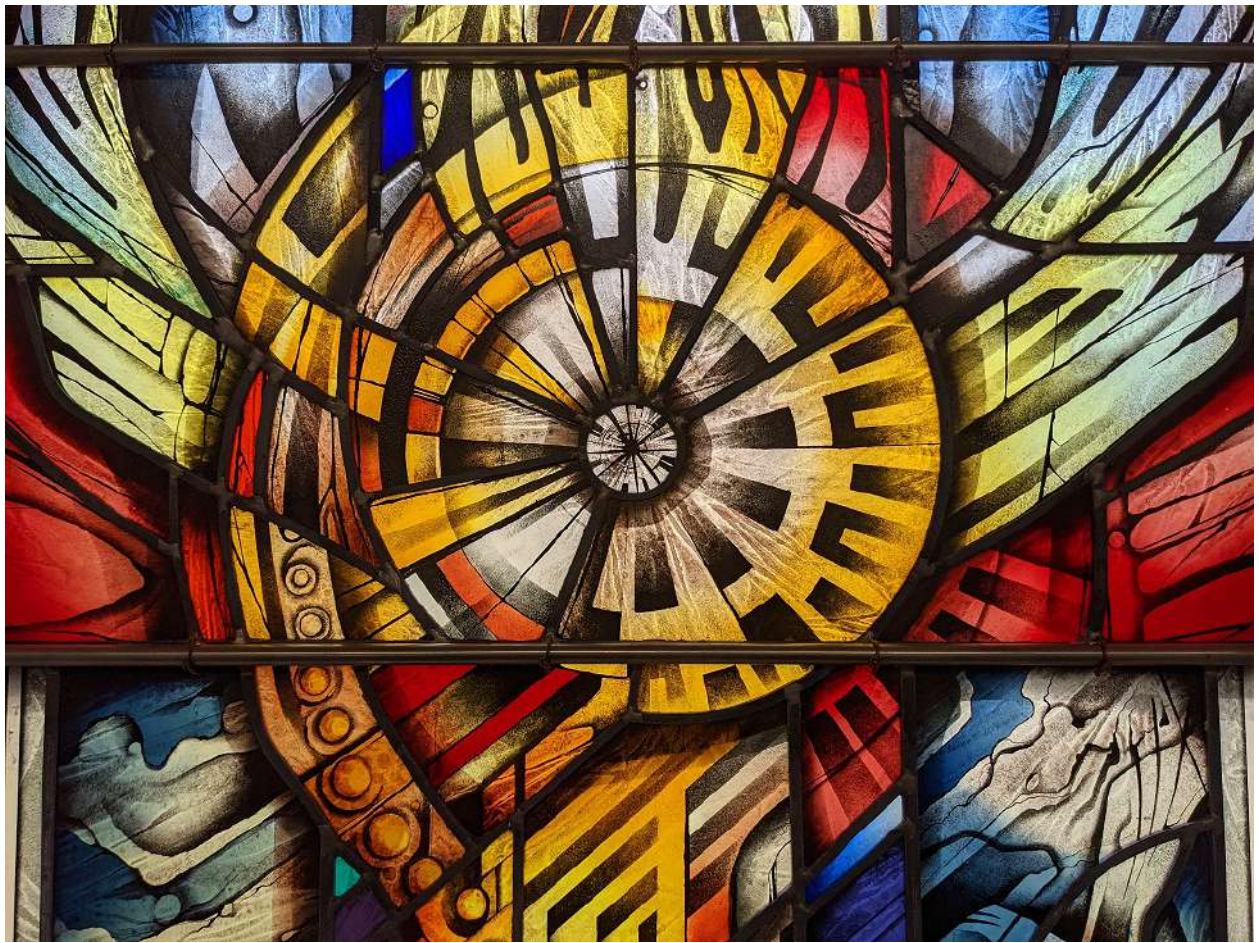
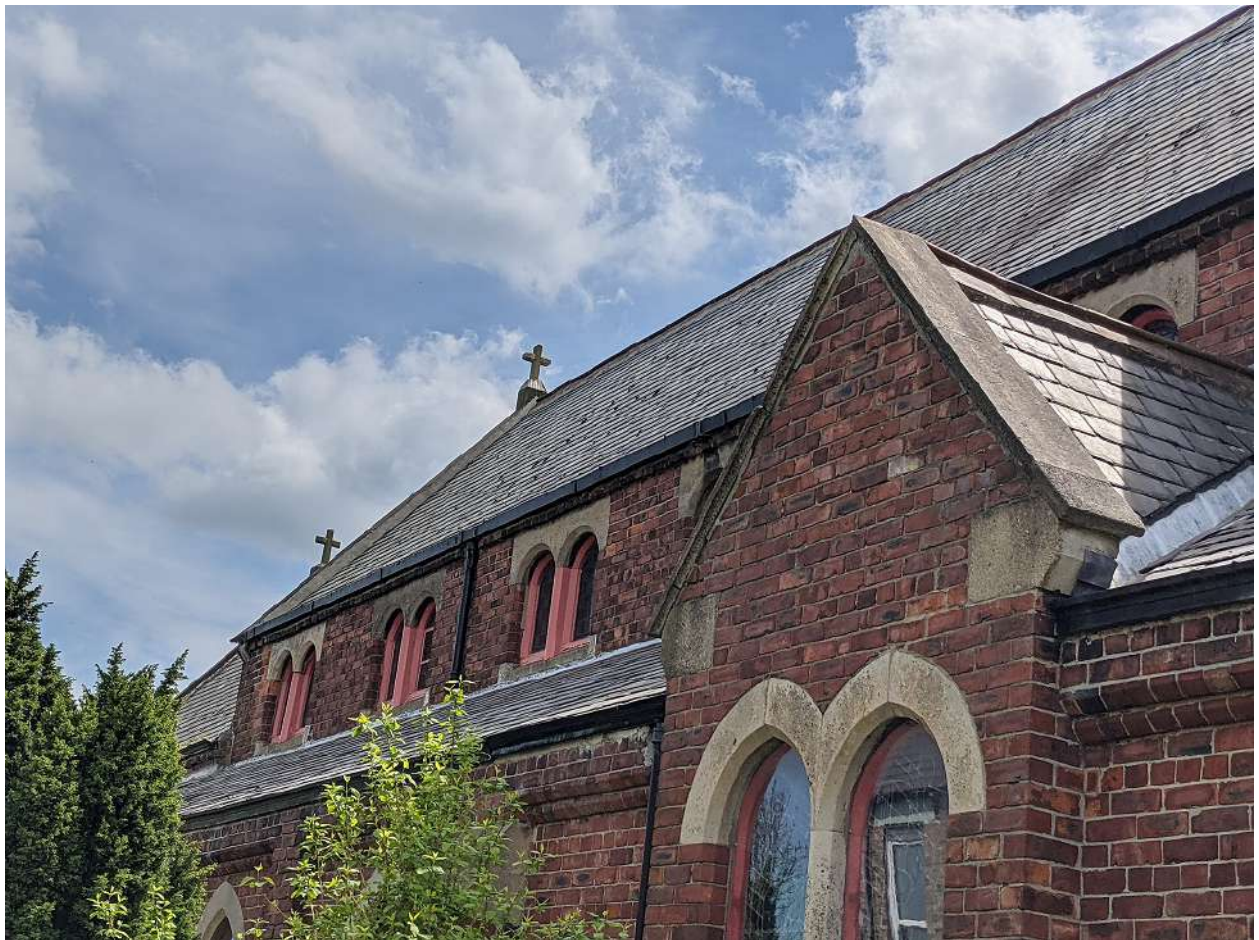
- 9.2.1 The glazing is generally found to be in a sound, good condition. There is a degree of buckling to the south window but not yet at a degree that requires attention and repair.

R4	It is desirable to commission a conservators report on the condition and future repair of the glazing.
-----------	--

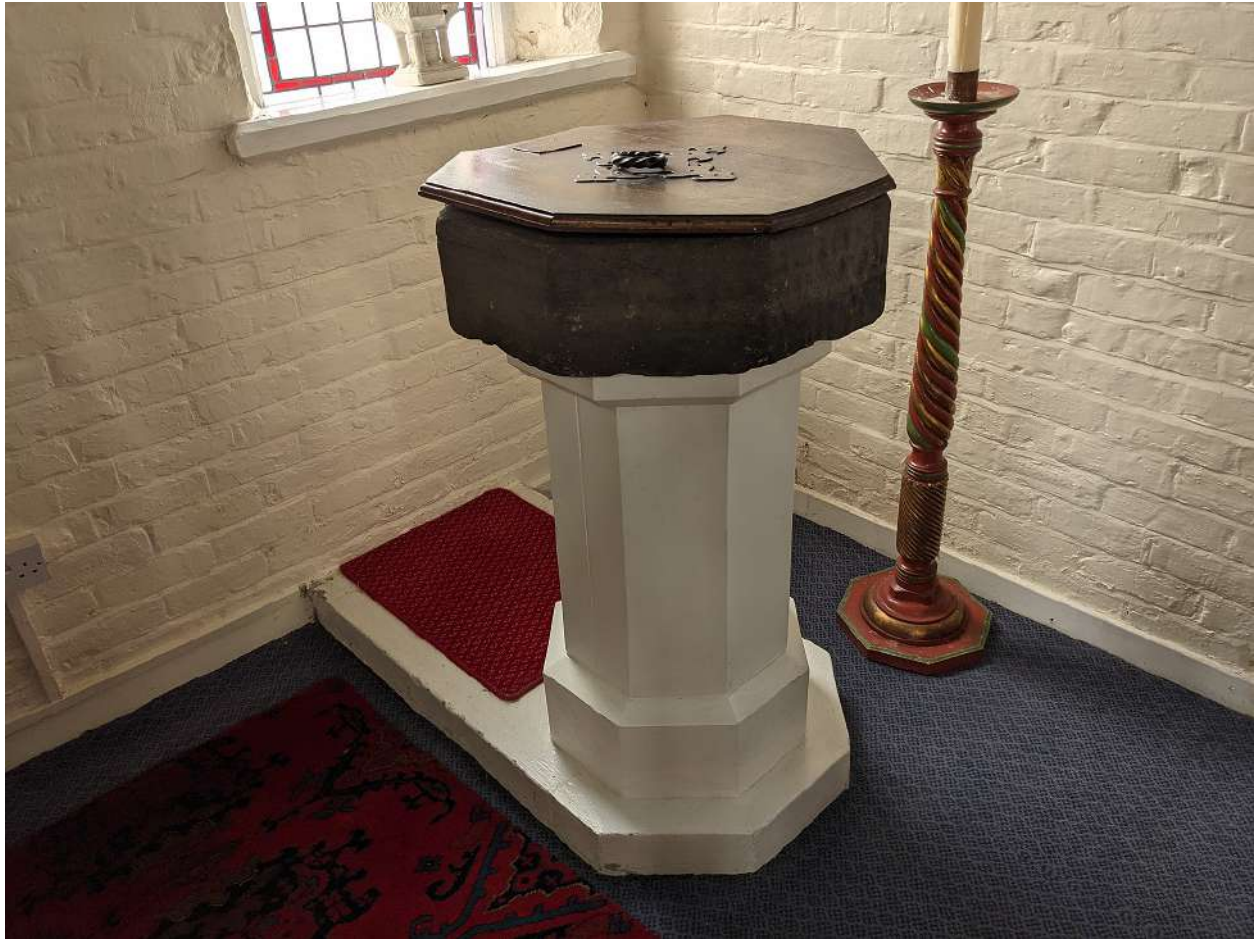
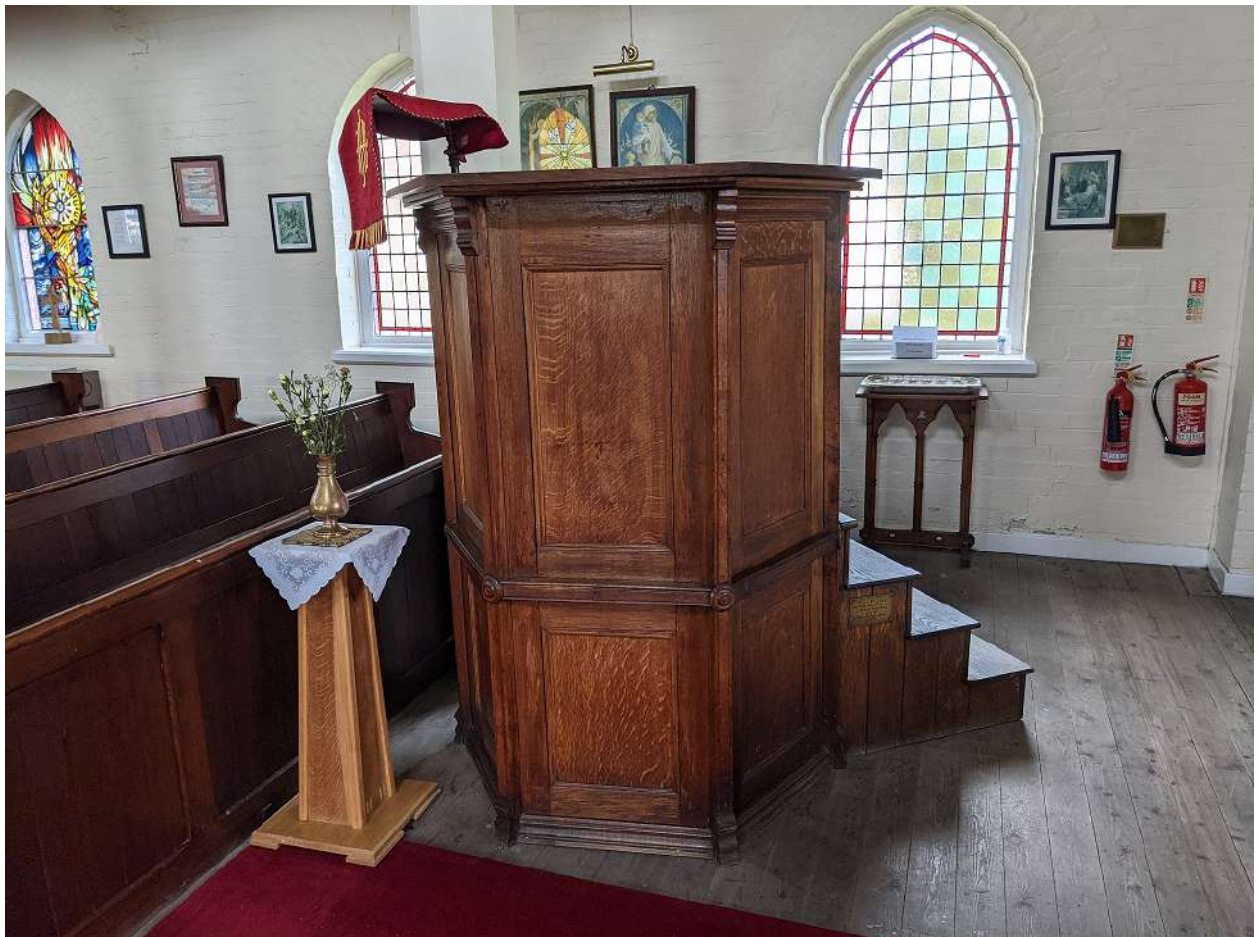
There is a single bell; c.9 inch in diameter, dating from c.1923 and foundry unknown. It is housed externally in a low-level bellcote at the north west corner of the nave.

The condition of the bell and its mountings were refurbished as part of the church fabric repairs carried out in 2019. It is understood to be in regular use.

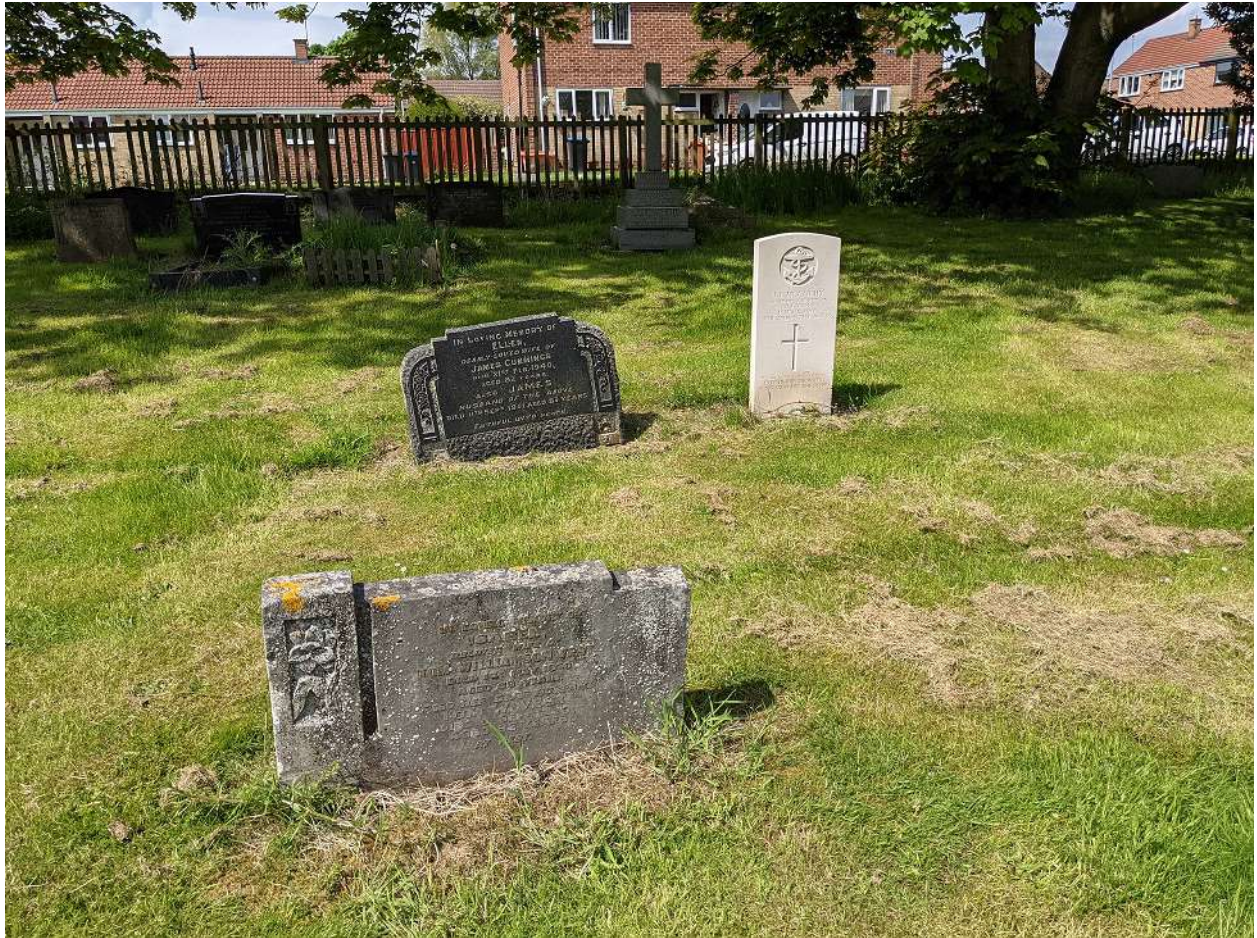
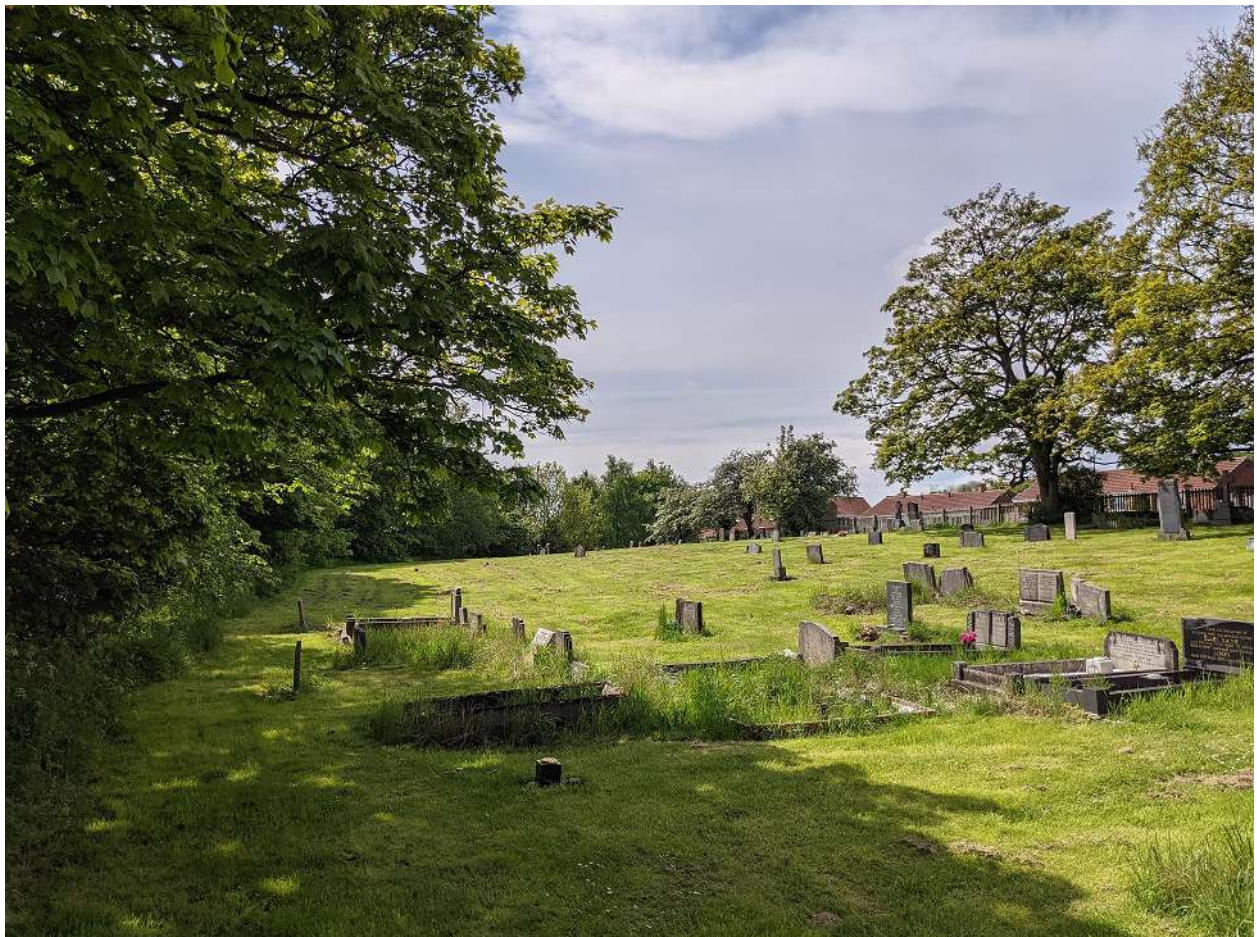
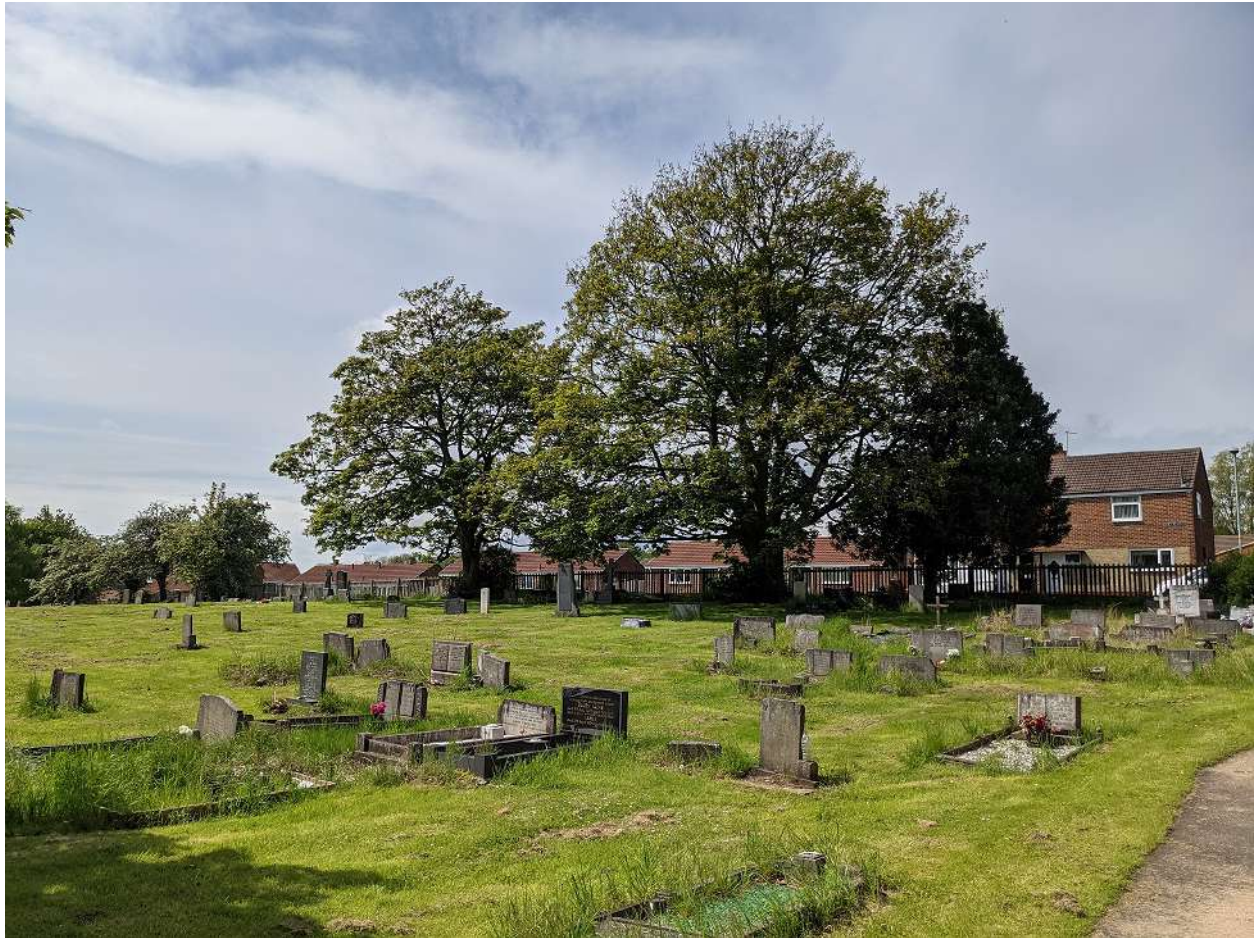
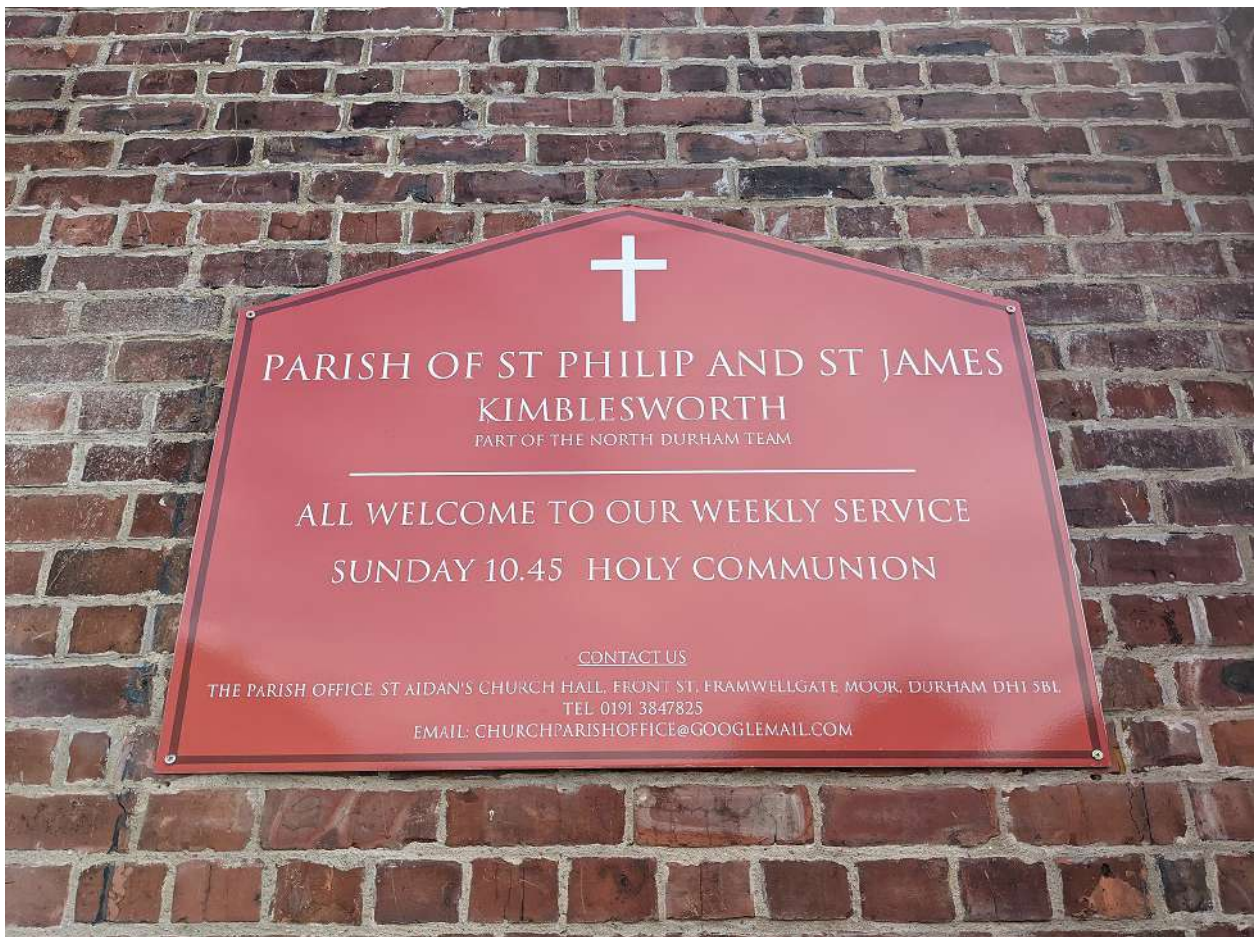
- 38.1 There are several mature trees existing within the church grounds along the east, south and west sides.

The last known date of any condition inspection is not known, presumably carried out by Durham County Council.

It is recommended that enquiries are made with Durham County Council regarding the last known inspection date of the trees.
