St. Mary Magdalene Parish Church,
Medomsley

Diocese of Durham

Quinquennial Inspection Report
April 2019

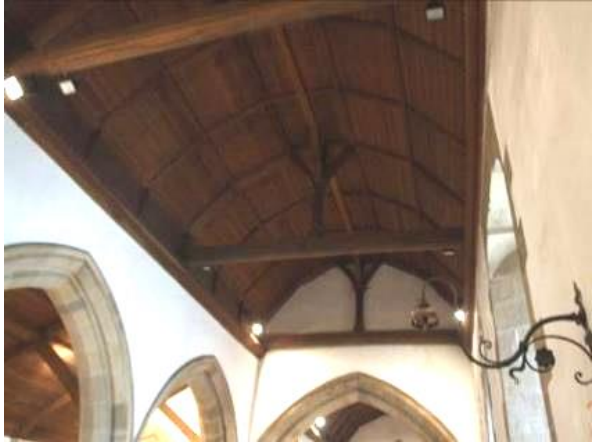
| 9.1 | <p>The roof internally has four bays formed with heavy oak trusses and shaped king posts and brackets. The barrel-vaulting is all formed in timber and at a height beyond ladder reach for close inspection. Timbers are dark and artificial lighting does not help with a detailed inspection. There are, however, no obvious signs of water penetration or decay as reported previously.</p> |

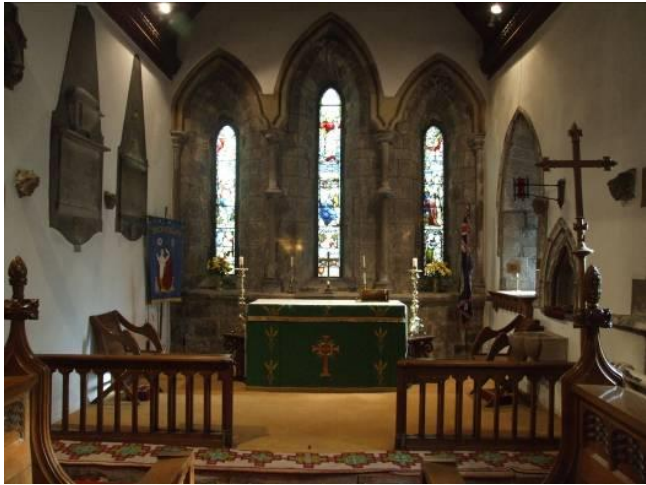
| 11.1 | East end sanctuary and west end nave windows are figured stained glass memorials to the Hunter family, in sound condition and well protected externally. Two brass plaques to Martin & Jean Hunter were relocated in the floor at the west end of the nave during the reordering works. |

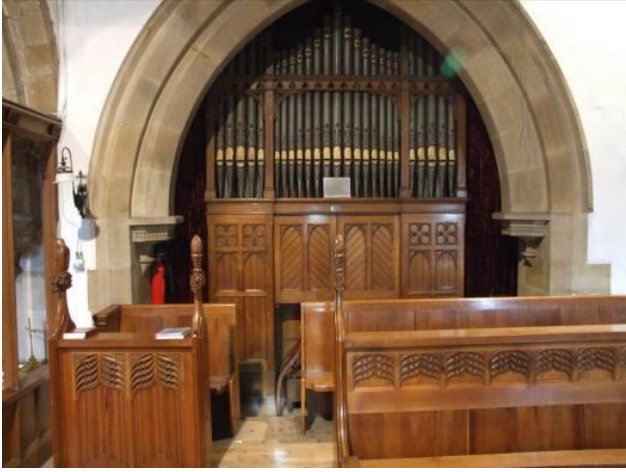
| 13.2 | <p>ORGAN: This is a Brindley & Forster instrument, dated 1882, and is serviced regularly by Harrison & Harrison of Durham. It is reported to be in good condition.</p> |
