# Holy Trinity

## Durham

### Quinquennial Report

**30<sup>th</sup> September 2020**

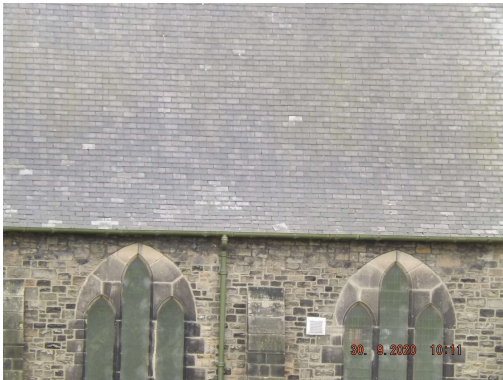
- 5.1. The main roof slopes are steeply pitched with Welsh blue slate coverings fixed directly to sarking boards. Concrete ridge tiles, lead valleys and cover flashings over soakers at gable upstands. Overhanging eaves with gutter brackets fixed to boards under slates. Following repairs carried out in 2017, the slates appear to be in generally good condition. Some previous repairs show signs of lead clips which appear to be sound.

- 5.2. Chancel slates are in good condition.
- 5.3. One slate has slipped to the north nave but generally in good condition.
- 5.4. Fairly extensive repairs to the south nave remain in good condition. Some slight displacement at west gable ridge.

Remove vegetation from external gutters	6.1
Clean out rain water gullies and channels	6.3
Replace slipped slate to north elevation	5.3

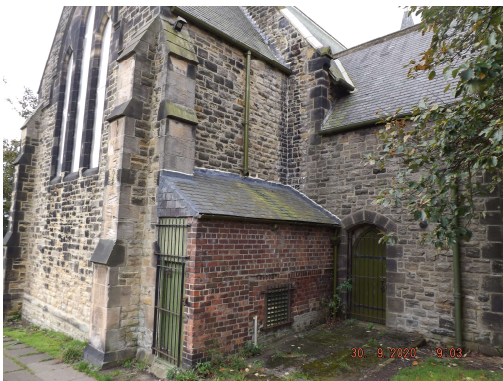
5.10. The roof to the boiler house which was replaced in 2017 remains in good condition.

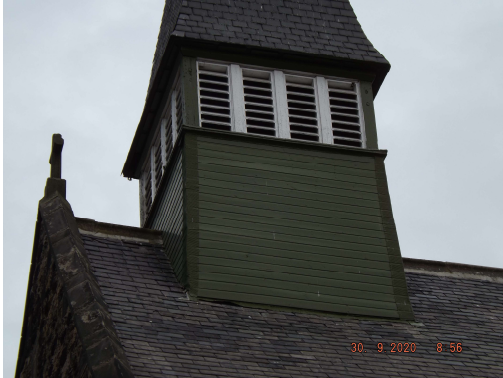
- 8.1. A tall slate roof with painted timber louvres below. Repairs and redecoration of the shiplap timber in 2017 remains in good condition. No access to the bell tower but understood to contain one 36" bell from 1868 in a steel frame. The bell is rung from the upper room with a hole in the ceiling to storage loft floor.

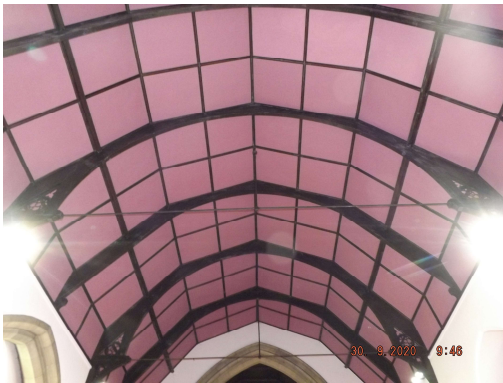
- 11.1. The roof structure to the chancel and transepts is concealed above the barrel ceilings but are likely to be scissor trusses. The nave trusses are partly visible including small curved braces and hammerbeams with iron tie rods at alternate trusses. There were no apparent defects from a floor level inspection. The ceiling access hatch was not entered. Stiffening to two trusses appear to support the bellcote.

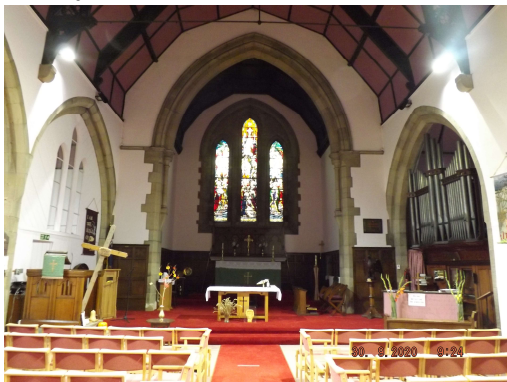
- 17.1. At east, three stepped lancets by A L Moore of London in 1905, very good quality and appears to be sound.

- 17.2. South east nave by Lowes Noble 1901 memorial geometric decorated, S Paul, fair condition with minor loss of paint, dirt and some distortion of lead. Support bars are widely spaced with some bowing of leads at Evangelist symbols.

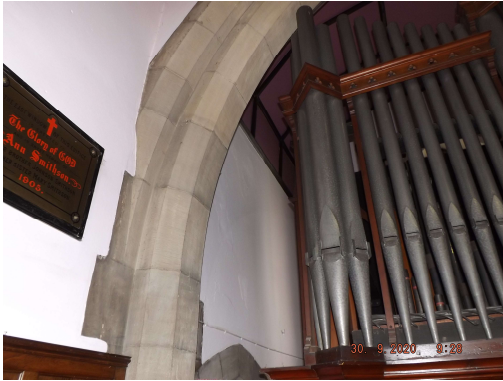
19.4. Two manual pipe organ with oak case, glass doors by Vincent 1884 in good order and tuned annually by Brian Brighton.

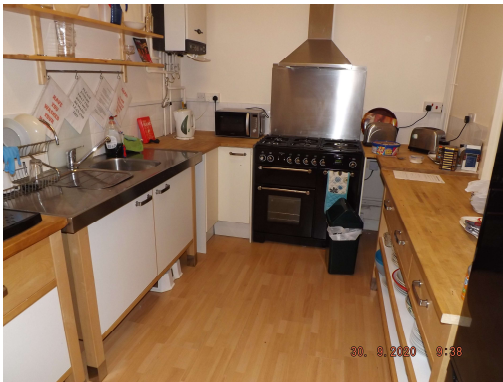
24.2. Large catering double stainless steel sink and inset stainless steel wash basin provided in the kitchen.

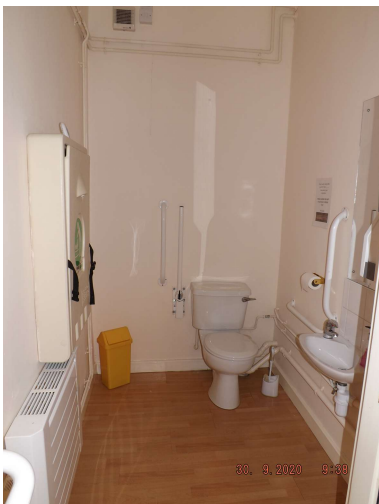
25.3. Accessible wc with appropriate fittings and baby change shelf. No alarm.

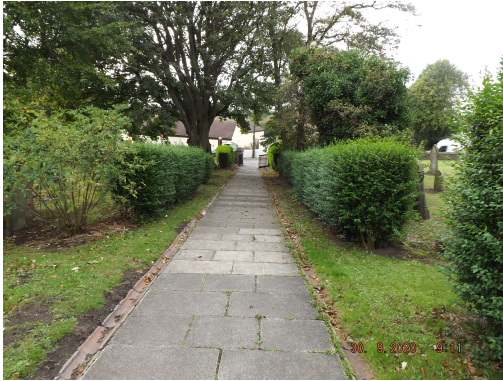
- 27.1. A large sloping church yard with numerous headstones in all parts. Many of the headstones have been lowered for safety reasons or have been vandalised. Some near west boundary very damaged. Some interesting designs
- 27.2. Concrete flagged path is in reasonable condition.

- 27.3. Trees at boundary and adjacent to church. Tree preservation order 1984.
- 27.4. Some trees close to north and west boundary wall are affecting the stability of the wall and should be pruned back.
