Oxclose Church, Washington
(CH. No 300)

Quinquennial Report

16th August 2021

Sarah Harrison RIBA

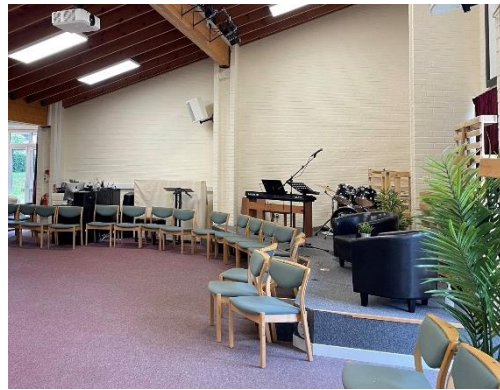
62. Worship Area: Upright piano having a walnut veneered case, made by Hyundai. (covered), keyboard, drum kit and digital audio control panel area, various seats and other sundry items. Beech veneered altar, one large cross.

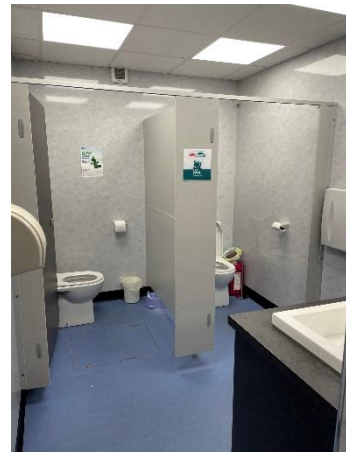
73. There are 3 separate toilets, 1 unisex accessible standard toilet 1 ladies' toilet with 2 cubicles and 1 former WC adjacent to the creche.
74. The WC accessed from the creche is no longer used, it was unclear if the fittings have been removed as the room is currently used as storage and items could not be cleared out.
75. There is a cleaner's Belfast style sink located within the Cleaner's Room.
76. The kitchen has a Selectra electric water heater, all other areas are supplied by the new boiler at item 67.
