Diocese of Durham

St Thomas Church, Petersfield Road, Sunderland, SR4 9BD

Quinquennial Inspection

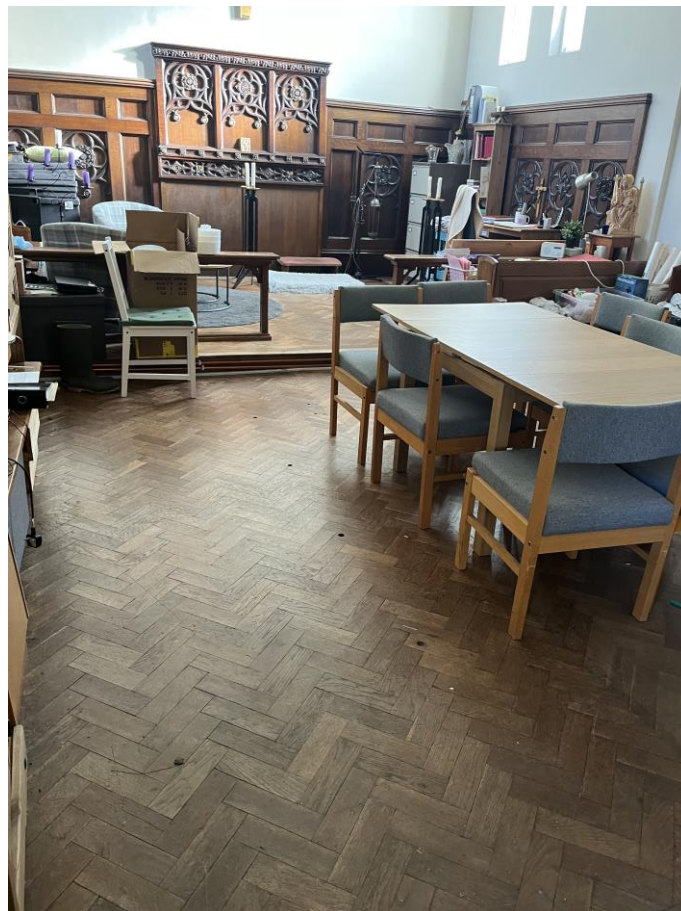
The lady chapel which is now being used as the office. The walls are plastered and in fair condition, to the rear there is hardwood timber panelling all in good condition.
