QUINQUENNIAL INSPECTION REPORT

PETERLEE, ST CUTHBERT

**QUINQUENNIAL INSPECTION AND REPORT
January 2024**

David Beaumont BA (Hons) Grad Dip, RIBA, AABC

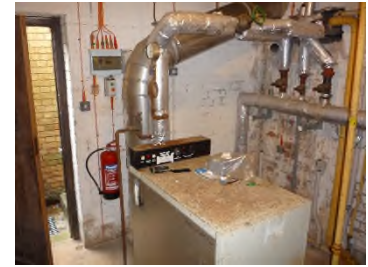
- **Heating:** by gas fired Hamworthy Broadstone boiler installed in 1990 and providing heating through large diameter pipes to radiators, serviced in July 2023. Relay repaired. Grundfos circulating pump. Sump in the boiler house which is understood to be working. Pressure vessel with low feed cistern on the boiler house floor. The circulating pipework was reinstalled in 2000.

Recommendation: none

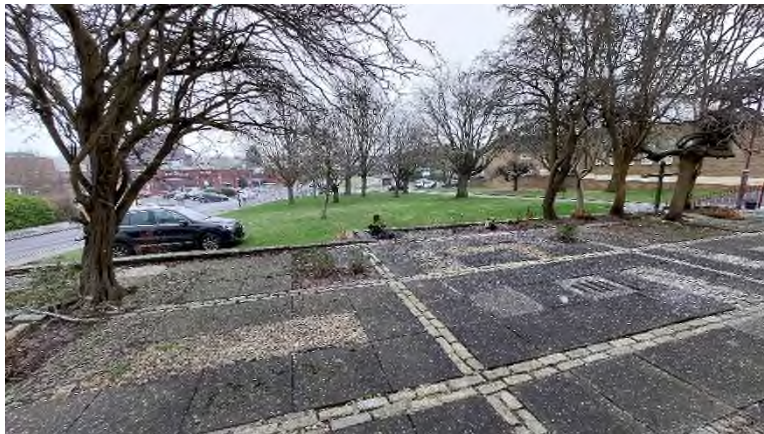
- **Churchyard:** there is no churchyard with burials, though the church sits within a large, landscaped site. The responsibility for maintenance lies with the PCC (but was formerly the Town Council).

Recommendation: none

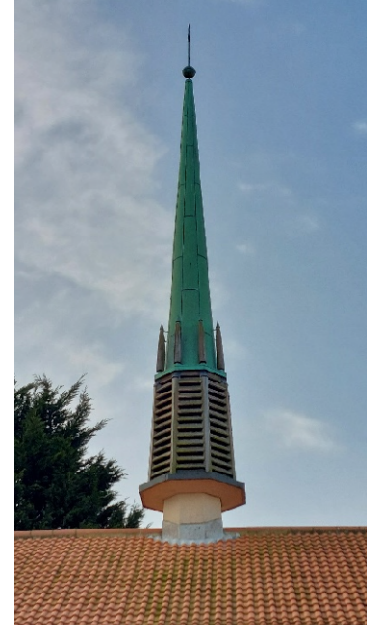
Found to have rotten structure during 2019 roof reslating requiring immediate attention due to concern of possible collapse. Works were: rib member repairs, holding down metal brackets replaced, new larch louvres, electric bell chiming system renewed. Copper cladding was looked over and appeared sound. Concrete octagonal base repainted and new flashings to roof. All looks ok from the ground.

Recommendation: none

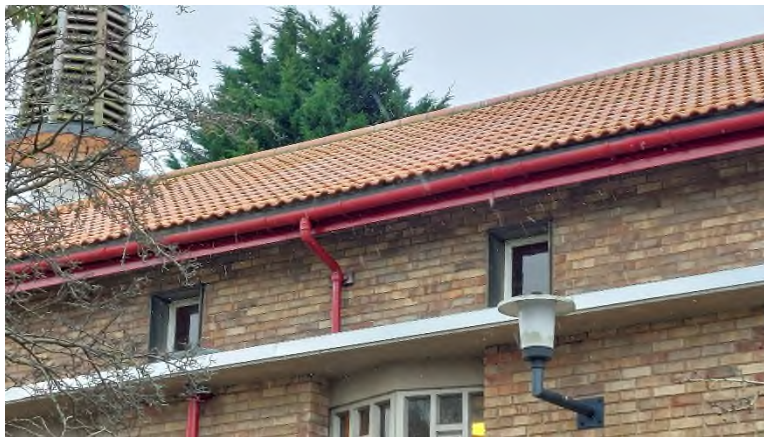
ROOF COVERINGS

B Roof general:

Nave/Chancel Pitched roofs covered in 2019 with new Bridgewater clay double roman tiles and clay ridges. Including new Roofshield underlay and 75mm Kingspan insulation. Loss of verge pointing at east end.

Recommendation: carry out stair roof repairs, repair verge pointing
