St Cuthbert, Redmarshall

Quinquennial Report

18th January 2024

Sarah Harrison RIBA

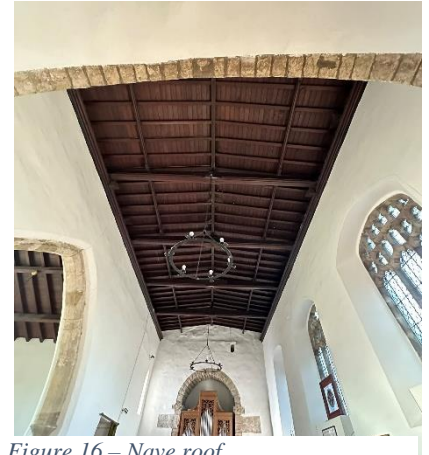
Figure 16 – Nave roof

- 12.1 **Nave & Chancel:** Reported as C19th, stained shallow softwood trusses, purlins and rafters. Exposed sarking boards.
- 12.2: **South Chapel:** Exposed rafters and purlins with softwood boarding above. The boarding is very stained to the E, SW and at ridge. The roof above is due for replacement.
- 12.3 **Flower Room:** has modern coupled rafters, ply boarded between rafters.
- 12.4 **Porch:** mono-pitch with exposed rafters and boarding. All boarding is very stained and any rotten timber should be replaced as part of the re-roofing scheme.
- 12.5A small area of watermarked and softened boarding at the chancel SE corner was found at the reroofing to be strong enough on top to be left unrepaired. The same area of staining can still be seen and it will need to be evaluated if it is getting any worse over time.

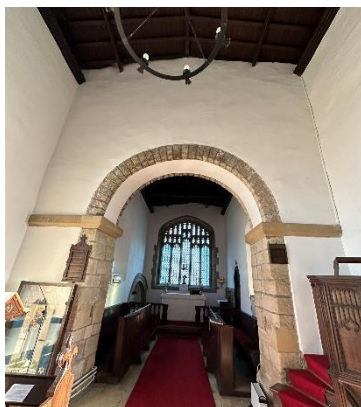
Figure 17- Chancel Arch

- 13.1 At the Chancel a round arch, slightly flattened at the top, exposed stone to each side with plastered finish in the centre. All in good condition.
- 13.2 The South Chapel arch is chamfered limestone inner arch on corbels with carved heads. The surrounding arch is chamfered and finished with plaster down to floor. Both good. Signs that a former screen has been removed.
- 13.3 In the Chancel, an ancient arch to the N of the altar is weathered but sound, in the recess the cill is said to be a medieval cross slab. On the opposite side, the traceried sedilia are equally worn. The seats are now very low, perhaps because the sanctuary floor has been raised over time.

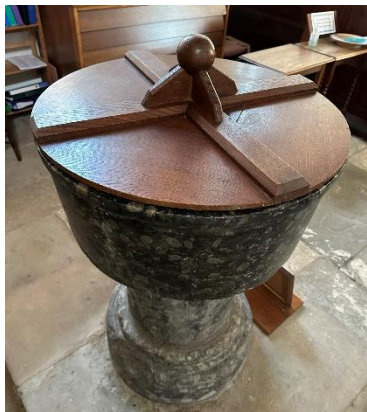
Figure 25- Font

19.3 Frosterley marble font, circa 1200, on a later large square stone base all in good condition. A more modern cover has been added.
