St John's Church, Shildon
(CH. No 184)

Quinquennial Report
On the architect's inspection of

26th August 2021

Sarah Harrison RIBA

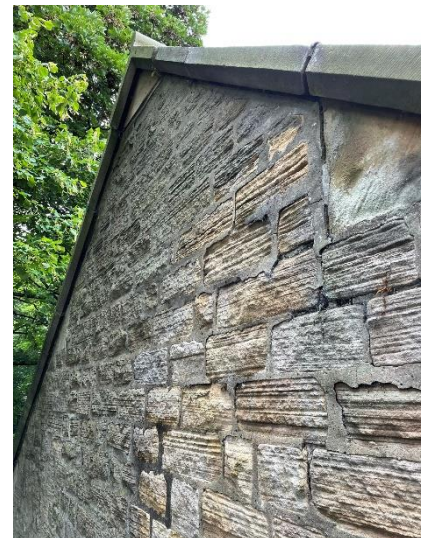
Item 50- Open Joint

48. The dressed stonework to both window openings to the **nave either side of the tower** have severe face erosion to the hoodmould and reveals.
49. There is one laminated jamb stone to the **south porch** window and an eroded plinth stone under.
50. There is an open joint to the side of the intermediate kneeler block to the right side of the **North aisle** gable. Much of this area shows signs of surface erosion with over hard mortar. A clean area of stonework could be caused by warm moist air from the kitchen boiler flue.
51. Very minor crack to immediate left-hand block of the kneeler and quoin below to the south corner of the **south aisle**.

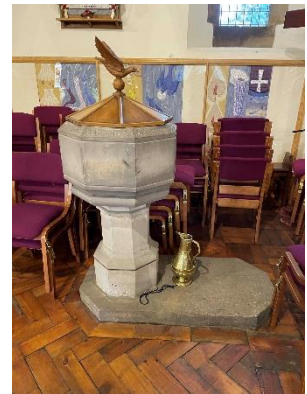
Item 119- Font

119. There is a simple oak lectern and a brass eagle lectern. The pulpit is stone with brass detail. The font is located in the north aisle, made from stone with a sculpted lid.

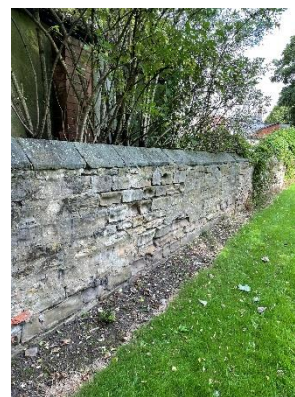
Item 153- Boundary Wall

152. These consist of essentially private or restricted areas to the east and south sides, with the church yard on the west and north open to the public and maintained by the local authority.
153. The boundary wall to the north side of the church yard is in poor condition, the stone is eroding and there are several areas of large vegetation growing through the wall, destabilizing the stonework. This should be reported to the maintaining authority for action. The remainder of the church yard appears to be in good condition.
