QUINQUENNIAL INSPECTION REPORT

SHINCLIFFE, ST. MARY

QUINQUENNIAL INSPECTION AND REPORT

October 2021

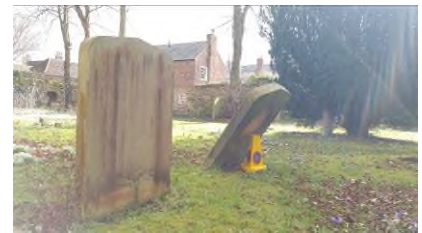
- B Churchyard:** The churchyard is open though the Council cut the grass. The headstones were topple tested circa. 2016 and there is one on the S side that is threatening to collapse.

Recommendation: Attend to headstone.

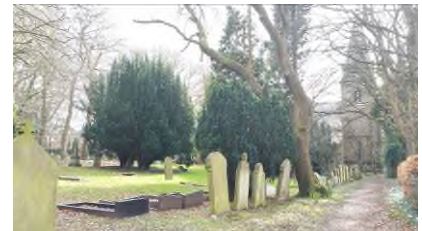
- **Trees:** A very large number of mature trees, in fact the site is perhaps over filled with trees. They are subject to tree preservation orders and were assessed in 2019 by the PCC's own contractor. Removal of trees to the N side are planned for this year.

Recommendation: None.

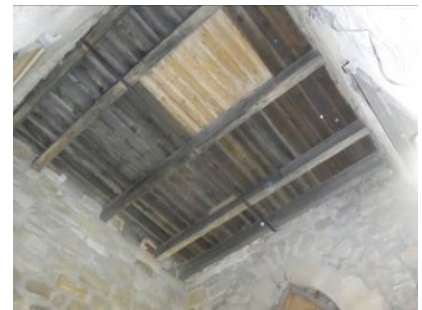
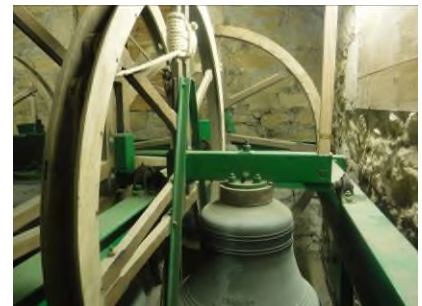
No obvious access to trap door to the ceiling. Walls are all exposed stonework cement and lime pointed with some evidence of earlier limewash, they all seem ok. The floor is dry, slightly dusty but good boarded floor. Has a steel bell frame, painted that looks alright, has six bells that look like Whitechapel bells with 1969 date on one of them. The hand hold is coming away here and it needs far better grabrailing and obviously access up to the spire. Walls have permanently fixed baffles to them with drop down hoppers for sound and they seem ok.

Recommendation: provide access to spire (not a vertical ladder) and grab handles

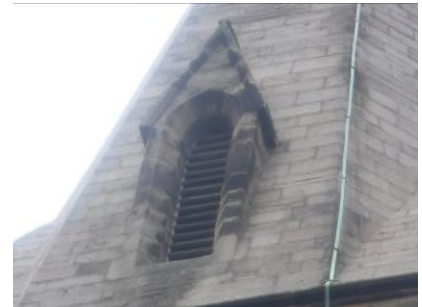
Erosion to the Lombardy corbels. Replacement circular mullion, timber louvres slight wear to one of the louvres by the looks of it and there are Rooks up in the belfry resting on the quatrefoil, don't think they can get through.

Recommendation: none

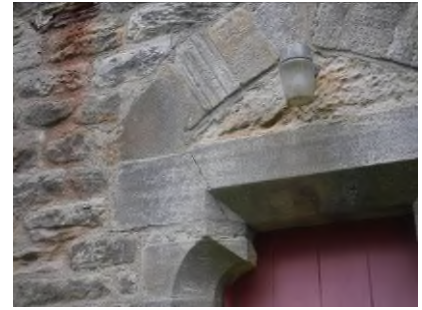
walling eroded slightly by the nave and to the left of the doorway. Crack to the lintel of the doorway (same as last QI) and the door itself has decoration breaking down, same sort of design and colours as the porch door. The pointing around the step could be renewed.

Recommendation: renew pointing around step, redecorate door

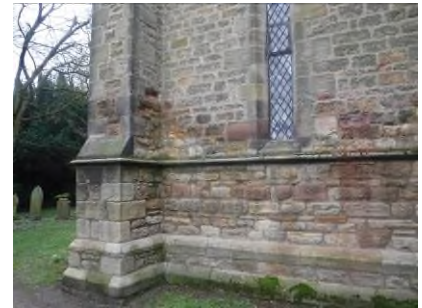
Walling ok. Lancet window clear glazed and ventilator looks rusted up. N buttress slight erosion to the stonework.

Recommendation: repoint open joints

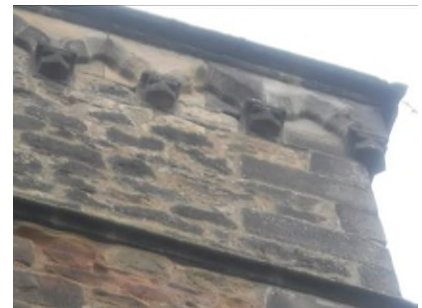
OK. Lancet window, diaper leadwork, clear glazing alright.

Recommendation: repair louvre

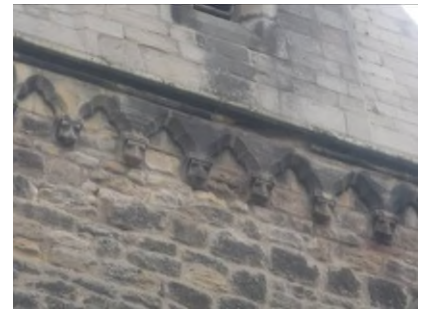
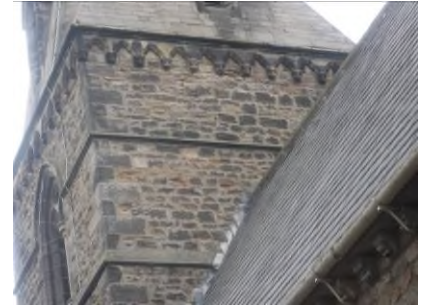
Frieze some erosion to the stonework I think and below that the walling is ok and it is mostly enclosed by the nave.

Recommendation: none

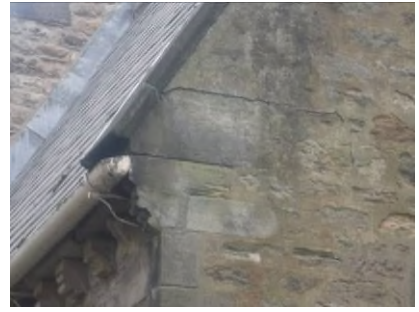
All the ridge bedding is ok but it has been patched in the past, couple of cracked slates, some slipping the E abutment flashing to remedy.

Recommendation: remove moss, replace cracked and slipped slates

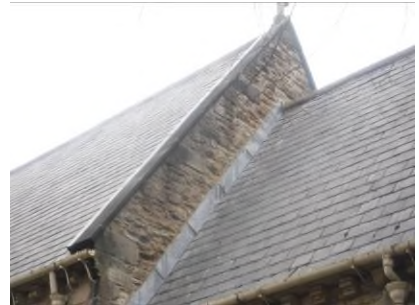
South Side

Ridge has lost its pointing in four or five places, it has been patched in the past, tower abutment step flashing looks ok with one minor open joint halfway down. The masonry abutment to the chancel arch is due for a repoint (see walls section). General slating ok, has been patched much at the top and there is some foreigners in there as well.

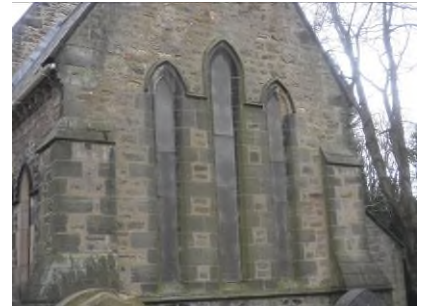
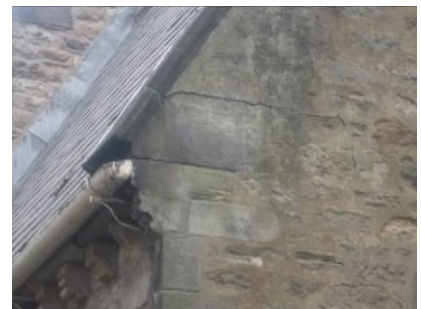
Crack to the kneeler on the S side but that is probably not a problem, it has been smeared over with cement rather, couple of pockets and the bottom plinth has a line of an open joint.

Corbel looks ok apart from the penultimate at the E, walling is ok, slight open joints at the string course at the buttress, no obvious cracking.

Recommendation: none

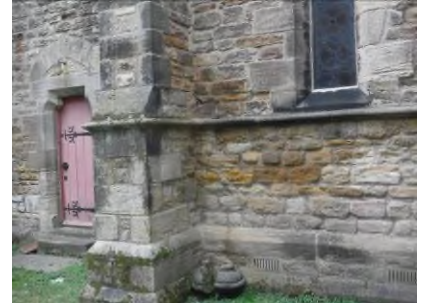
East: Open joints and eroded stonework.

South Side: Corbel course ok, walling alright apart from the plinth that is worn through just damp erosion over time and there is some open joints to the W side, the buttresses look ok.

North Side: A Small area of stone just above the N aisle, pointing looks fair but when someone is next up on the roof it would be worth looking at it particularly the eaves overhang if there is any rot to the timber there, that might be possible.

Porch: some damp affecting the masonry on the S side. Repoint wanted but not in next 5 years.

Recommendation: replacement walling and repoint east gable, check stone band above north aisle below nave eaves

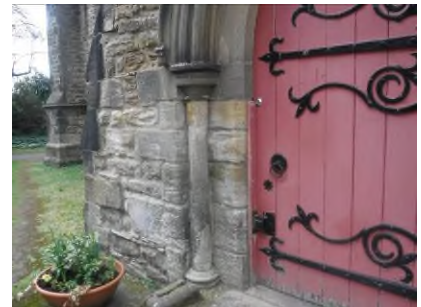
South Side

Some cracking and erosion here, it is not troublesome but we could do with keeping on top of this, it is a lime mortar, looking good, there is a slight crack to the W side above the arch. The arch itself has eroded and the nook shafts on the W is wasting away, quite a nice gritty sandstone and that is due to damp. The E has had a cement repair which hasn't helped. The order of the arch on the E side is eroding, why only the E side? Perhaps that is the quality of the stone.

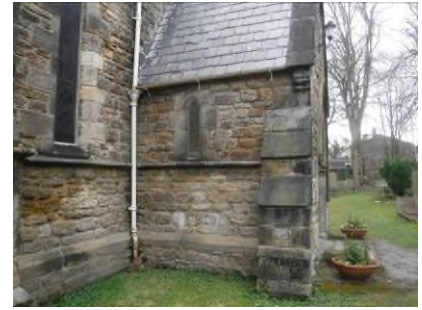
West Side

Couple of open joints that could do with repointing. Walling is a bit poor by the W buttress.

Recommendation: repoint open joints

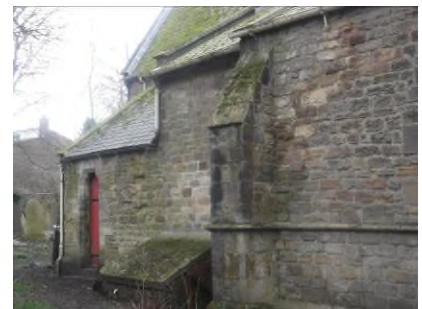
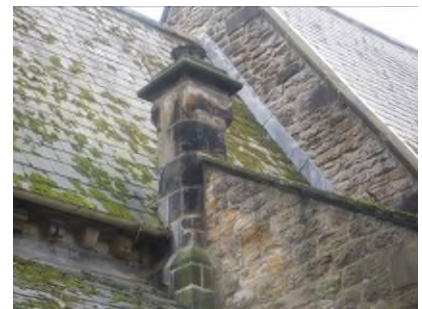
Walling here is a bit patchy, the arch to the boiler house going a bit but it will survive 5 years, there is wear at the window above the arch and patchy pointing, it is the guttering failing again it must be back falling, some eroded stones but they are fine.

Recommendation: none

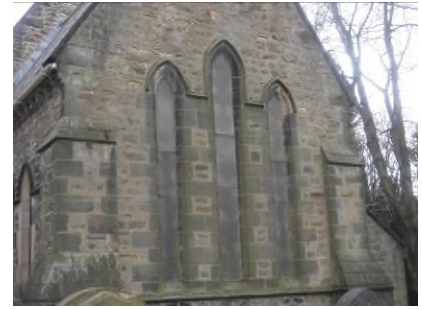
Four individual lancets, ashlar surrounds look ok, pictorial glass, diaper pattern and no protection.

Recommendation: none

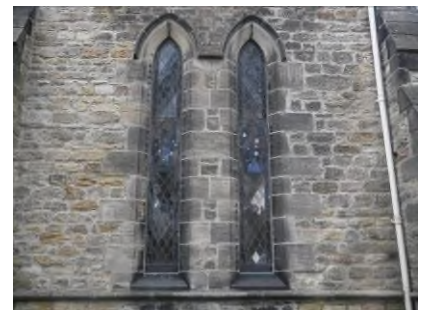
A pair of lancets plus three individual lancets, five in total, pictorial same as the chancel, unprotected, it looks as if the ventilators have been repaired in the past to keep them operational and all the glass looks good but unprotected.

Recommendation: none

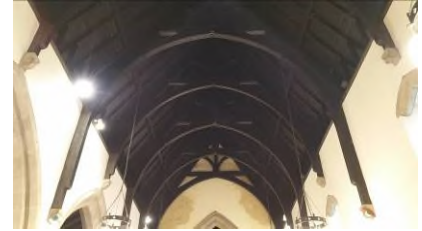
Arched braced roof with nine trusses with legs down on to decorated corbels, dark staining to them, all reasonably sound. There is a little light water penetration on the N side due to previous leaks and there are a few cobwebs. The water staining is most prominent on the N side W end against the tower.

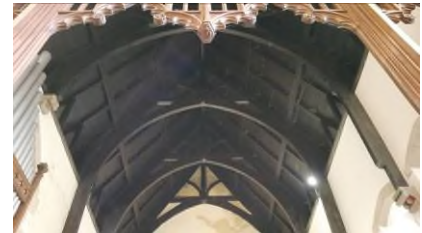
Same design as the nave with five trusses one shortened just above the nave arch and they look ok, some water staining at the N E corner looks more recent and that's close to where the wall damp is, there might also be some damp behind the truss up against the chancel arch on the S side, it would be worth checking when works have been carried out up there.

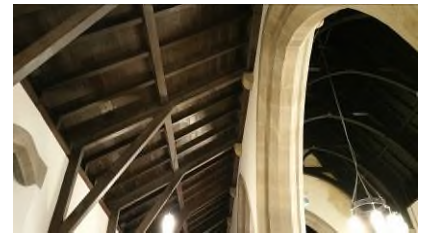
The roof timbers are simple trusses with raking struts off corbels like the nave and all looks ok, the wall plate up at the arcade seems sound, there doesn't seem to be any movement but the decoration is just a little dull.

Recommendation: none

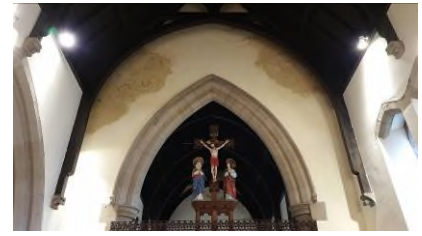
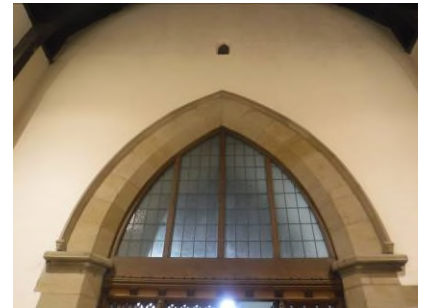
The arch itself is sound there is no cracking to it. Its lancet shaped arch and the bases appear not to be affected by damp significantly though there is a little bit on the N side.

Lancet arch like the chancel, no defects though there is some erosion to the stonework at the bottom.

Recommendation: none

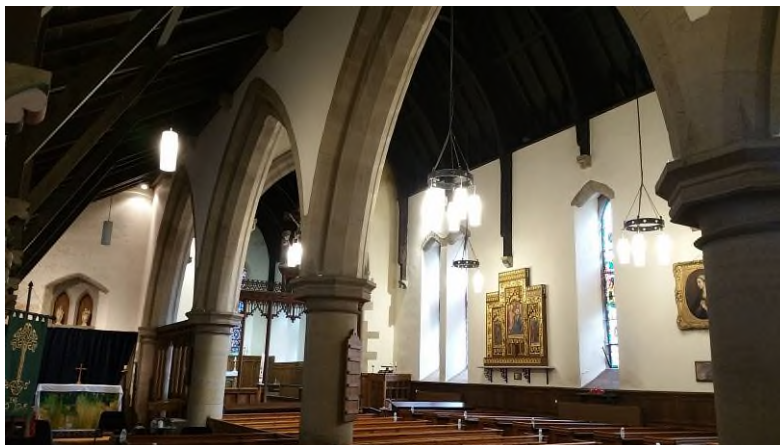
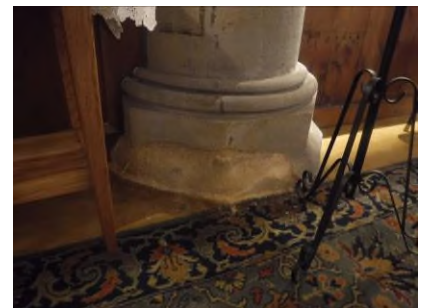
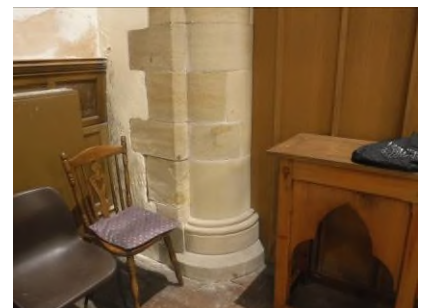
- **Arcades:**

Four arcade arches with circular columns and semi-circular responds, the arches are all sound, no cracking to them at all. There has been some stonework repair to the W column at low level. Slight erosion to the bases of the two full columns to the E.

Recommendation: none

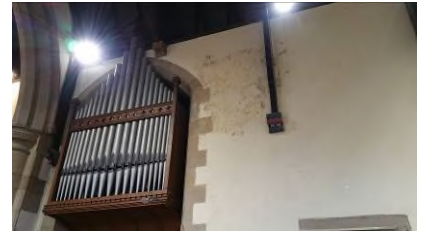
N wall alongside the organ arch is a large area of plaster where the chimney has previously given problems but that has now been repaired.

East end high level at the S side this is possibly the watertabling above.

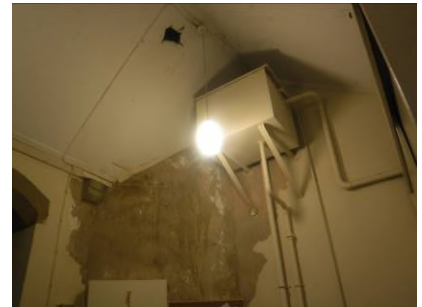
Plaster loss above the chimney fireplace, probably a previous leak otherwise generally fair.

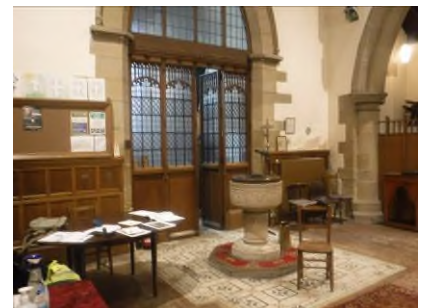
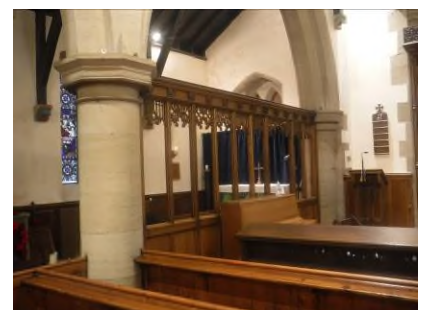
A parclose screen in oak, same design as the tower I think. The chapel was refurbished in January 1974

Recommendation: none

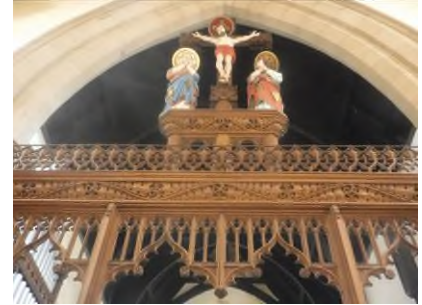
There is dado panelling both to the chancel and the nave in oak and in good condition.

Another nice delicate screen separating the nave from the chancel in good condition.

Recommendation: none

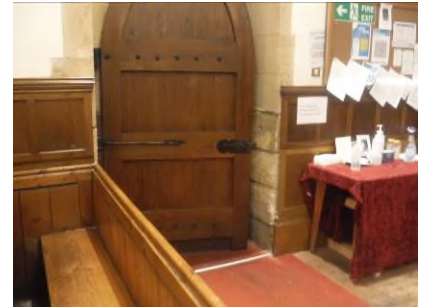
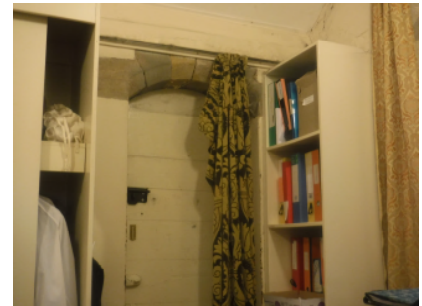
Boarded oak with heavy ornamental hinges all ok.

Recommendation: update porch door

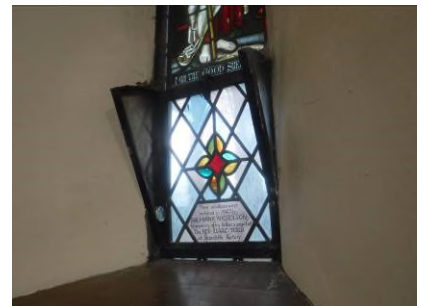
C There are opening ventilators to the glazing and it would be worthwhile just checking that they all operate.

Recommendation: check ventilator operation

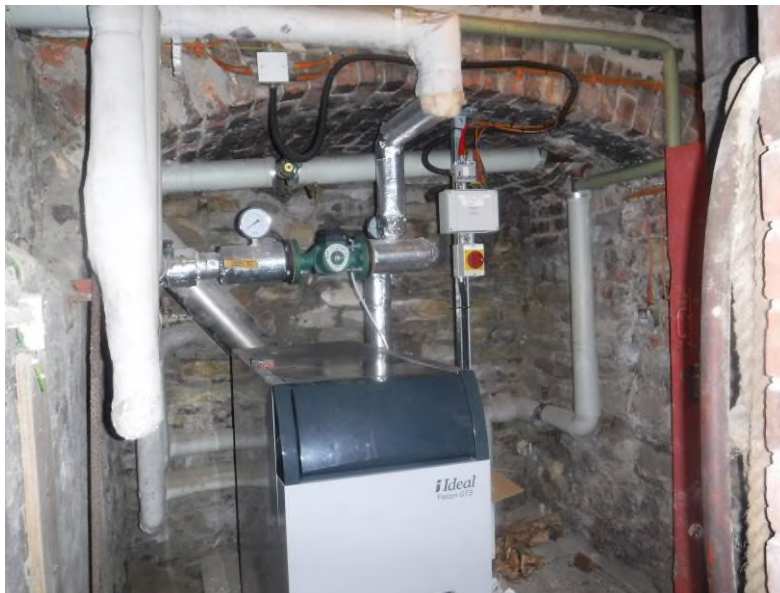
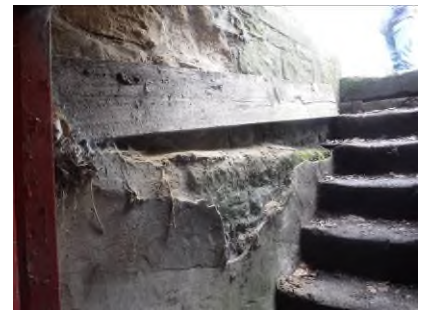
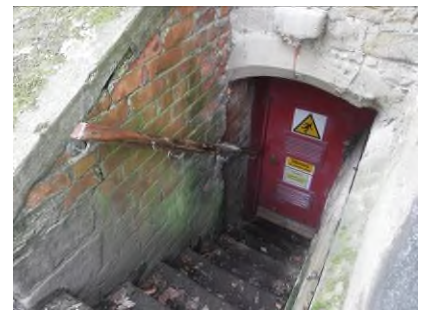
Concrete flat roof is ok, it has got a timber part and that seems dry enough.

Walls are a combination of stone and brick, they are ok. Floor is concrete and that is alright. Boiler sits on a concrete plinth to get it out of the water and there is a sump pump and hole that is all dry.

The boiler is an Ideal Falcon GTS. The door is a little bit lightweight it has got quite a simple rim lock on it that could be easily broken into and it looks like it has had a little bit of a temporary repair, someone could kick that in reasonably easily. The handrail to the steps is rotten and the steps themselves are a bit worn and a bit slippery when wet, the sides to the stairwell has got some render that is coming away now and there is some stonework that is

Recommendation: upgrade door security, replace handrail, remove render and boards to sides

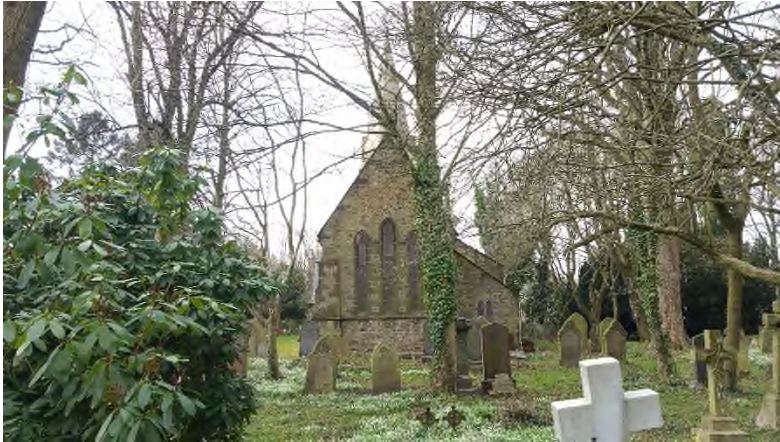
There is a bit of build-up of brash about the place but that is planned to be removed.

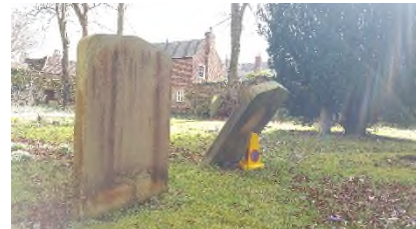
- B Churchyard:** The churchyard itself is open and it has a gravel path around the perimeter of the church building in golden gravel, with a tarmac path up to the entrance. The area is containing many memorials and tablets. Some have toppled. There are also mature trees covered by Tree Preservation Orders.

Recommendation: The church should establish which boundaries are in their ownership and thus their responsibilities. Ensure topple test has been carried out. Develop management of fallen gravestones.

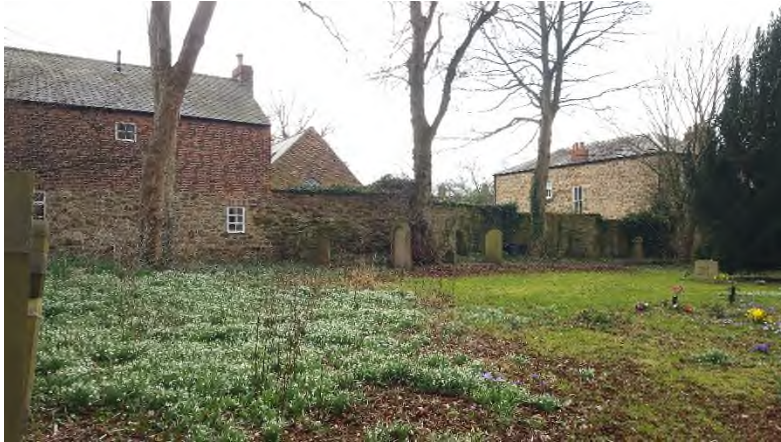
This is the principal access on to the site from the village. Limited car access available across grassed and tarmac area. The boundary has a house and its adjoining garden walls on the boundary, whose wall is in reasonable condition. At the Easternmost end is another dwelling. At the South-East corner, the land has a piece taken out of it by a lean-to construction built in poor quality stonework and some brickwork which has multiple open joints.

The remaining part of the boundary is that house's garden wall which has open joints to the stonework.

Recommendation: repoint open joints

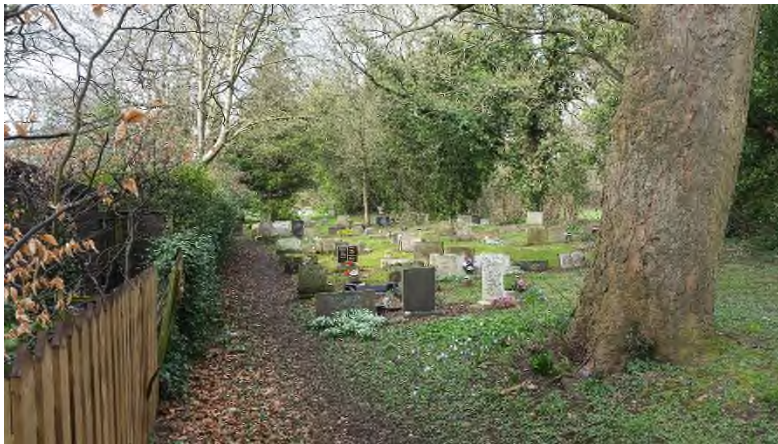
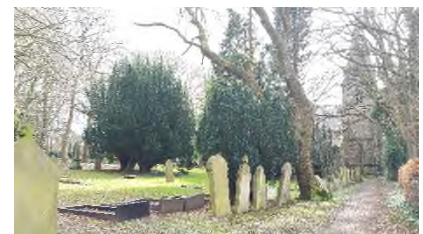
At its Northern end, there is a further parcel of land that projects beyond the West boundary to provide additional burial space. This also has its Northern boundary open to the road. The Western and Southern boundary is a combination of domestic fencing, hedges and stone walling.

Recommendation: repoint open joints

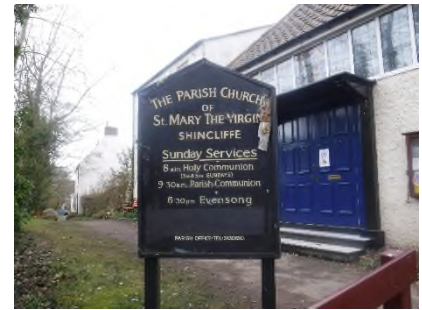
E Signs: Poor condition

Recommendation: update
