Diocese of Durham

St SIMON SOUTH SHIELDS
(119)

QUINQUENNIAL REPORT
on the architect's inspection on

14 September 2022

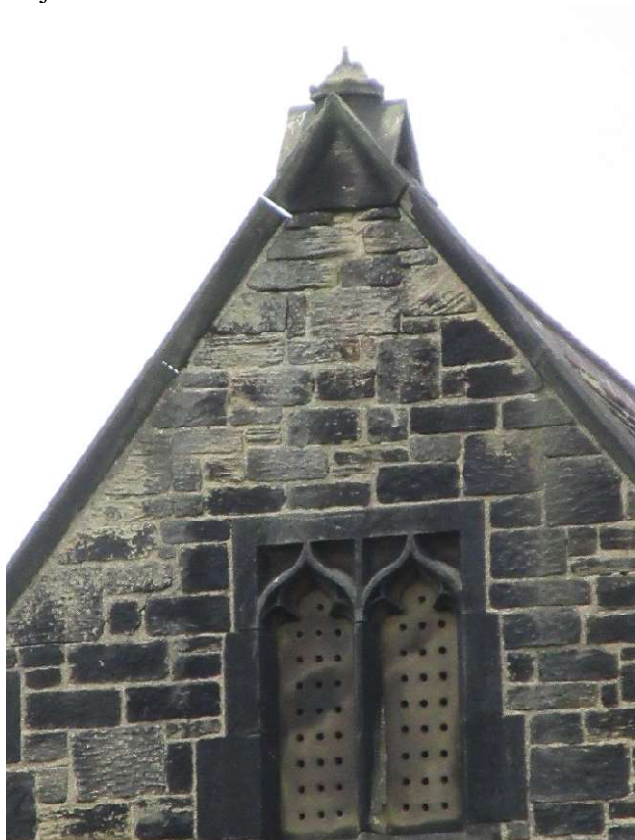
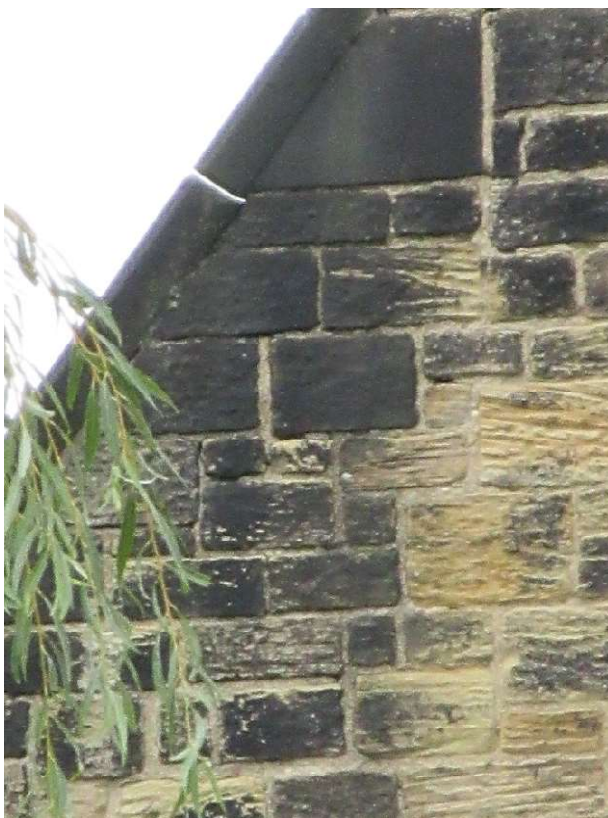
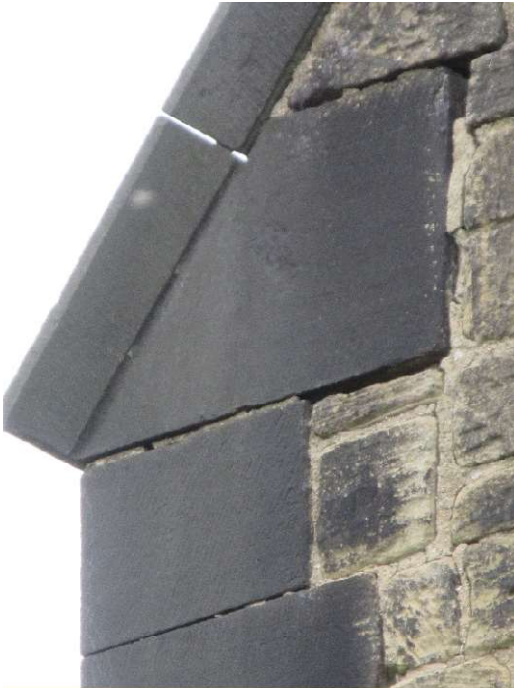
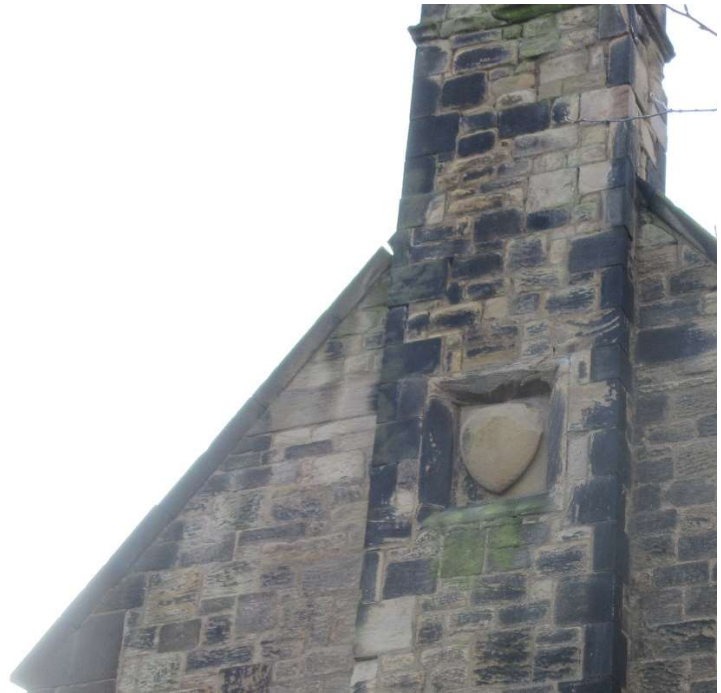
paragraph 30

27. Squared random sandstone with dressed quoins. No buttresses.
Crosses missing from both gables. Single or double plinth. Seven blank shields carved at E end.
28. At E gable very minor crack just over and under the N side of the window and opening of some window arch joints show slight spread of the gable, also shown by opening of some glazing joints (paras 7, 56).
29. Visible slight lean of the S wall has separated its head from the timber cornice inside and dirt falls down the plaster. No change.
30. Some gable coping joints are open. Slight movement of some kneelers (the top stones at the corners which support the copings on the gable). They are too short to be well bonded. Slight movement cracks at the joints around the SE kneeler

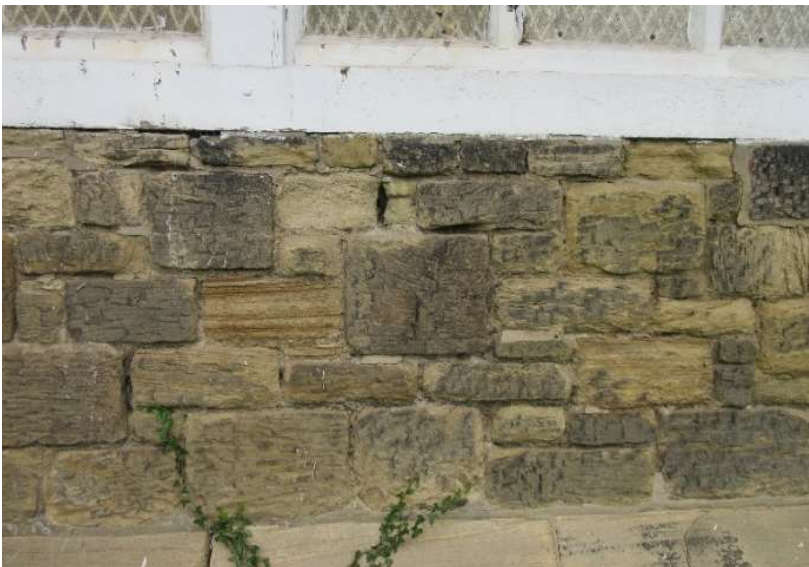
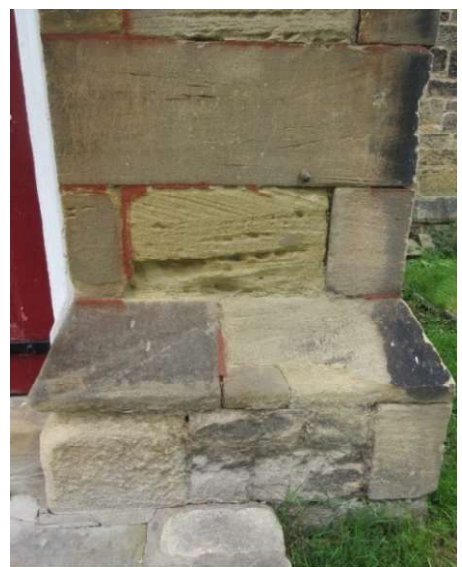
31. The spread of the Porch inner arch is unchanged.
32. Good flush lime mortar pointing throughout except minor erosion and open joints at gables under open joints in the copings, under the SE gutter end and under the Porch W cill.
Old telltales at narrow cracks under the E and W windows and two S windows. The cracks are pointed in hard cement mortar which is dropping out with part of an old telltale under the SW window.
33. Open joints in Vestry plinth. Some stone decay begins at the Porch S and W faces.

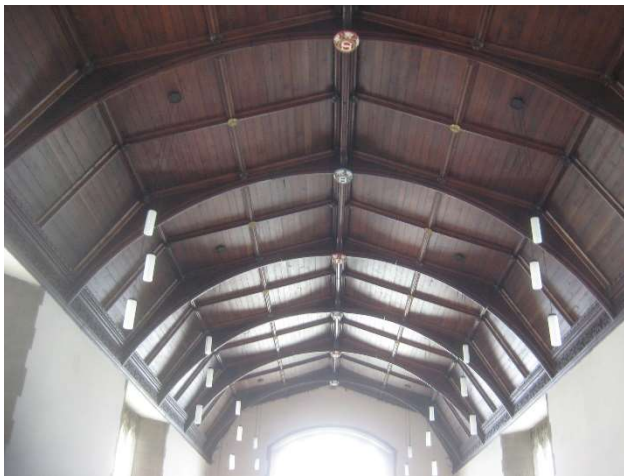
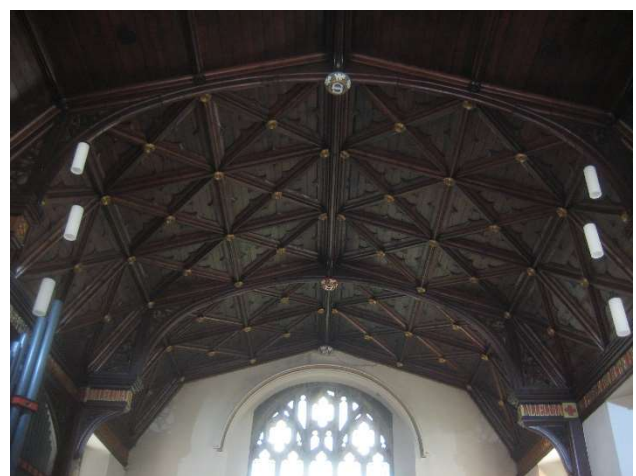
44. The **Nave** and **Chancel** wagon ceiling is close butted horizontal varnished softwood between moulded ribs and major curving cross ribs. Gold painted carved minor bosses and white, gold and blue or red major 'S' bosses at the ridge.

45. Numerous minor gaps between the boards must let warm air escape. The strip of glass fibre laid each side of the ridge does little to prevent heat loss.

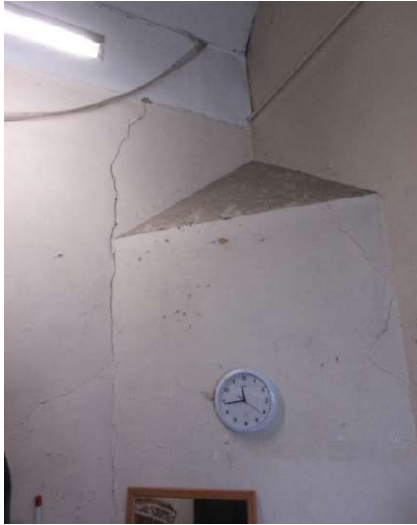
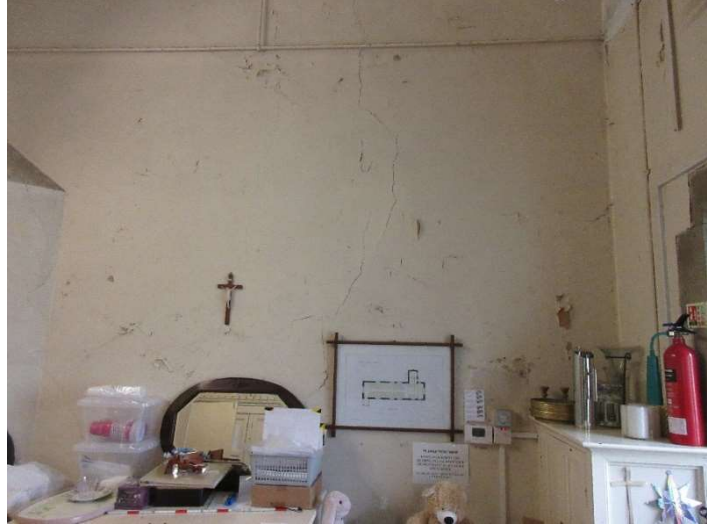
52. Decoration is generally fair except in the Vestry but all cracks catch dirt and look poor. Corner cobwebs. Dirt at the top of the S wall by the Chancel step due to wind blow at the gap between cornice and wall is highlighted by a floodlight. Vertical cracks in the **Vestry** N wall especially L of the former NW corner fireplace. Flaking paint in the Vestry passage R of the external door.

53. Last decoration seems to have been at the end of the 1960's, soon before the expanded floor fill, the probable cause of the cracking, was dug out. Movement appears to have stopped then. Filling and painting at least the cracks would improve appearance and reveal any future movement.
54. Natural stone window reveals, painted over at Chancel.

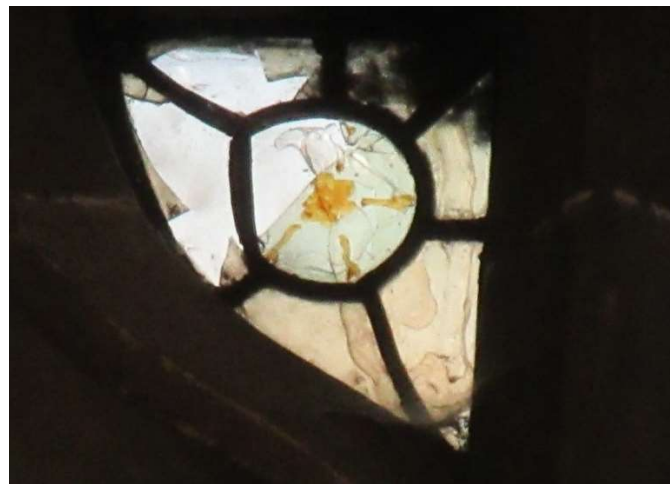
57. S Chancel two light - Meshlite dirty and very clouded.
58. S Chancel three light – SS Mark and John, The Seed in the Word of God, 1906 Wolstencroft commemoration. Heavy saddle bars, sound glass but very dirty.
Wire mesh sound but visible against sun.
59. Six four light Nave windows and five light W window all have sound Meshlite, clouded with some burn marks and very dirty especially at W.
60. At top of N and S tracery small leaded floral painted glass remains with several minor cracks and seven broken pieces letting out warm air.

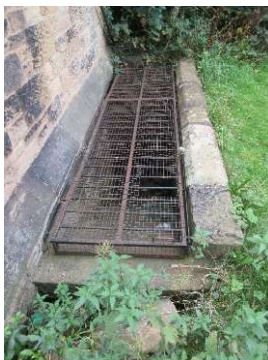
76. Changed 1997 from boiler and radiators to Temcana individual gas fired convectors each with stainless steel balanced flue and sound galvanised mesh cover. All replaced since last inspection. Six Kestral 400s in church, one Kestral 250 in Vestry. Timer and thermostat in Vestry. Said to be effective and economical. The fans in convectors tend to become noisy with age.
77. For the former boiler room an outside stone stair with low kerb is secured by a hinged welded steel mesh lid with two padlocks.
The timber door hangs open and one hinge is broken. Door and frame are deteriorating.
78. The two rooms are well ventilated but said to flood. Sump pump with plastic waste to outside gully. A lagged water pipe to the Vestry sink is not well supported. Used as a gas meter room and furniture store. Cut end of a stainless flue liner still in the disused flue.
